PHOTOGRAPH LOG

Environment and Infrastructure, Inc.
7376 SW Durham Road
Portland, Oregon 97224

PROJECT NAME: Pasco Landfill Cap Project - Cap Construction Project

Project No: 4-61M-10705-1 P-02

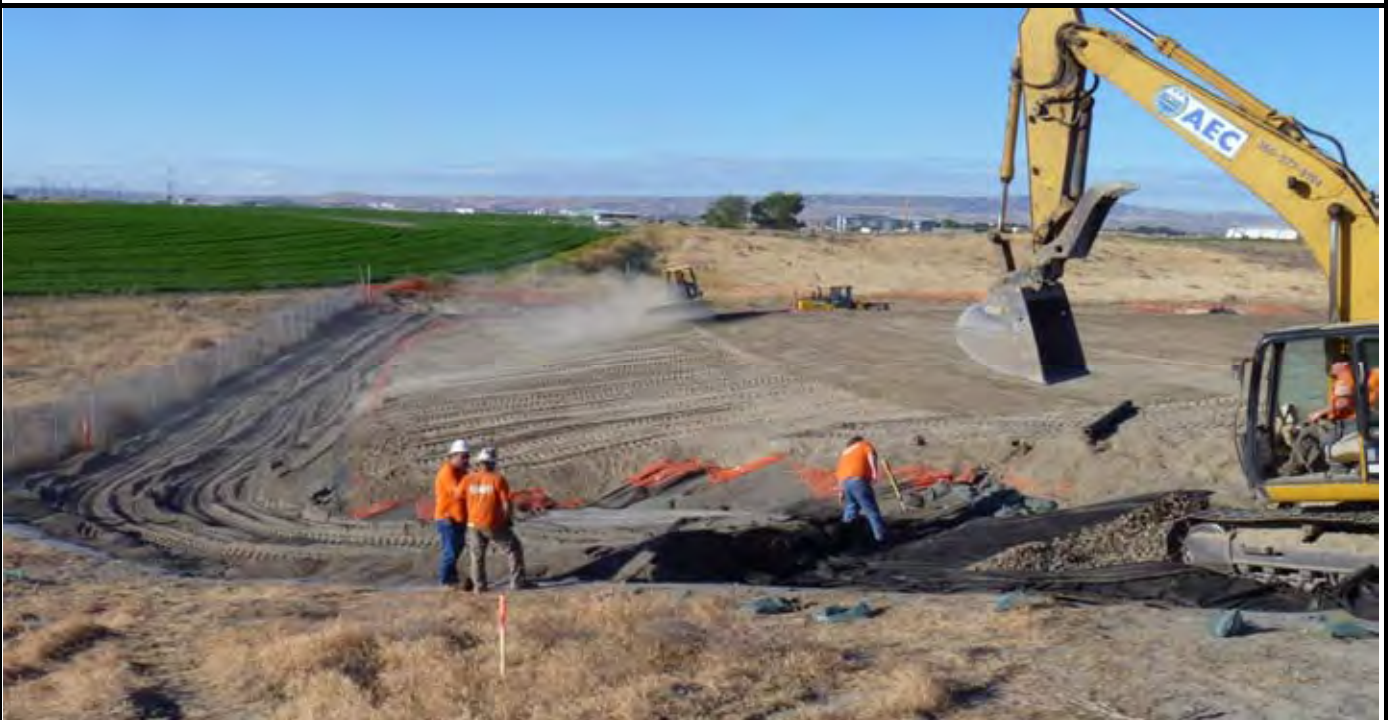
Photo 2: AEC grading perimeter swale sand and laying out Geo-Fabric and perimeter rock on Northeastern swale. View looking south from NE corner of the site.

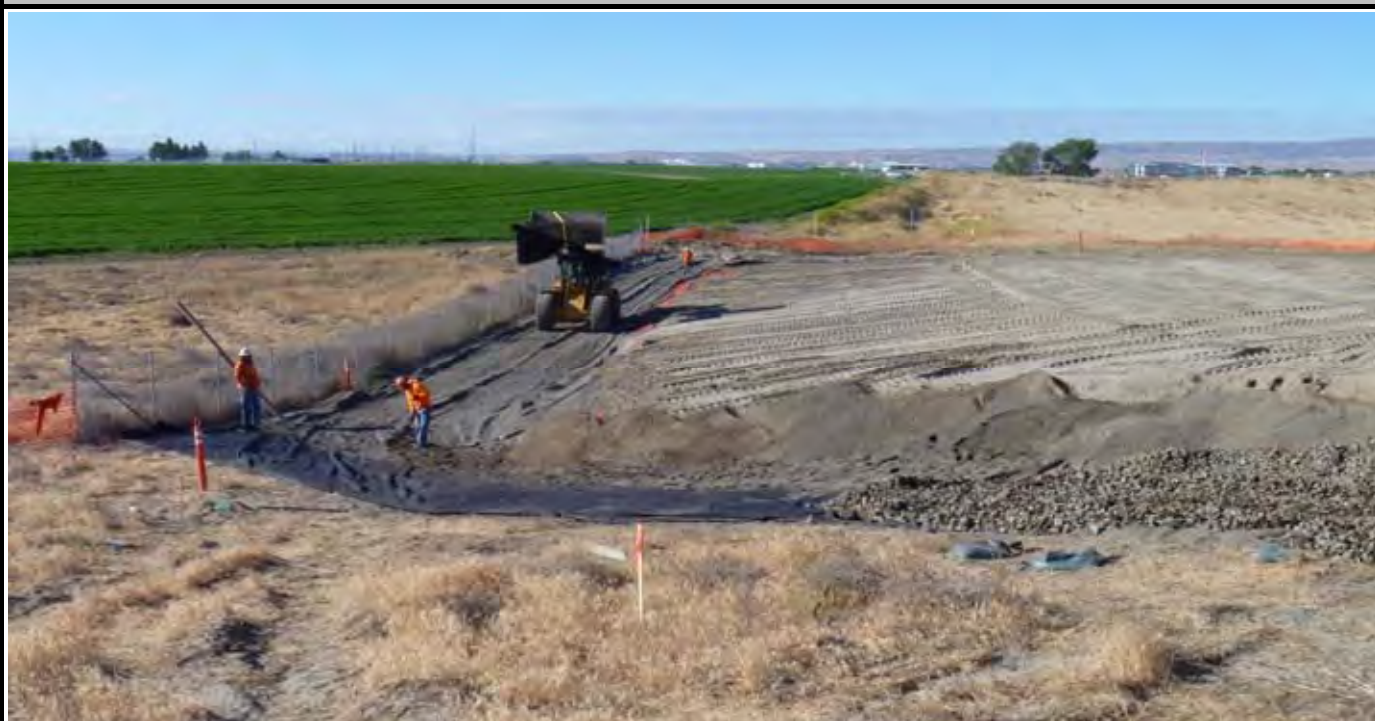
Photo 3: View of AEC working on the NE and eastern swales. Note loader bringing roll of Geo-Fabric to be installed over the sand layer on the eastern swale. View looking south from NE corner of the site.

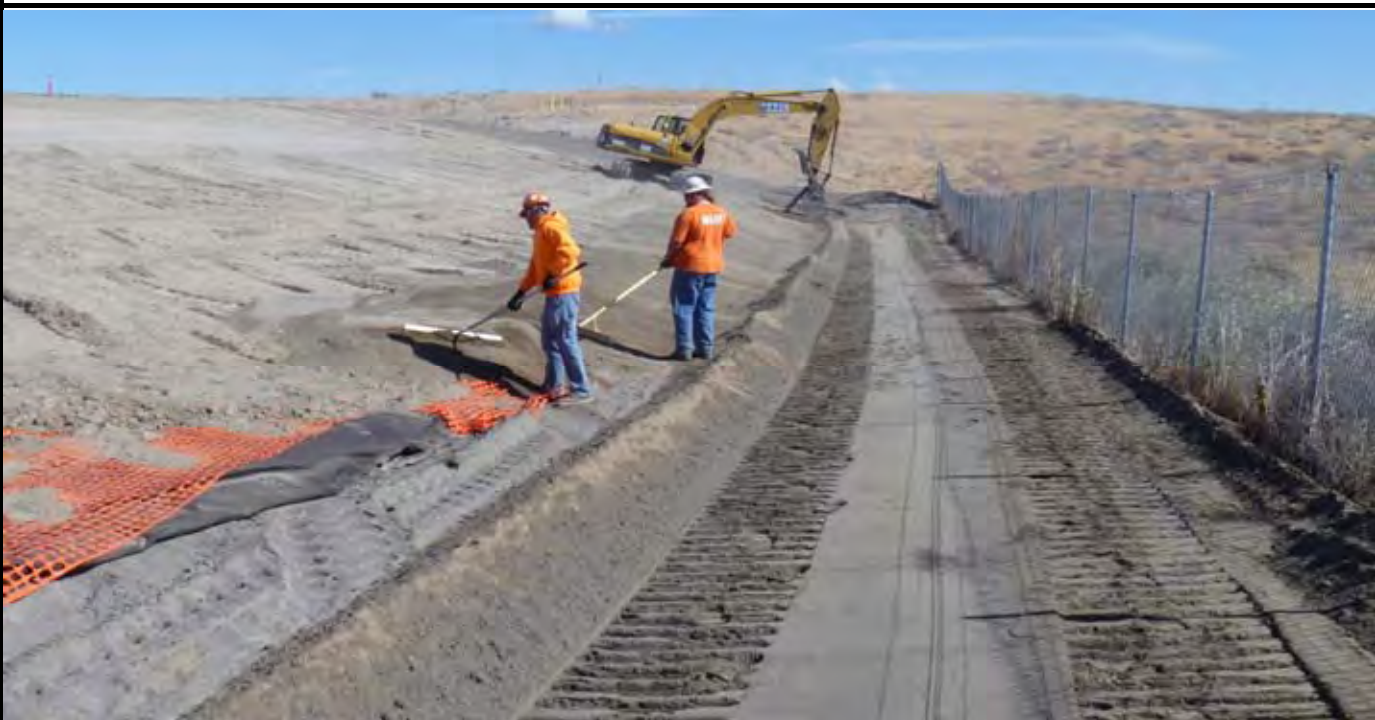
Photo 4: AEC fine grading the EOC along the eastern perimeter of the CAP. Note the bulldozer has graded the perimeter sand layer and prepared it for the Geo-Fabric. View looking north from SE corner of CAP.

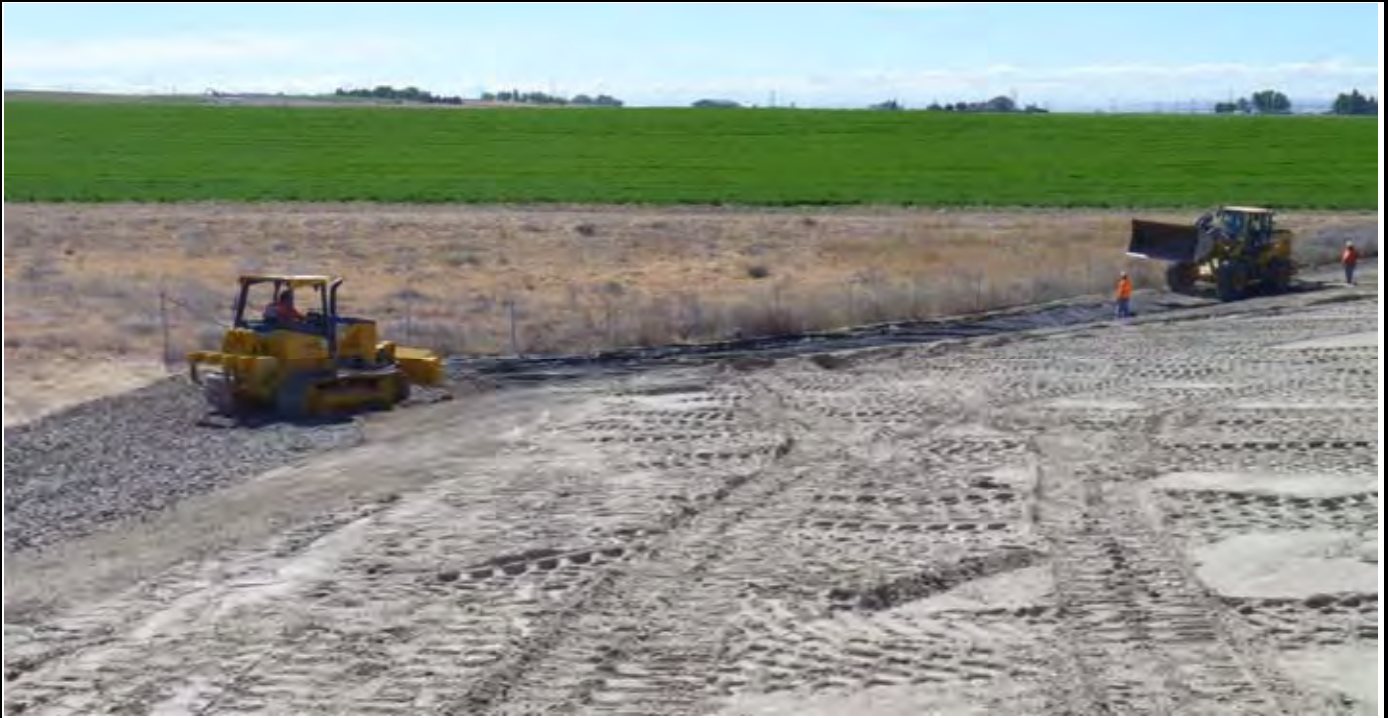
Photo 5: View of AEC grading perimeter rock over the Geo-Fabric in the eastern swale. View looking SE from the northern end of the CAP.

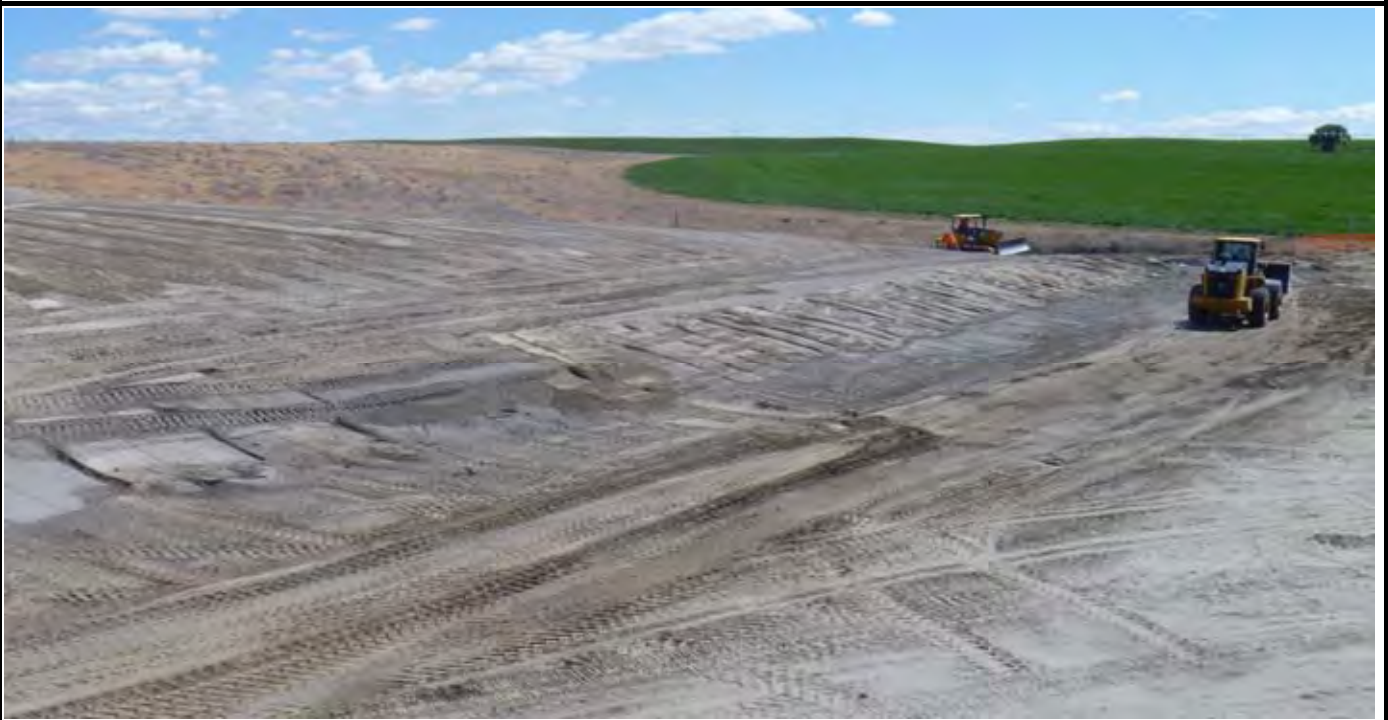
Photo 6: View of the rough grading along the southern EOC to EOL and almost ready to accept perimeter rock. Note AEC equipment nearly completing eastern swale rock work. View looking east/NE from rock pile SW of the SW corner of the CAP.

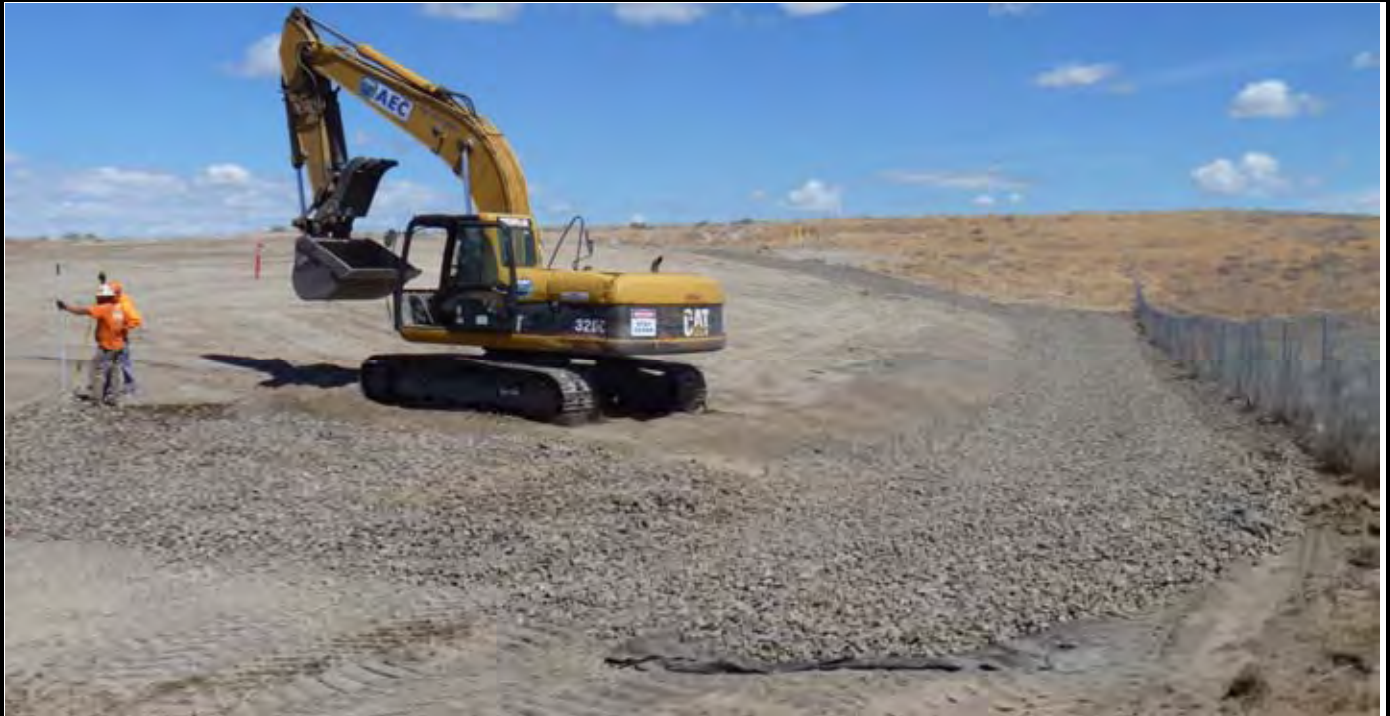
Photo 7: View of AEC completing the perimeter rock installation on the eastern swale and starting the perimeter rock work on the southern EOC to EOL zone. View looking north from the SE corner of the site.

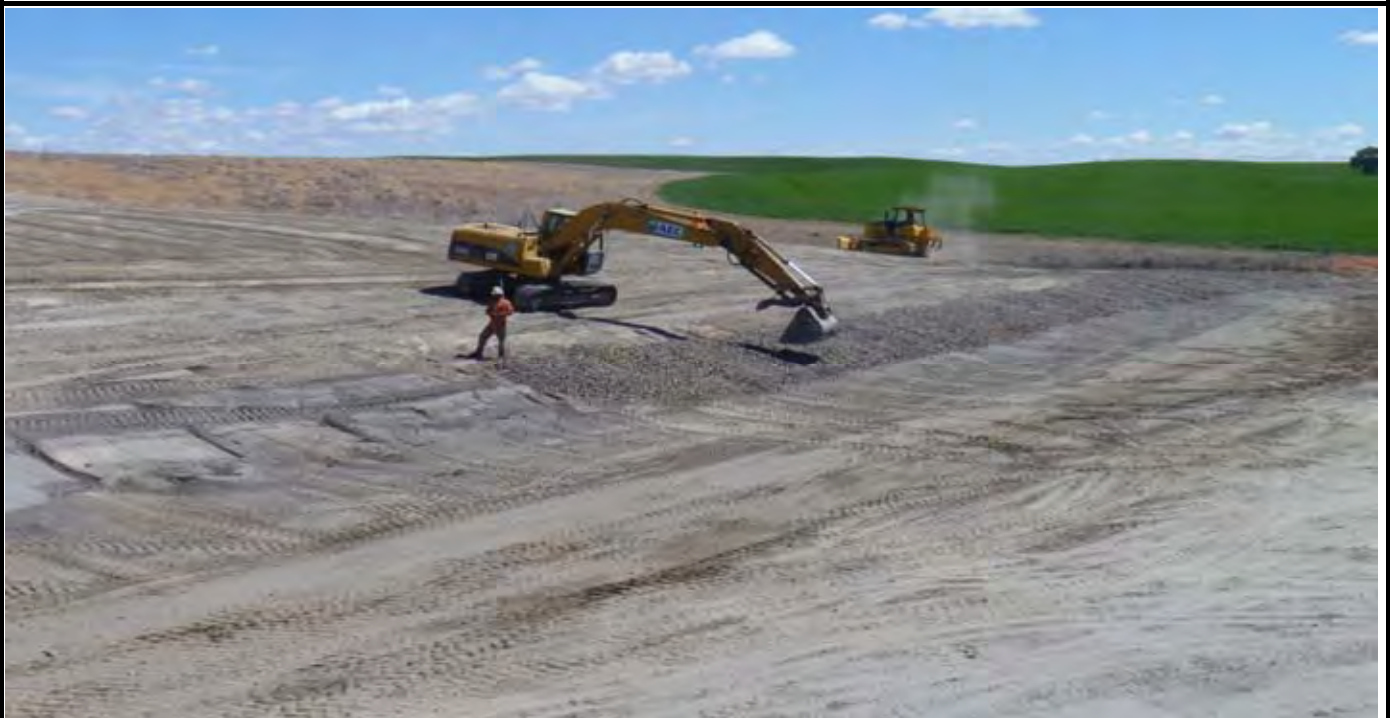
Photo 8: View of AEC trackhoe installing and grading the perimeter rock along the center of the southern EOC to EOL. View looking east/NE from rock pile located SW of the SW corner of the CAP.

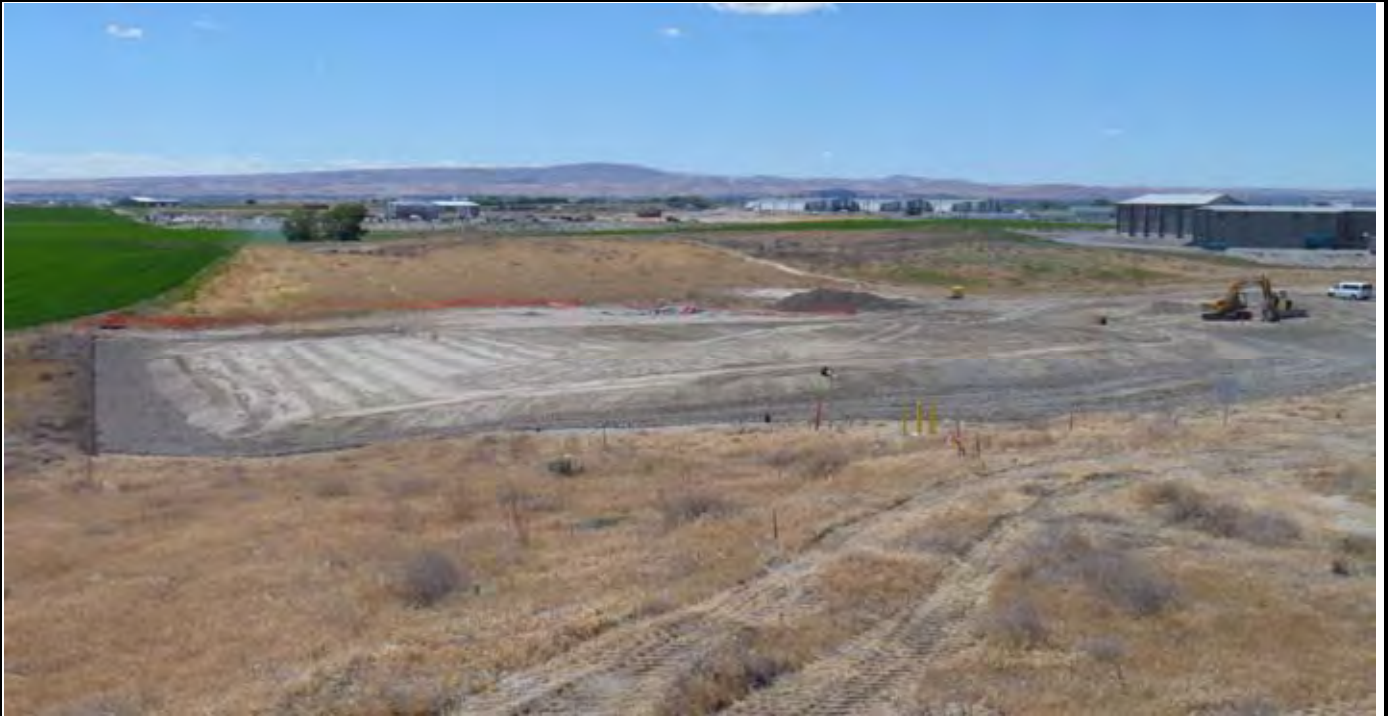
Photo 9: View of the site at the conclusion of the work day. Note the northern and eastern perimeter swales are completed and the top of the CAP is rough graded and ready for final grading on Monday. View looking south from area north of the site.

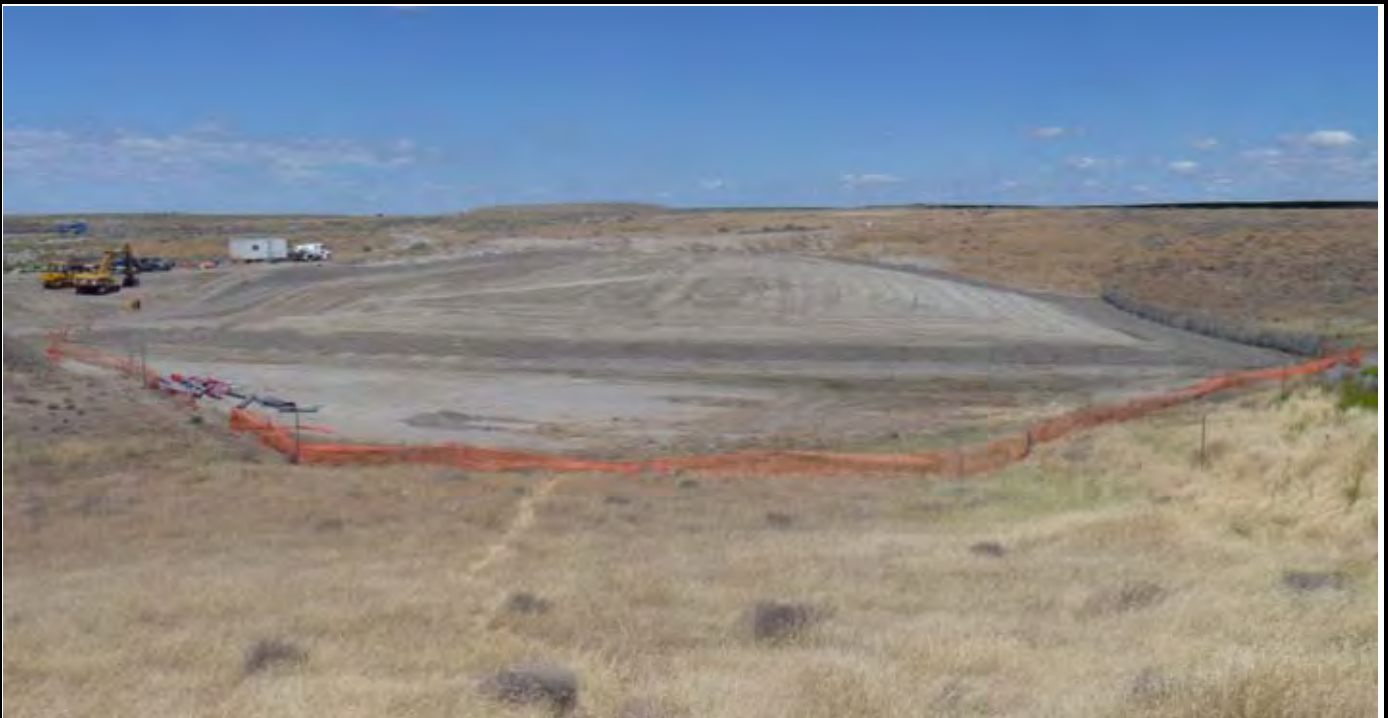
Photo 10: View of the site at the conclusion of work for the day. Note the perimeter rock is installed along the southern EOC to EOL and the CAP is rough graded and ready for final finish grading on Monday and for QC survey on Monday. View looking north from area south of the site.

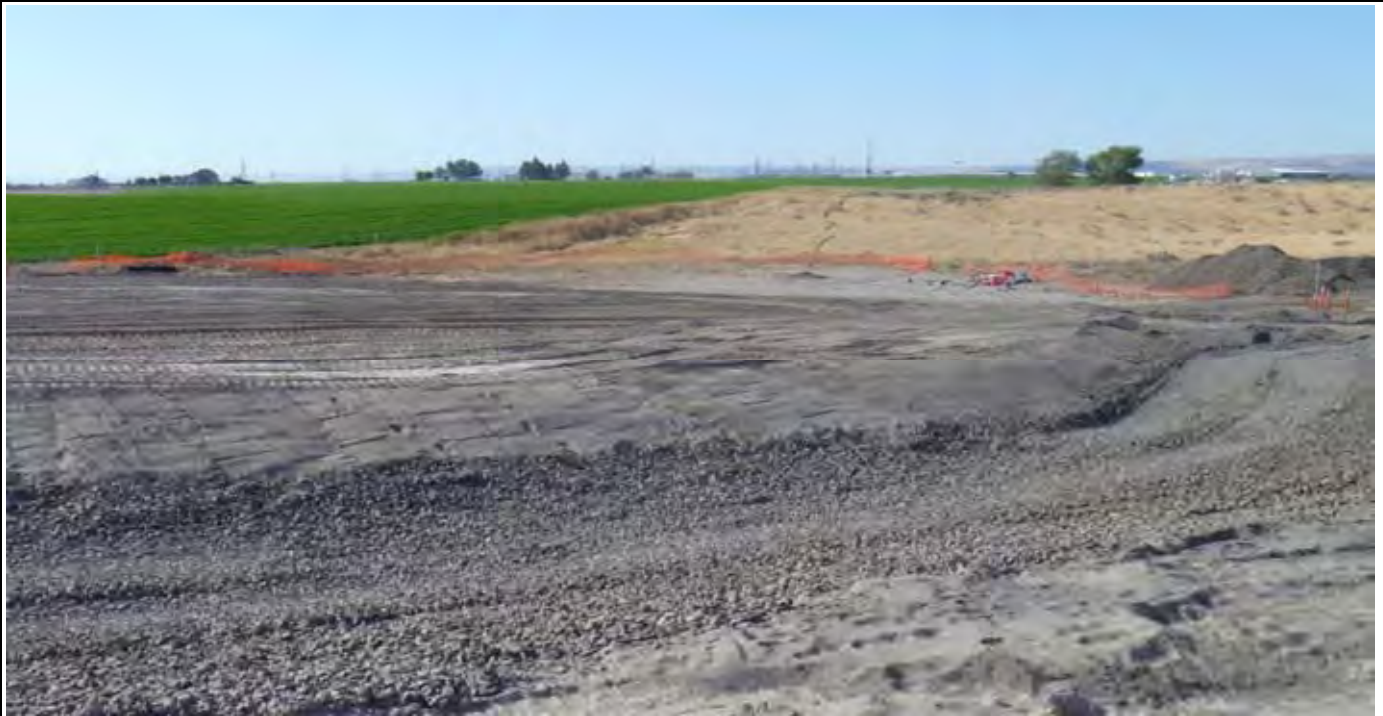
Photo 1: View of the site at the beginning of the day. Note the erosion protection rock stockpile (right edge of photo) and lack of fence posts. View looking south from NW corner of the CAP.

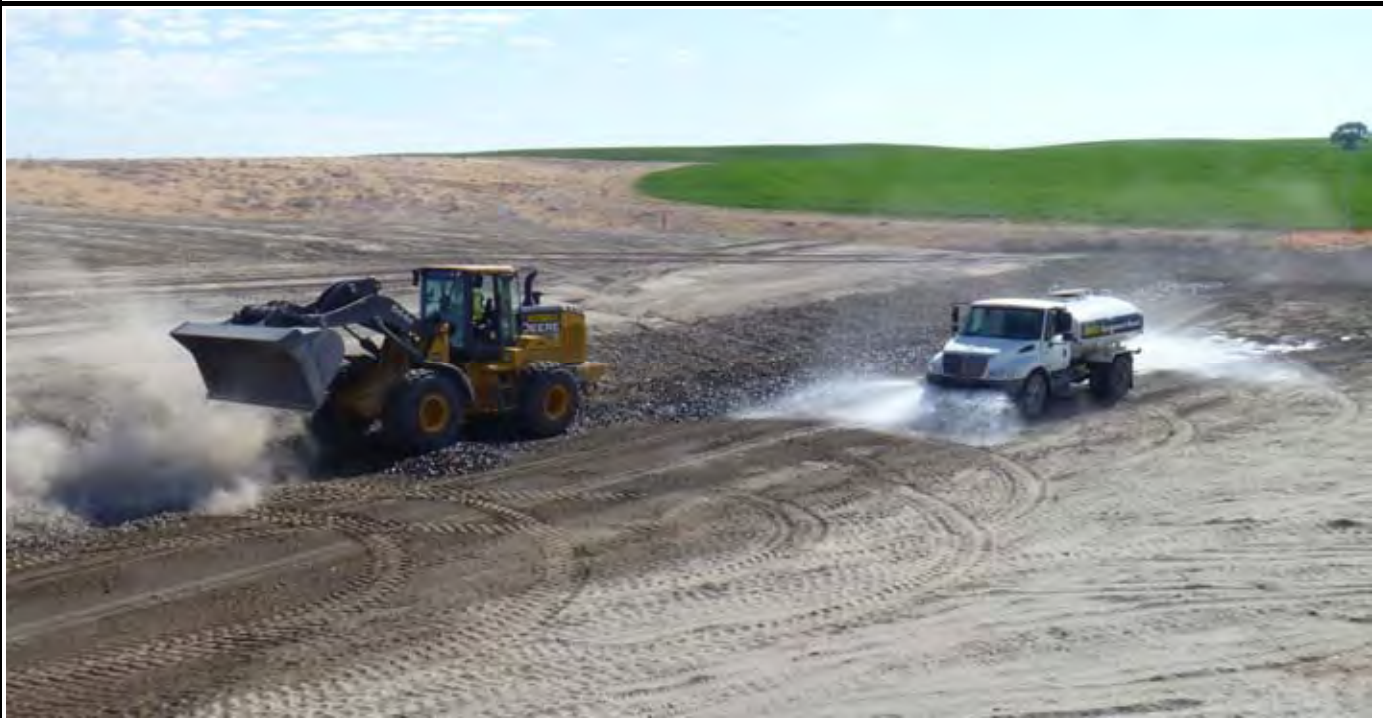
Photo 2: View of AEC placing erosion protection rock and watering along the southern EOL / Cap. View looking NE from area SW of the CAP.

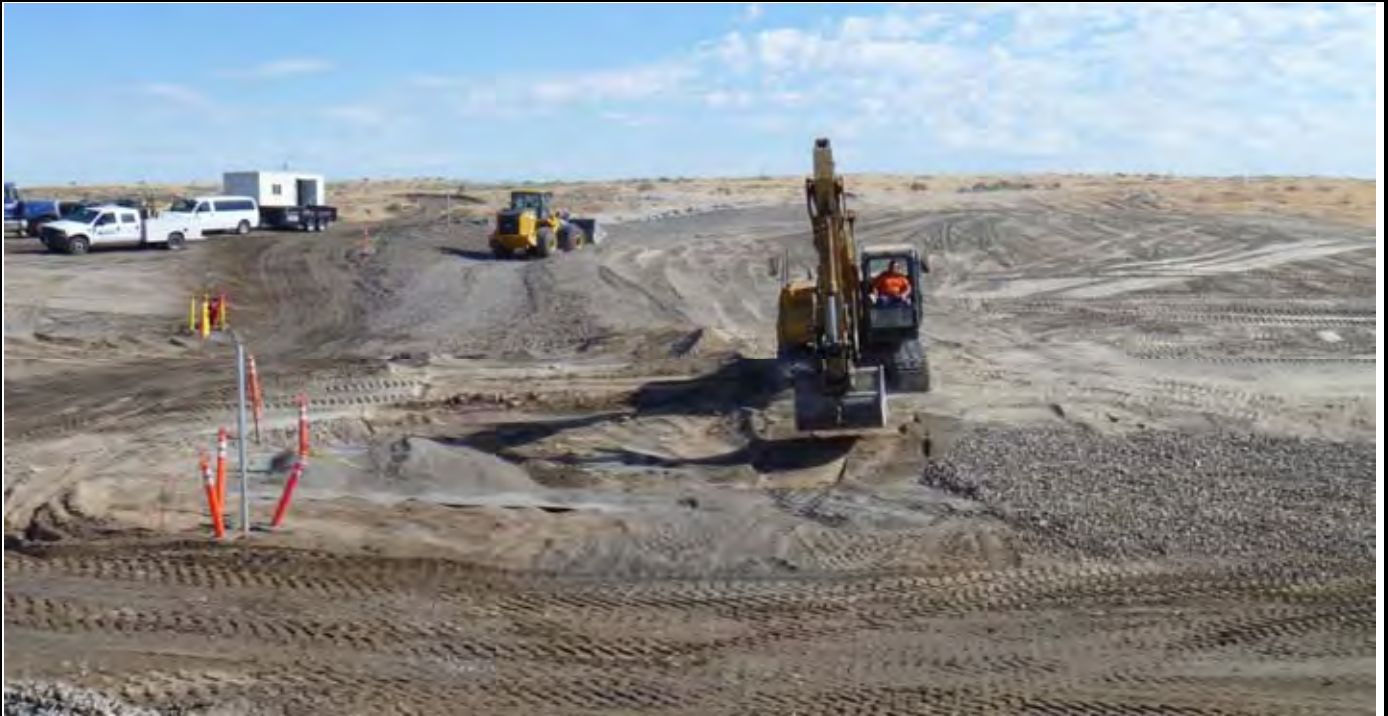
Photo 3: View of AEC grading EOC to EOL area on the SW corner of the CAP and placing rock with loader in the background. View looking north on western half of the CAP from area SW of the CAP.

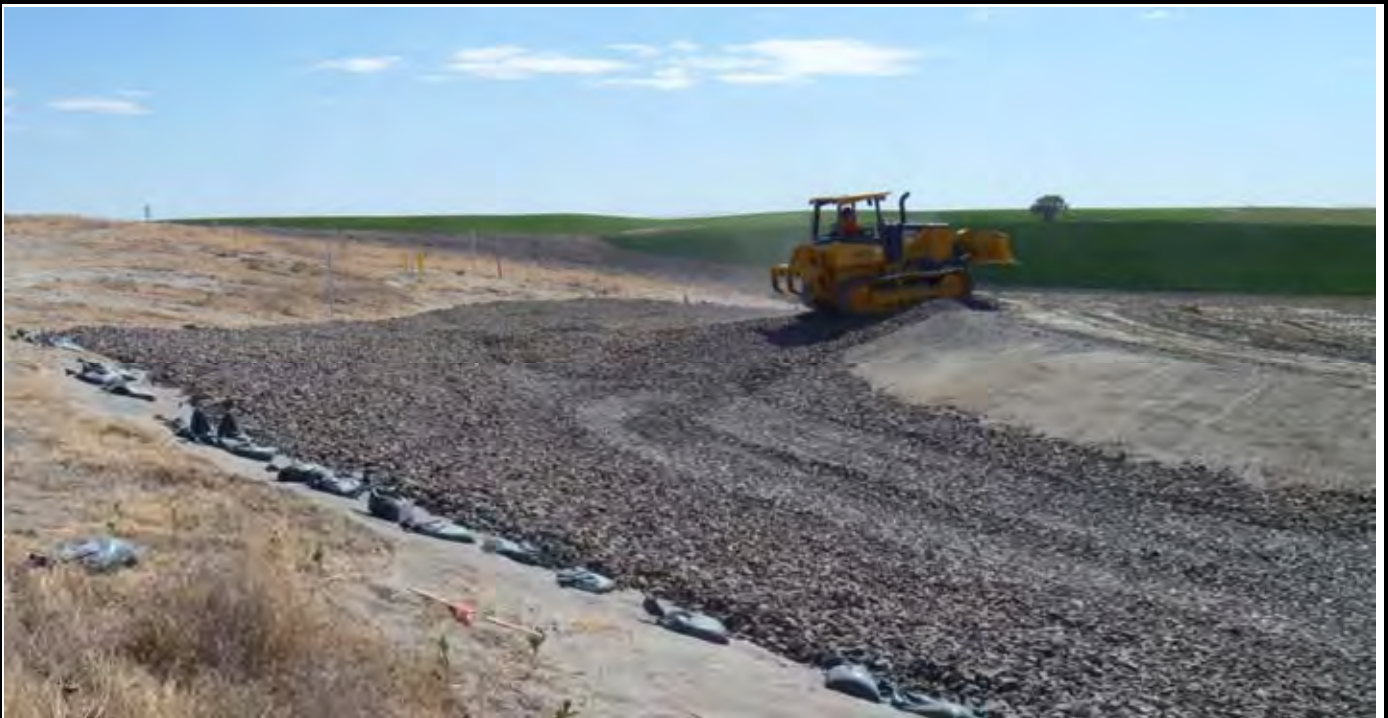
Photo 4: View of AEC finish grading the erosion protection rock roadway access point on the northern end of the EOC to EOL area. View looking east from NW corner of the CAP.

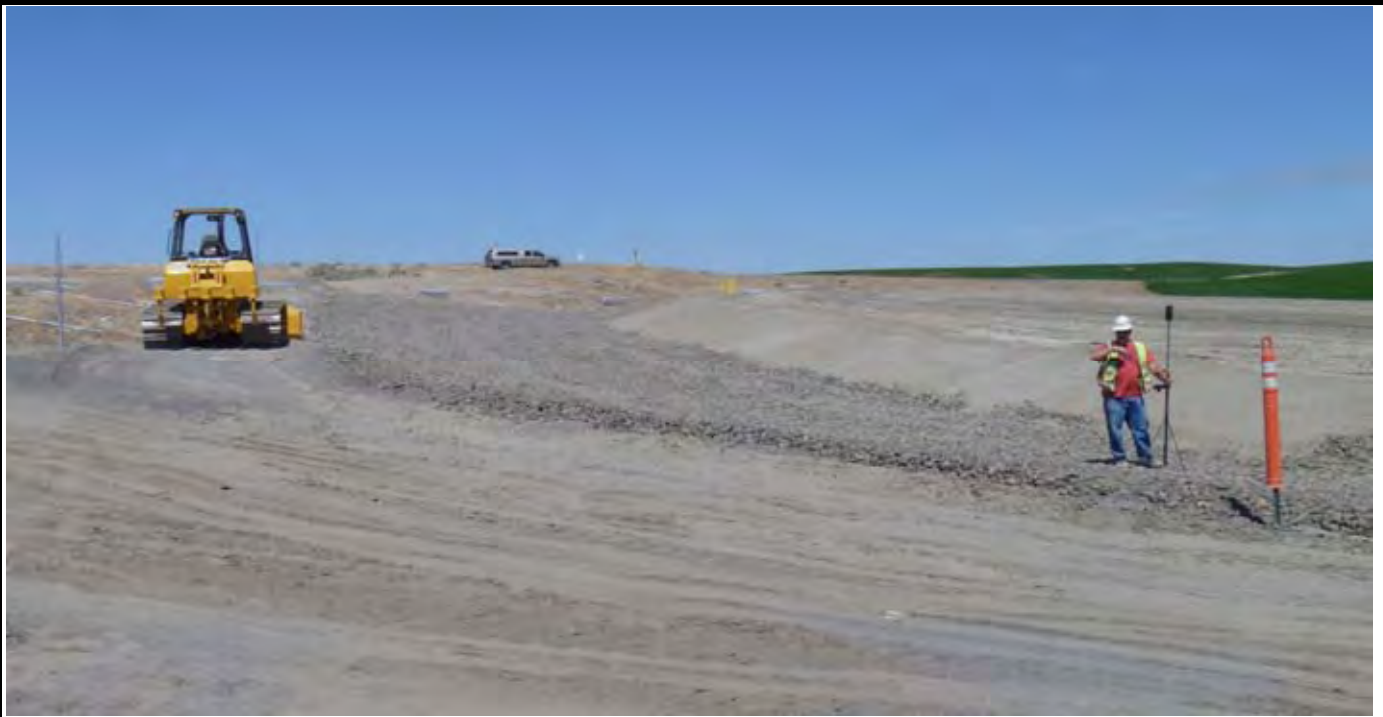
Photo 5: View of DSE conducting the quality control survey of the final CAP grading. View looking NE from western side of the CAP area.

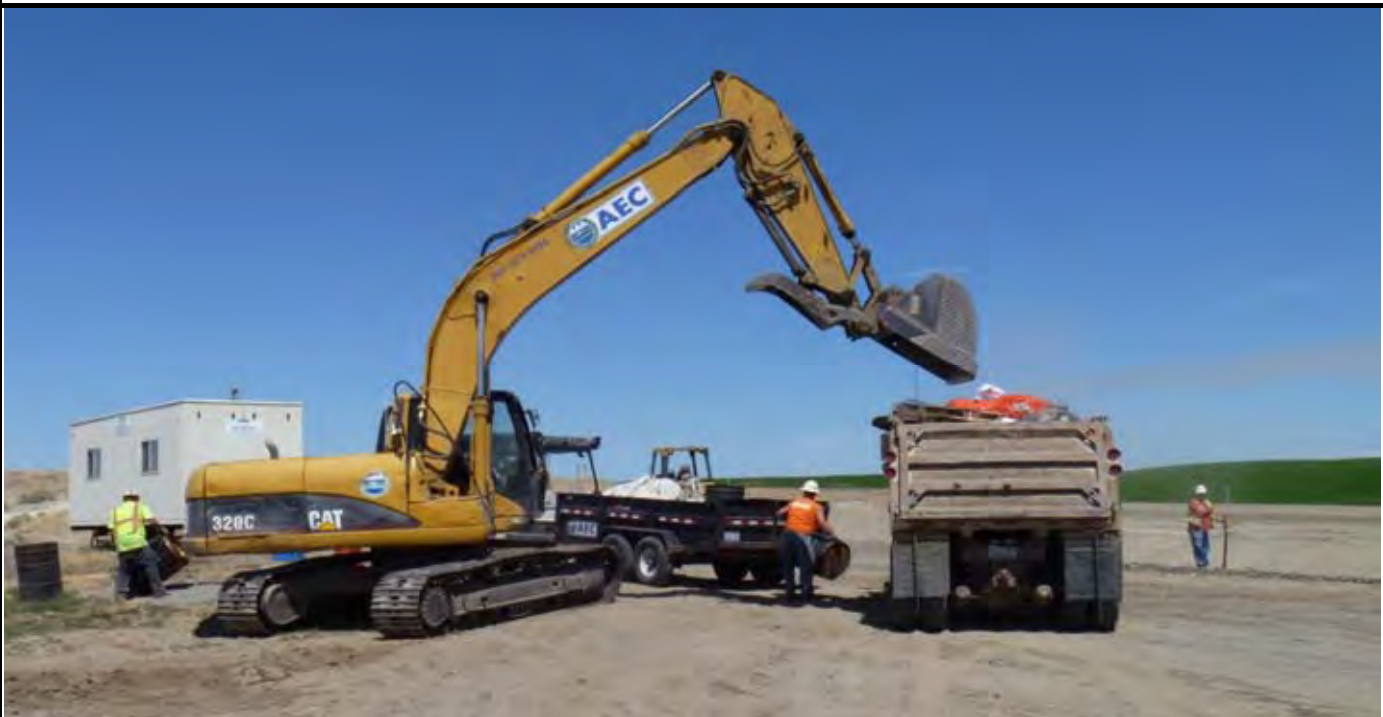
Photo 6: View of AEC loading out the remaining debris from the site during the DSE quality control survey work. View of area west of the CAP from area SW of the CAP.

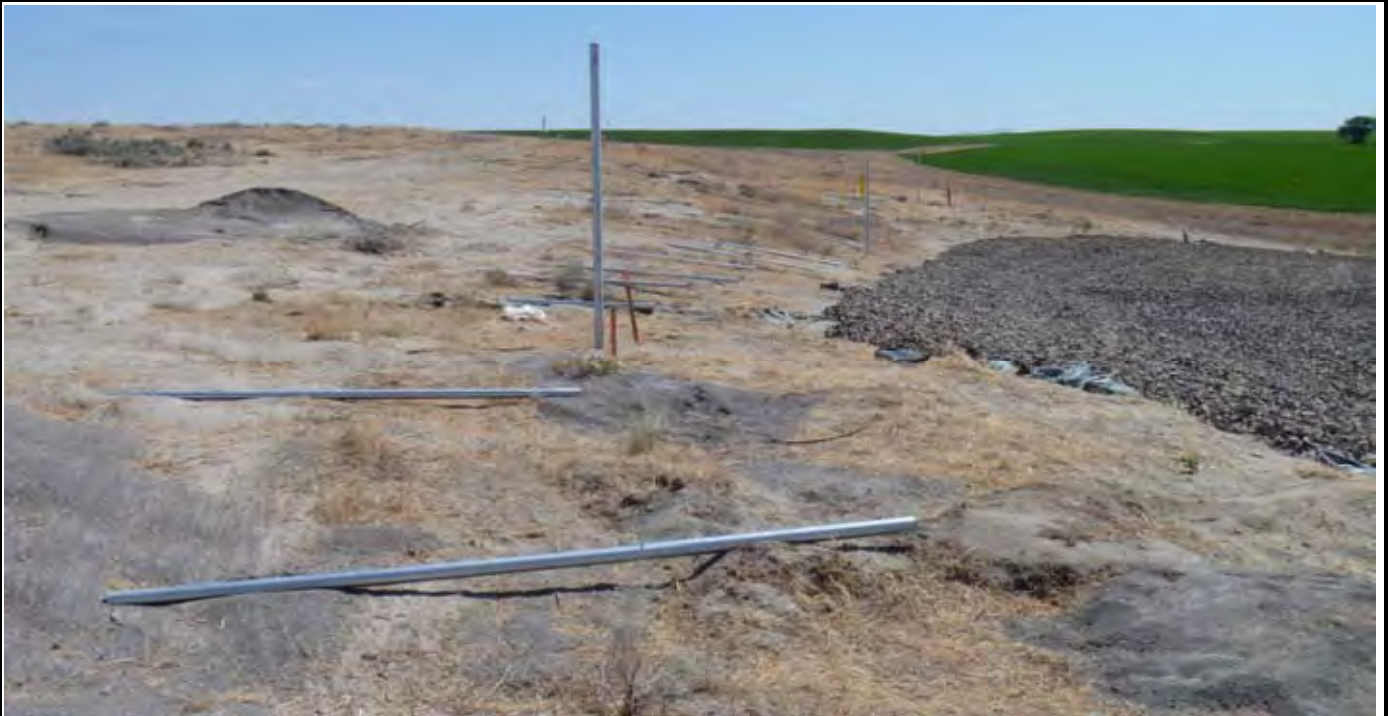
Photo 7: View of the fence posts staged along the northern side of the CAP zone perimeter. View looking east from the NW corner of the CAP perimeter.

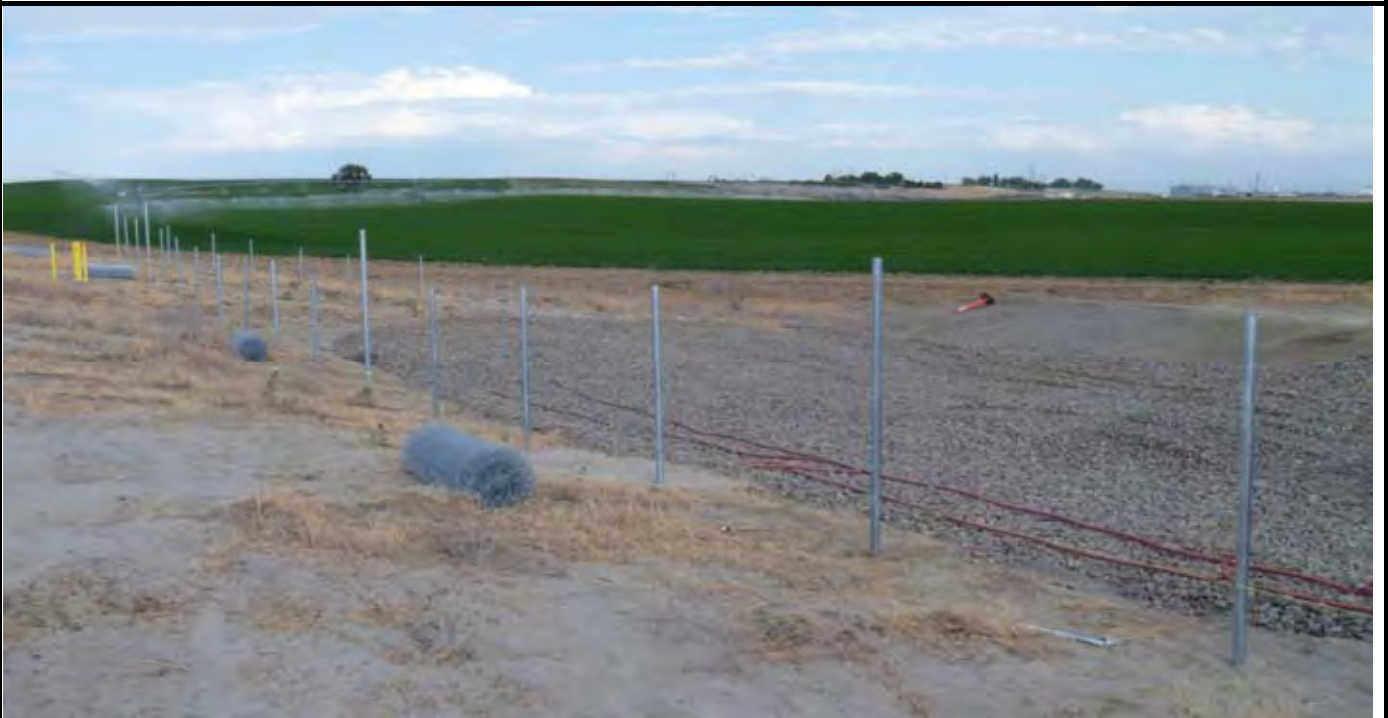
Photo 8: View of the fence posts installed along the northern edge of the CAP perimeter. View looking east to SE from area NW of the CAP perimeter. Note the fencing rolls are not staged for installation.

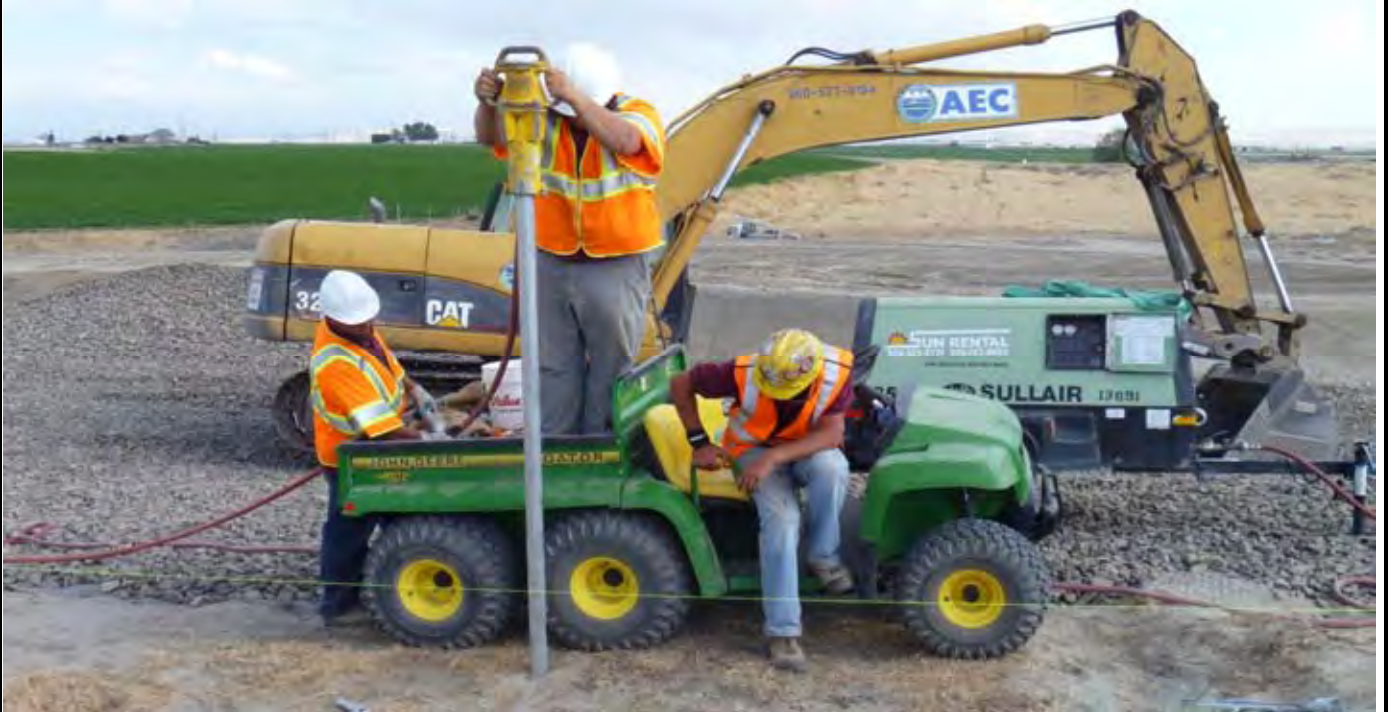
Photo 9: View of Rick's Custom Fencing using a pneumatic hammer (see green compressor in background) to install the majority of the fence posts. Corner posts were installed with concrete early in the project with larger posts. View looking south from NW corner of the CAP.

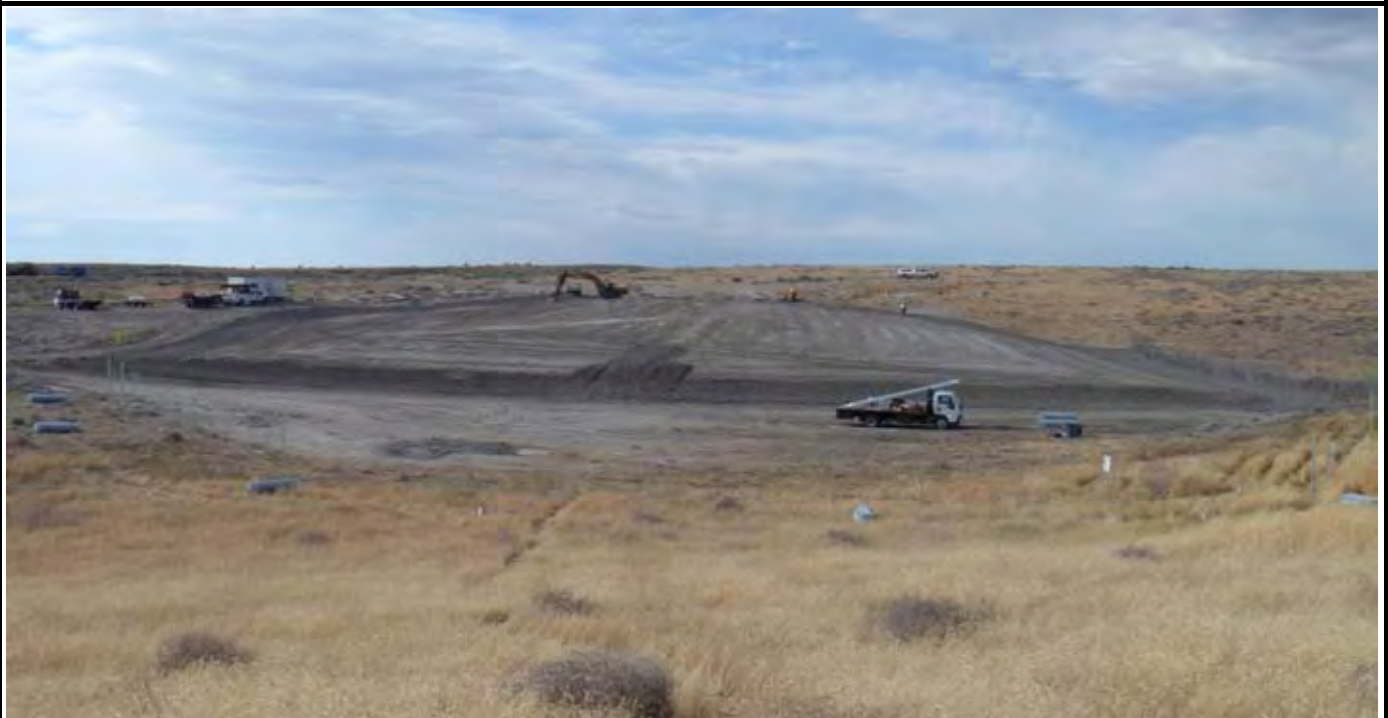
Photo 10: View of the site near the end of the work day. View looking north from area south of the site. Note Rick's Custom Fencing crew trucks, posts, and equipment.

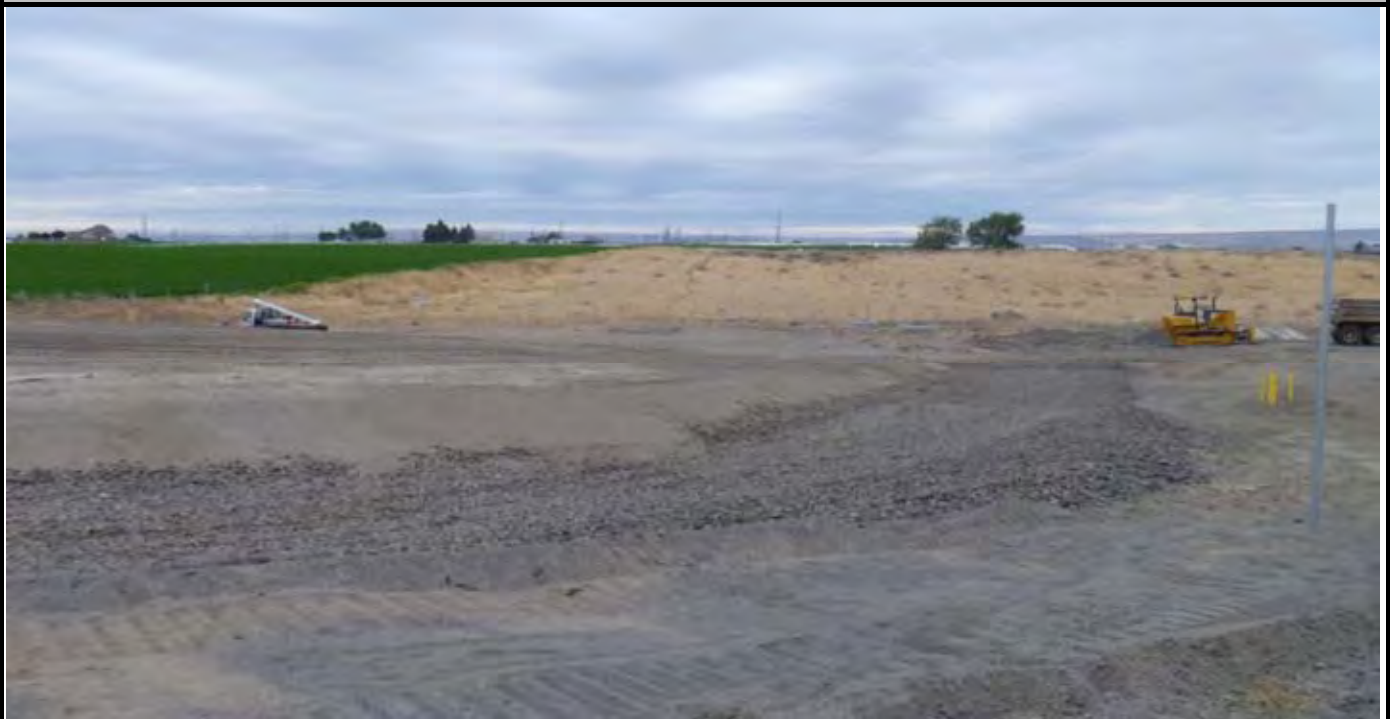
Photo 1: View of the site at the beginning of the work day. Note that many of the fence posts have not yet been installed on the western side of the CAP perimeter. View looking south from NW corner of the CAP.

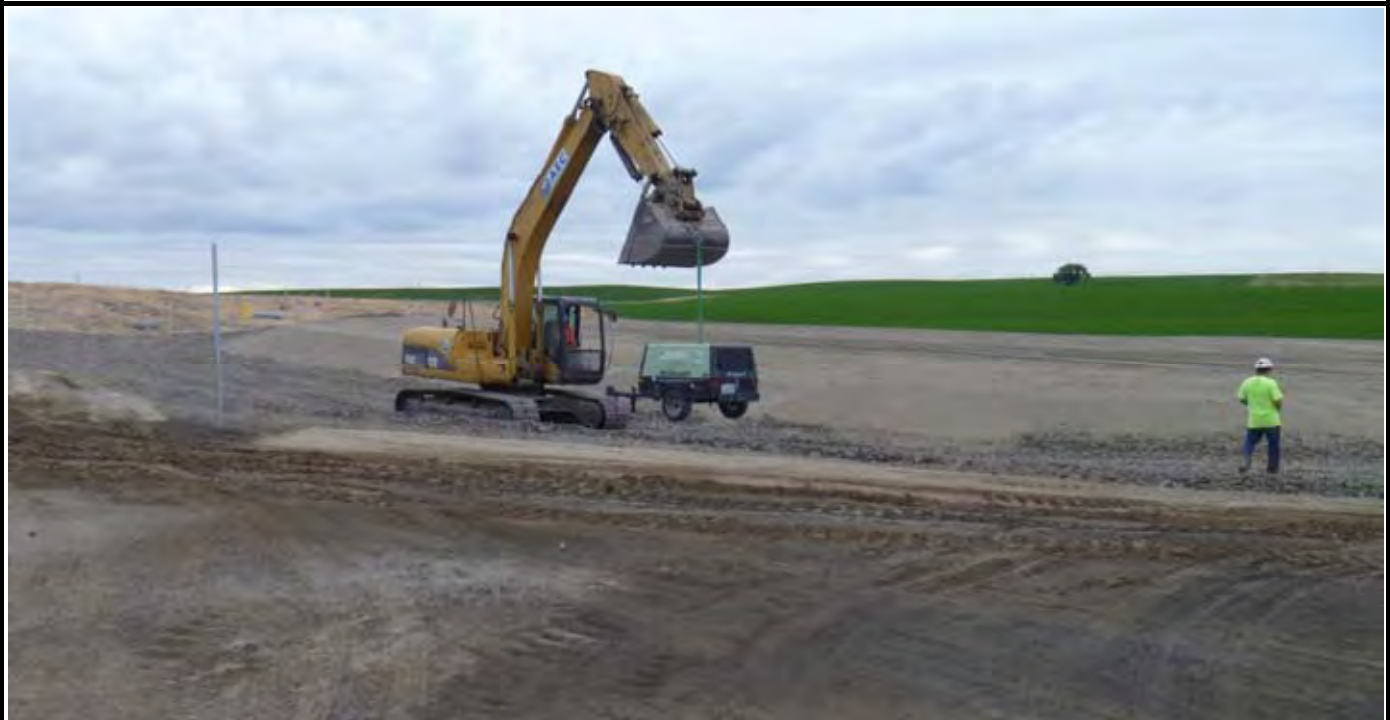
Photo 2: View of AEC moving the towable compressor for Rick's Custom Fencing to the western perimeter of the CAP so they can use it to install the fence posts. View looking east from the western side of the CAP.

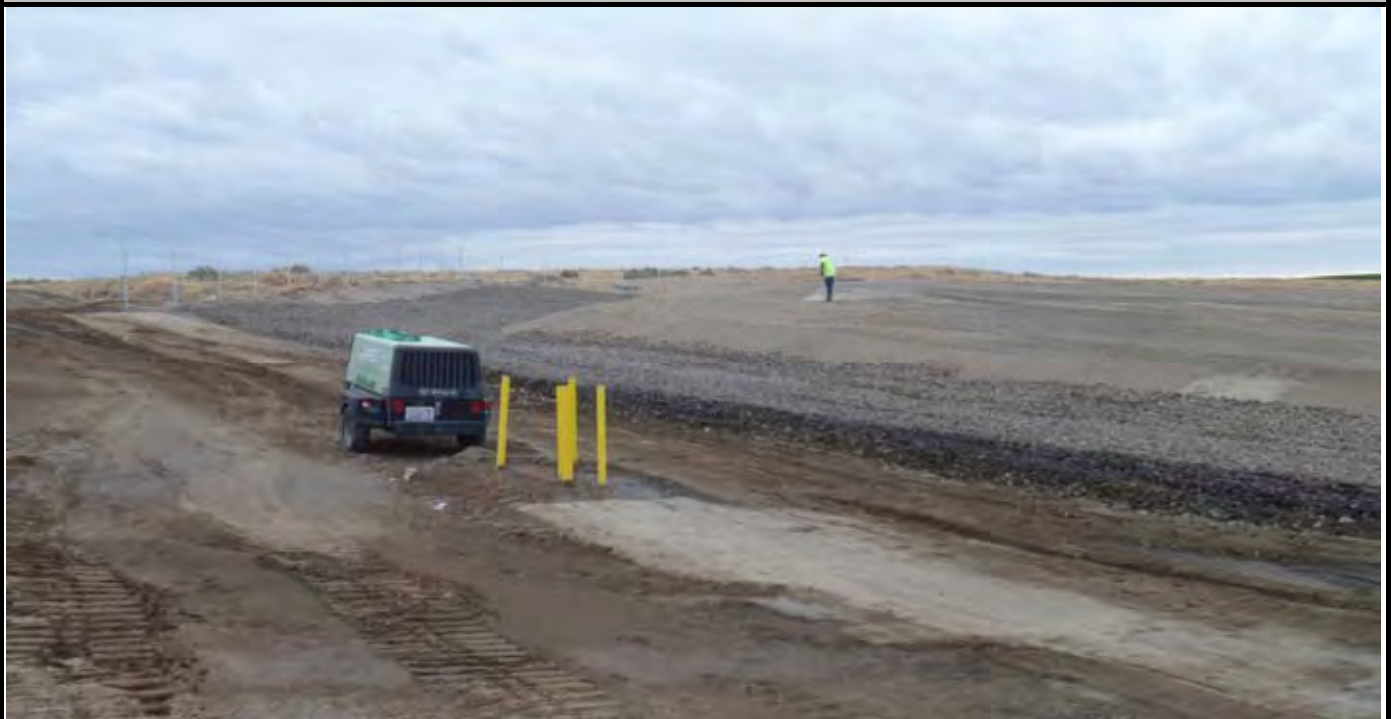
Photo 3: View of the western side of the CAP prior to installation of the fencing posts. Note the towable compressor near the monitoring well. View looking north/northeast from SW corner of the CAP.
