PHOTOGRAPH LOG

Environment and Infrastructure, Inc.
7376 SW Durham Road
Portland, Oregon 97224

PROJECT NAME: Pasco Landfill Cap Project - Cap Construction Project

Project No: 4-61M-10705-1 P-02

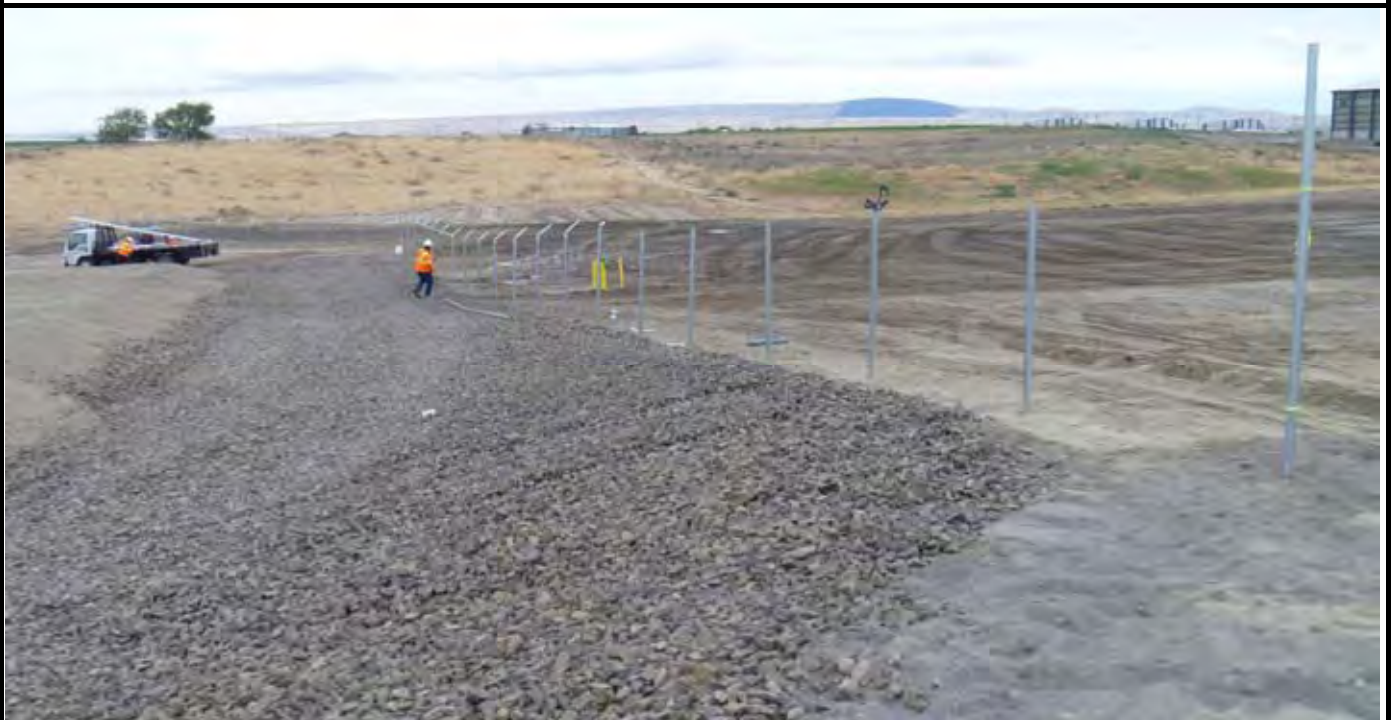
Photo 4: View of Rick's Custom Fencing installing the top bar and barb wire mounts along the western perimeter fence. View looking south from NW corner of the CAP.

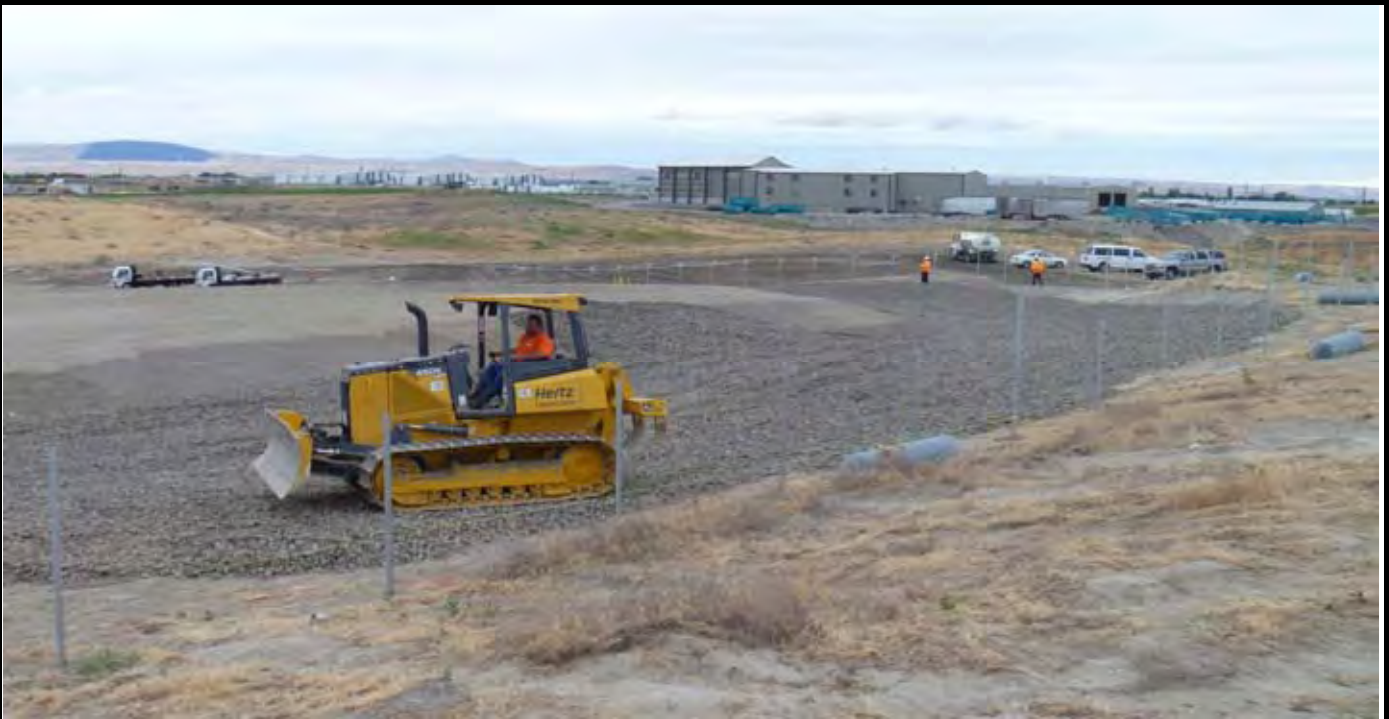
Photo 5: View of AEC using the bulldozer to complete finish grading and smoothing of the perimeter erosion rock and Rick's custom fencing installing the top bar and bar wire mounts to posts along the western perimeter of the CAP. View looking southwest from area north of the site.

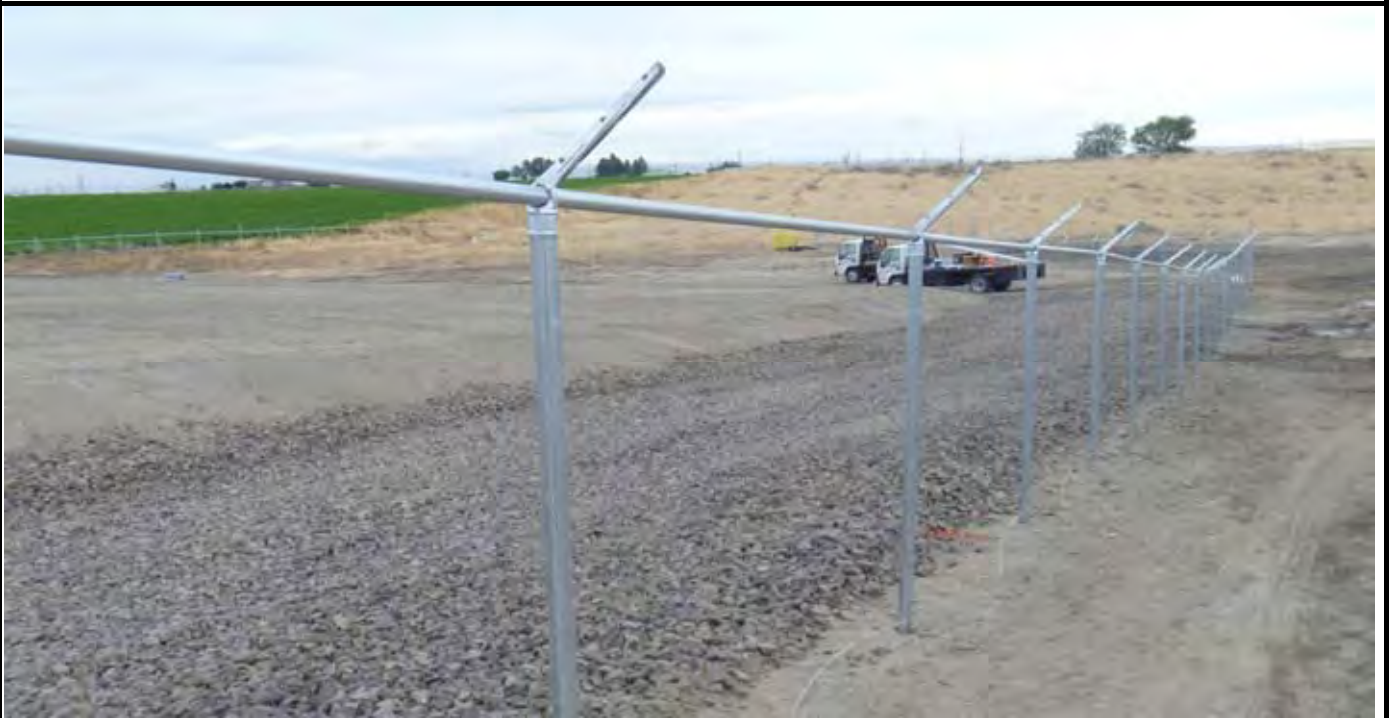
Photo 6: View of the western perimeter fencing with the posts, top bar, and barb wire mounts installed. View looking south from NW corner of the CAP.

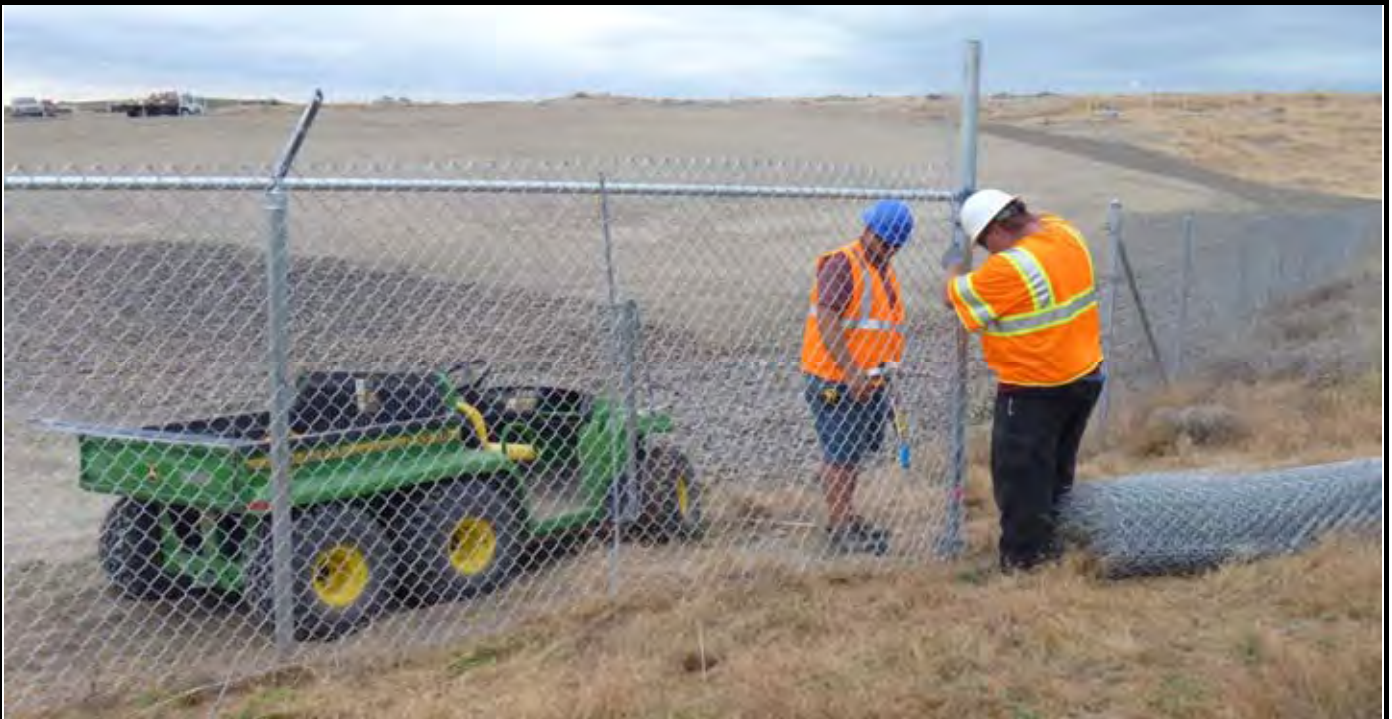
Photo 7: View of Rick's Custom Fencing beginning the installation of the first couple rolls of cyclone fencing material. Note the winch and spreader bar pulling the fencing to the post. View of area along SE corner of the CAP looking to the North/Northwest.

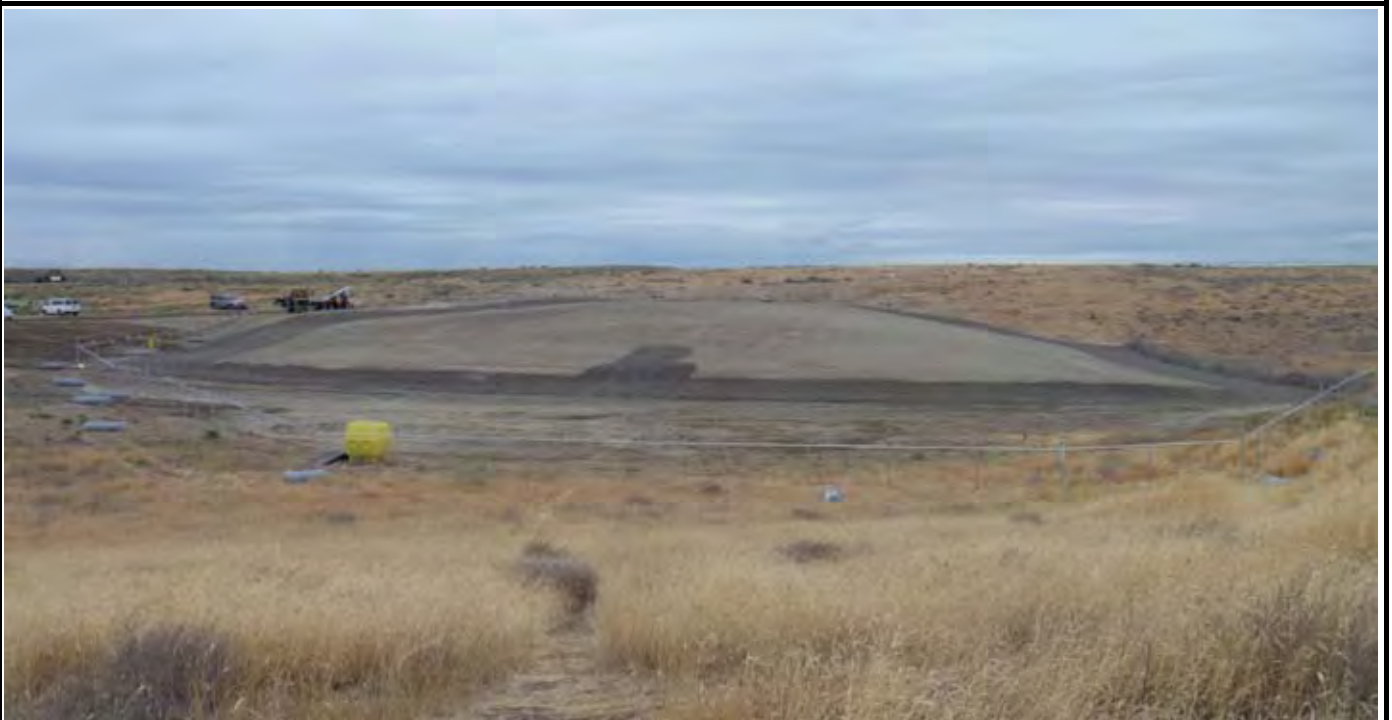
Photo 8: View of the entire site near the end of the working day from area south of the site. Note that fencing work is underway with rolls staged around fence perimeter.

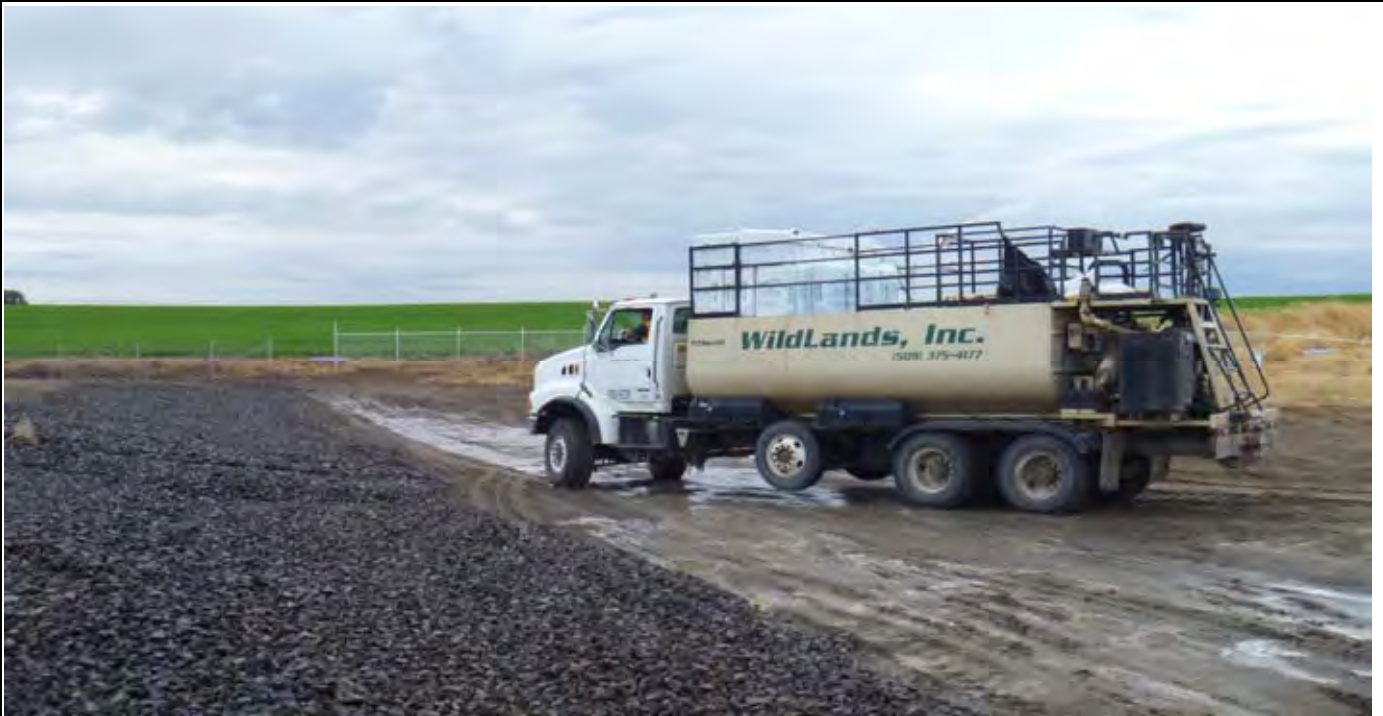
Photo 1: View of the hydroseeding truck (Wildlands, Inc.) along the southern side of the CAP just prior to them commencing with hydroseeding work. View of the southern edge of the CAP (EOL) from SW corner of the CAP.

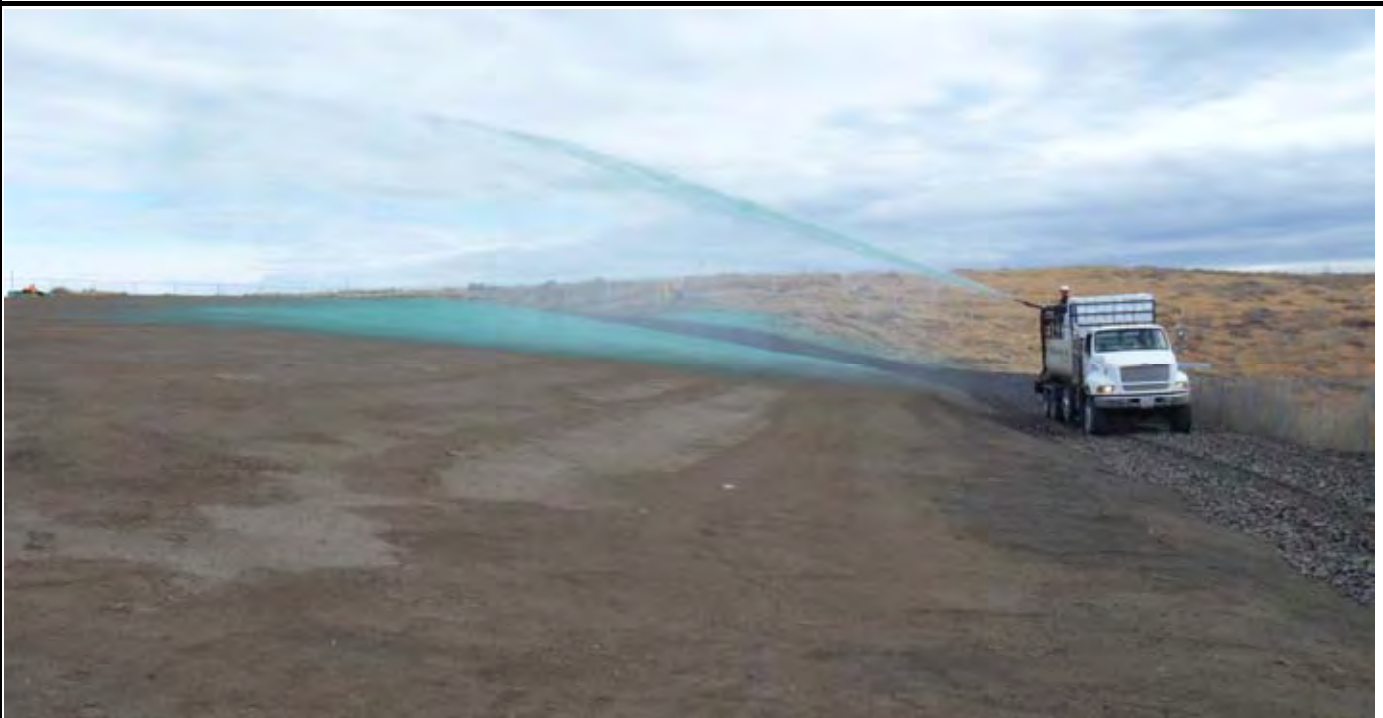
Photo 2: View of Wildlands hydroseeding the eastern half of the CAP surface from the eastern perimeter access road (erosion protection rock road). View of the eastern half of CAP from SE corner of the CAP.

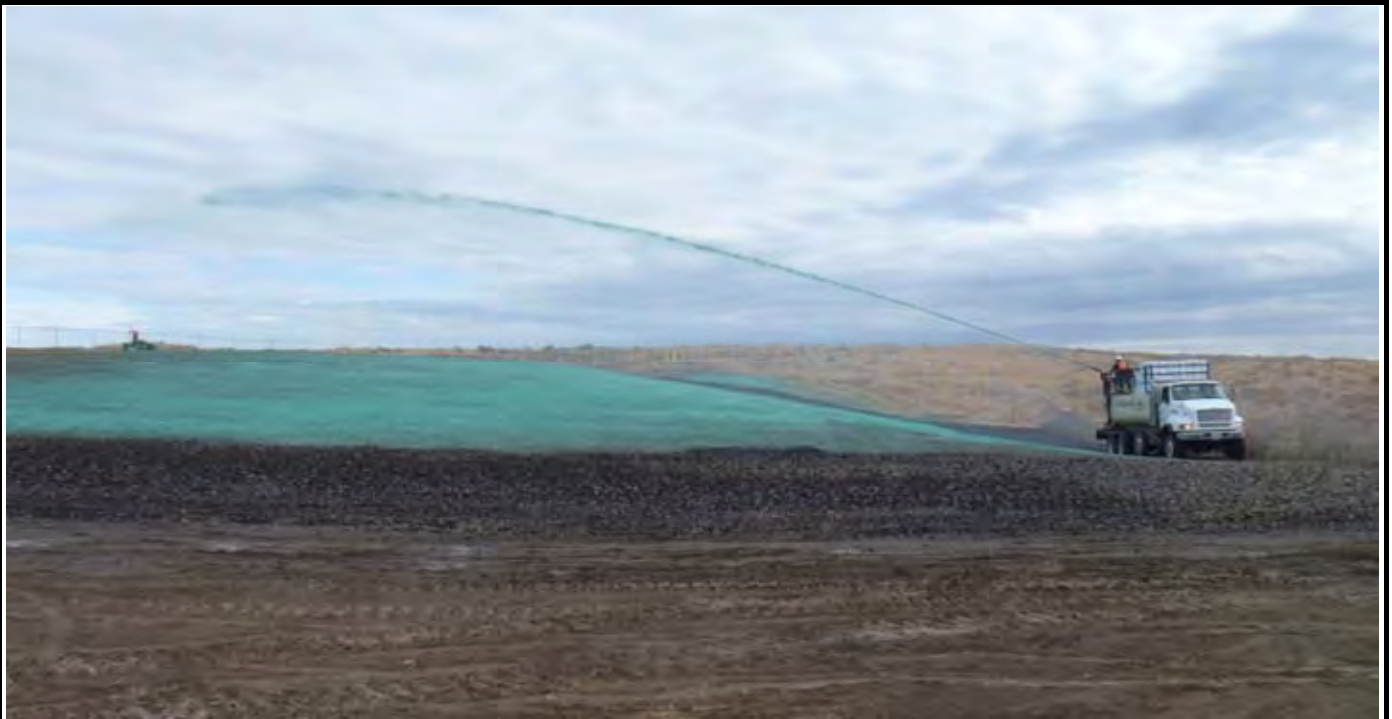
Photo 3: View of Wildlands hydroseeding the eastern half of the CAP surface from the eastern perimeter access road (erosion protection rock road). View of the eastern half of CAP from infiltration basin.

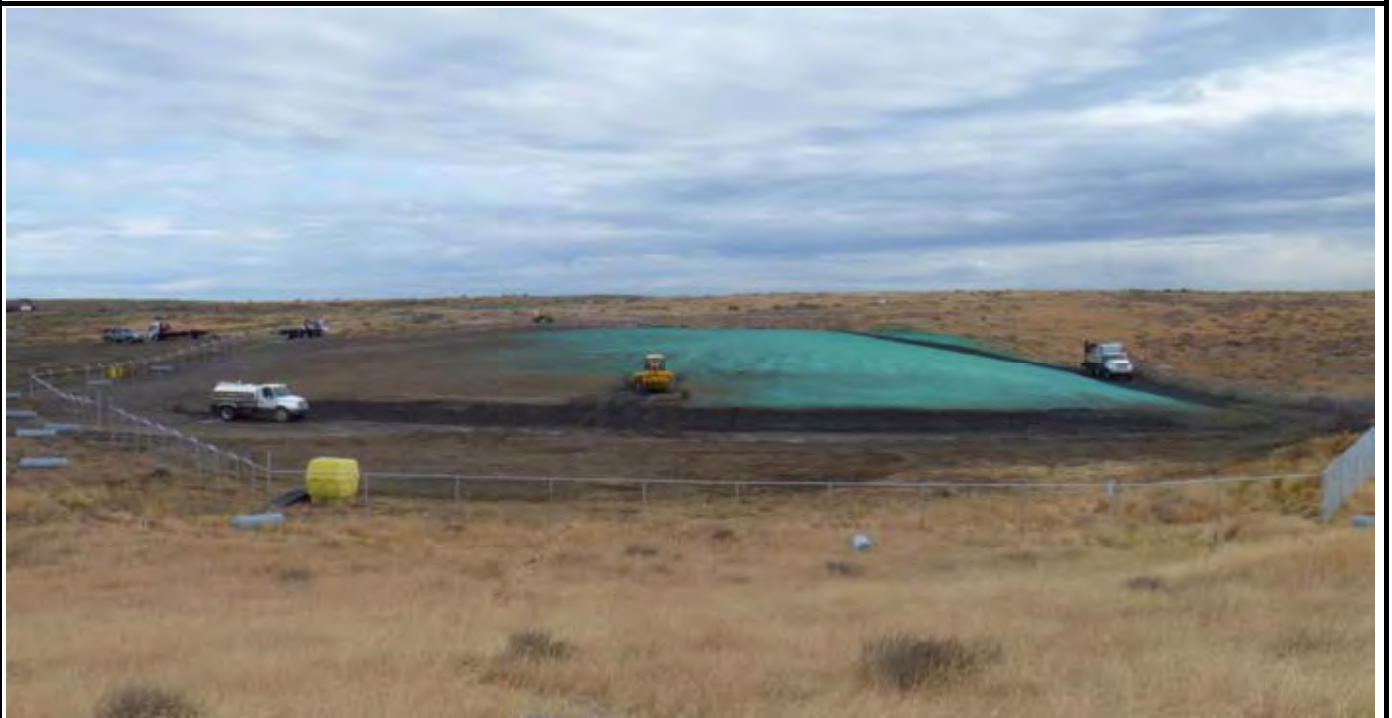
Photo 4: View of Wildlands hydroseeding the eastern half of the CAP surface from the eastern perimeter access road (erosion protection rock road). View of the entire CAP from area south of the site.

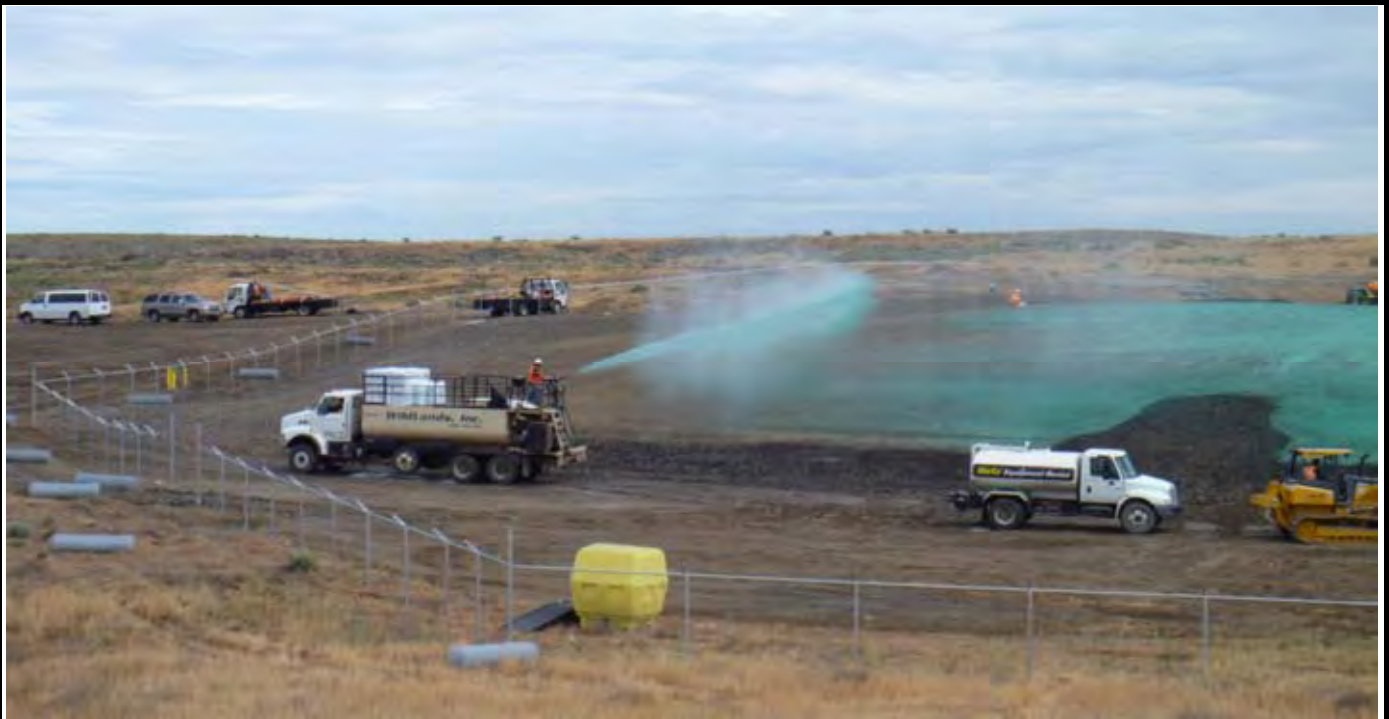
Photo 5: View of Wildlands hydroseeding the SW corner of the CAP. Note water truck and bulldozer on right side. View of the western half of the CAP from area south of the site. Note fencing is staged for installation.

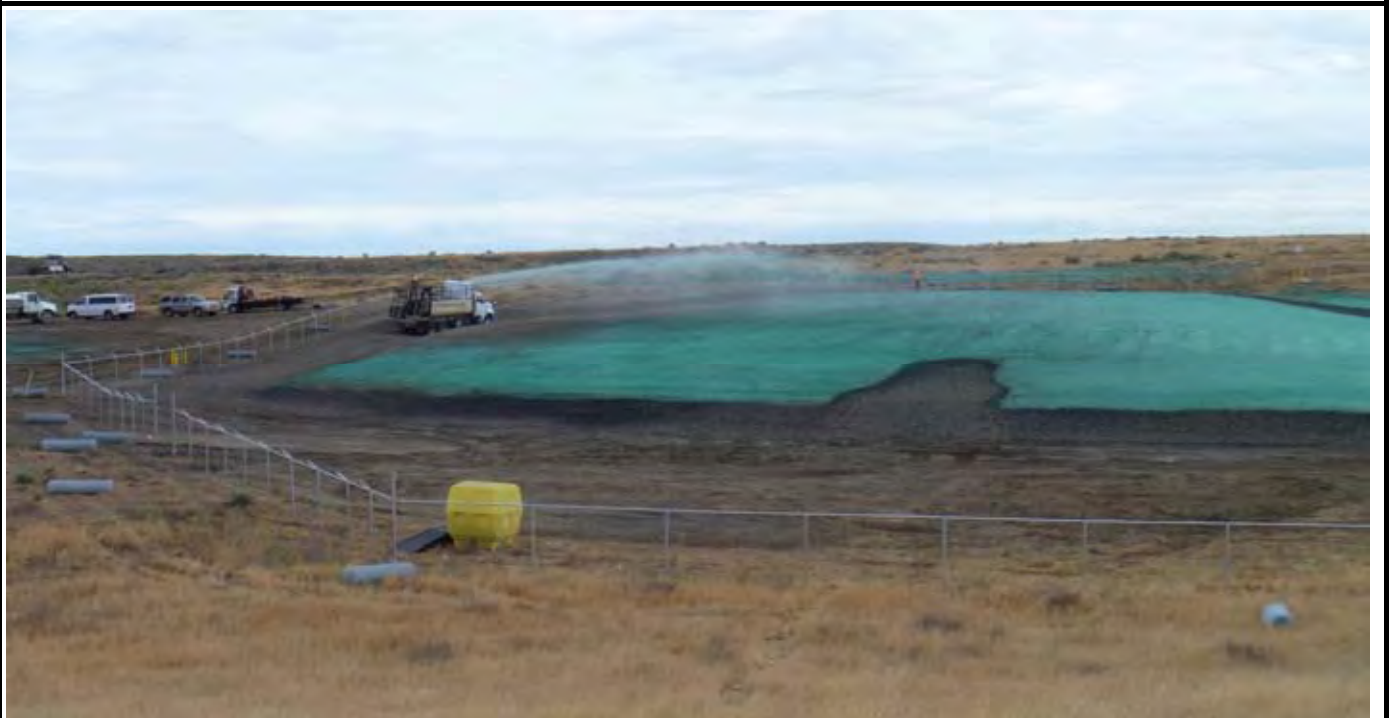
Photo 6: View of Wildlands completing the hydroseeding of the western half of the CAP from the western perimeter access road. View of the site from area south of the site.

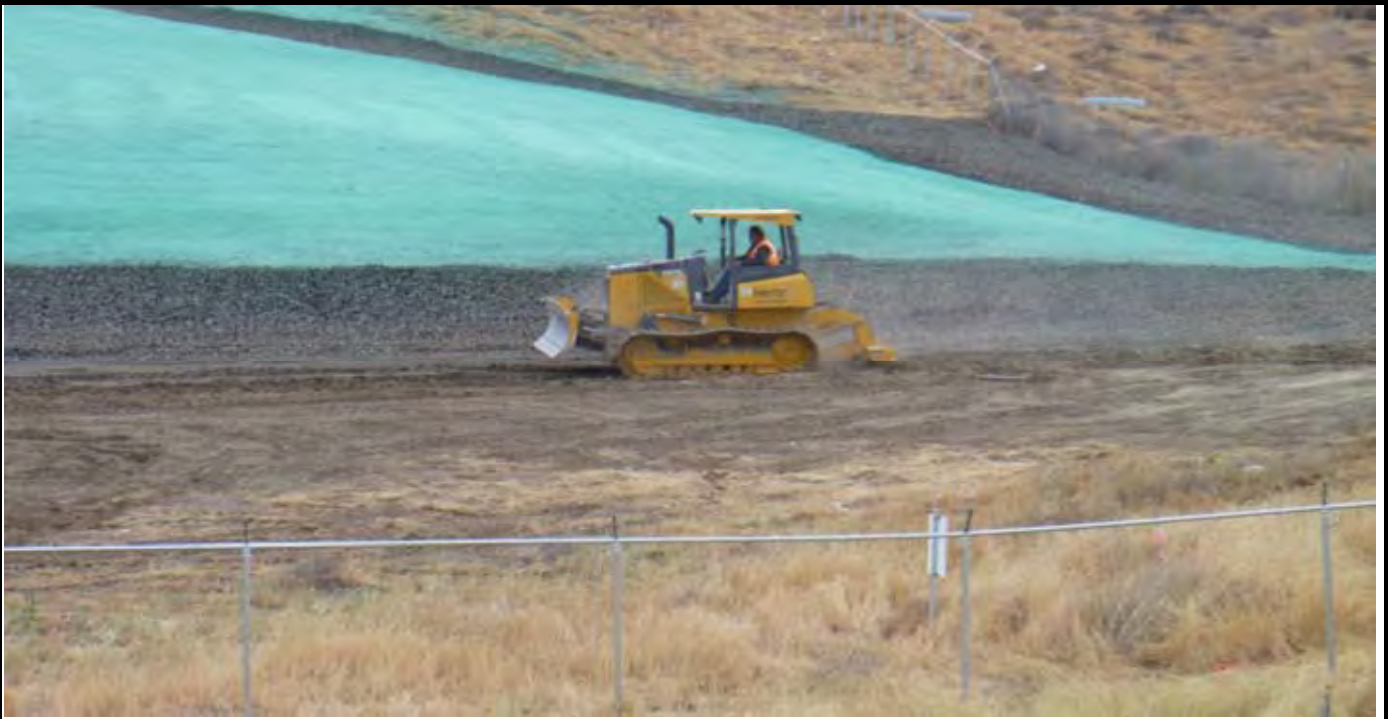
Photo 7: View of AEC using bulldozer to plow the infiltration basin area to break up the surface soils to allow for easier infiltration of precipitation. View of the southern side of the CAP from area south of the site.

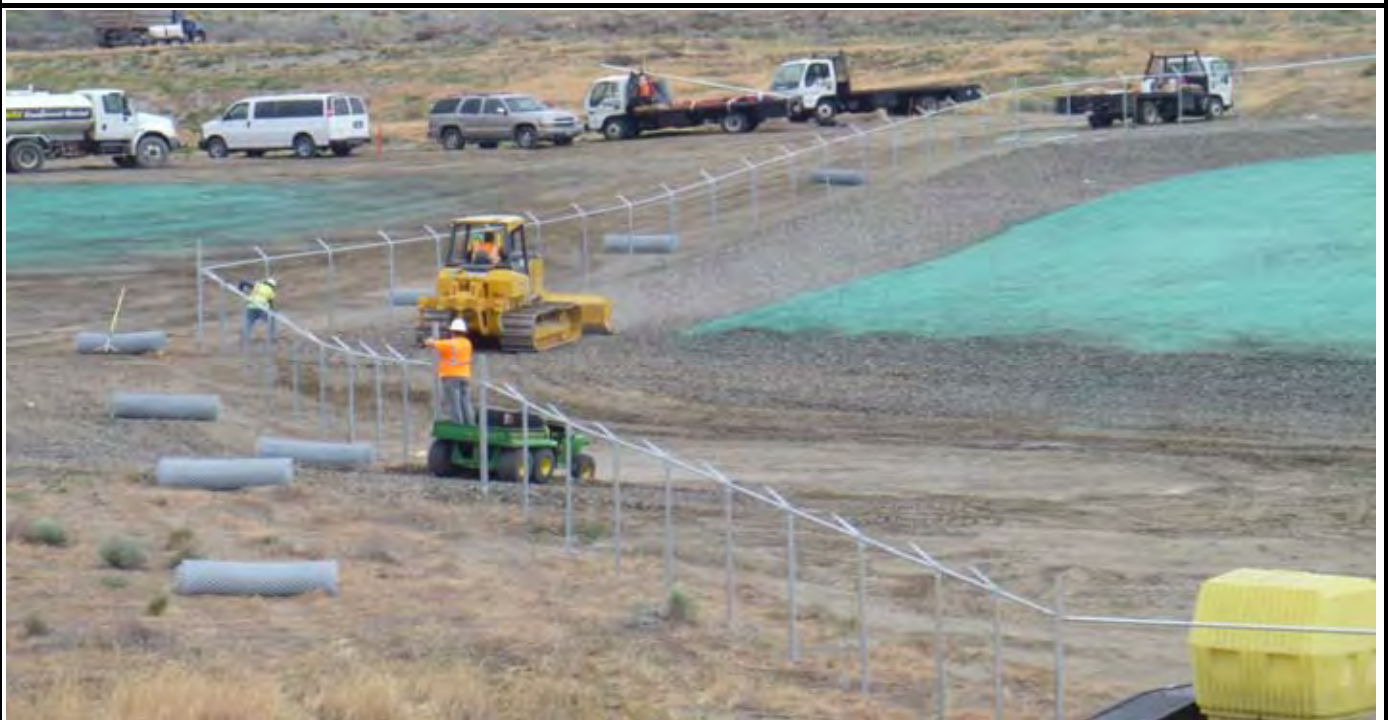
Photo 8: View of Rick's Custom Fencing (RCF) crew installing perimeter fencing components. Note the rolls of fencing materials staged along the perimeter. View of the western side of the CAP from area south of the site.

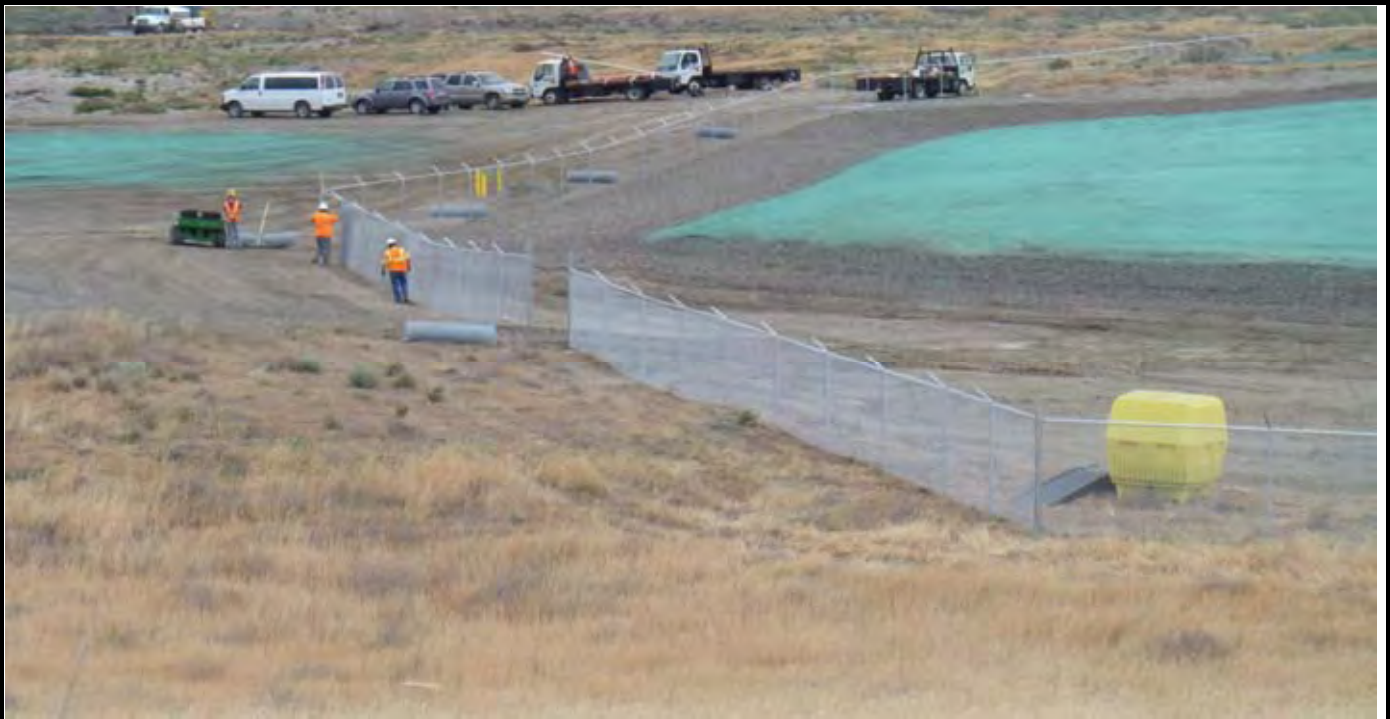
Photo 9: View of the west and southwestern side of the CAP where RCF is installing the fencing on the posts. View of the western side of the CAP from area south of the site.

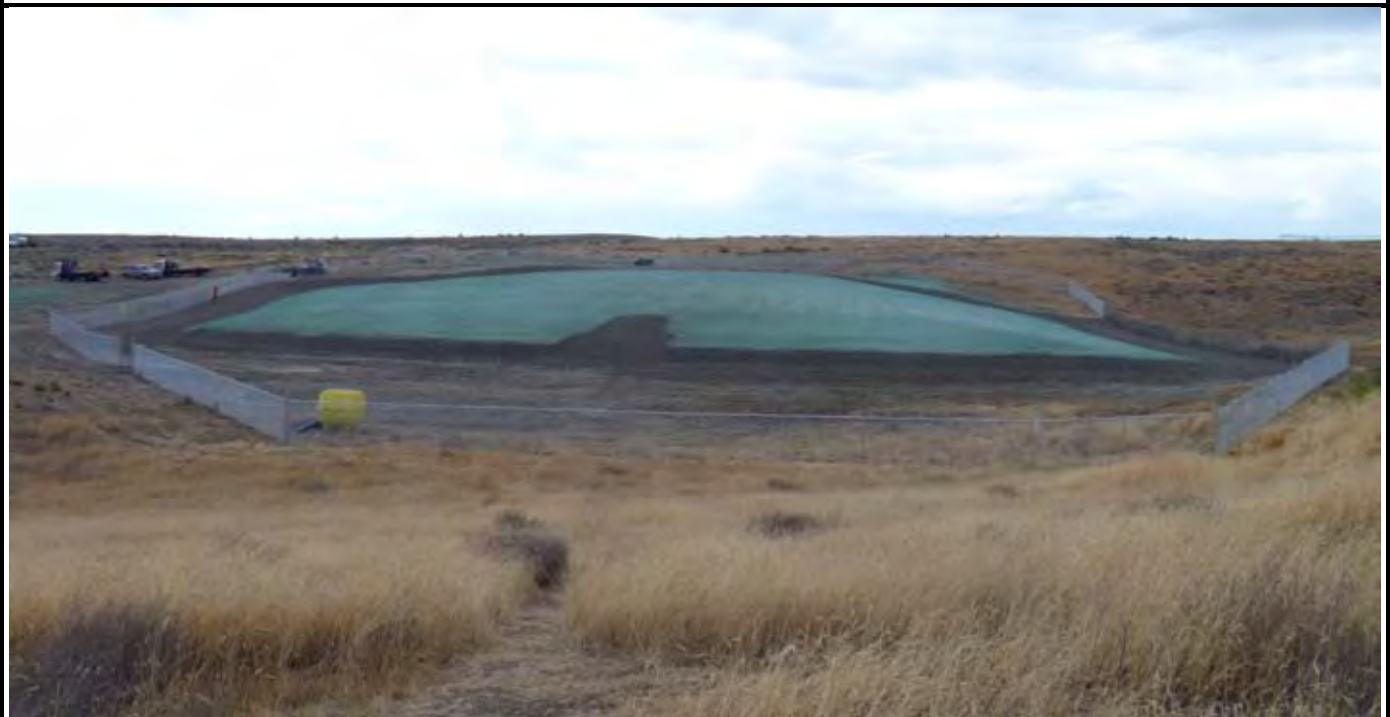
Photo 10: View of the site at the conclusion of work for the day. Note the perimeter fencing is up (no gates or barb wire yet) and hydroseeding work has been completed by Wildlands. View looking north from area south of the site.

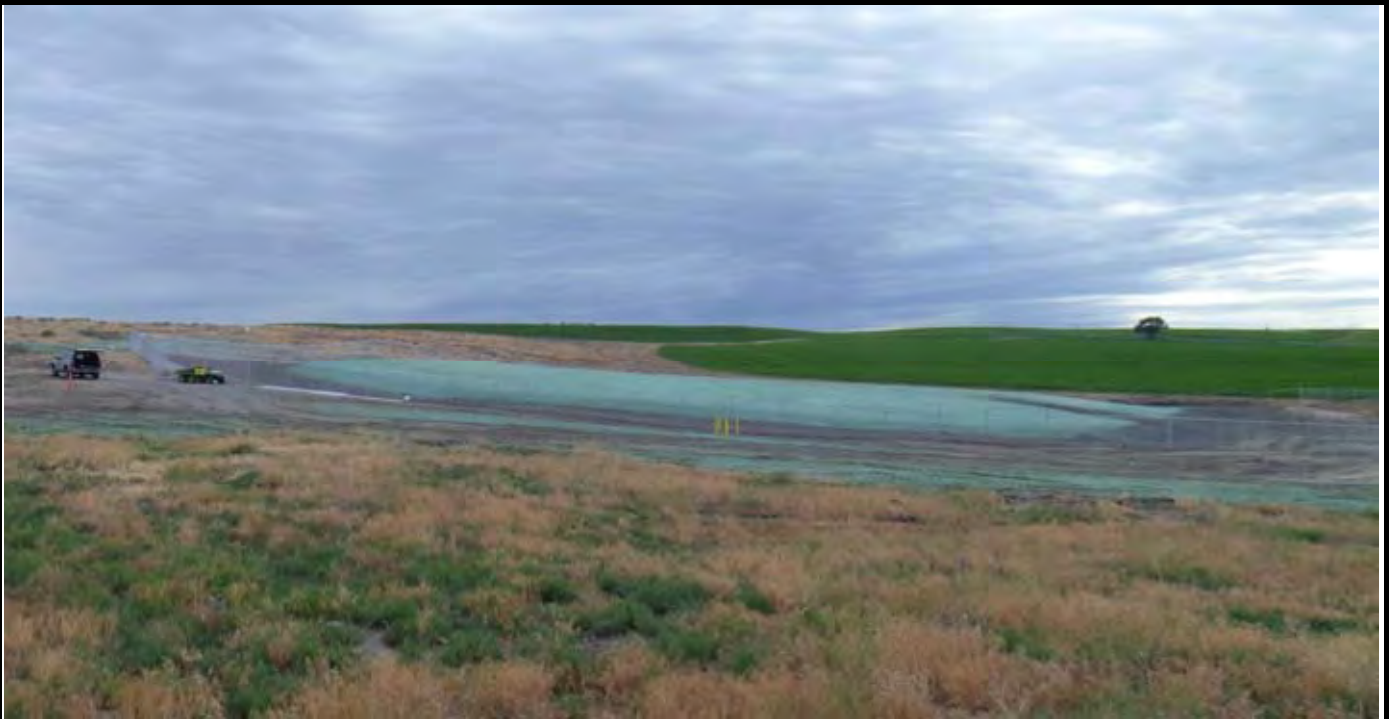
Photo 1: View of the site from the western edge of Zone B. Note the completed hydroseeding and perimeter fencing. View of the CAP from west of the CAP.

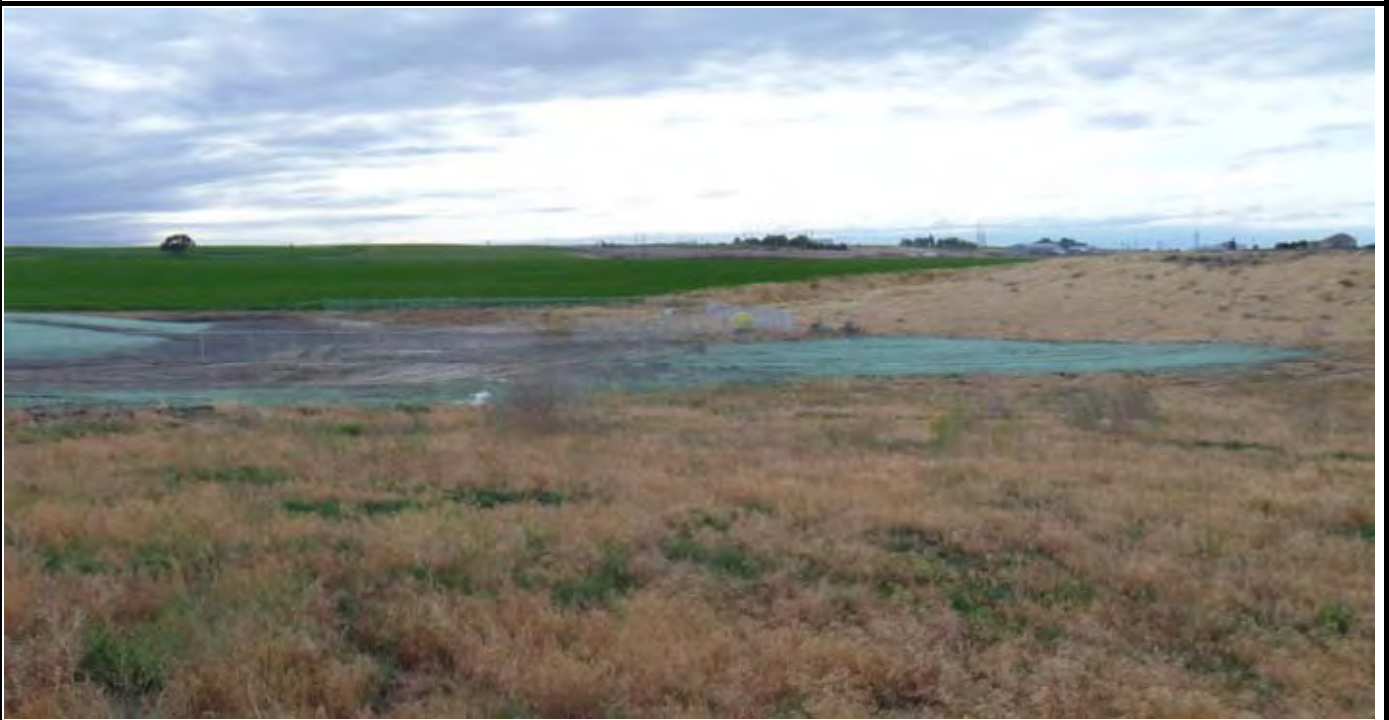
Photo 2: View of the southern portion of the CAP area and disturbed area SW of the perimeter fencing. Note that hydroseeding has been applied to the areas of disturbed soils. View looking east to southeast from west.

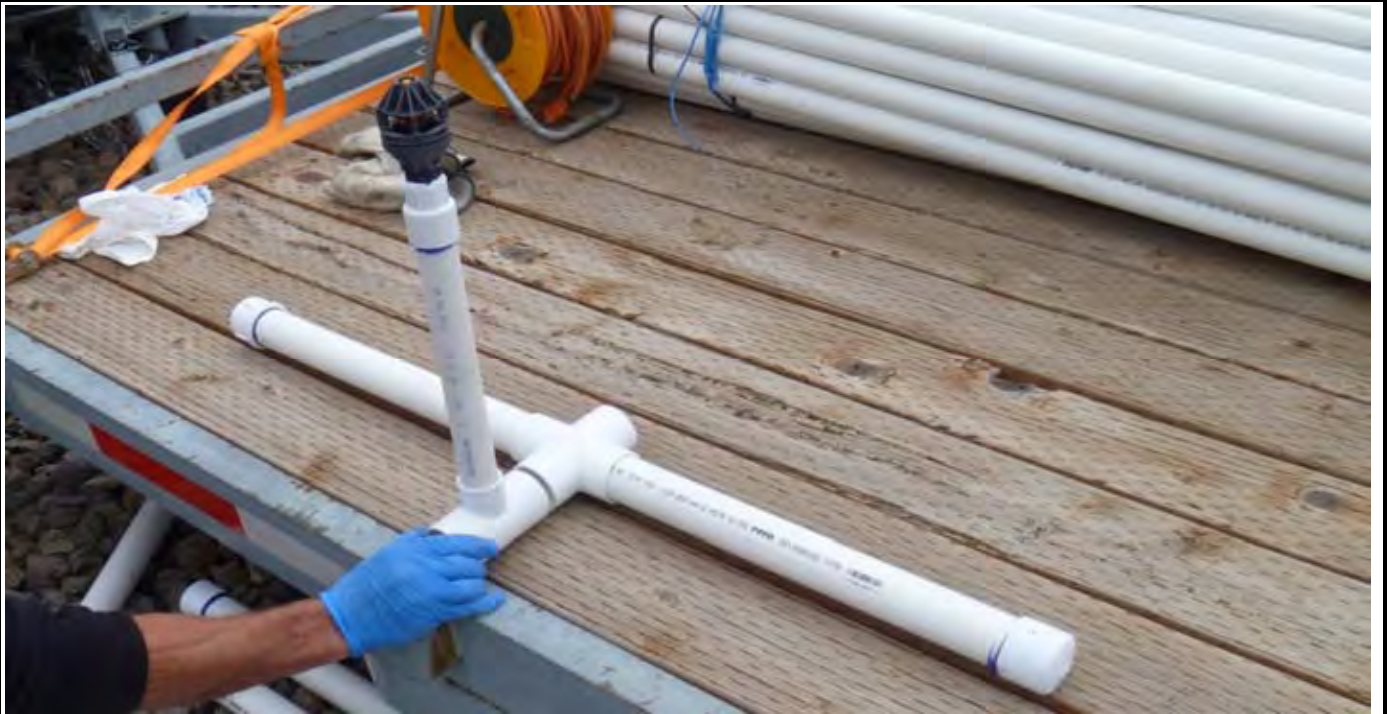
Photo 3: View of typical irrigation sprinkler head and stabilizing bars. Many of these heads were installed across the CAP surface to help establish the vegetation layer.

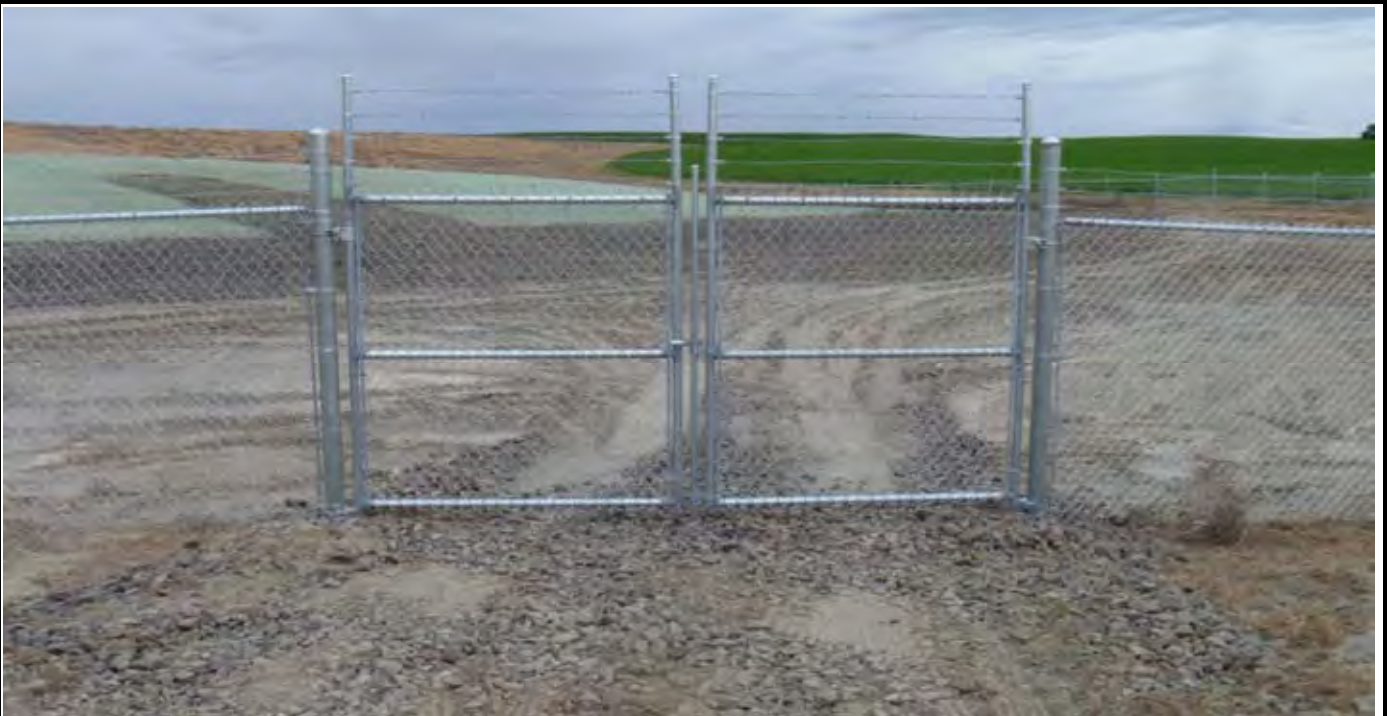
Photo 4: View of the completed perimeter fencing access double swing gate and roadway into the CAP. This work was completed by Rick's Custom Fencing. View looking NE from the SW corner of the CAP.

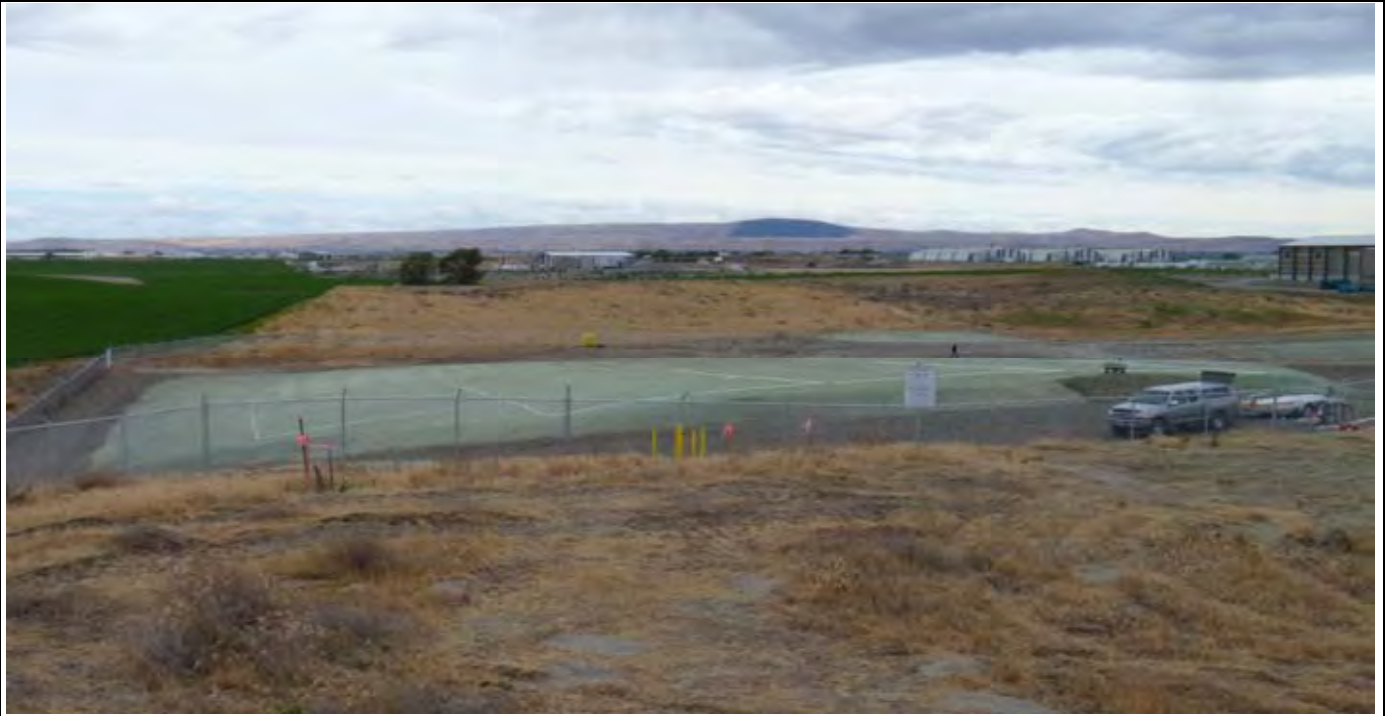
Photo 5: View of the completed CAP, perimeter fencing, hydroseeding, and irrigation system (currently installed in the picture). View of the CAP from area NE of the CAP.

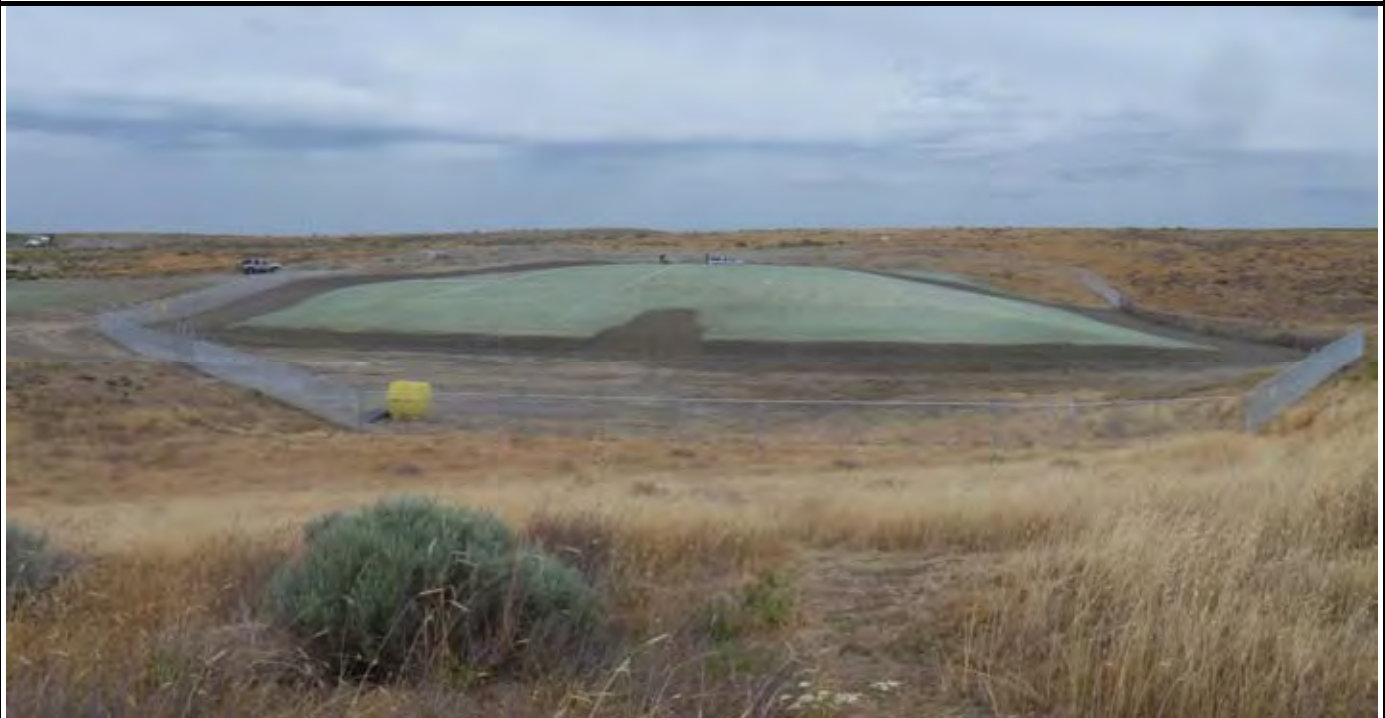
Photo 6: View of the completed CAP, perimeter fencing, hydroseeding, and irrigation system (currently installed in the picture). View of the CAP from area south of the CAP. Note that the yellow container has been moved back inside the CAP perimeter fencing.

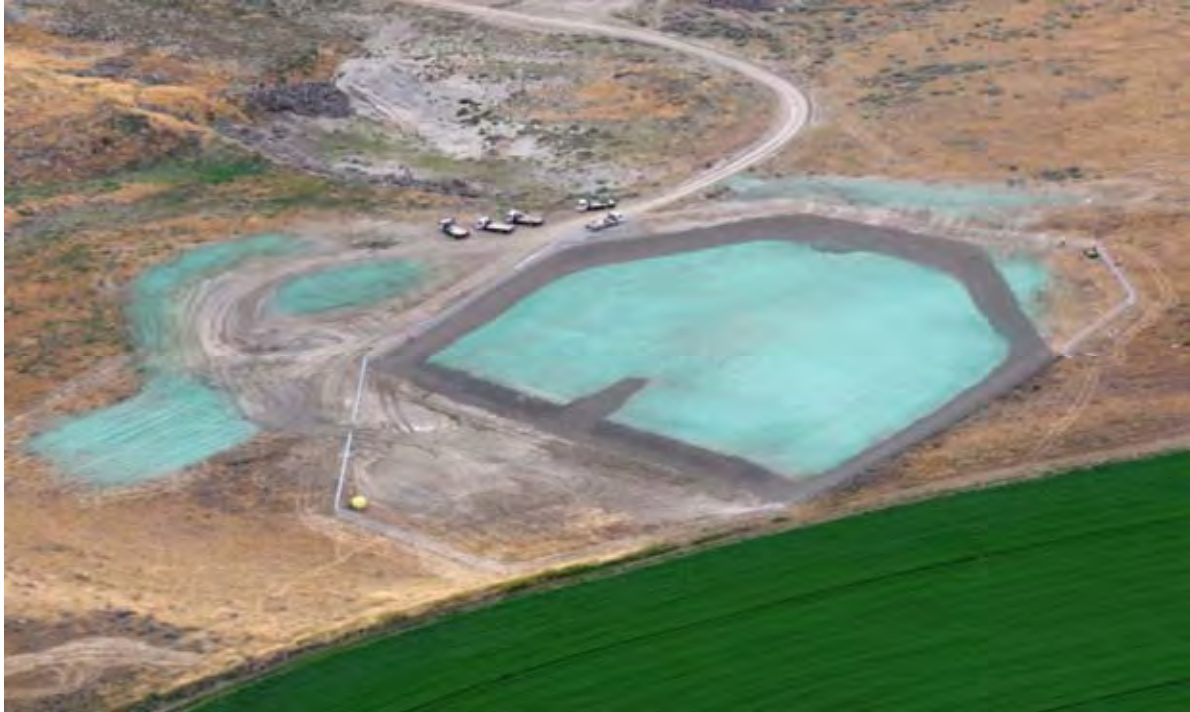
Photo 7: View of the completed CAP and perimeter fencing and hydroseeding on the CAP and surrounding areas that were disturbed during the CAP construction. This is an aerial photograph taken in the sky southeast of the landfill.
