PHOTOGRAPH LOG

Environment and Infrastructure, Inc.
7376 SW Durham Road
Portland, Oregon 97224

PROJECT NAME: Pasco Landfill Cap Project - Cap Construction Project

Project No: 4-61M-10705-1 P-02

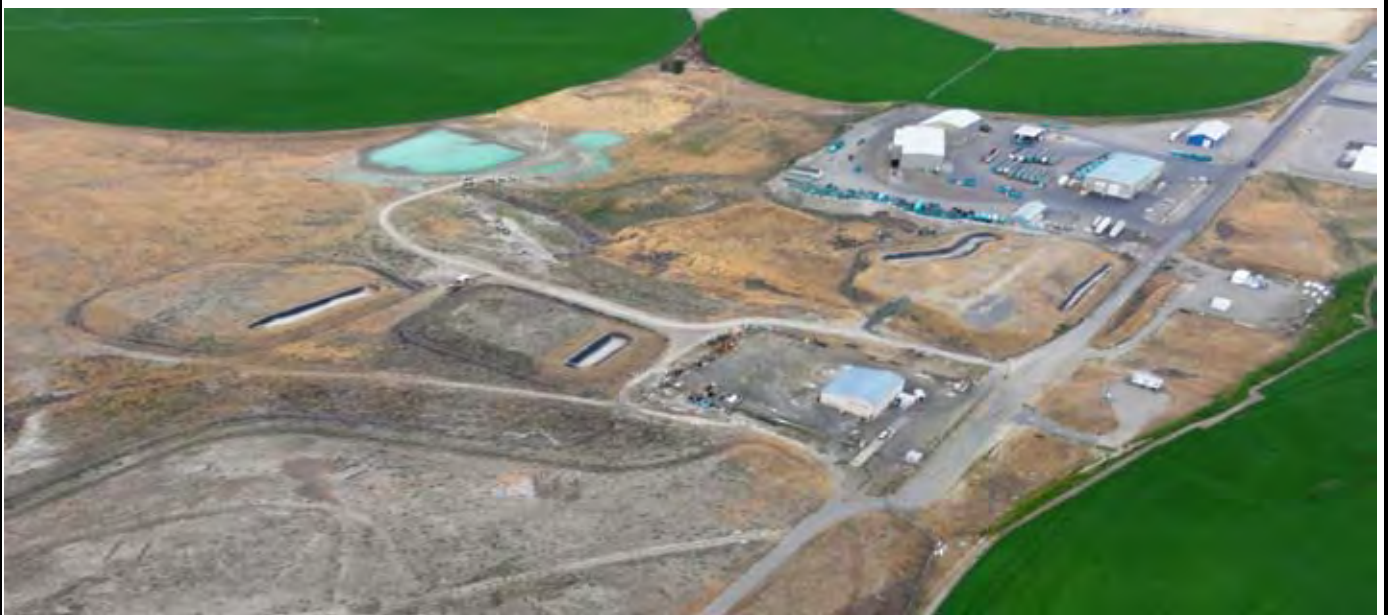
Photo 8: View of the southern portions of the former Pasco Landfill property. Zone B is visible in the upper left side of the photograph (see light green coloring). Aerial photograph was taken in sky northwest of the landfill.
