Pasco Sanitary Landfill: Managing a Subsurface Fire at a MTCA Cleanup Site

Washington State LEPC-Tribal Conference
Chelan, WA, May 16, 2017

Chuck Gruenenfelder & Jeremy Schmidt, site managers
Toxics Cleanup Program, Eastern Region

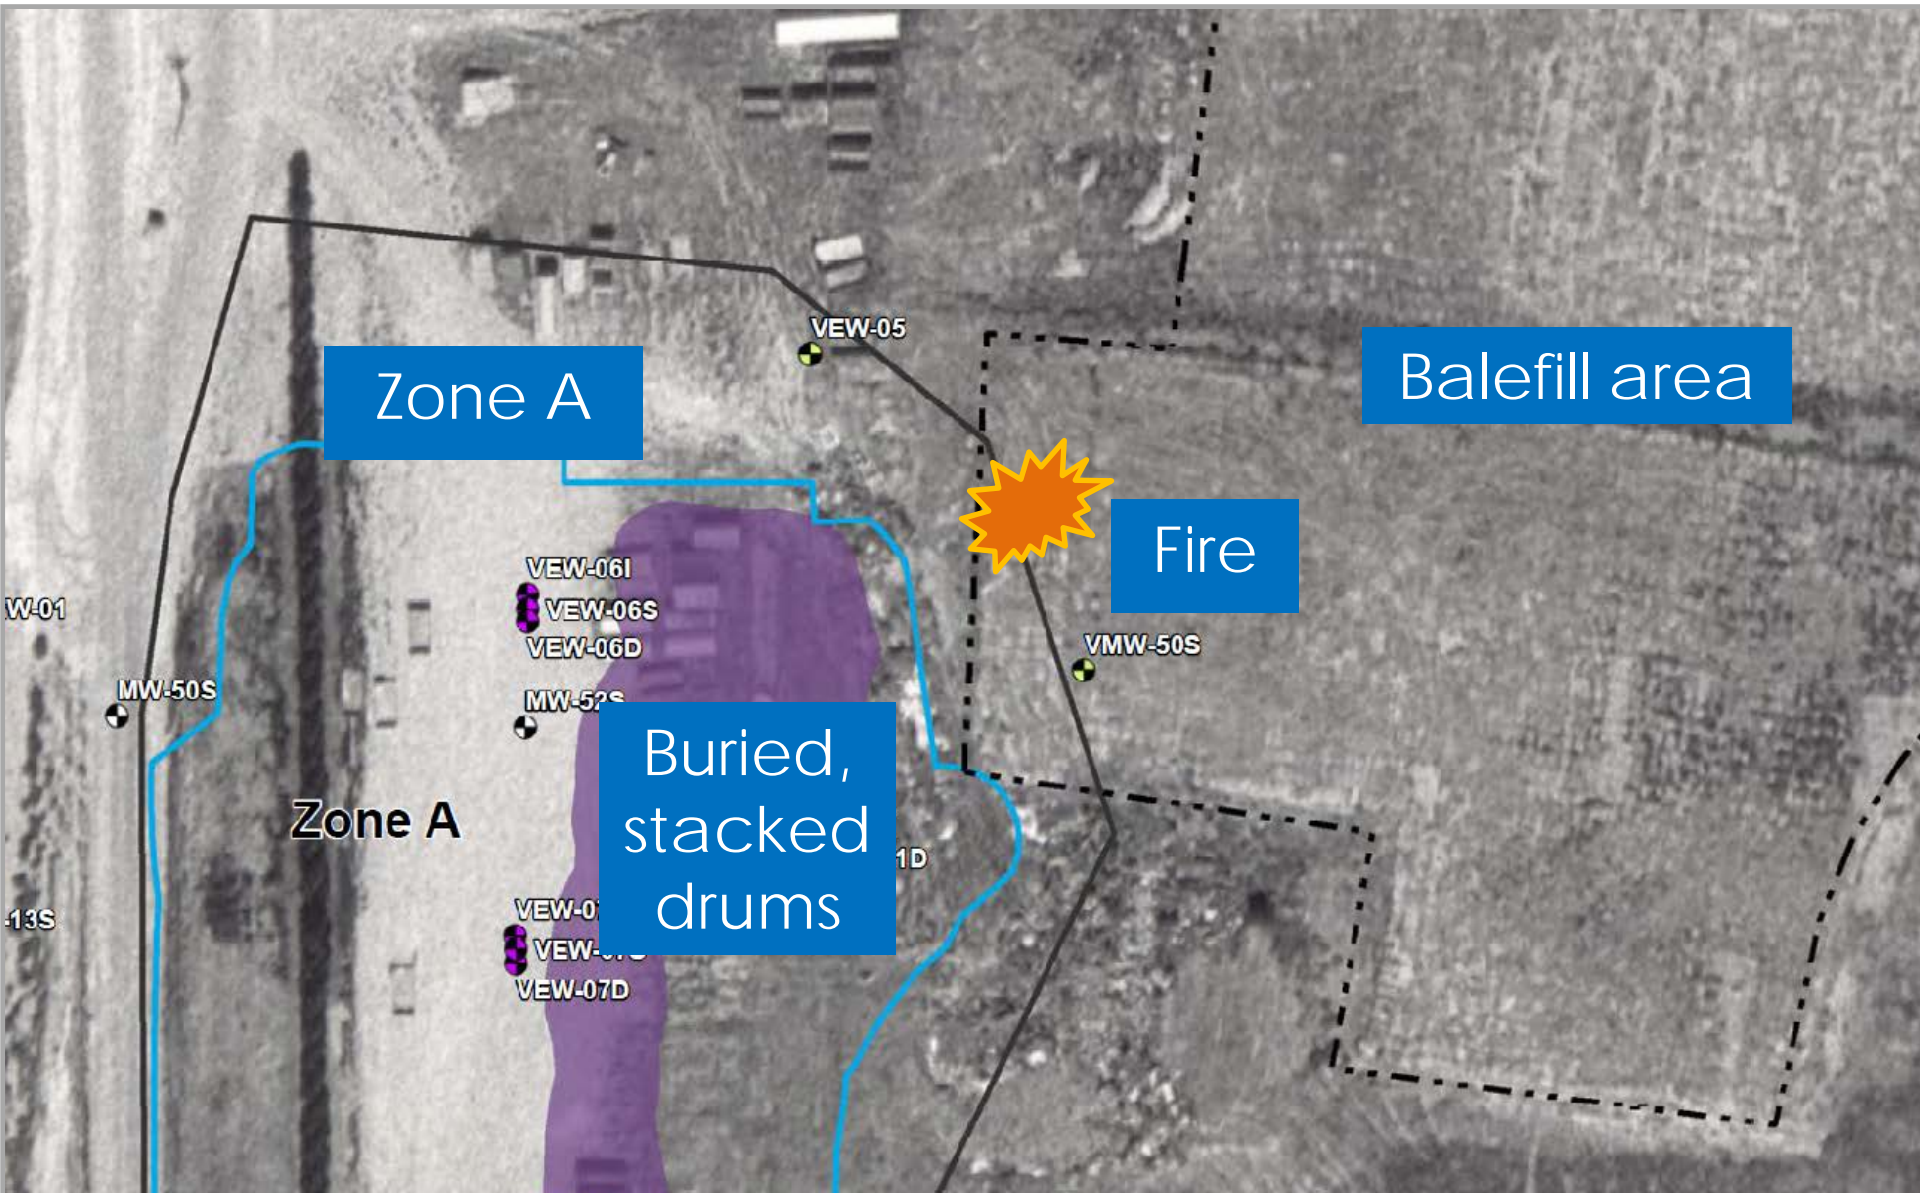
Balefill Area Underground Fire November 2013

A landfill fire is suspected and reported in Balefill area following a routine visual inspection

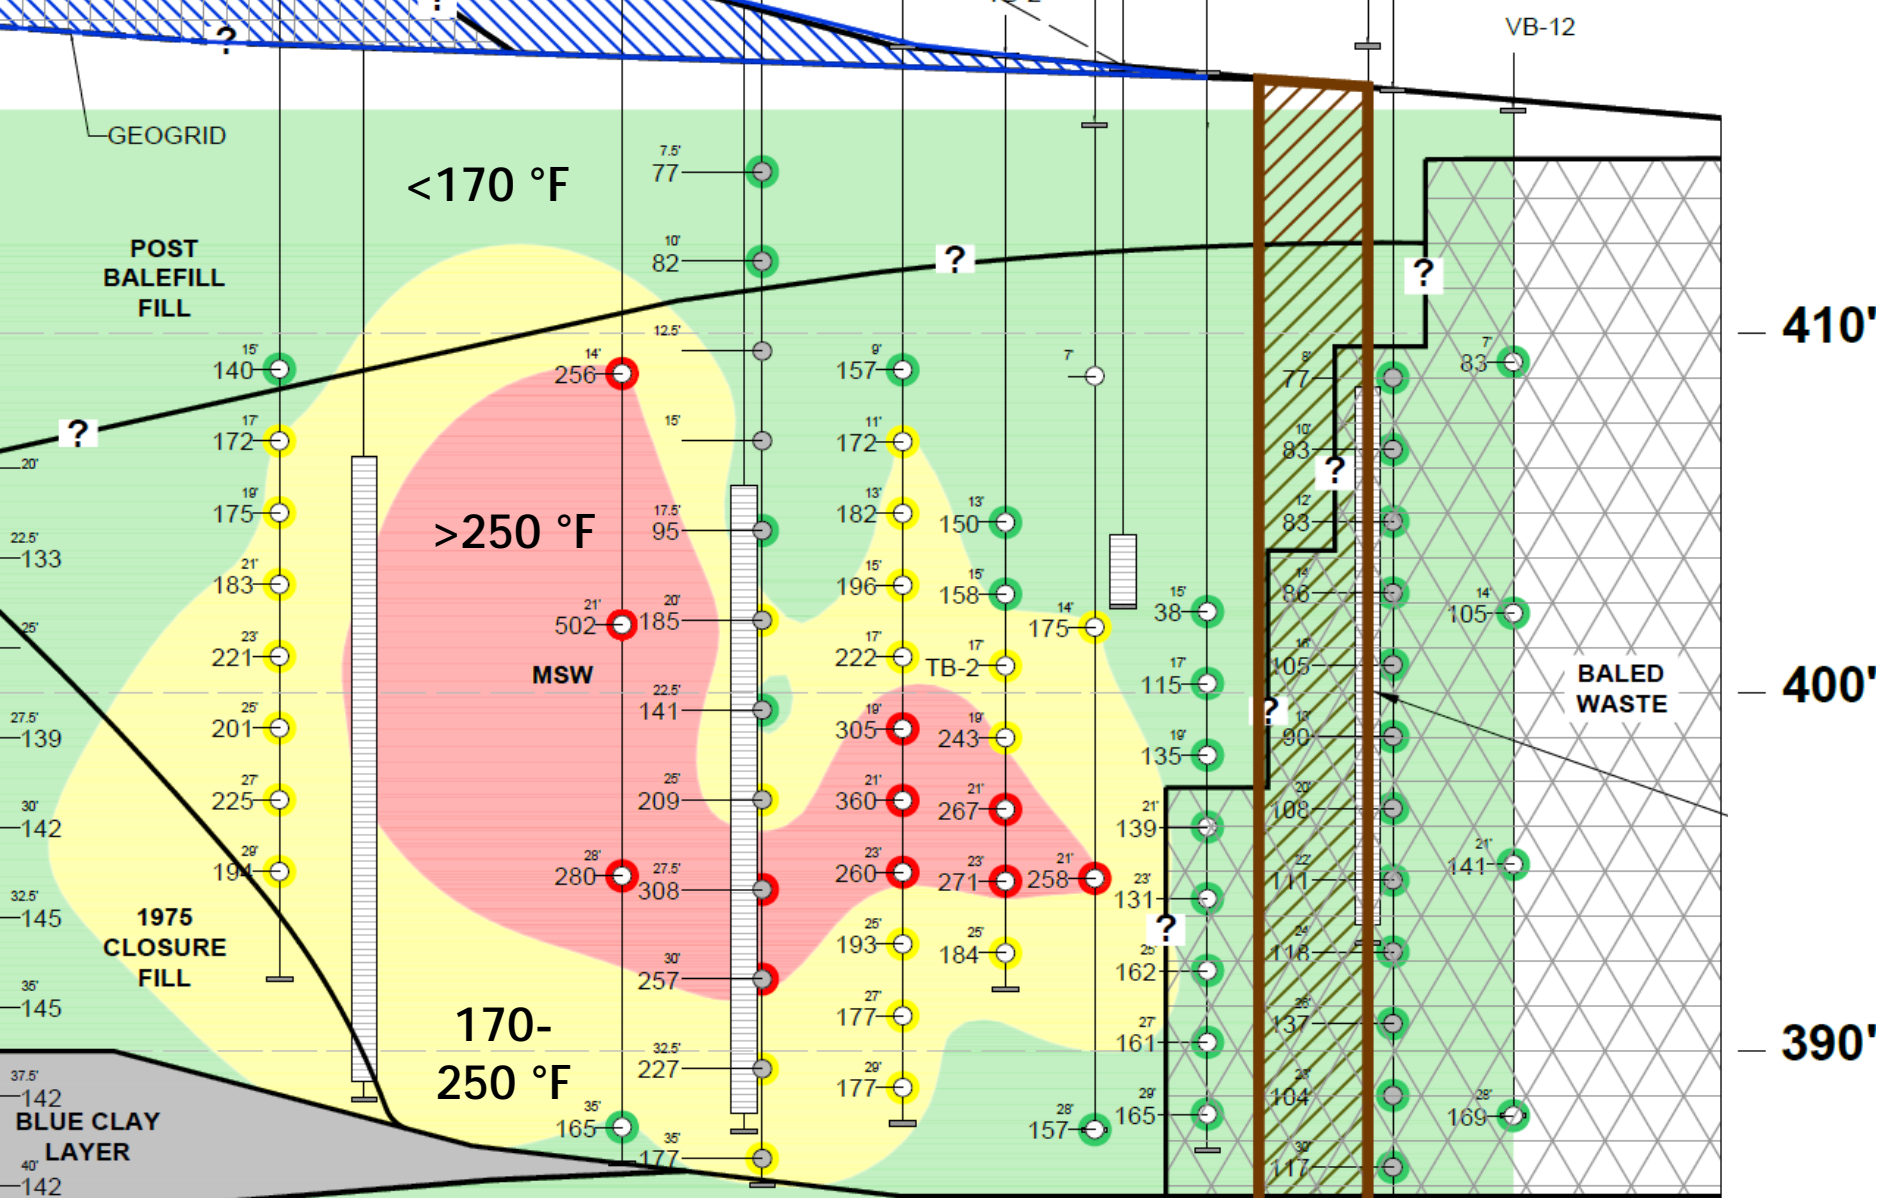
- 21 injection events (June 2014–March 2015)
- 5,000 to 23,000 pounds of liquid carbon dioxide injected per event (6–15 probes per event)
- Total quantity injected: 255,000 pounds
- Carbon dioxide residence time ~1 week or less
- Oxygen intrusion and uneven gas dispersion appears to limit overall effectiveness

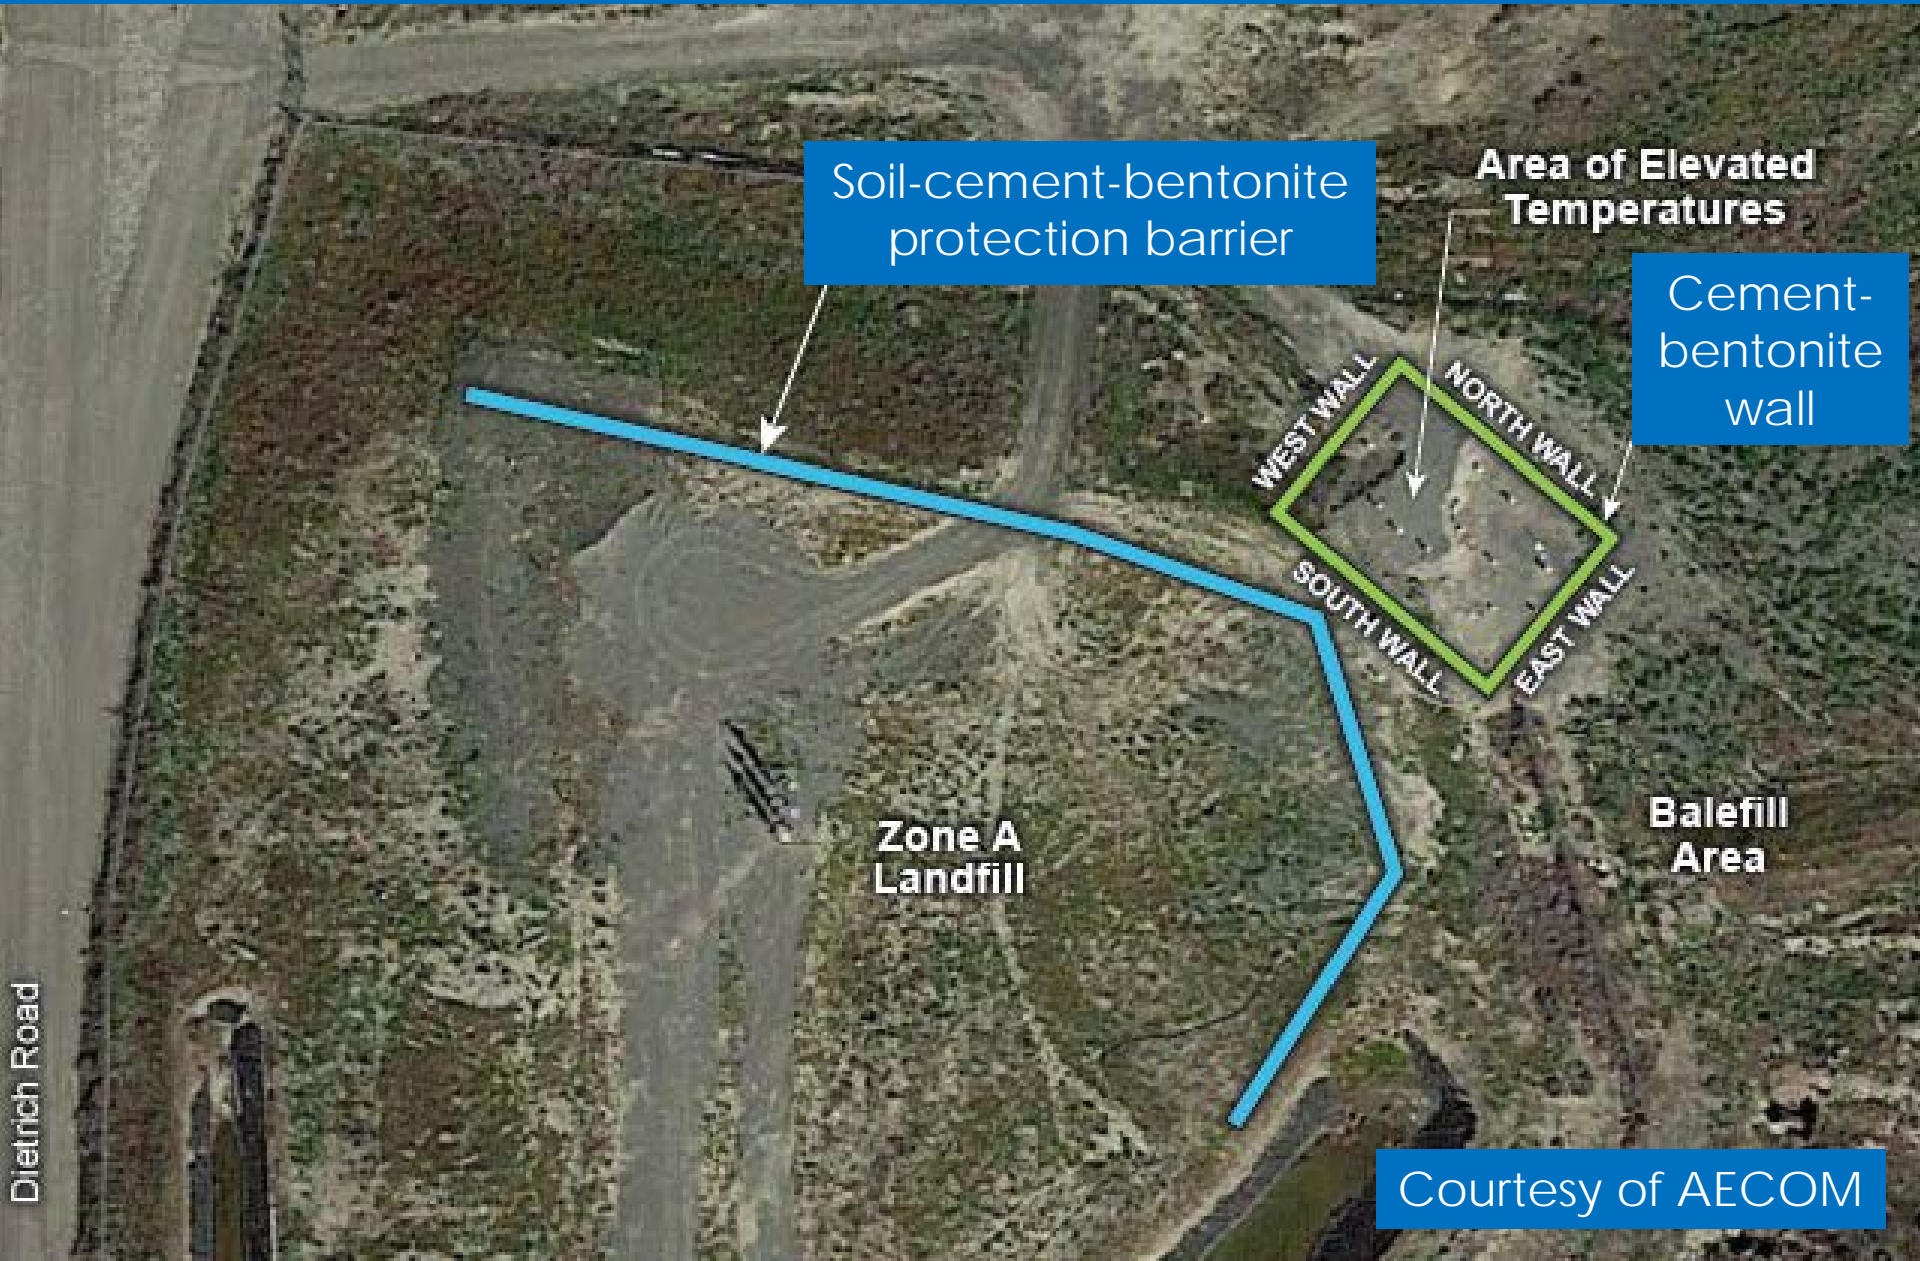
Phase III: Contain/excavate/quench approach

Area of Elevated Temperatures

Soil-cement-bentonite protection barrier

Cement-bentonite wall
