Westmoreland Property  
23019 192<sup>nd</sup> Ave SE  
Renton WA 98058

ERTS # 614667/628570

ICT visits by Debra Oliver & Sue Hamilton, HEI III, King County Hazardous Waste Management Unit; Initial Investigation on behalf of Ecology TCP.

First visit: 18 August 2011:

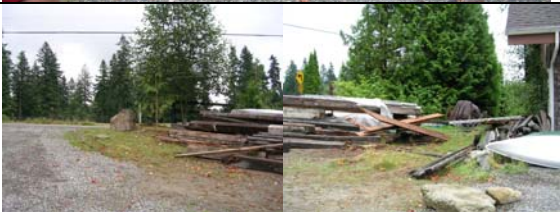
<p>This is inside the property looking east to 192<sup>nd</sup> Ave SE. A pile of lumber sits between the house and the fence along 192<sup>nd</sup> Ave SE.</p>

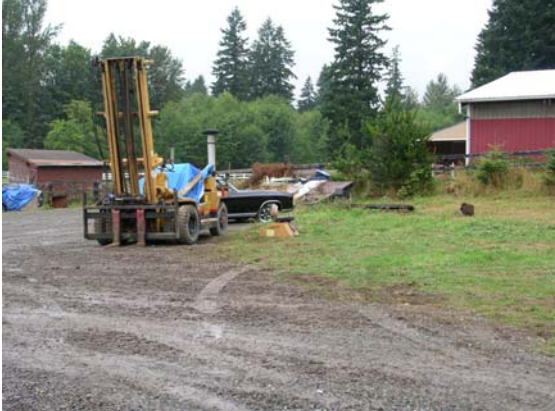
<p>From the area of discoloration looking north.</p>

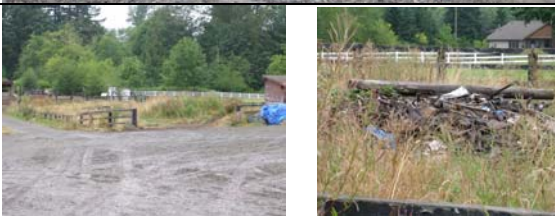
<p>Looking into the NW corner of the property from the discoloration. In the foreground is a fenced, grassed area with the remains of one demolished building and beyond that are the horses being housed on Westmoreland's property.</p>

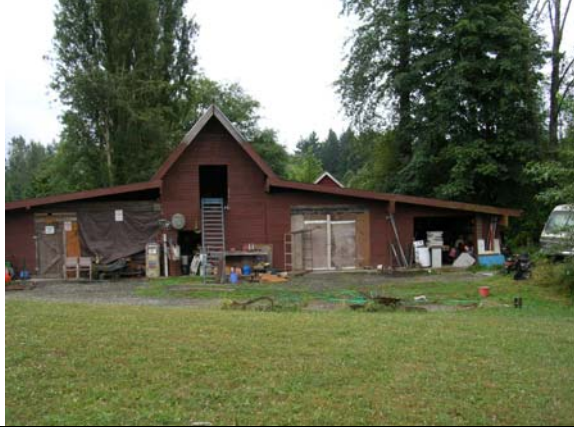
The “barn.” Mr. Westmoreland stated he keeps construction materials in here. A friend uses the right side of the building for storage.
