STATE OF WASHINGTON
DEPARTMENT OF ECOLOGY

April 18, 2017

Subject: Van Stone Mine, Tailings Pond Dam; Dam Safety file no. ST 61-0608
Dam Safety Inspection, summary findings and required remedial actions

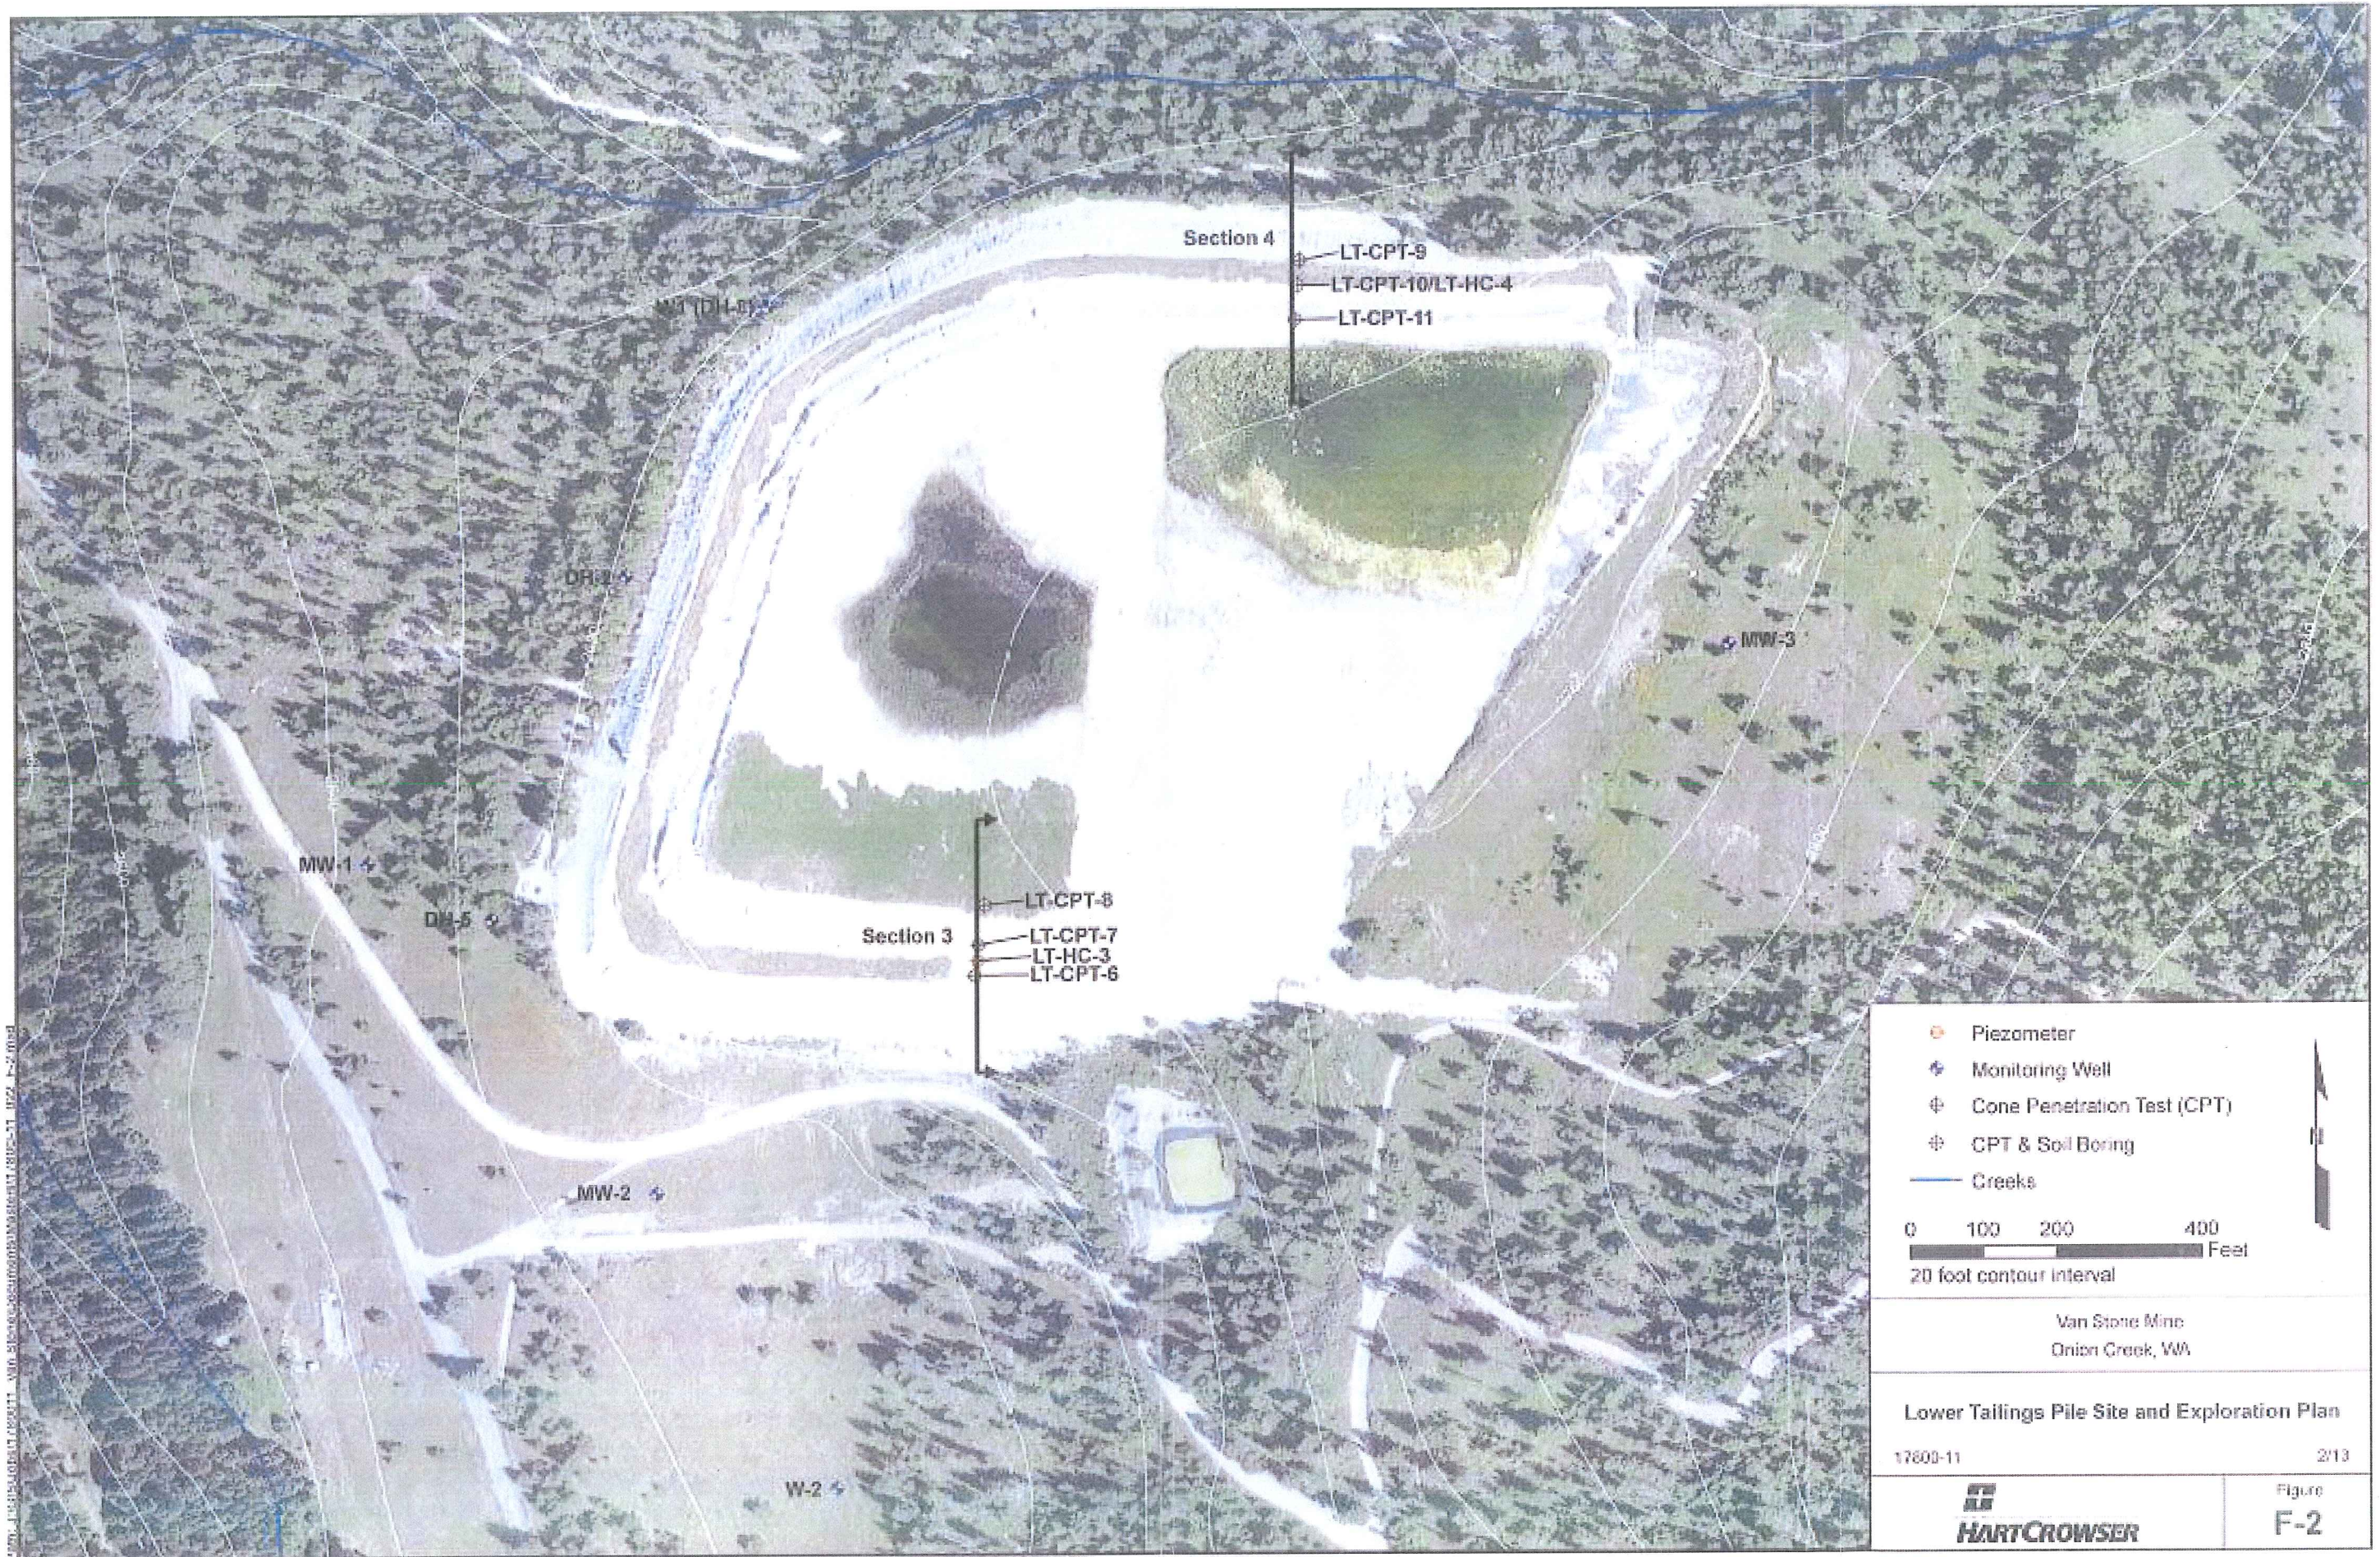
HALLAM KNIGHT PIESOLD LTD. ENVIRONMENTAL CONSULTANTS-WANCOUVER, B.C.		EQUINOX RESOURCES (WASHINGTON) INC.	
DESIGNED: BH		VAN STONE MINE-OPEN PIT	
DRAWN: AW		CLOSURE OF EXISTING TAILINGS AREA	
CHECKED: BH		FIGURE 26	
APPROVED:		DATE JUNE 2, 1999	SCALE AS SHOWN
		ORG. NO. H3172	REV. 0

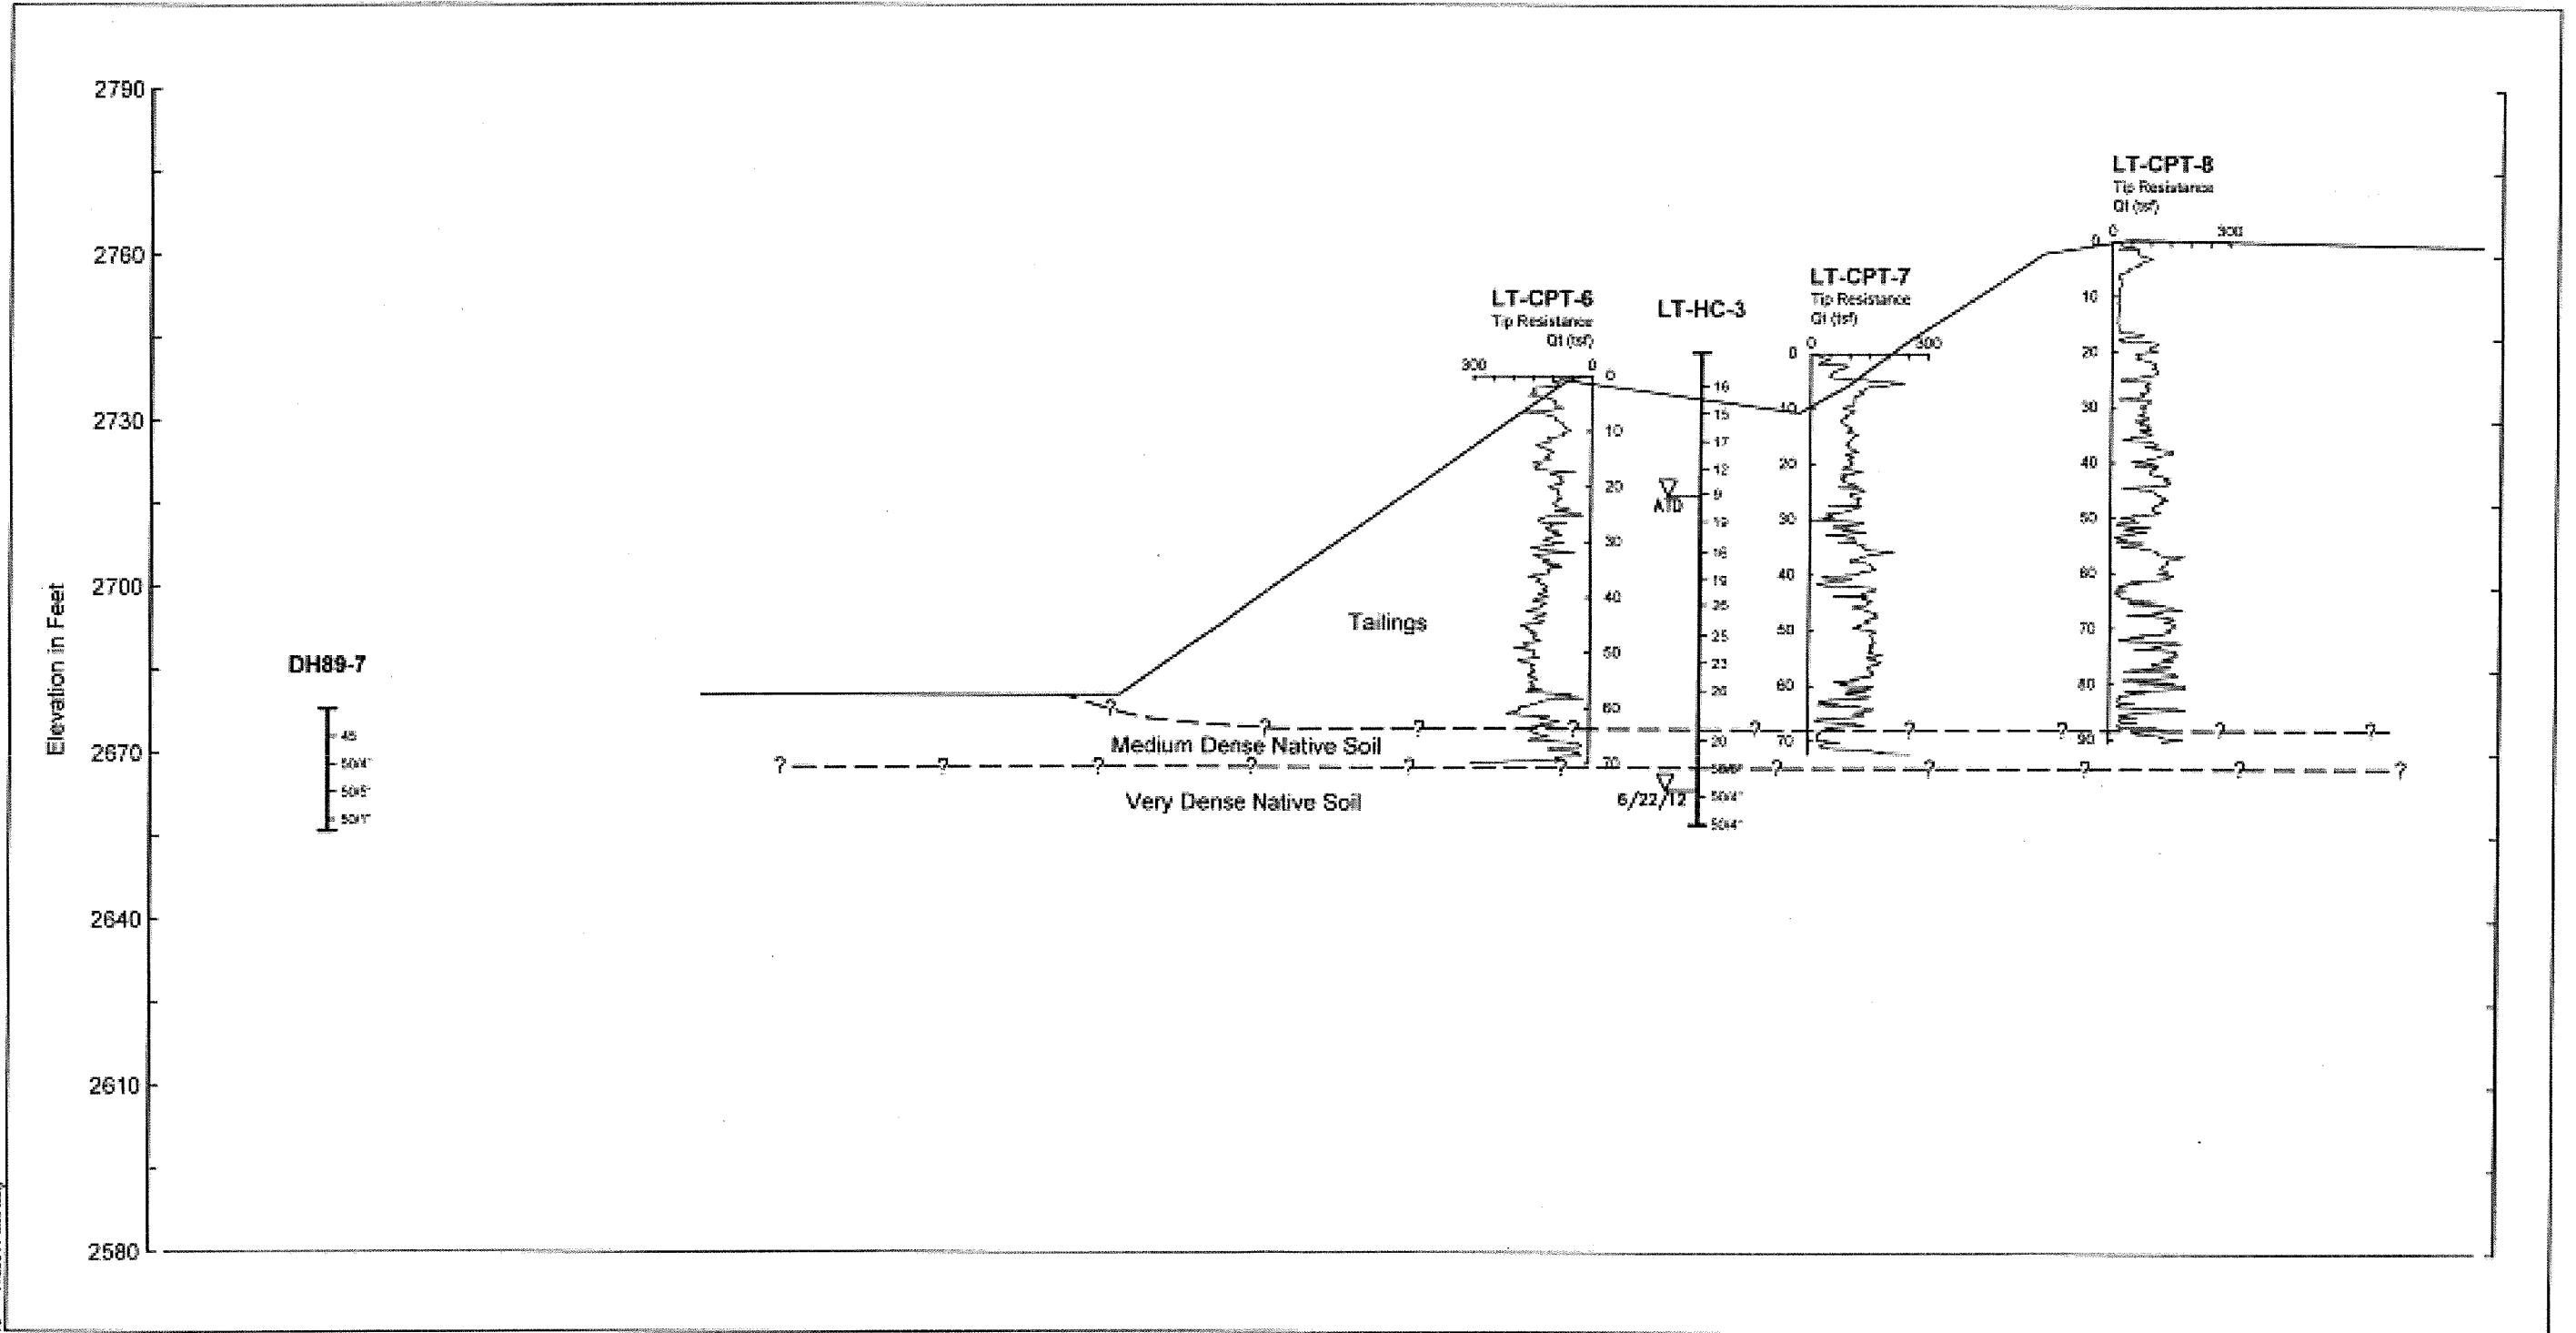
Figure F-5

**Generalized Subsurface Profile Along Lower Tailings Pile Cross Section 3
Van Stone Mine**

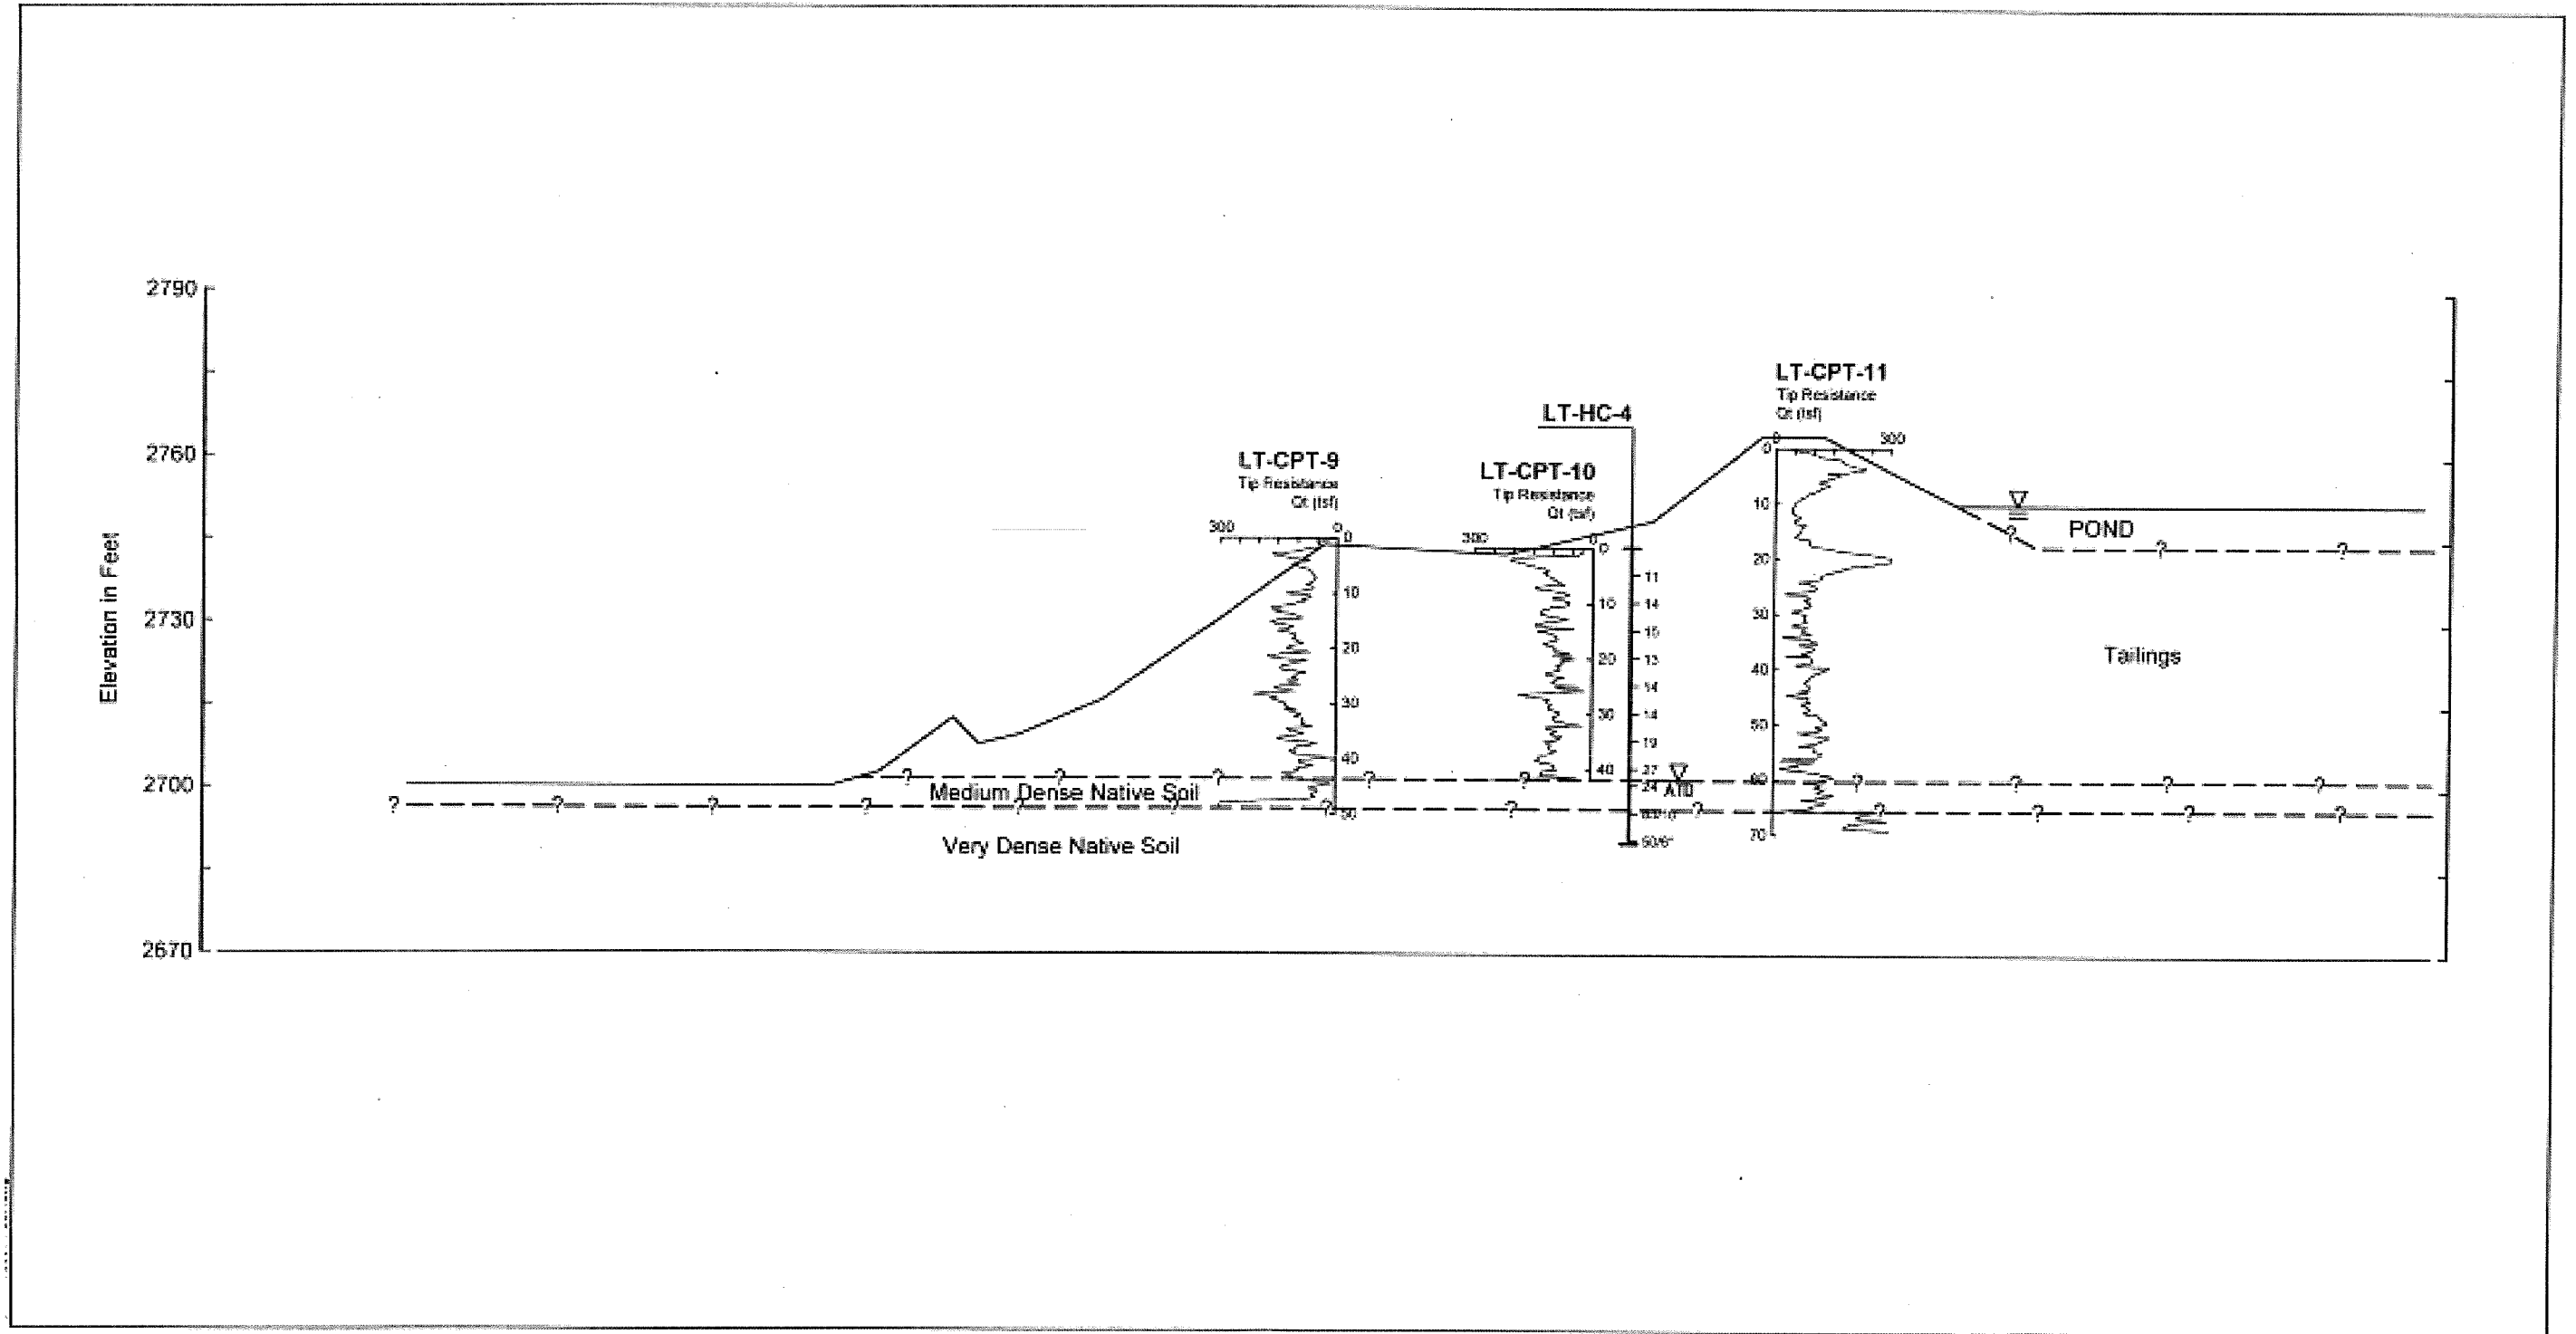
HARTCROWSER
17800-11 2/13
Figure F-6

**Generalized Subsurface Profile Along Lower Tailings Pile Cross Section 4
Van Stone Mine**
