**Former Hardel Mutual Plywood Site  
1210 West Bay Drive NW  
Olympia, Washington**

**Interim Action Closure Report**

**December 2010**

**GREYLOCK CONSULTING LLC**

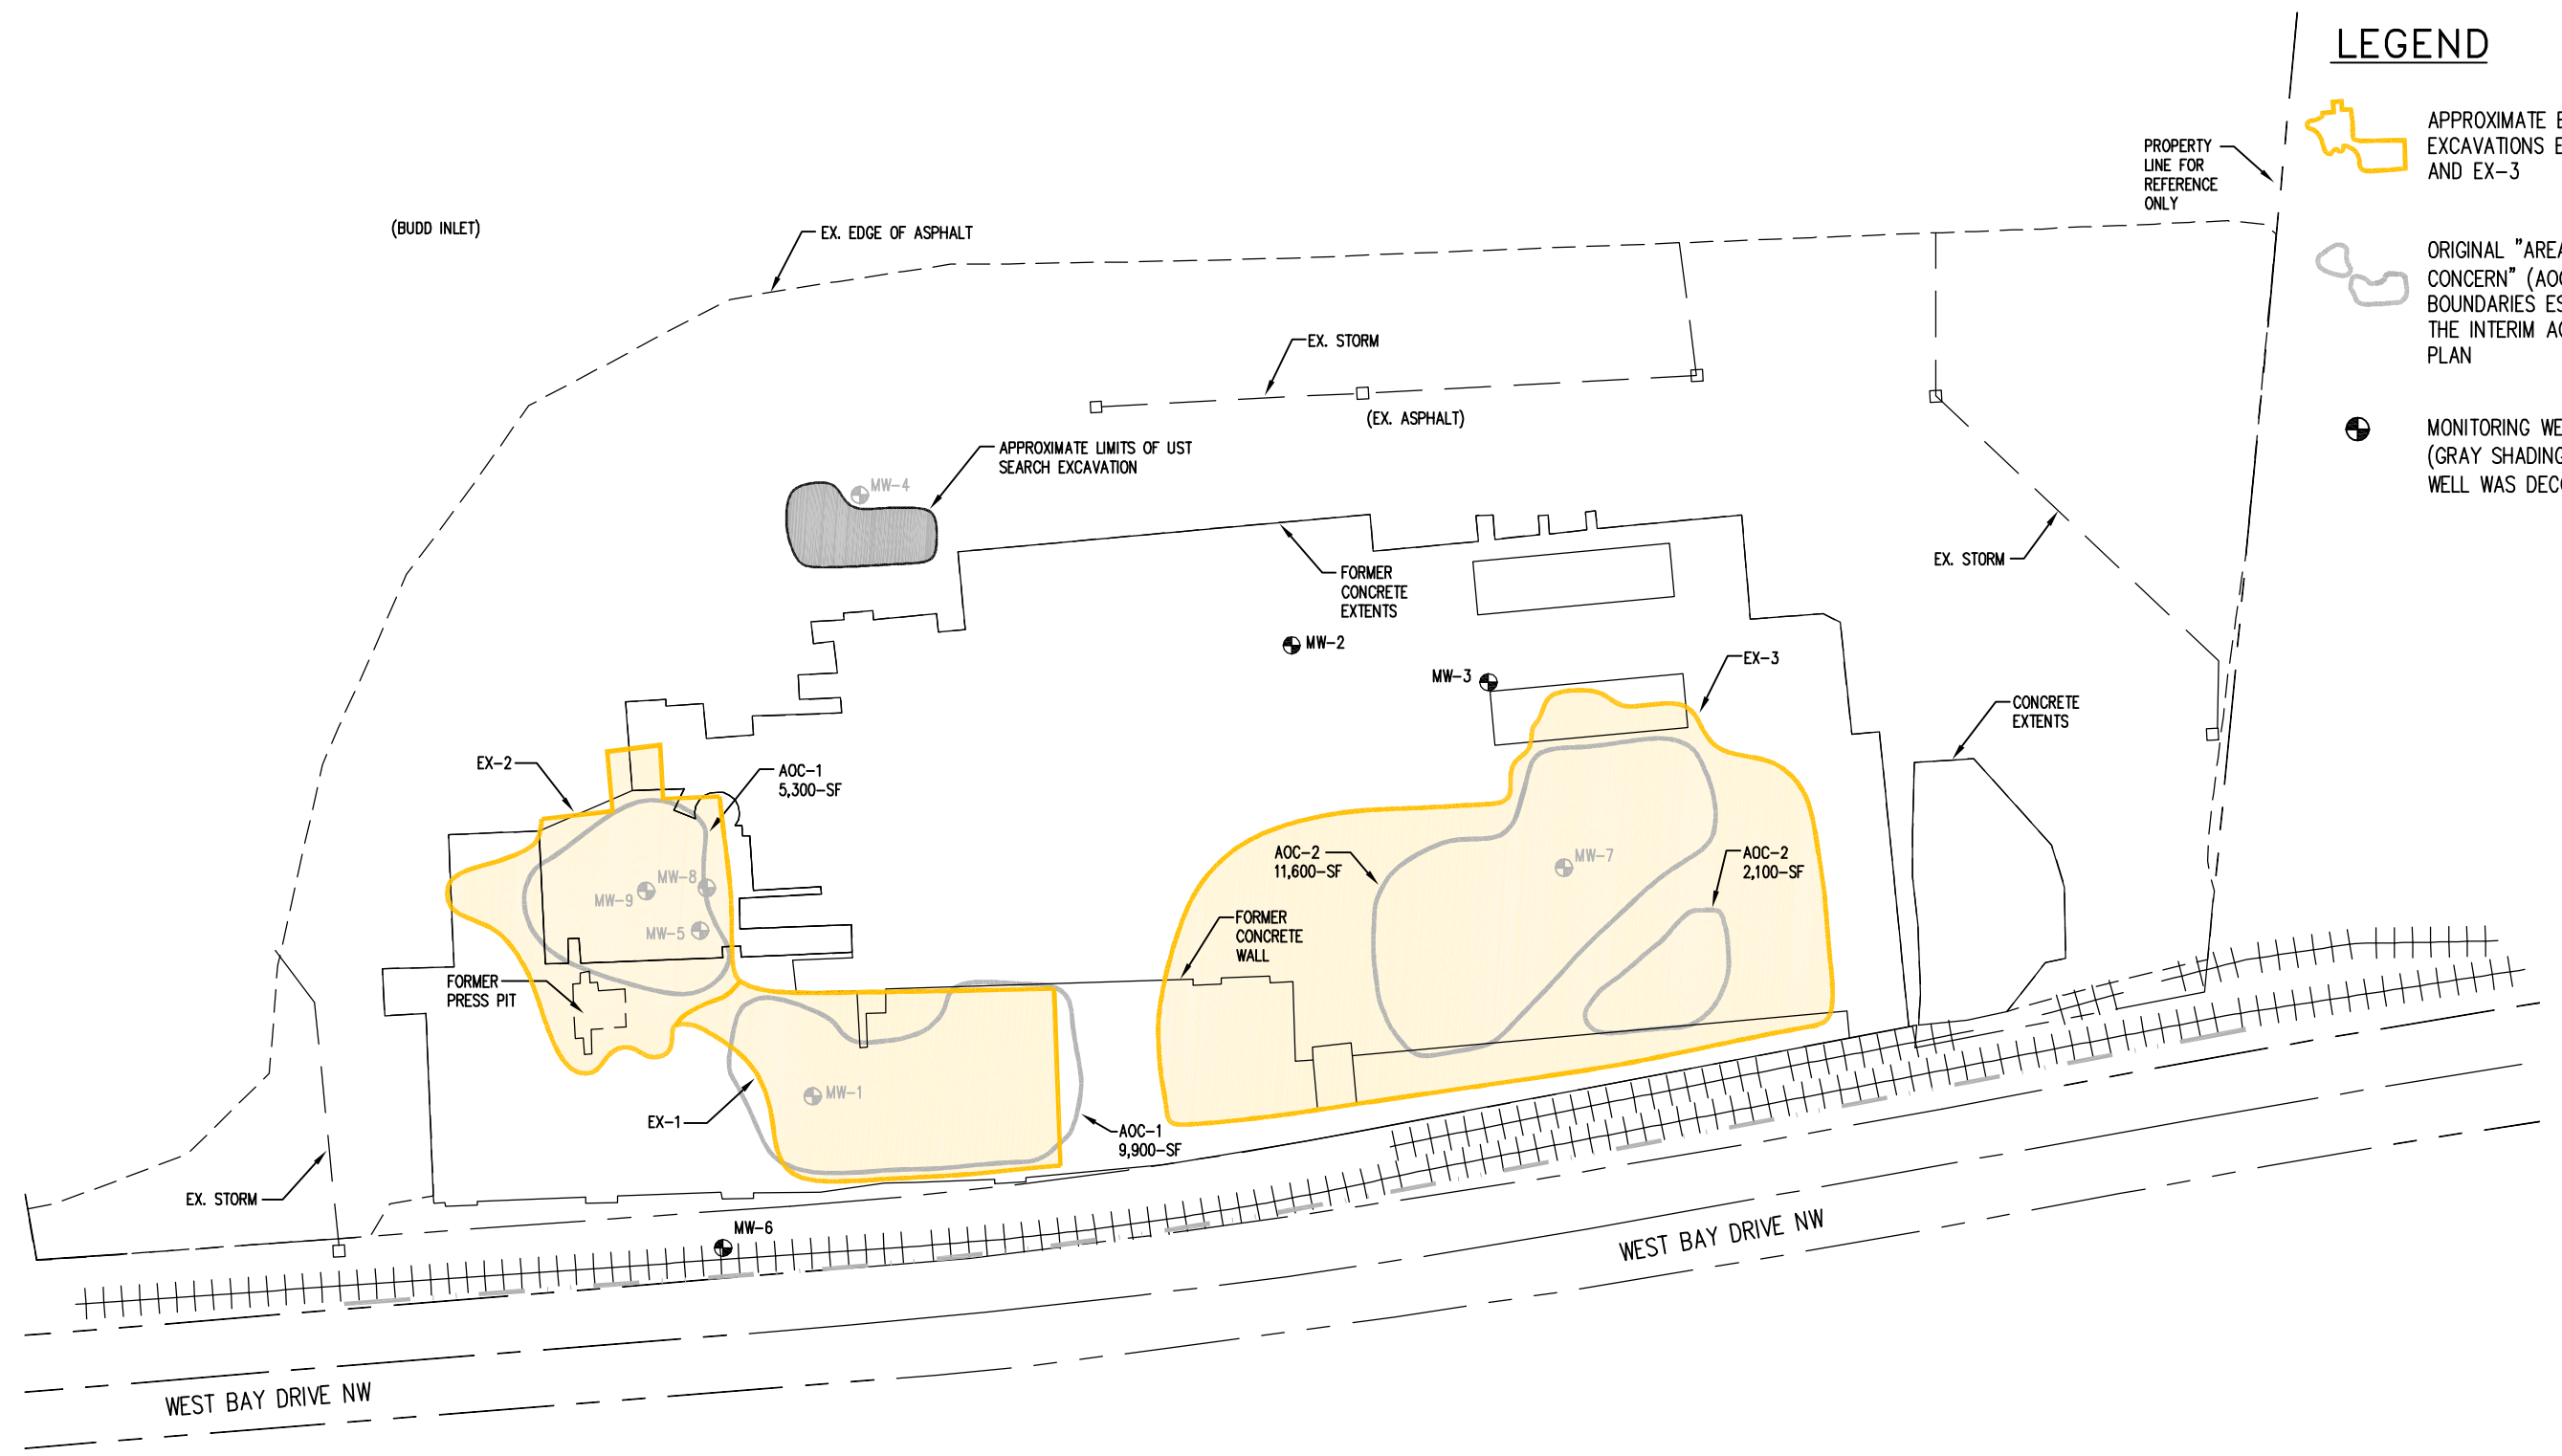
FIGURE 4 : EXCAVATION EXTENTS DETAIL - NORTH

Excavation EX-1 (Figure 3 and Figure 4) was excavated to depths ranging from approximately 9-to-13 feet below the ground surface (bgs), with an average depth of approximately 10 feet bgs. The deeper areas of the excavation were in the western portion of EX-1. A photograph taken during soil excavation activities in the northwestern portion of EX-1 is included as “Photo 3” in Appendix 2.

Excavation EX-2 (Figure 3 and Figure 4) was excavated to depths ranging from approximately 9-to-16 feet below the ground surface (bgs), with most of the excavation at approximately 16 feet bgs. The shallower areas of the excavation were nearby to the north and west of the former “press pit”.
