INTERIM ACTION REPORT
ENNIS CREEK-FINISHING ROOM
FUEL OIL TANK NO. 2
MACHINE SHOP

FORMER RAYONIER PULP MILL SITE
PORT ANGELES, WASHINGTON

Integral Consulting, Inc.

March 2003

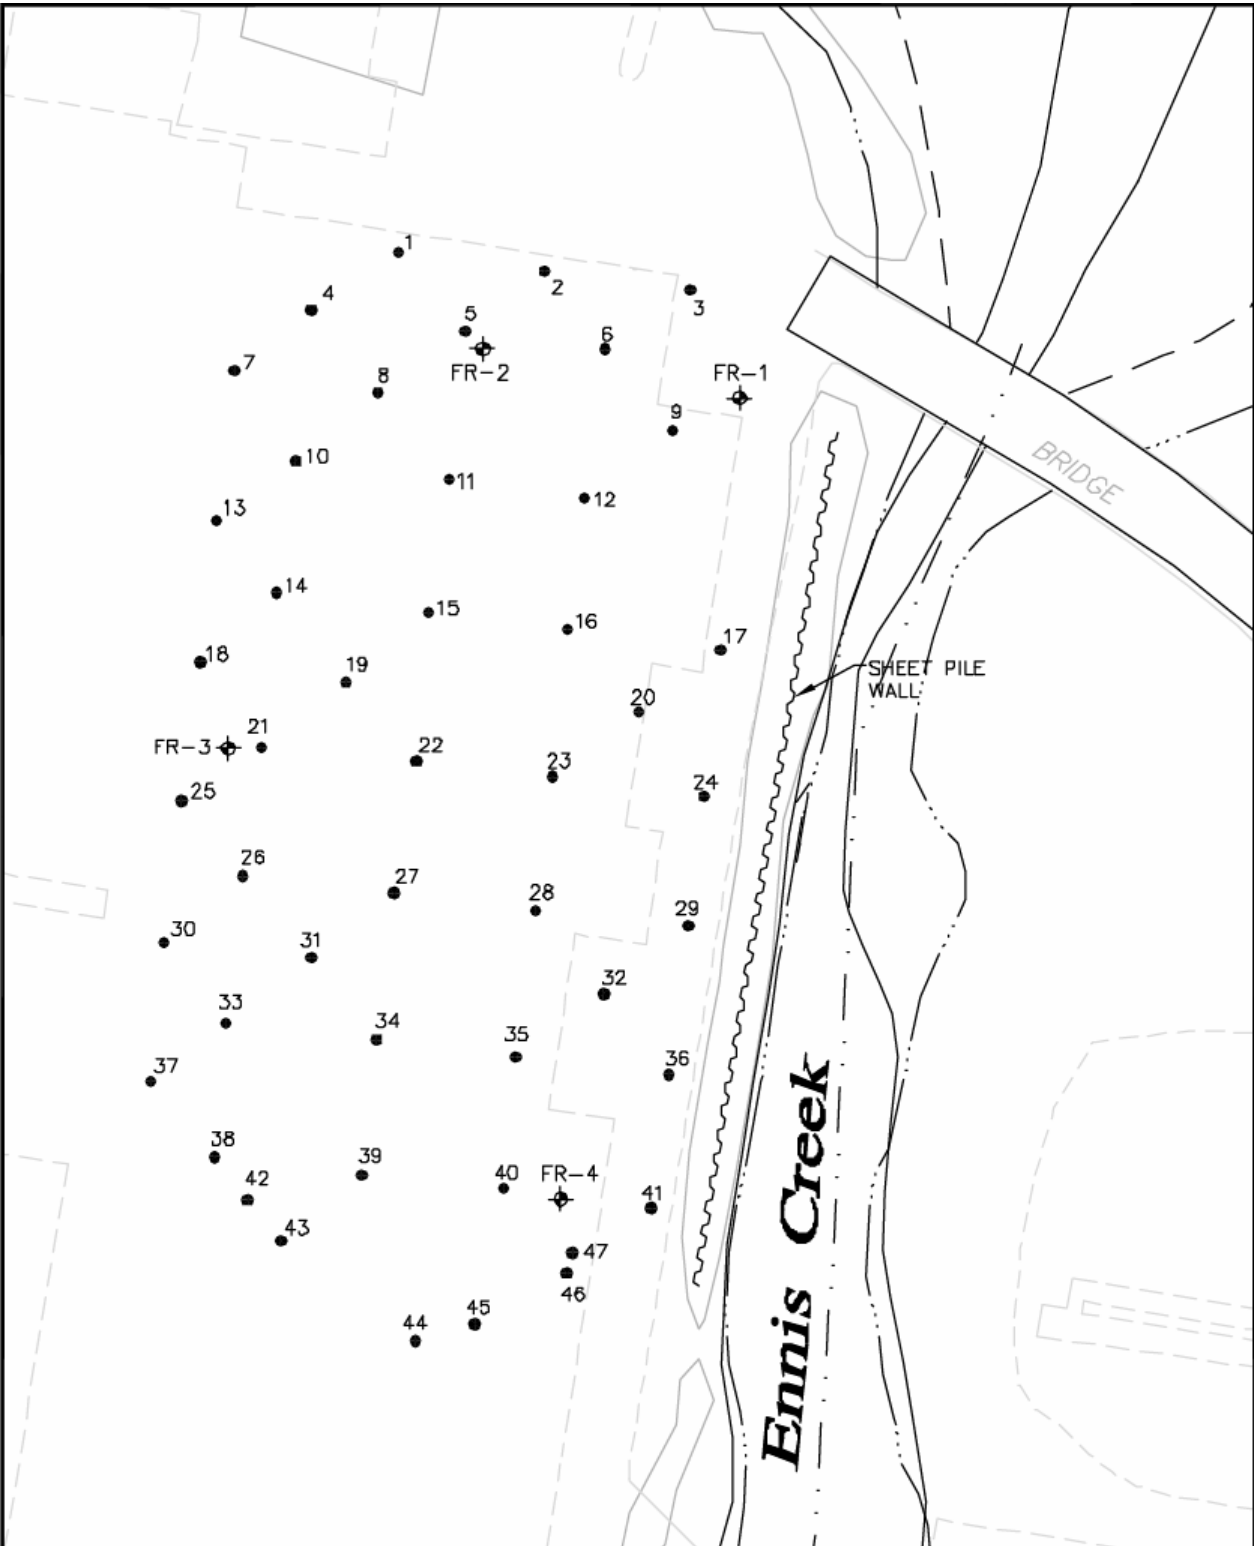
Figure 3-1
**Confirmation Sampling Locations
for the 1998 Interim Action at the
Ennis Creek-Finishing Room Area**

The confirmation samples collected after the 1998 Interim Action are presented in Figure 3-1 and Table 3-1. As shown in Table 3-1, the 1998 Interim Action reduced the COCs in the Finishing Room area to the following:

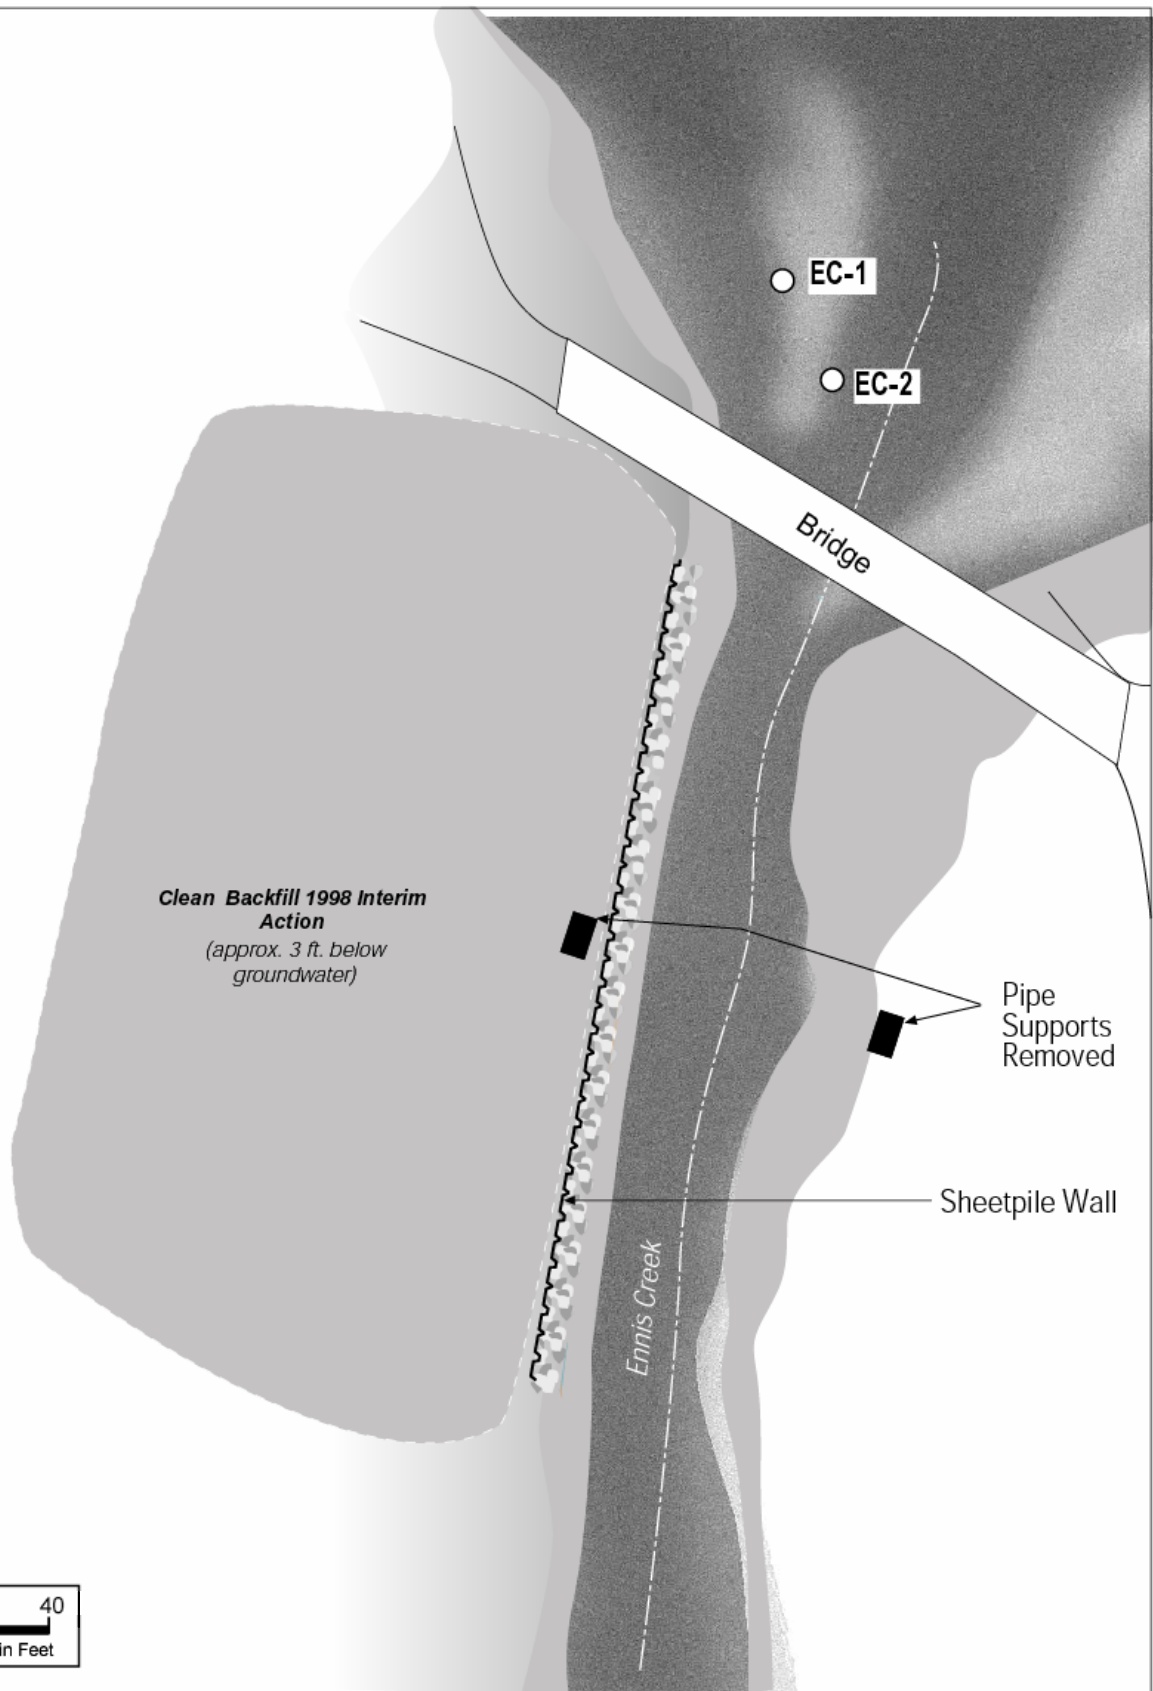
Figure 5-3.
Ennis Creek Monitoring Sample Locations

At the request of the Washington Department of Natural Resources, two surface sediment (0 to 10 cm) samples were collected on 6/25/02 and 8/9/02 from the alluvial fan of Ennis Creek (Figure 5-3) prior to excavation of soil/sediment from the Ennis Creek-Finishing Room Area, and on 9/04/02, several weeks after removal of the creek bypass, to assess the potential effect of the interim action downstream.
