**Re: Current Environmental Conditions Report  
Former Grays Harbor Paper Mill Facility  
Hoquiam, Washington  
Project No. 0016046.010.020**

**Current Environmental Conditions Report  
Former Grays Harbor Paper Mill Facility  
801 23<sup>rd</sup> Street  
Hoquiam, Washington**

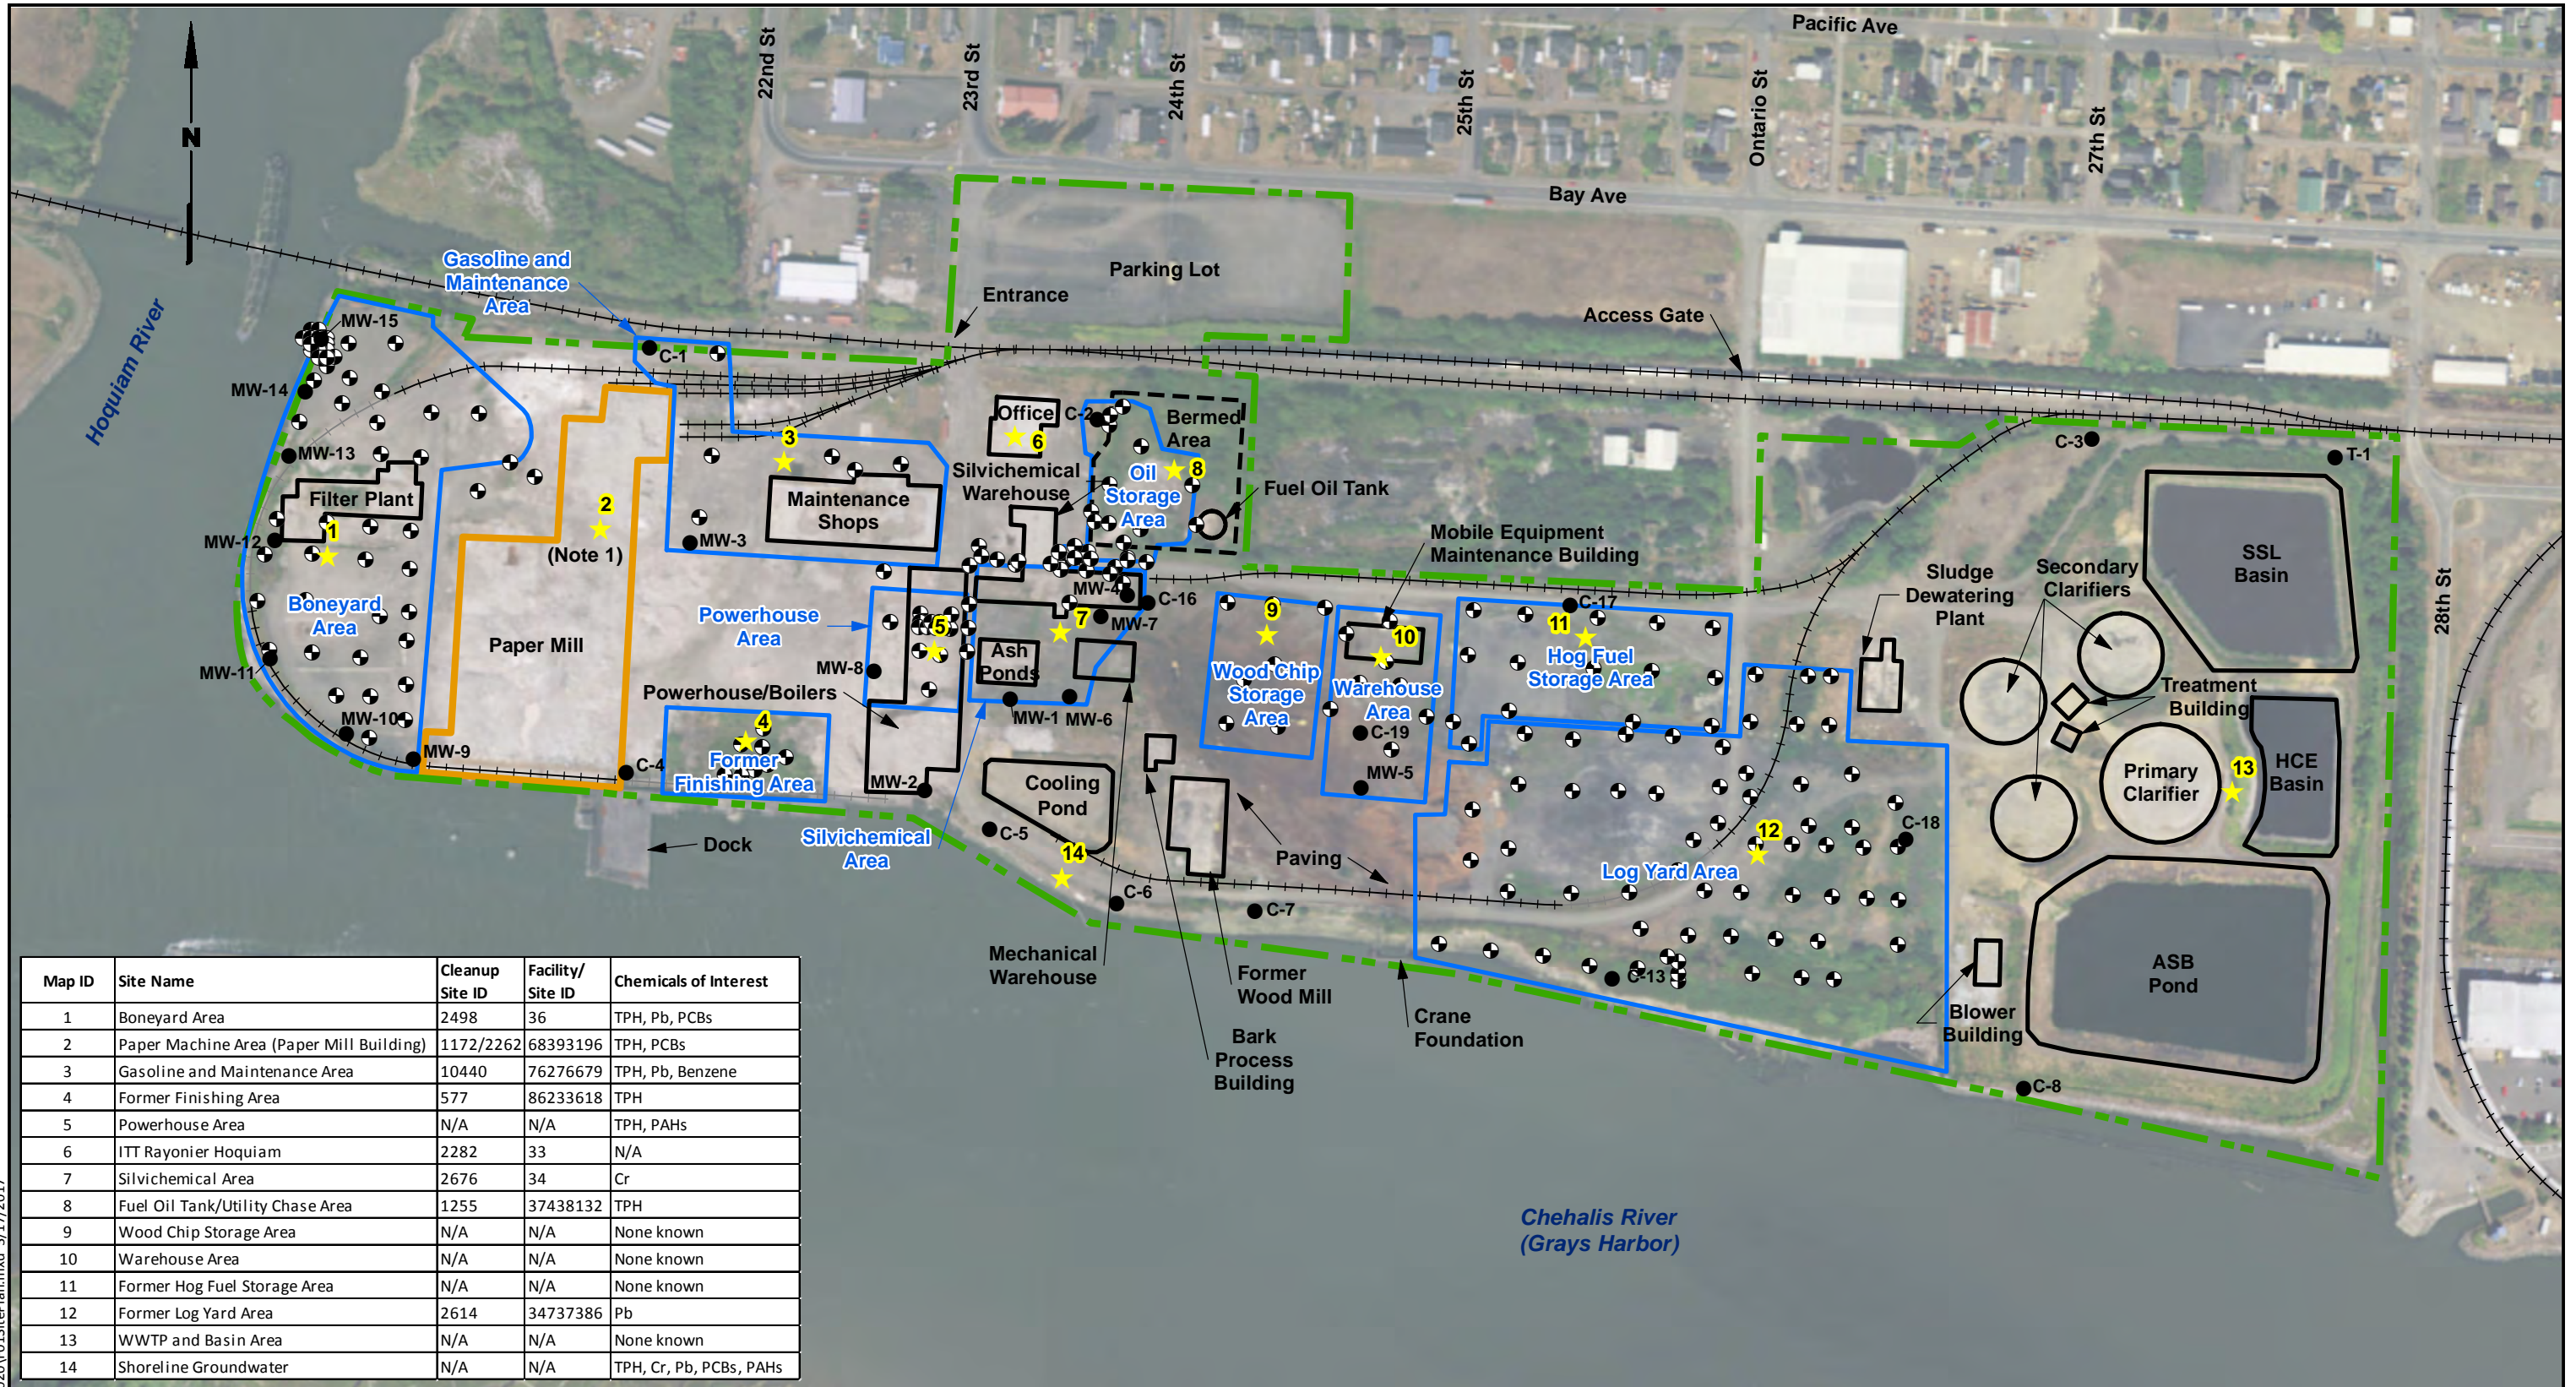
Rayonier AM Properties LLC Former Grays Harbor Paper Hoquiam, Washington	<b>Site Plan</b>	<b>Figure 1</b>
--	------------------	-----------------

The site is composed of 11 tax parcels, totaling an area of approximately 96 acres: 92 acres owned by Rayonier AM and 4 acres owned by Harbor Paper LLC (Harbor Paper). Property owned by Harbor Paper is designated as an “out parcel” on Figure 1.

Ecology assigned individual site identification numbers to some of the investigation areas, as shown on Figure 1 and in Table 1. In documents produced at the time of the historical environmental investigations, chemical concentrations in soil were compared to applicable Model Toxics Control Act (MTCA) Method A industrial or Method B cleanup levels, and contaminant concentrations in groundwater were compared to applicable Method A or B drinking water cleanup levels. Areas that were designated as Ecology sites, and for which site closure was established by issuance of an NFA determination, are described in Section 2.1 below. Other areas of the site—including Ecology-designated sites and other areas of interest—are described in Sections 2.2 and 2.3, respectively, with comparisons to current MTCA cleanup levels for screening purposes.

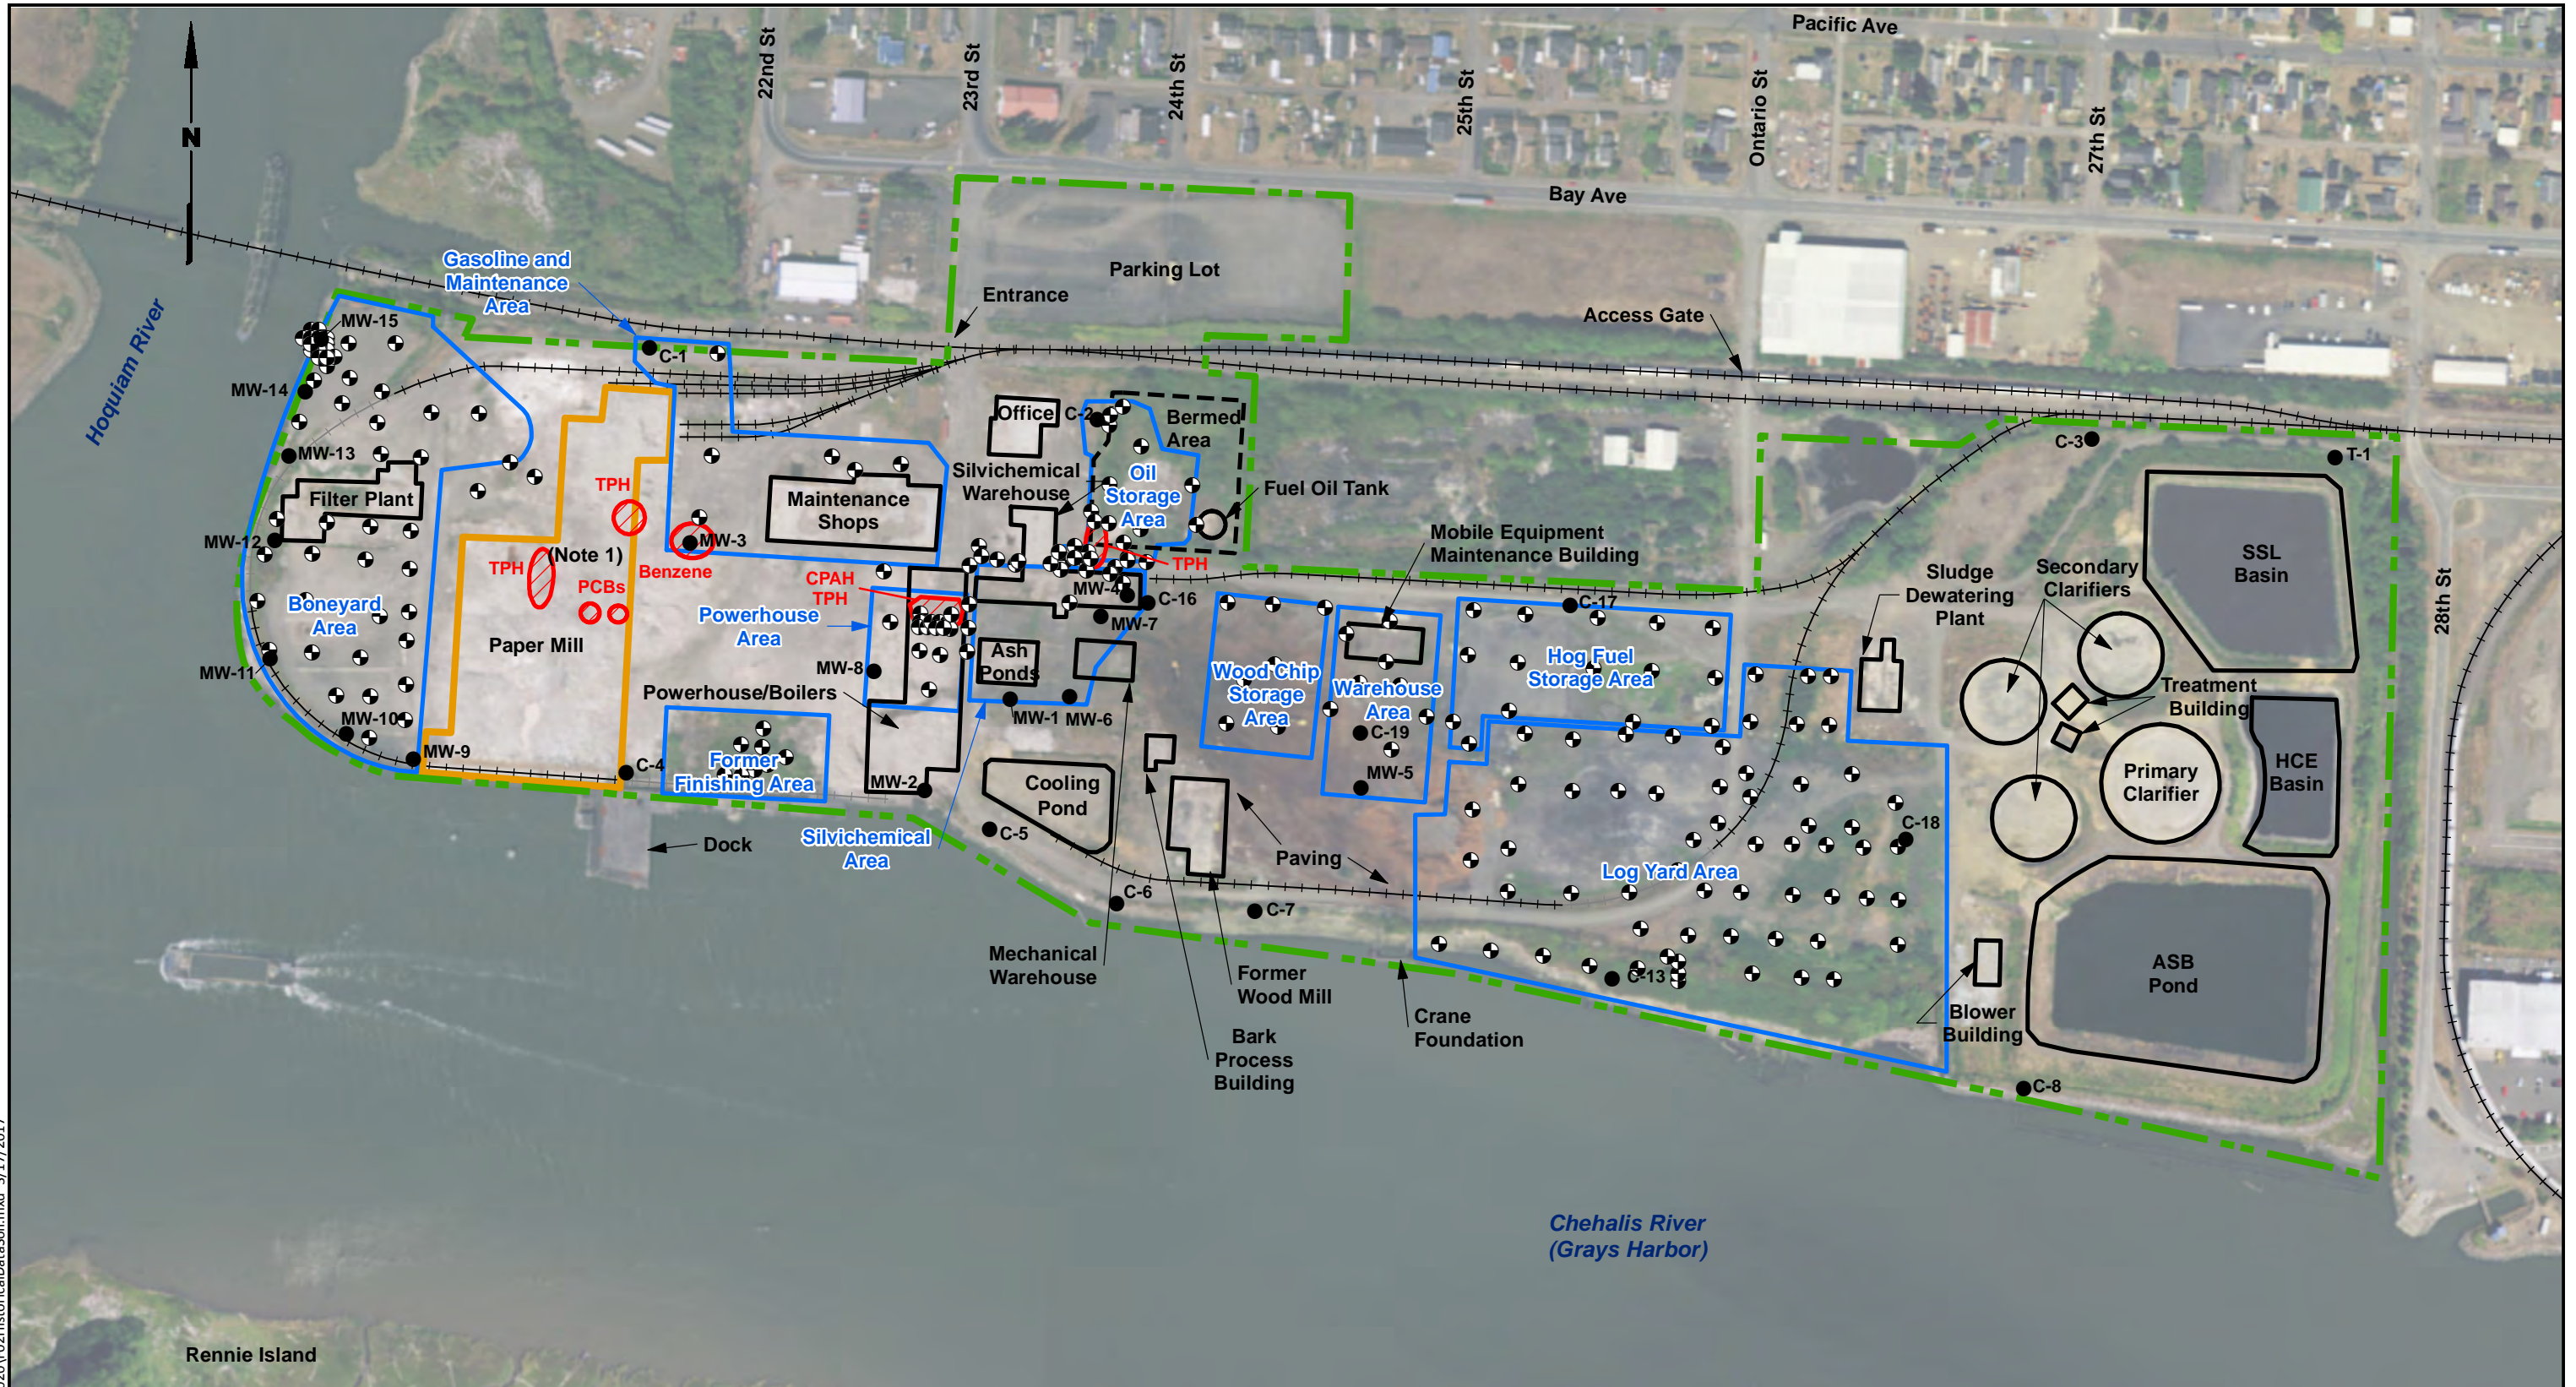
Rayonier AM Properties LLC Former Grays Harbor Paper Hoquiam, Washington	<b>Historical Data - Soil</b>	<b>Figure 2</b>
--	-------------------------------	---------------------

Data from soil samples collected from outside interim action areas and from samples characterizing post-interim action conditions were compared to current MTCA Method A industrial cleanup levels. Table 2 includes soil data that represent post-interim action conditions (i.e., soil sampling locations where soil was later removed are not included). Figure 2 shows areas in which current MTCA cleanup levels are exceeded by historical concentrations.
