## MEMORANDUM

**To:** Linda Berry-Maraist, Pope Resources/Olympic Property Group      **Date:** October 7, 2016  
**From:** Kathy Ketteridge, Ph.D., P.E., and John Laplante, P.E., Anchor QEA, LLC  
**Cc:** Clay Patmont, Anchor QEA, LLC  
**Re:** Port Gamble Bay Cleanup Project Coastal Engineering Evaluation of Shoreline Erosion

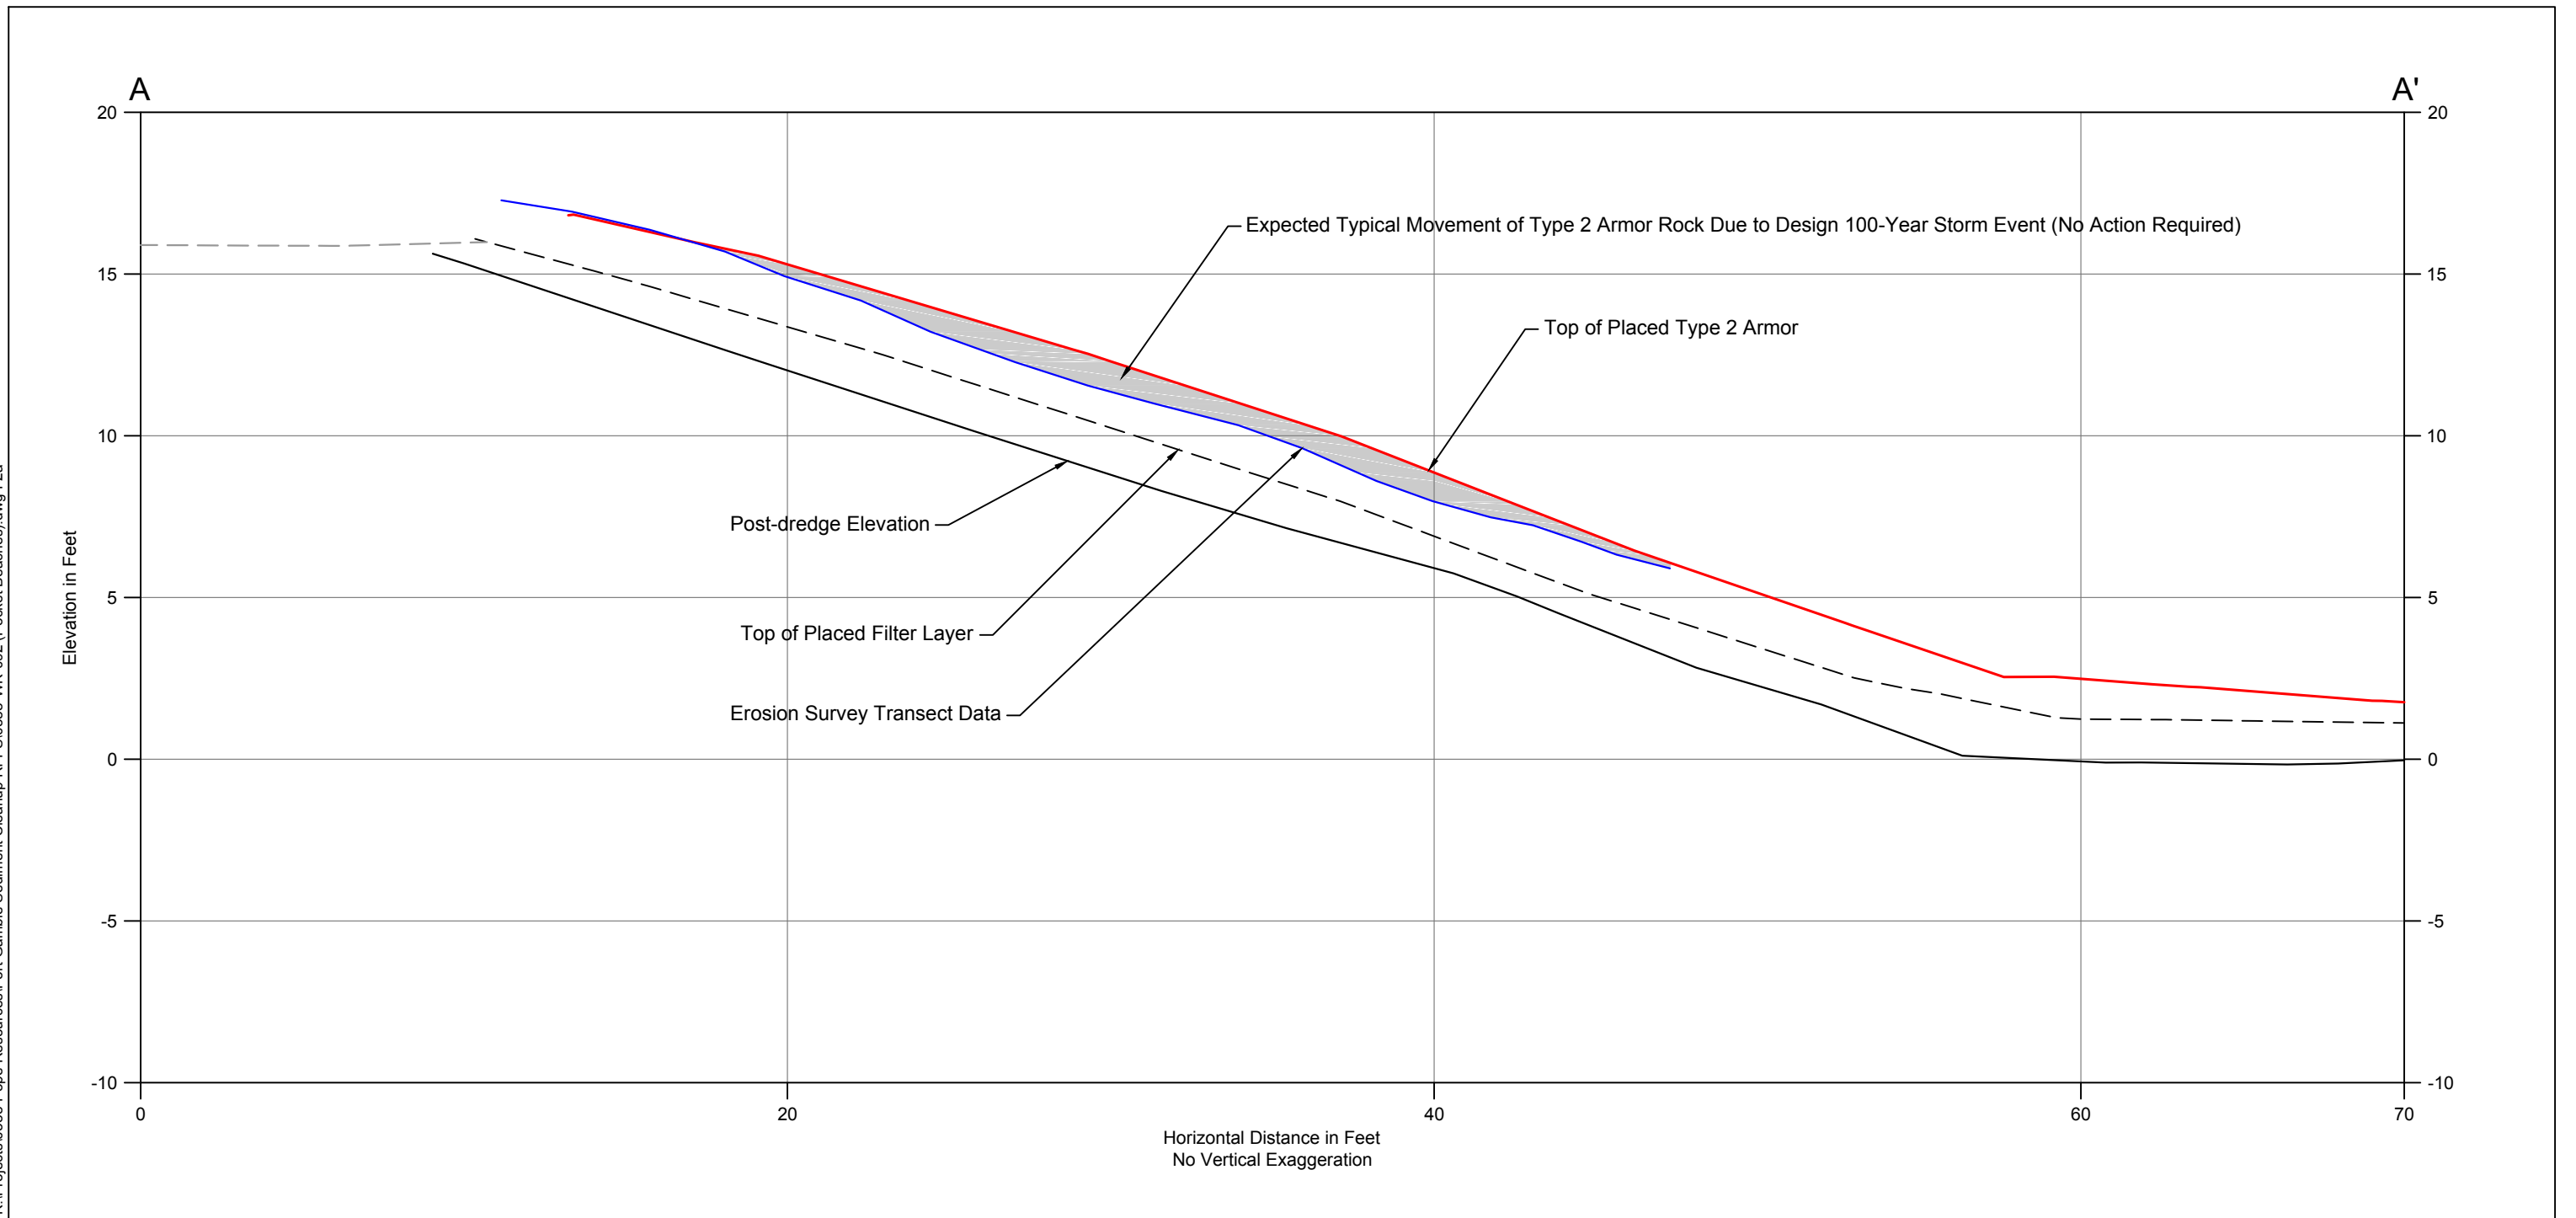
K:\Projects\0388-Pope Resources\Port Gamble Sediment Cleanup RI-FS\0388-WK-092 (Pocket Beaches).dwg F2b

Figure 2b shows a survey transect within Area 4 that illustrates Type 2 rock movement where the majority of the design rock thickness was displaced. However, as seen in Photograph 7, the extent of this level of damage is small, affecting approximately 20 to 30 feet of shoreline. Area 5, shown in Figure 2a, illustrates more typical and expected movement of rock on the slope; this area still has acceptable coverage of armor rock over the filter material. Survey data from Section A show more typical and expected movement of rock on the slope. Area 5 is representative of the conditions of the majority of the Type 2 cap area.

Design recommendations to address movement of the Type 2 cap material in Area 4 include adding additional Type 2 rock or smaller salvaged armor rock in the areas where significant movement has occurred (the approximate extent of this damage is shown in Figure 1).

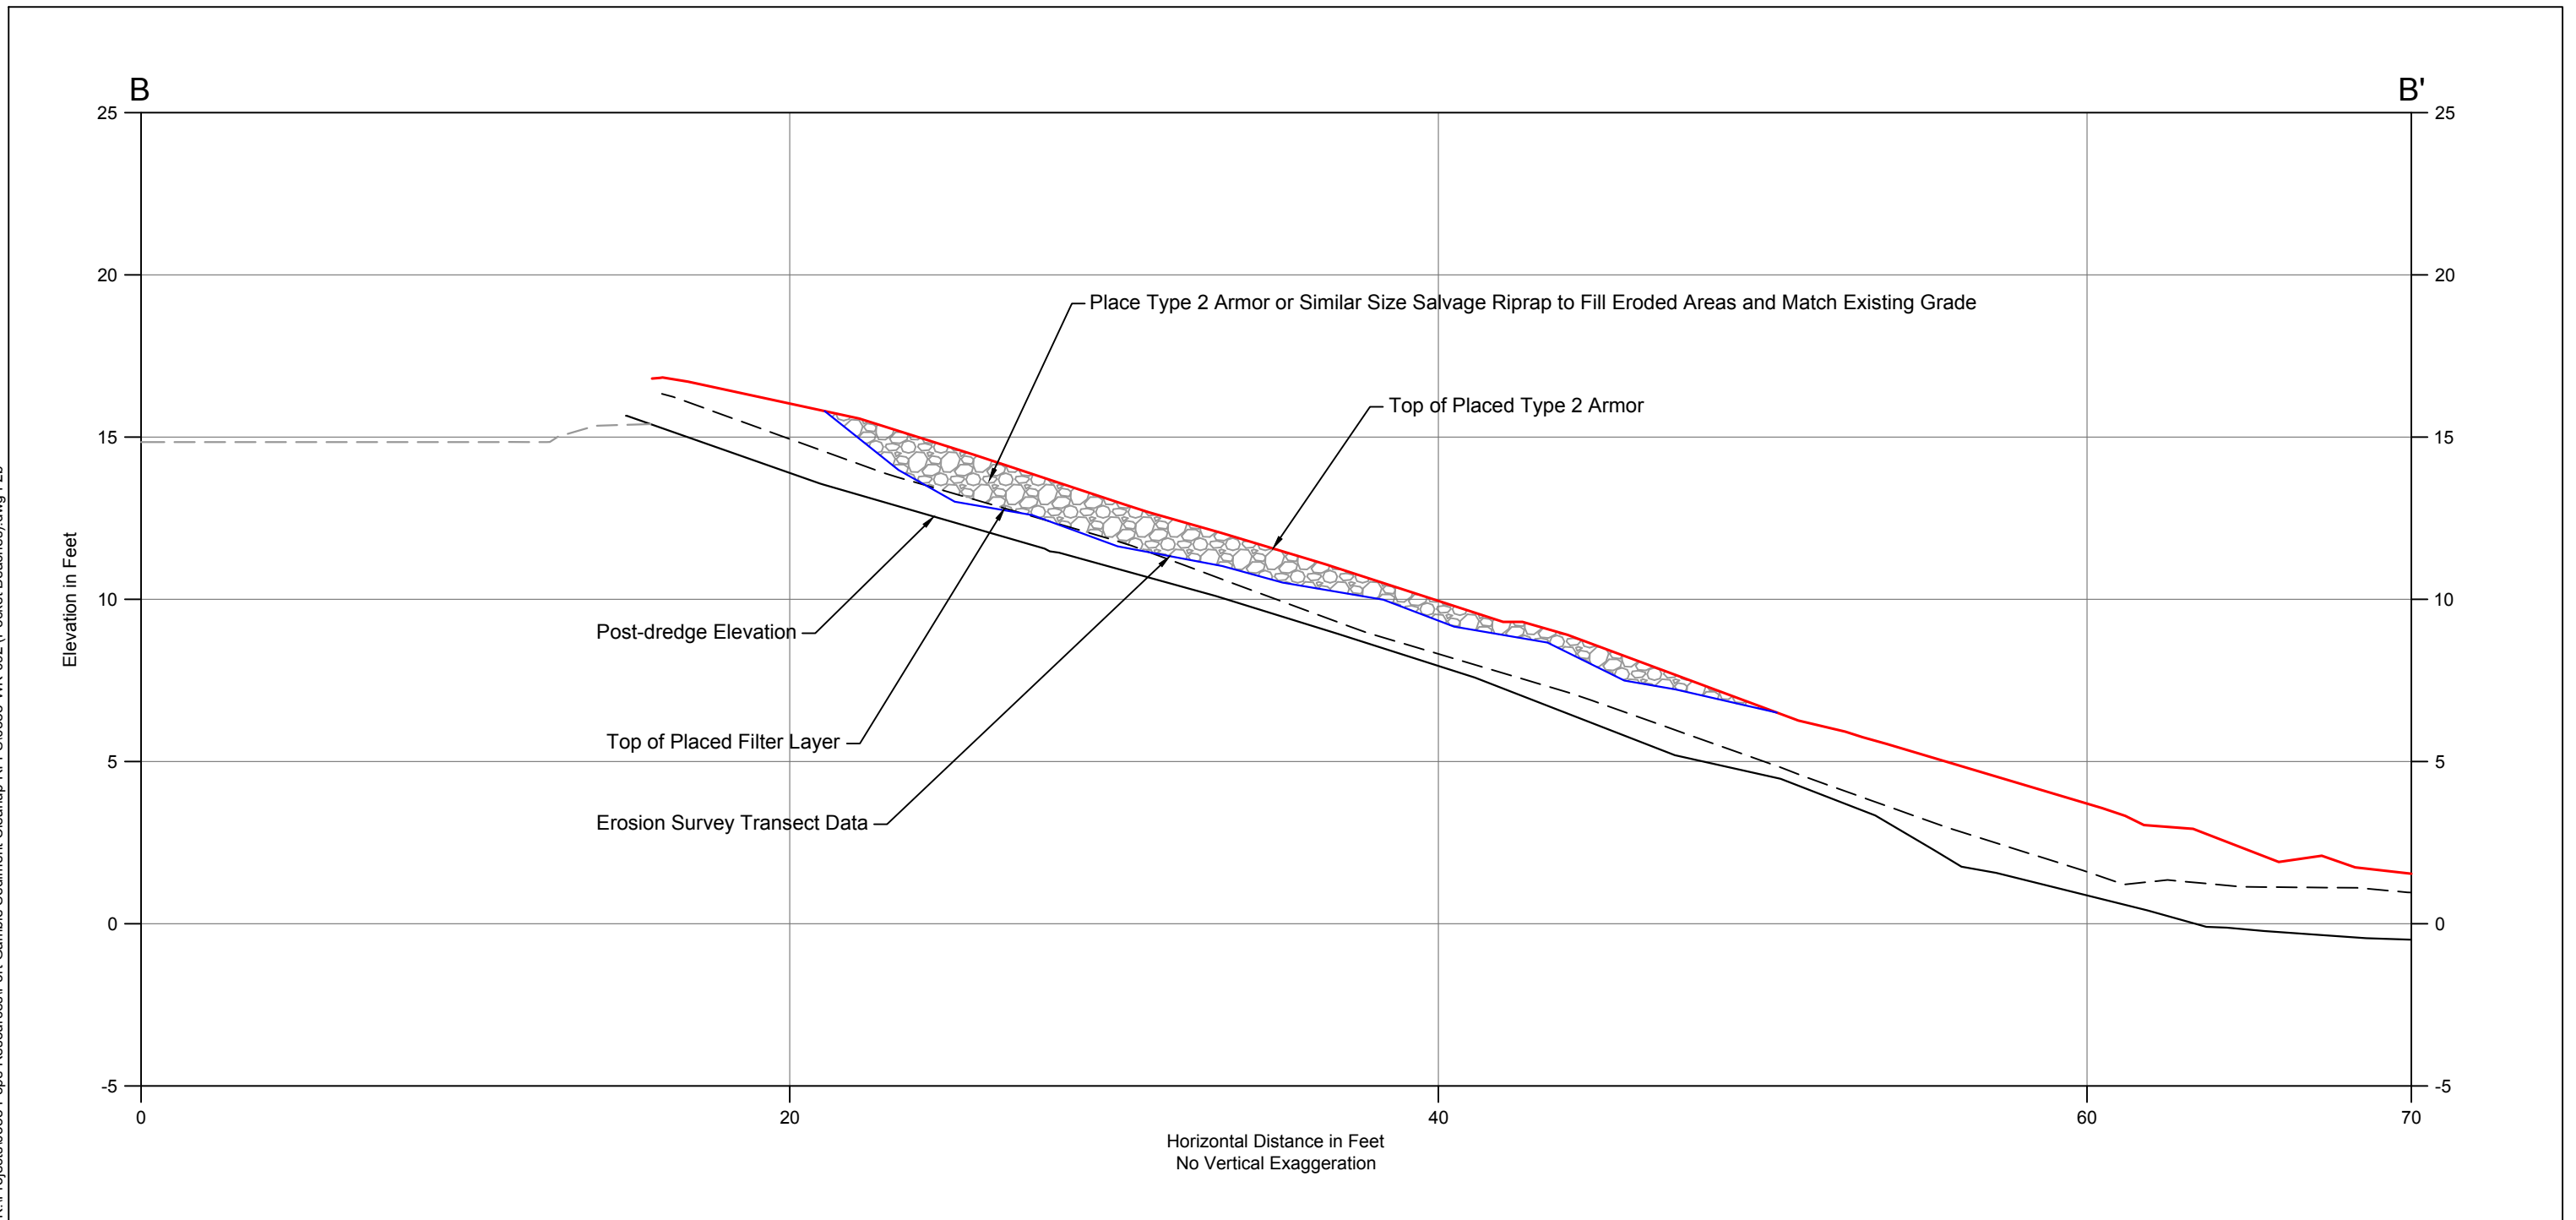
K:\Projects\0388-Pope Resources\Port Gamble Sediment Cleanup RI-FS\0388-WK-092 (Pocket Beaches).dwg F2c

The shoreline area where the transload facility was constructed was armored prior to construction of the transload facility, as shown in Photograph 6. Following removal of the transload facility, that area will need be restored to similar pre-project conditions with shoreline armoring that blends into the proposed remedy for Area 3.

Design recommendations to address shoreline erosion in this area are shown in Figure 2c. The shoreline in this area will be armored between the end of the Type 2 cap area and the armored shoreline at the location of the temporary transload area. Armor will consist of a layer of Type 3 material covered with large salvaged armor rock. The armor will extend from the top of the bank down to elevation +5 feet mean lower low water. A launching toe section will be placed at the toe of the armor (an extra two layers of Type 2 cap material) to provide toe scour protection for the newly constructed armored slope. These design recommendations are focused on preventing erosion at the top of the bank and preventing loss of uplands due to future storm events. The armoring detail shown in Figure 2c will be blended into the Type 2 capped area to the east and the armored slope replaced at the transload facility once it is removed (as discussed above).

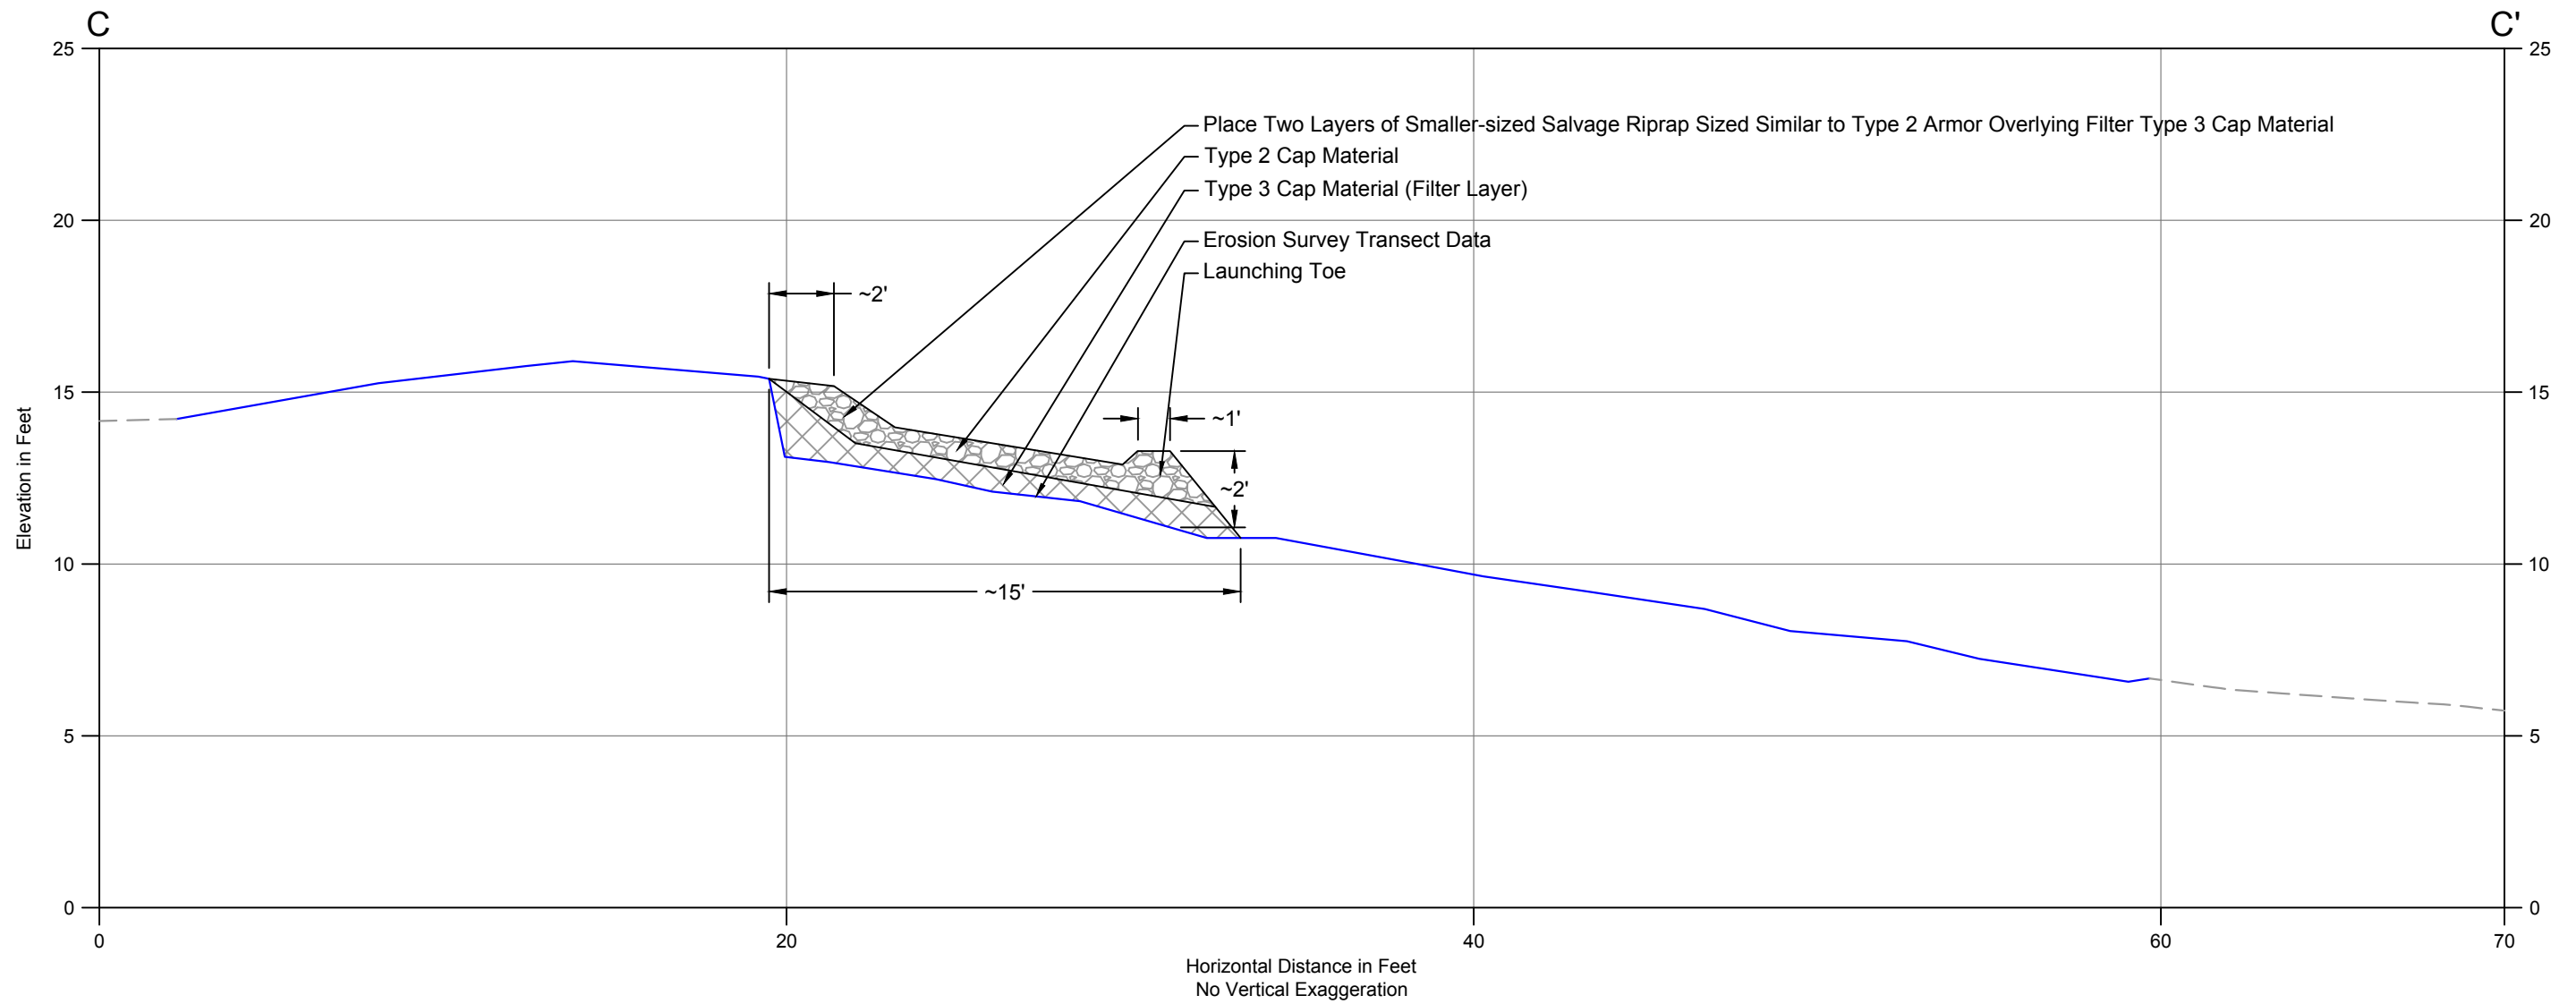
K:\Projects\0388-Pope Resources\Port Gamble Sediment Cleanup RI-FS\0388-WK-092 (Pocket Beaches).dwg F2d

Similar to Area 1, asphalt at the top of the slope was damaged due to wave runup and overtopping, as shown in Photograph 2, which occurred after the structure in this area (the former Eastern Wharf) was removed. Figure 2d shows a pre- and post-storm survey transect that shows no movement of the armor rock on the slope occurred as a result of the storm events.

The following recommendations to address shoreline erosion (shown in Figure 2d) were carried out prior to publication of this memorandum:

- Damaged asphalt at the top of the armored slope was removed
- Armor rock at the top of the slope was left in place
- The area where asphalt was removed was armored from the top of the remaining armor rock on the slope to the top of the bank
- Placed armor consisted of Type 3 material covered with large salvaged armor rock
