## **Environmental Investigation**

Carpenter Road Site  
Lacey, Washington

*for*  
**City of Olympia**

July 3, 2017

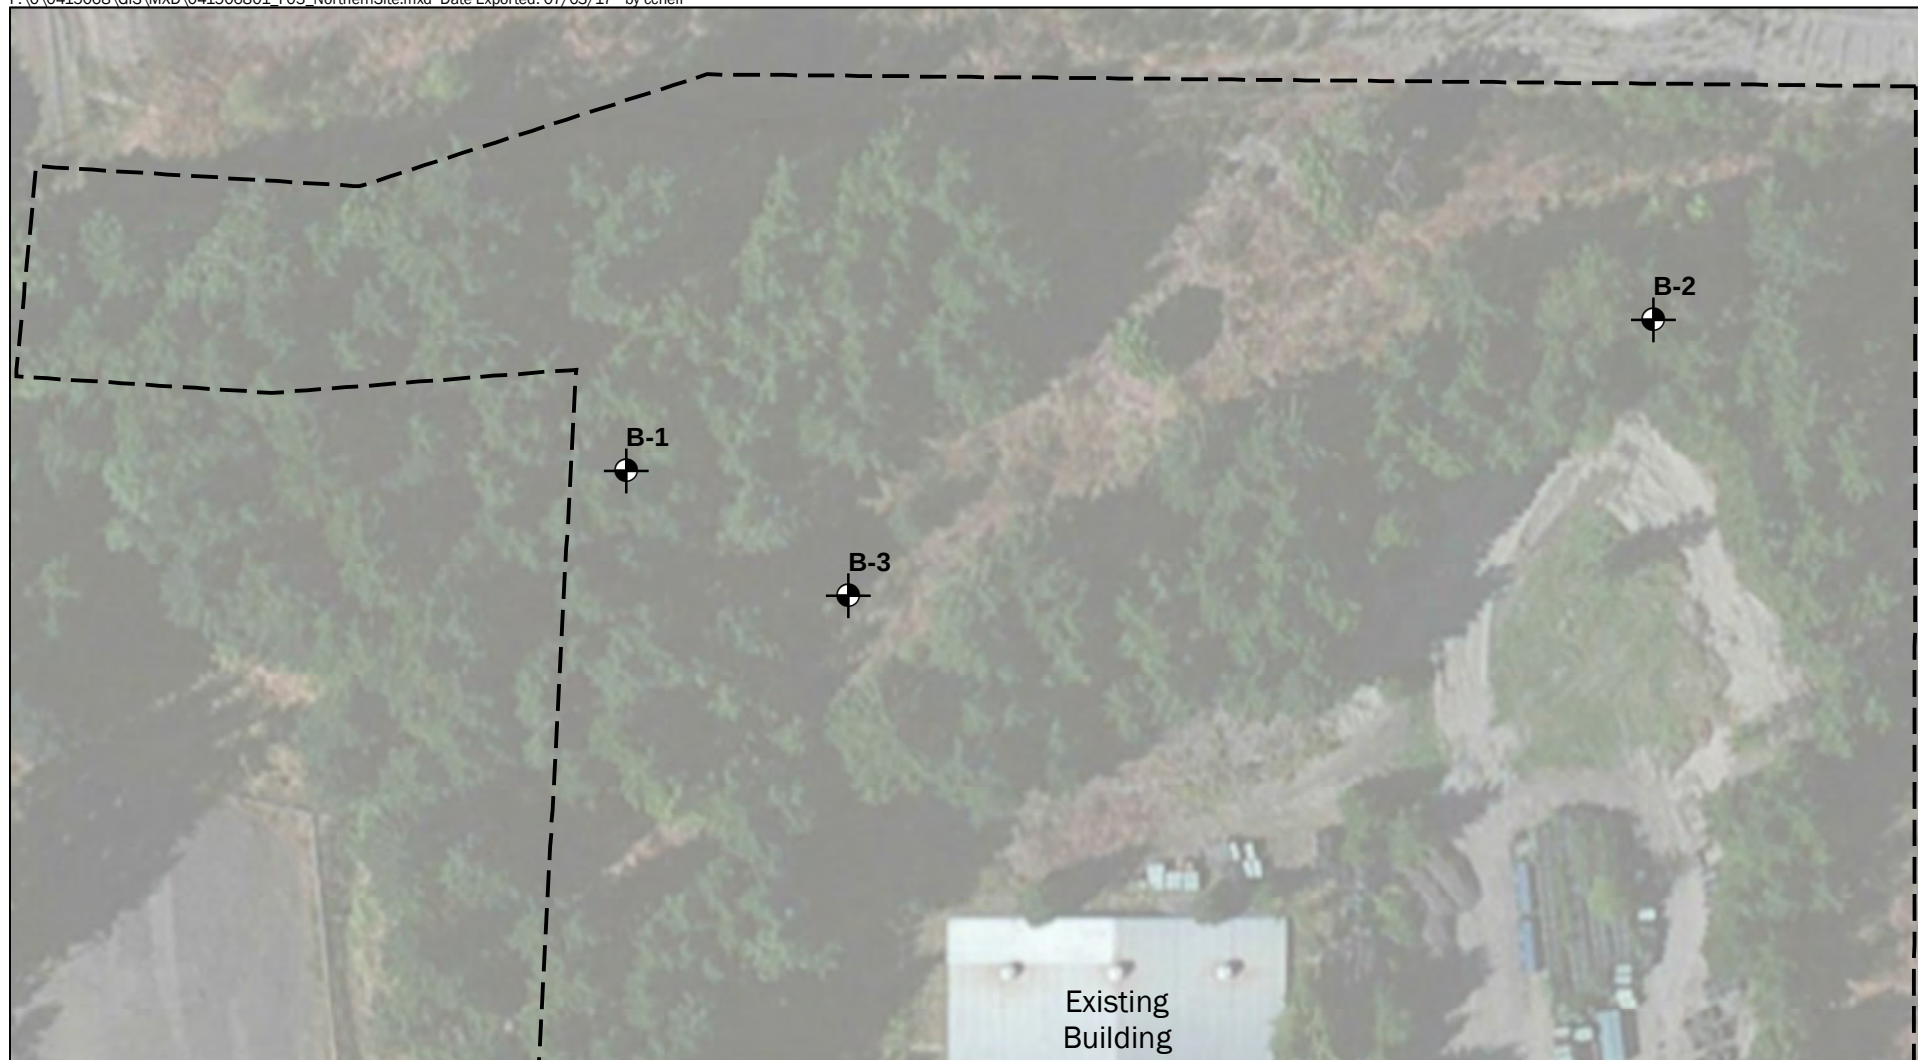
Figure 3

- Direct push soil borings were advanced at three (3) accessible locations in the northern portion of the property identified as B-1, B-2 and B-3 (Figure 3).

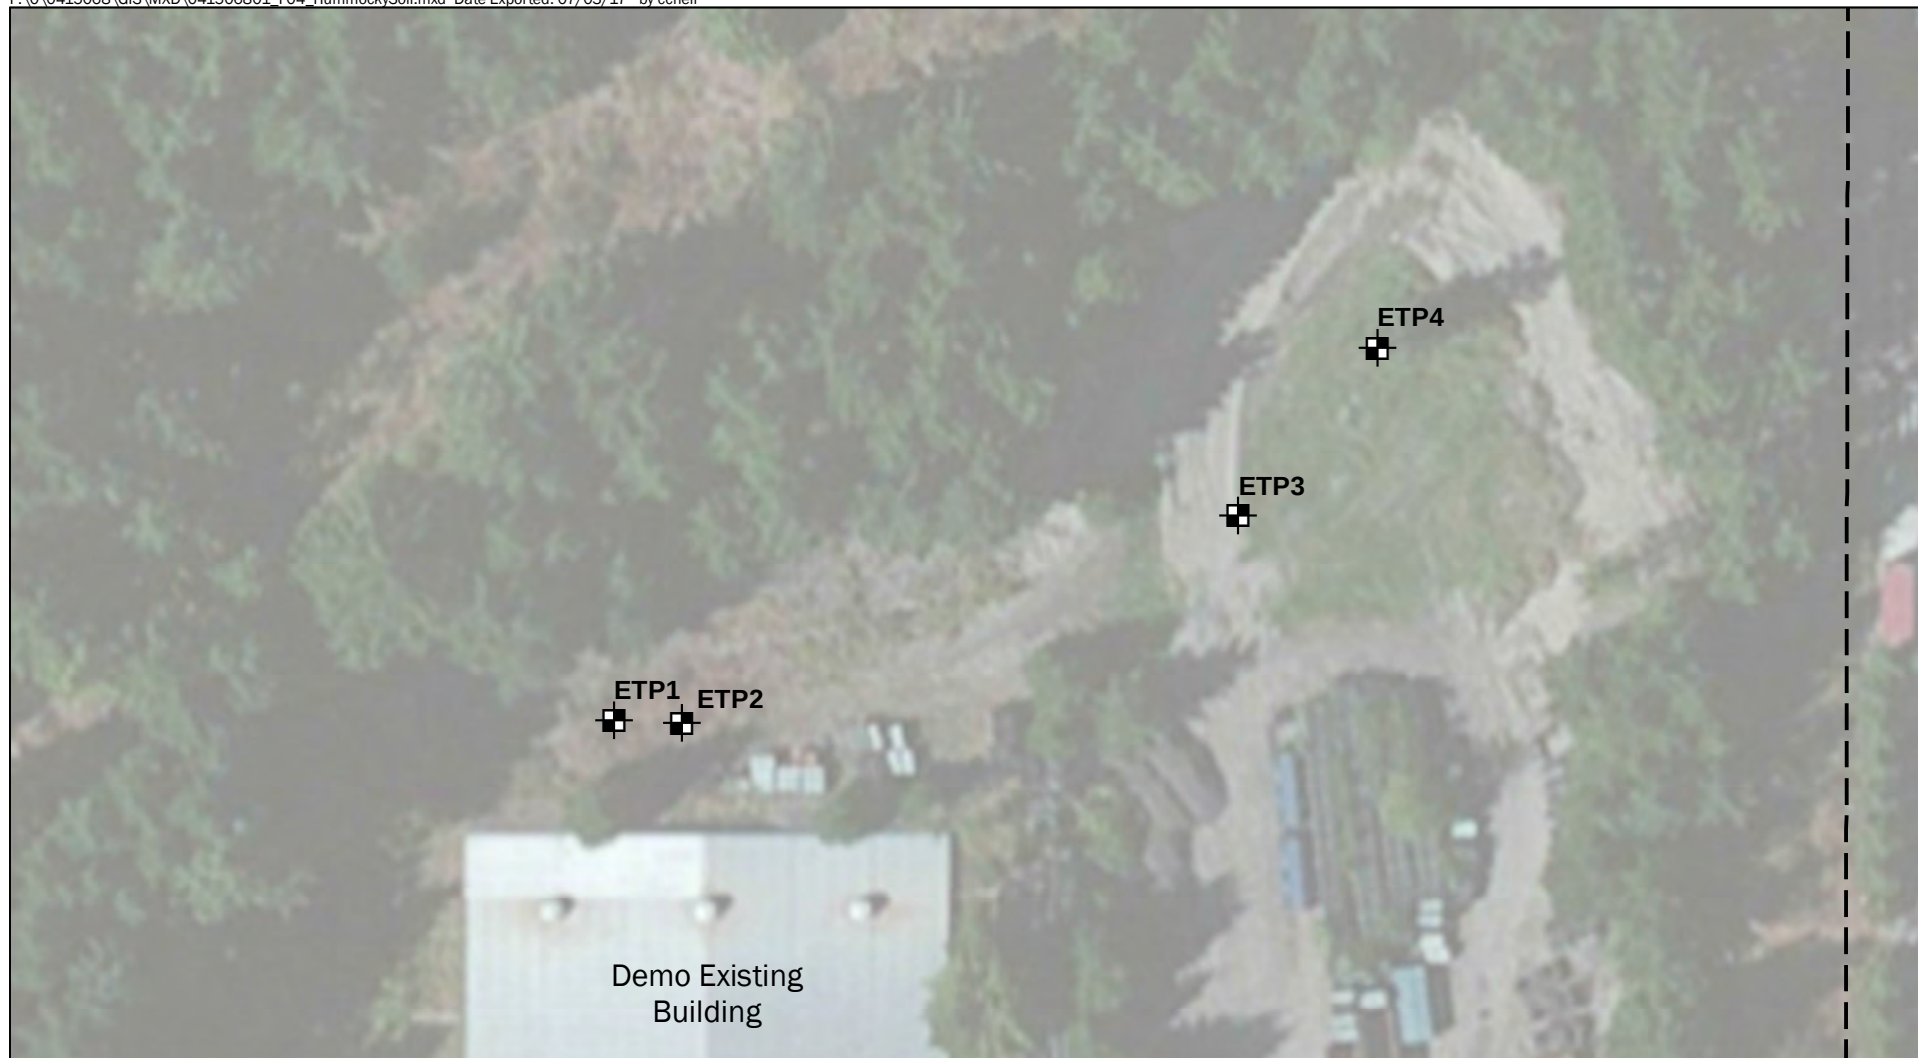
**Figure 4**

- Two (2) test pits identified as ETP1 and ETP2 were excavated into the soil piles north of the building and two (2) test pits identified as ETP3 and ETP4 were excavated into the soil piles northeast of the building (Figure 4).
