STATE OF WASHINGTON
DEPARTMENT OF ECOLOGY

December 20, 2018

Re: Further Action at the following Site:

- **Site Name:** Provisioners Express Inc
- **Site Address:** 2102 West Valley Highway N, Auburn, WA 98001
- **Facility/Site No.:** 91612121
- **VCP Project No.:** NW3206
- **Cleanup Site ID:** 6847

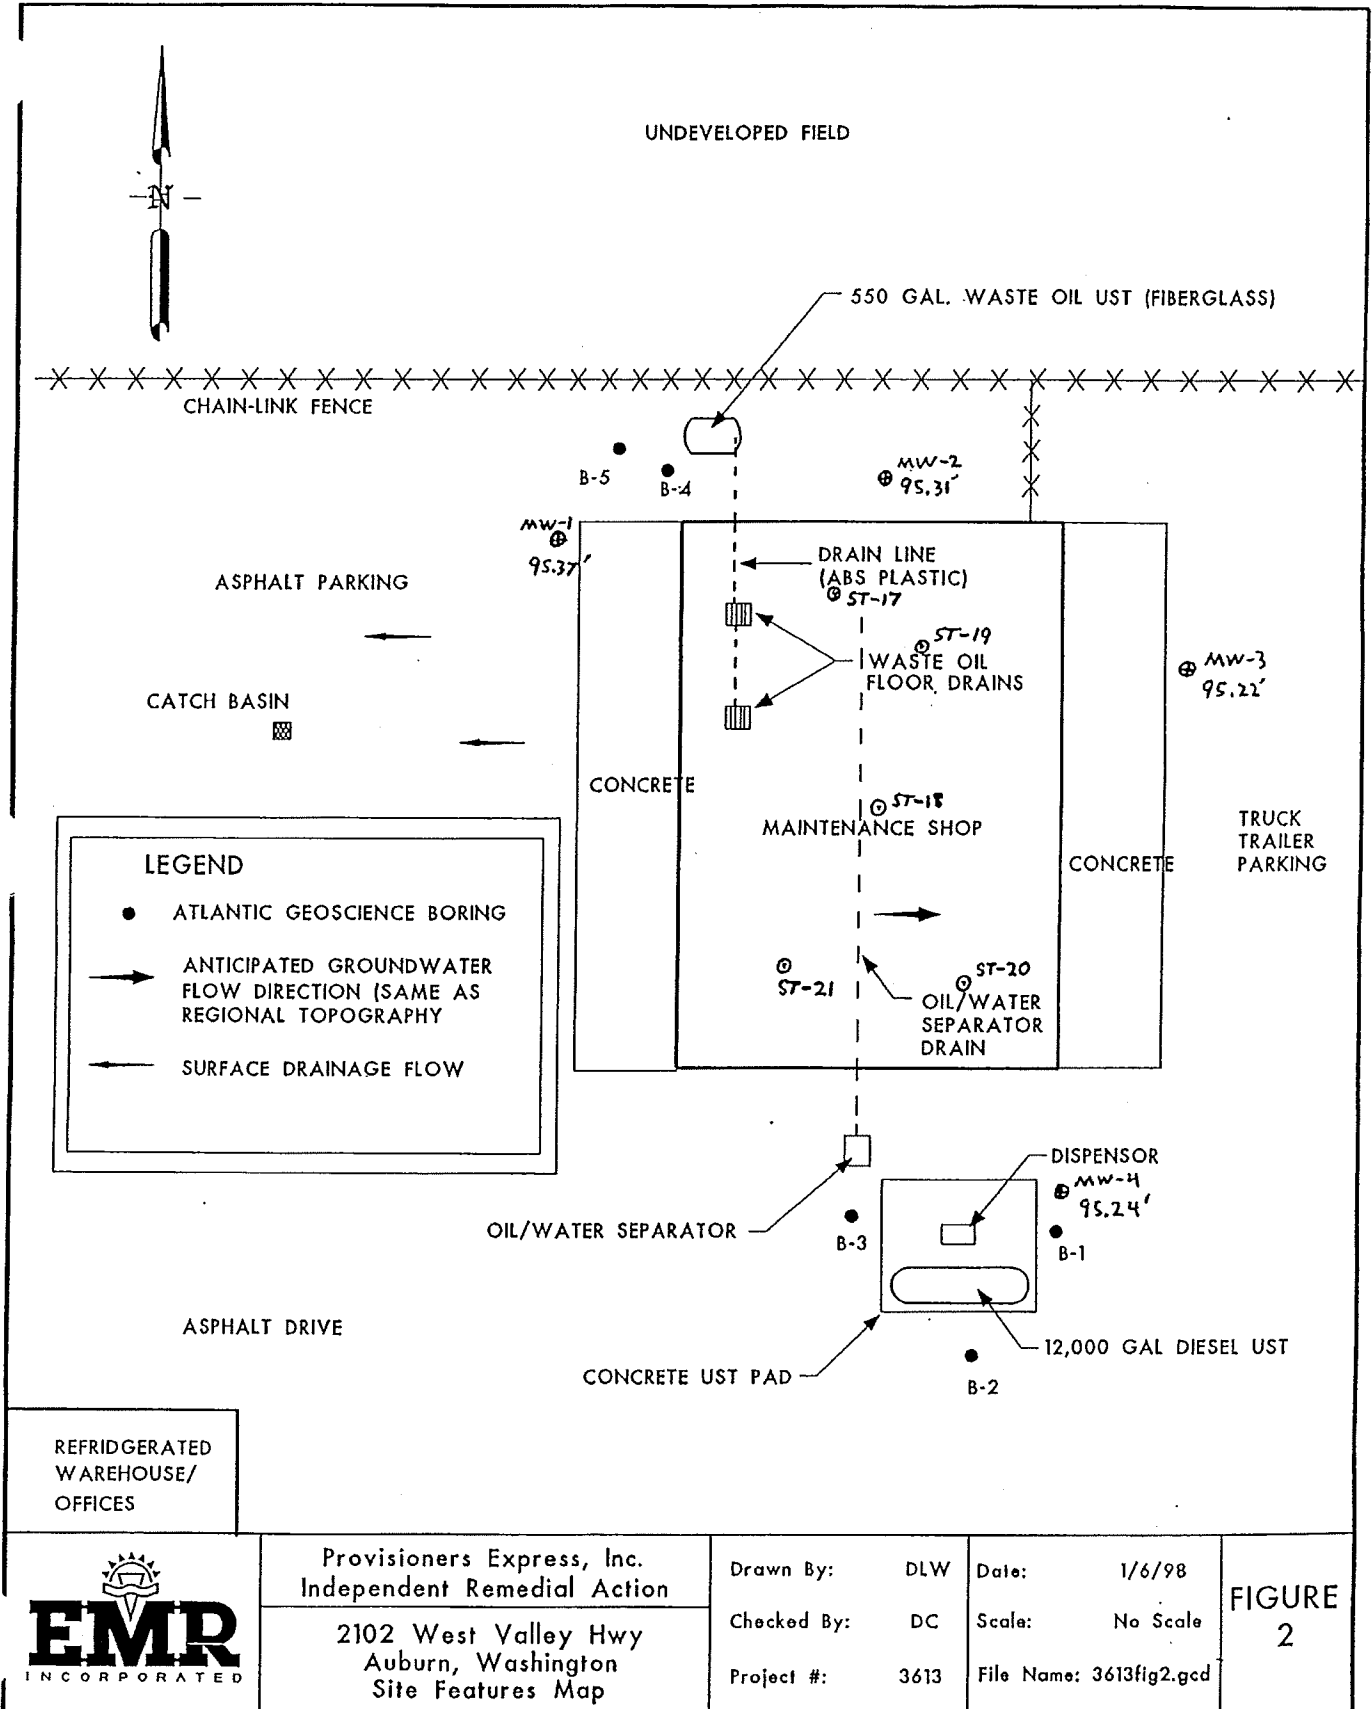
Enclosure A: Figure 3

- In December 1998 and January 1999, four ground water monitoring wells (MW-1 through MW-4) were installed to a total depth of 15 feet bgs and screened from 5 to 15 feet bgs. The monitoring well locations are depicted on **Figure 2**. No soil samples were collected.
- In April 1999, three soil borings (ST-17 through ST-19) were advanced inside the vehicle maintenance building. The soil boring locations are depicted on **Figure 3**.

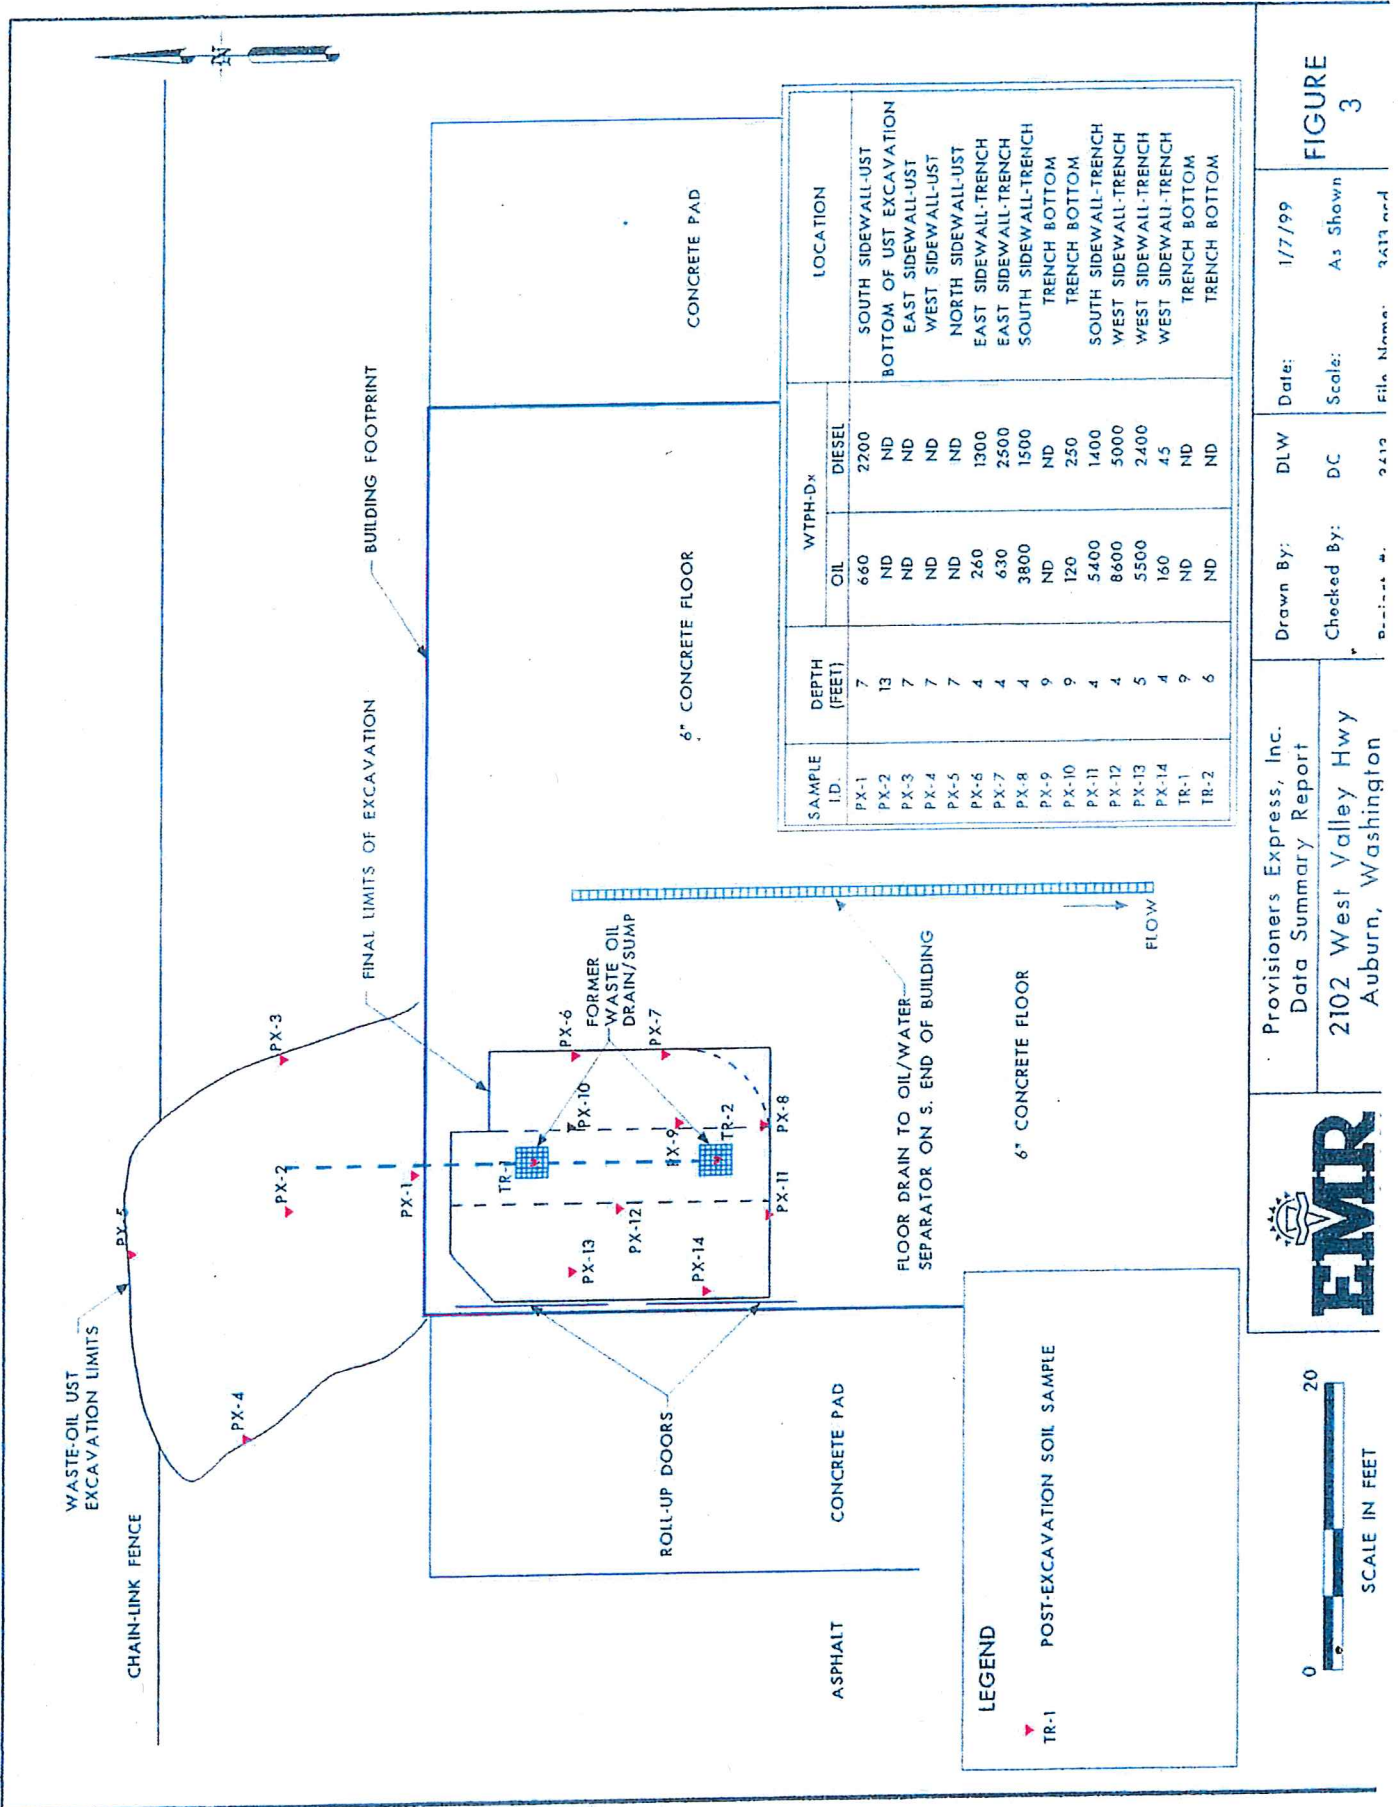
Enclosure A: Figure 4

Five post-excavation samples (PX-1 through PX-5) were collected between 7 and 13 feet bgs from the bottom and sidewalls of the excavation. The excavation limits and soil sampling locations are depicted on **Figure 4**. The soil samples contained concentrations of TPHd, TPHo, and metals below the MTCA Method A soil cleanup levels, except for soil sample PX-1 collected at 7 feet bgs from the south sidewall, which contained concentrations of TPHd and TPHo above the MTCA Method A soil cleanup level.

Eleven post-excavation soil samples (PX-6 through PX-14, TR-1 and TR-2) were collected between 4 and 9 feet bgs from the bottom and sidewalls of the excavation. The excavation limits and soil sampling locations are depicted on **Figure 4**. Concentrations of TPHd and TPHo were detected above the MTCA Method A soil cleanup level between 4 and 5 feet bgs in soil samples PX-7, PX-8, PX-11, PX-12, and PX-13. Additional soil excavation was limited due to the potential impact on the structural integrity of the building.

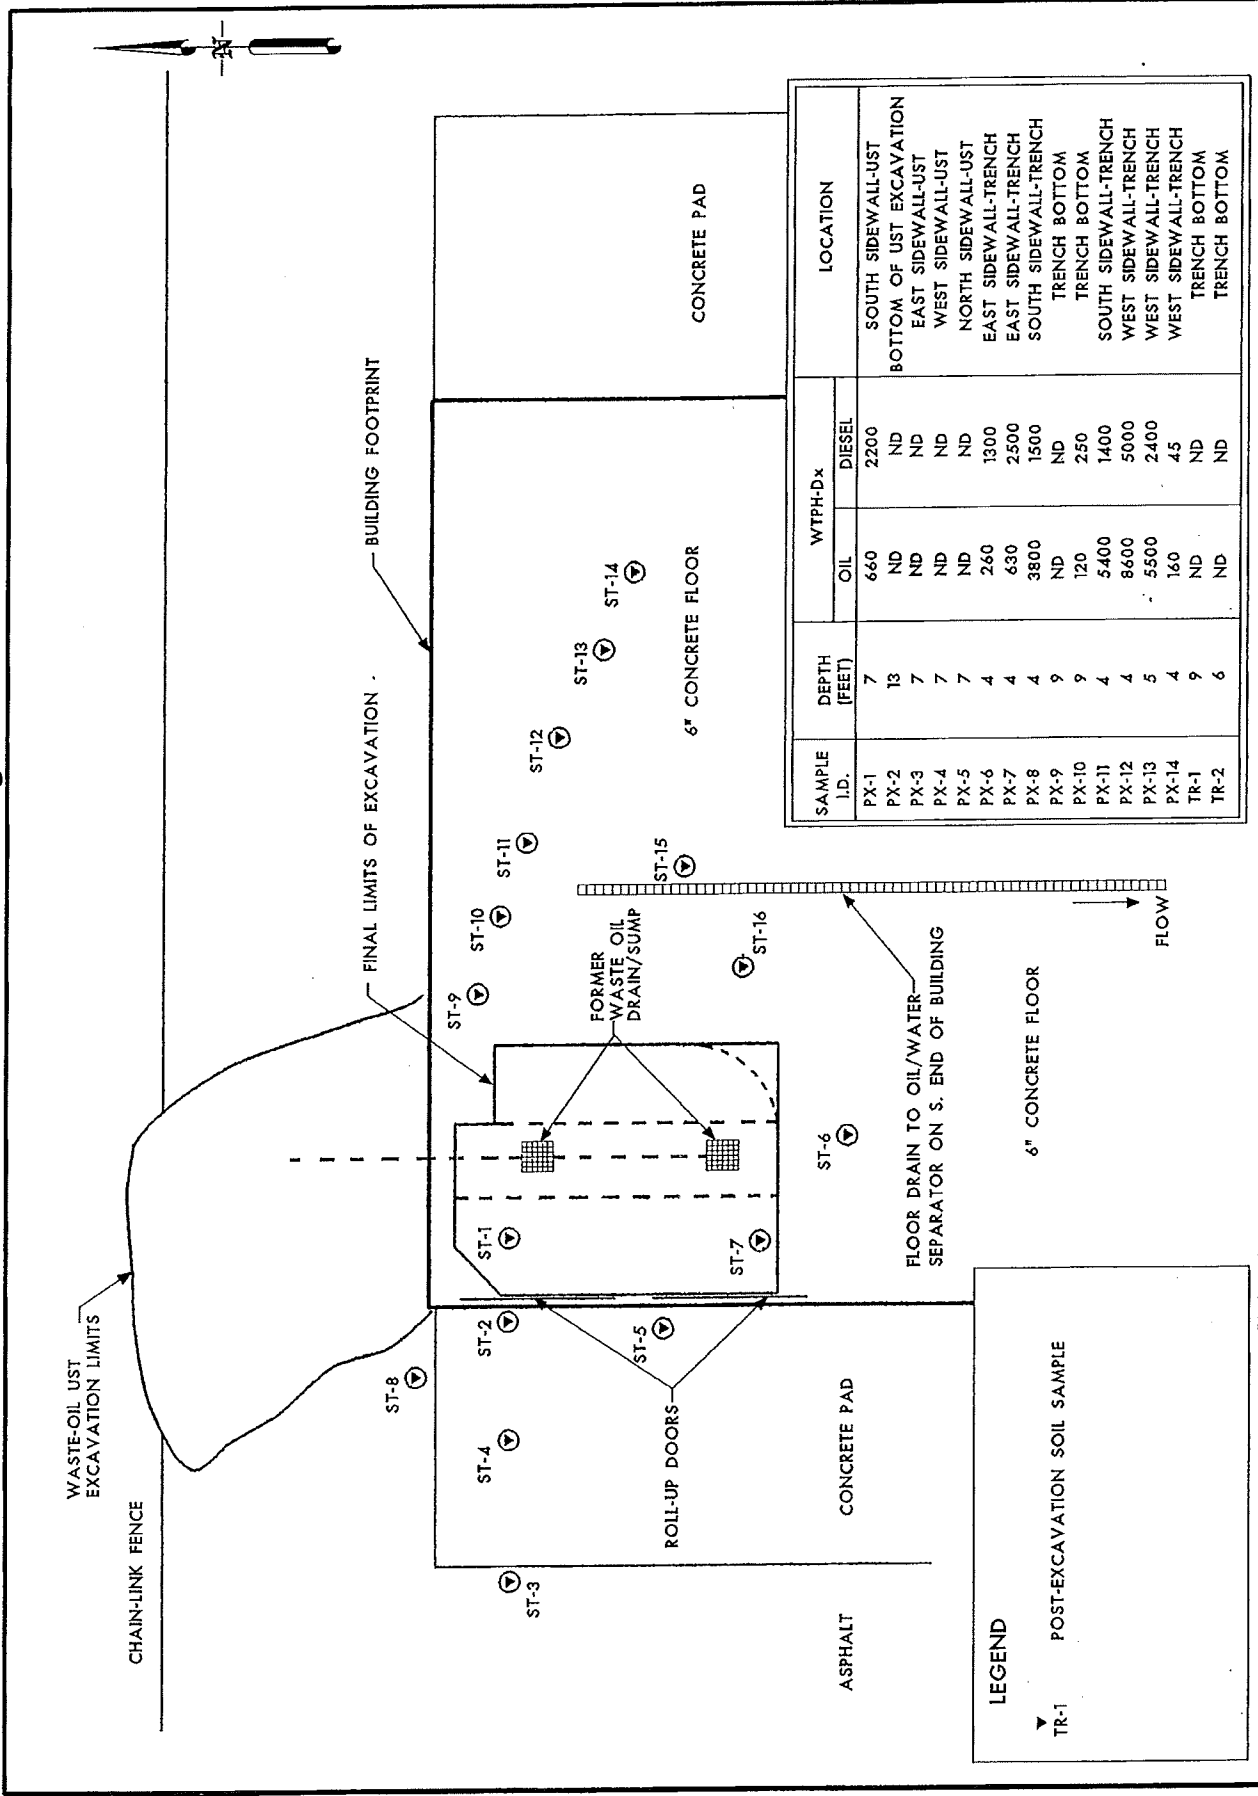
Enclosure A: Figure 5

- In November 1998, sixteen direct push soil borings (ST-1 through ST-16) were advanced to delineate the residual soil contamination inside and outside the vehicle maintenance building. The soil boring locations are depicted on **Figure 5**.

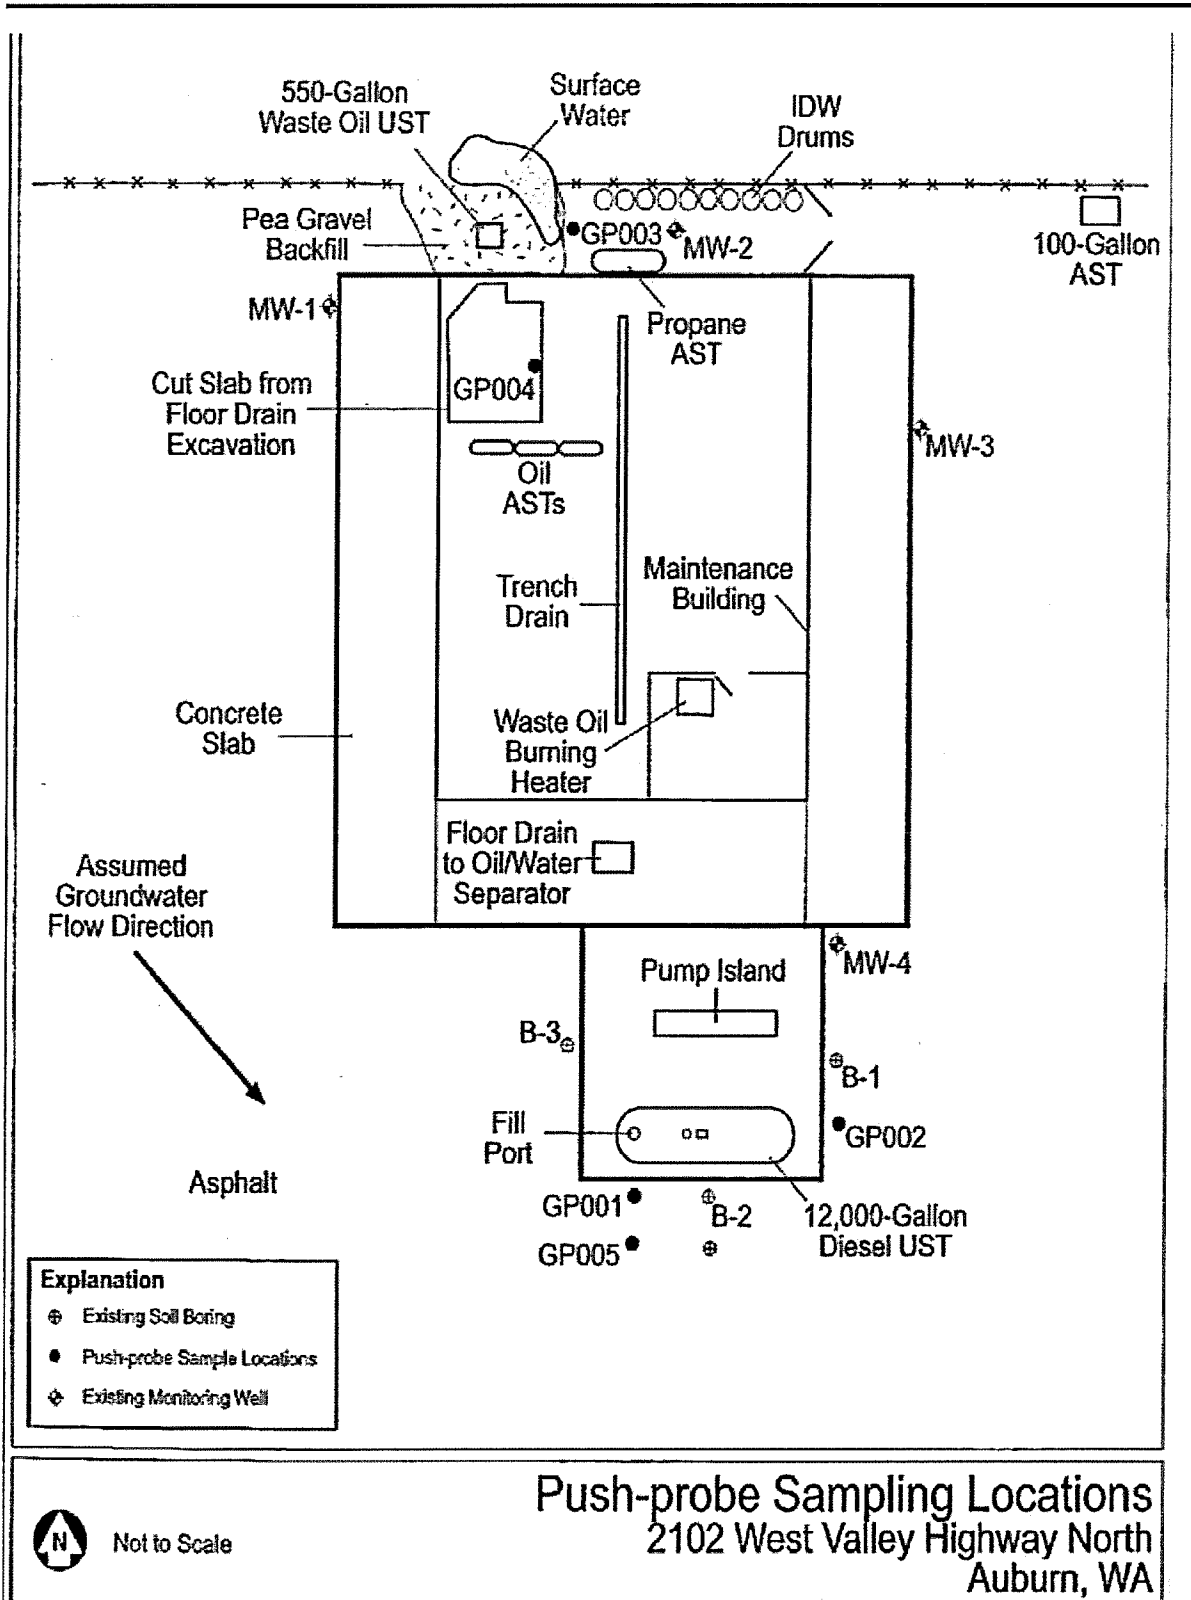
Enclosure A: Figure 6

- A limited subsurface investigation was conducted in November 1999, which included advancing five direct push soil borings (GP001 through GP005) to 9 feet bgs inside and outside of the vehicle maintenance building. The soil boring locations are depicted on **Figure 6**.

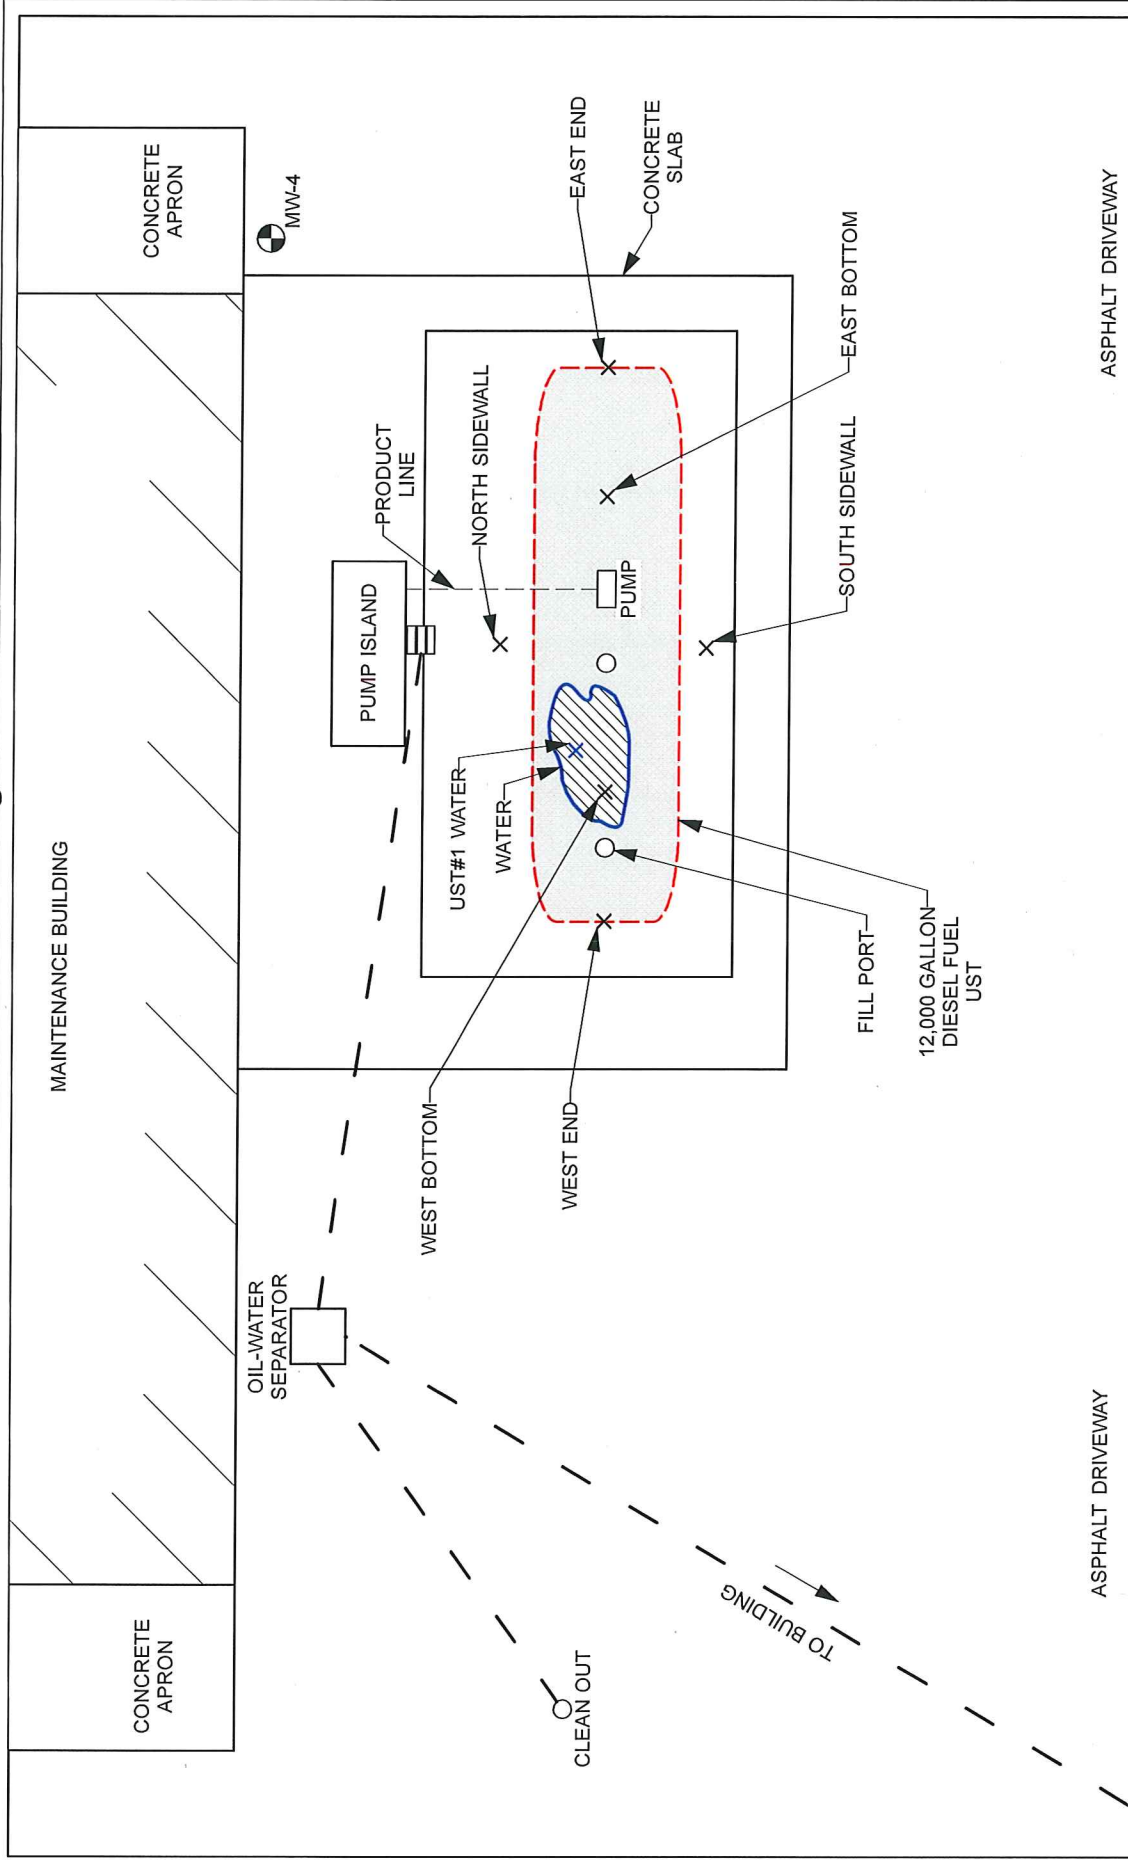
Enclosure A: Figure 7

water sampling locations are depicted on **Figure 7**. The soil samples contained TPHd and TPHo concentrations below the MTCA Method A soil cleanup level. The grab ground water sample contained TPHd and TPHo concentrations above the MTCA Method A ground water cleanup level.

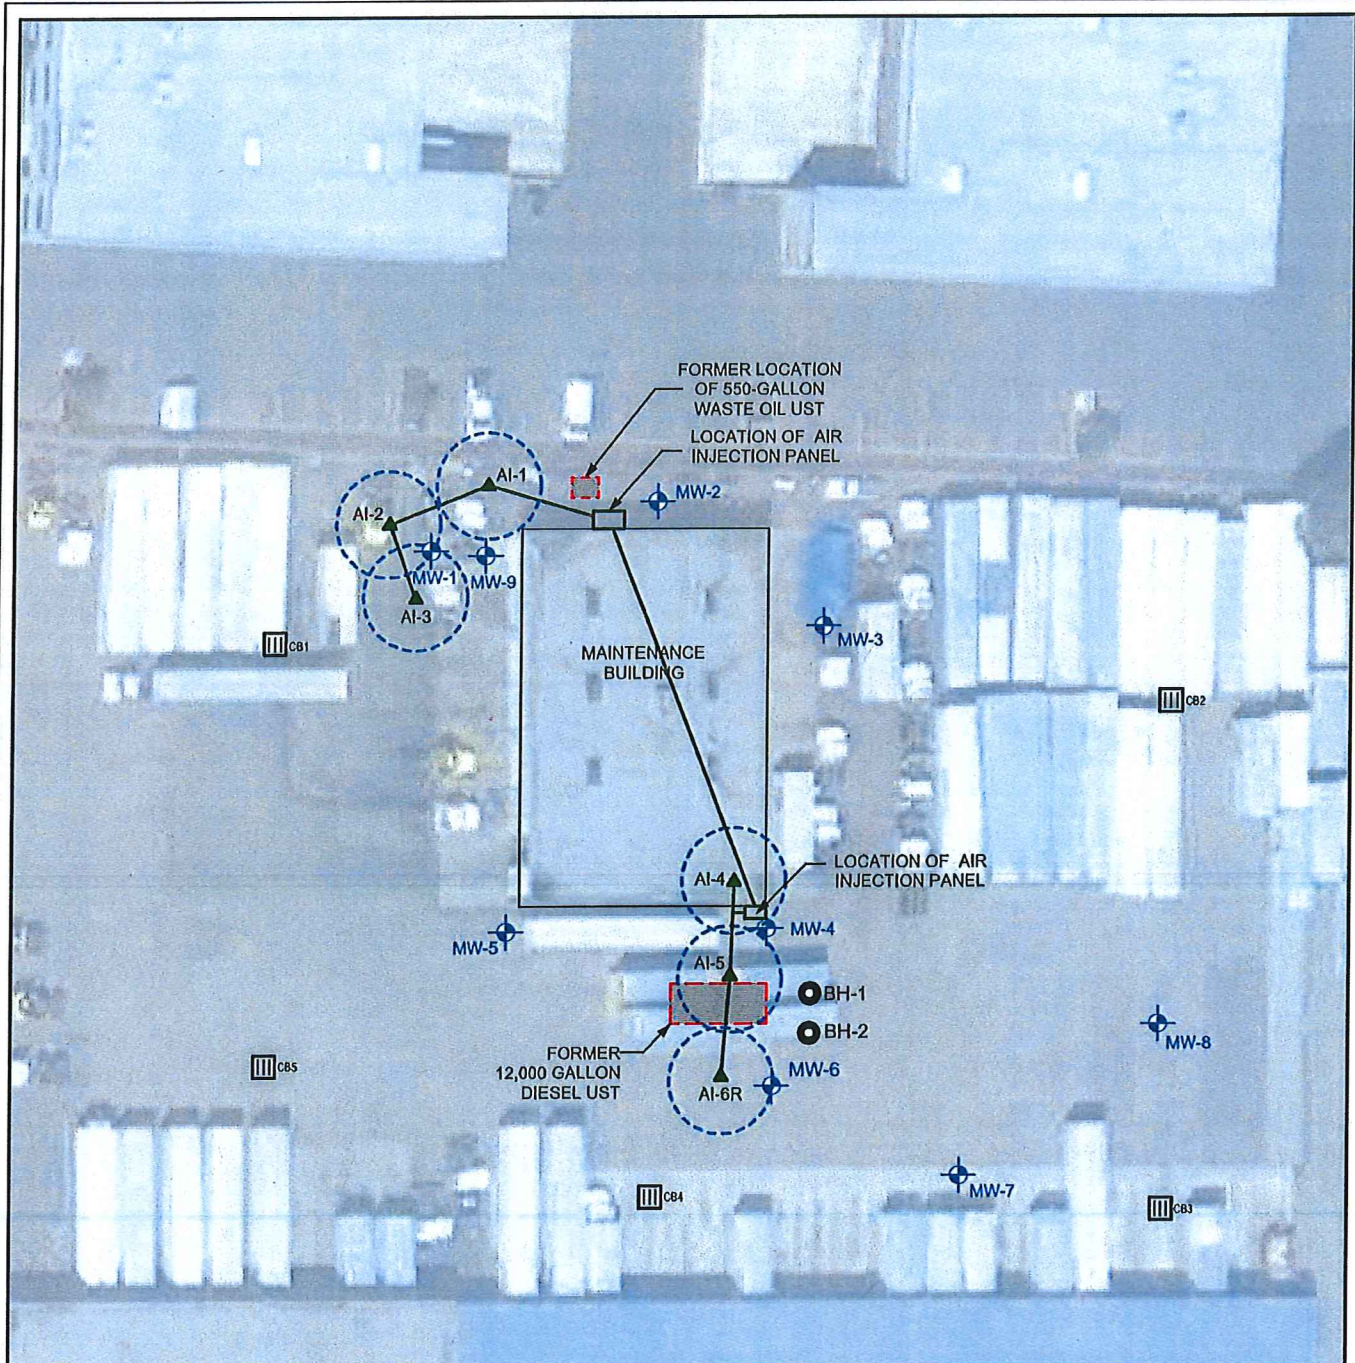
Enclosure A: Figure 8

- Two separate ground water remediation systems were installed northwest (near monitoring wells MW-1 and MW-9) and southeast (near monitoring well MW-6) of the vehicle maintenance building in 2014 and 2015, respectively. The remediation systems are depicted on **Figure 8**. Each of the remediation systems includes three shallow air injection wells to inject oxygen-containing air as microbubbles into the ground water. Due to some mechanical and electrical issues, the air injection systems operated intermittently from 2015 to 2017. The air injection systems have operated continuously from June 2017 to November 2018, except for a brief shutdown between December 20, 2017 and January 2, 2018, due to a compressor malfunction and replacement. The operation of the air injection systems was suspended in November 2018.
