SITE HAZARD ASSESSMENT

Worksheet 1: Summary Score Sheet

SITE NAME: Boeing Developmental Center

Cleanup Site ID: 5059

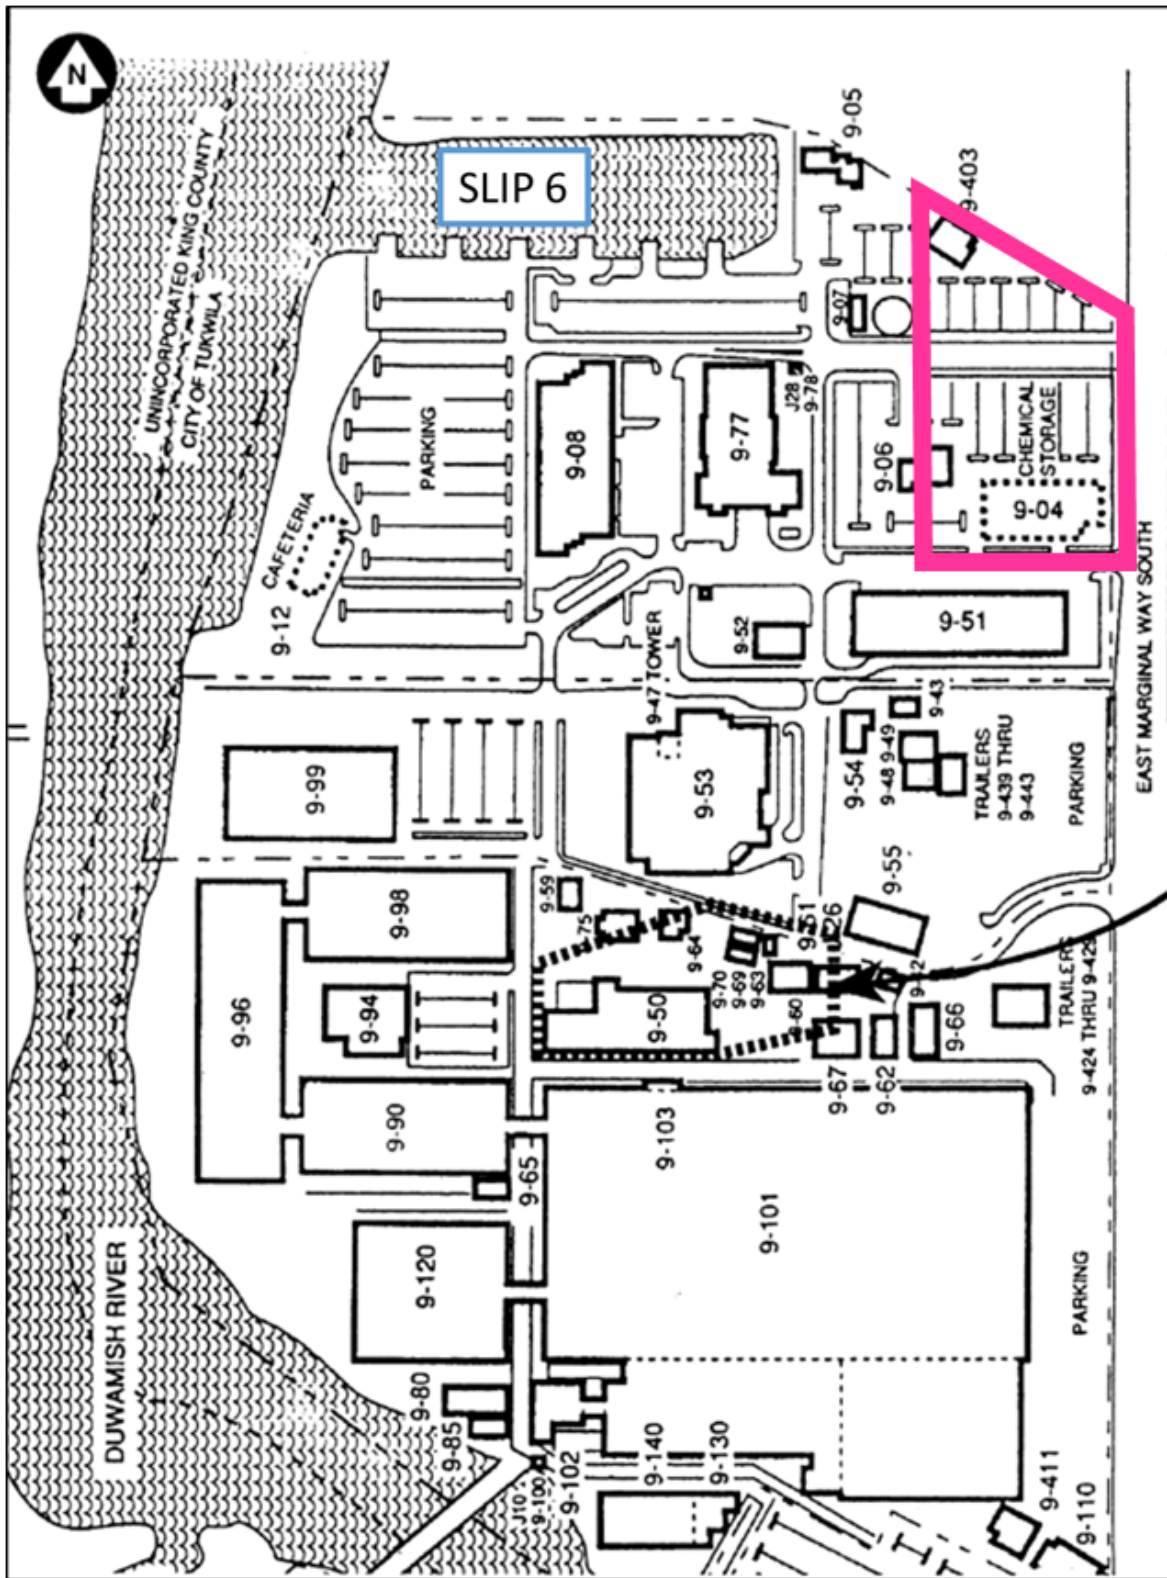
Figure 3. Buildings within the Developmental Center with building numbers. The southernmost parcels are not included in this figure, but are covered by parking lots and do not contain any buildings referenced in the Site Hazard Assessment. Dashed circle and arrow indicate general location of hazardous waste storage areas that underwent closure in the mid-1990s (figure taken from 1997 Weston closure report). The in-water area known as Slip 6 is also indicated on the northern portion of the Site. The area within the pink outline in the northeast corner of the property is currently part of the Museum of Flight property.
