## ENVIRONMENTAL CAP INSPECTION REPORT

### FORMER WASSER & WINTERS LOG SORT YARD

Consent Decree No. 93-2-08684-4 (August 27, 1993)  
Washington State Department of Ecology Facility ID # 1218  
Inspection Dates: February 21 and March 1, 2017

April 14, 2017

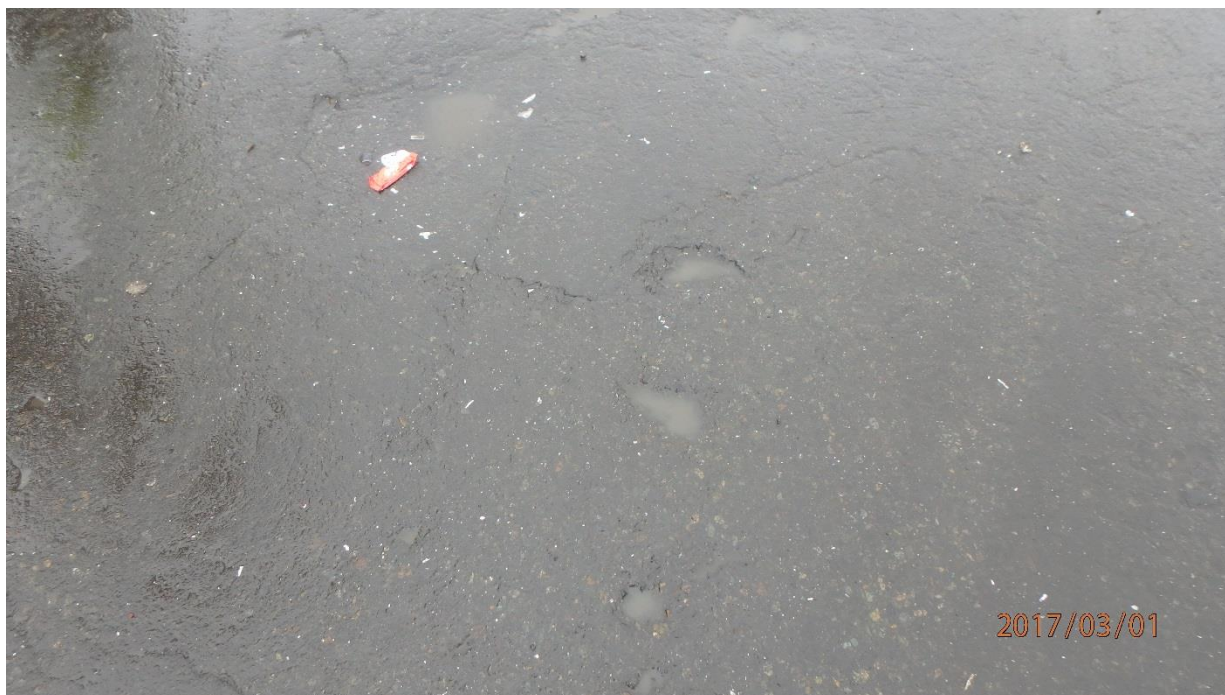
A large portion of the pavement on the north area was covered by scrap metal and equipment during Windward's inspection. The visible portions of the environmental cap showed signs of wear, likely from heavy equipment and scrap metal storage. The majority of the visible pavement surface was covered with shallow gouges; however, these were less than 1 in. deep and did not extend deeply into the cap cross section. Figures 4 through 7 show representative areas of the north area environmental cap. Figures 4 and 5 show typical gouges and debris on the cap. Figure 6 shows a divot (i.e., small depression) in the pavement surface. Figure 7 shows loose gravel and debris, which may be present as the result of raveling (i.e., dislodging aggregate from pavement) on the cap (USACE 2009). This gravel is not sub-base material; the raveling is limited to the cap surface.

**Figure 5. Gouges and debris on north area cap pavement surface**

The divots, gouges, and cracks on the north area should be monitored. These conditions should be repaired if they begin to impact the integrity of the environmental cap

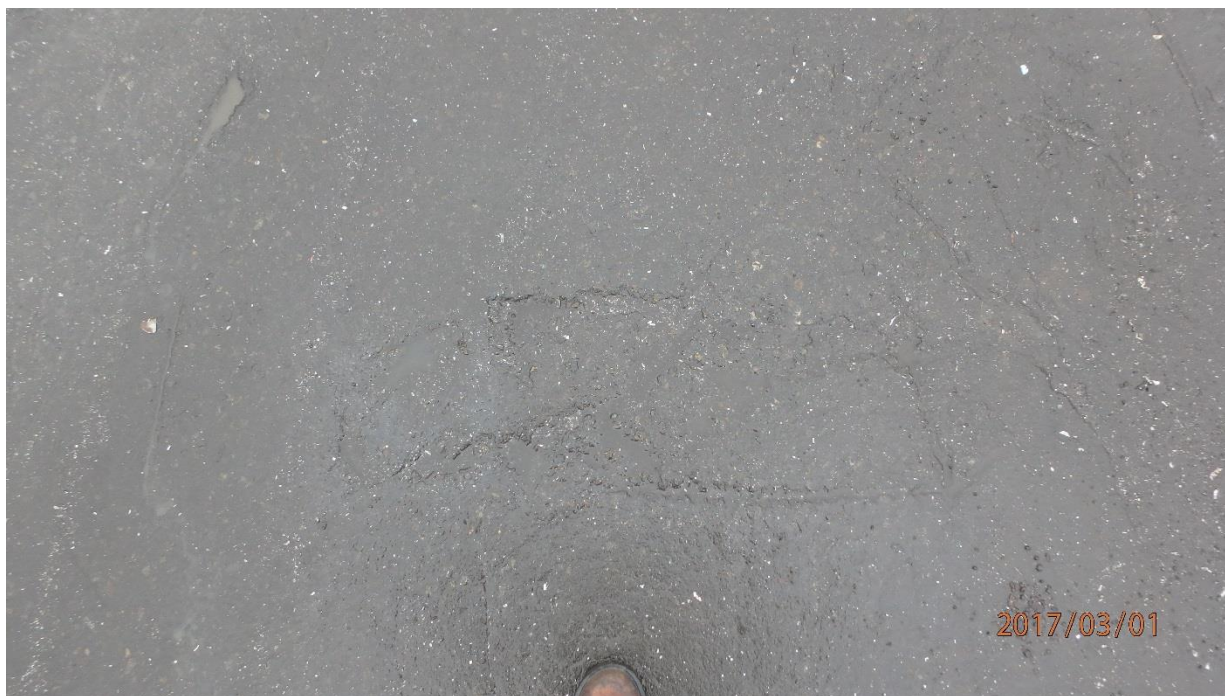
**Figure 6. Example of divot in north area cap pavement surface**

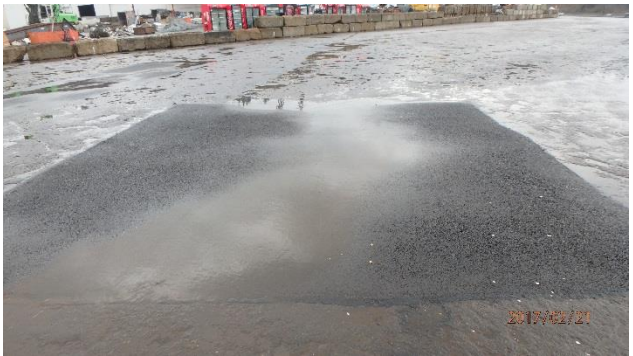
| Location ID <sup>a</sup> | Observations | Recommended Actions | Photos |
|---|---|---|---|
| AP1 | patch in good condition; <sup>b</sup> sealant around patch perimeter | none | |

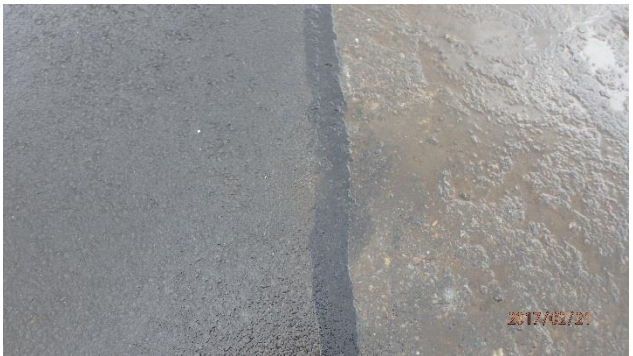
| Location ID <sup>a</sup> | Observations | Recommended Actions | Photos |
|---|---|---|---|
| AP2 | patch in good condition; <sup>b</sup> sealant around patch perimeter | none | |

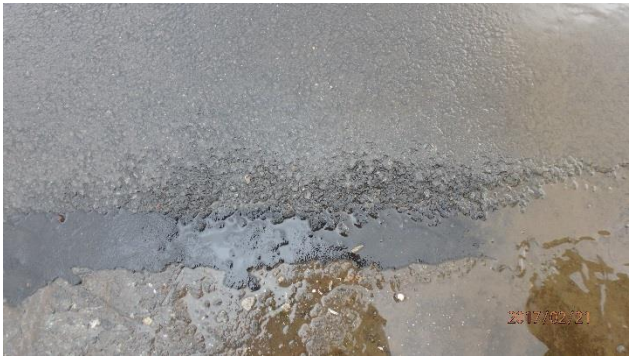
| Location ID <sup>a</sup> | Observations | Recommended Actions | Photos |
|---|---|---|---|
| AP3 | patch in good condition; <sup>b</sup><br>sealant around patch perimeter | none | |

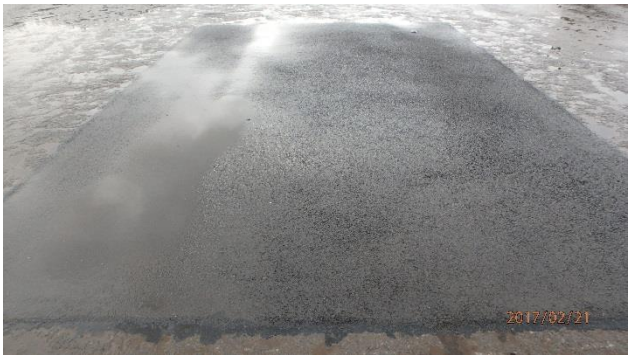
| Location ID <sup>a</sup> | Observations | Recommended Actions | Photos |
|---|---|---|---|
| AP4 | patch in good condition; <sup>b</sup><br>sealant around patch perimeter | none | |

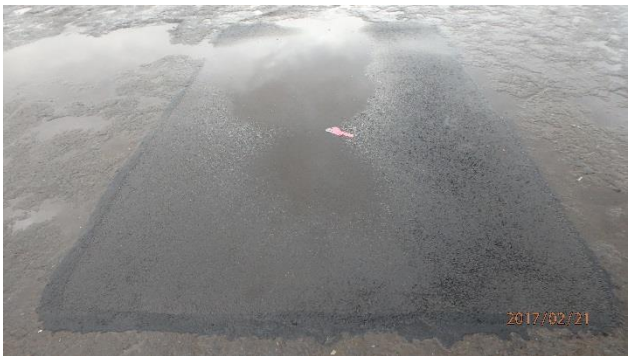
| Location ID <sup>a</sup> | Observations | Recommended Actions | Photos |
|---|---|---|---|
| AP5 | patch in good condition; <sup>b</sup><br>sealant around patch perimeter | none | |

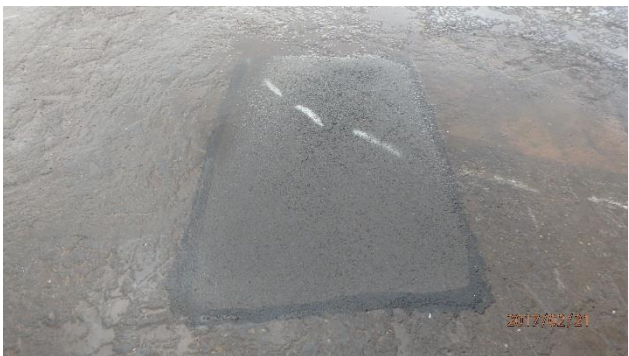
| Location ID <sup>a</sup> | Observations | Recommended Actions | Photos |
|---|---|---|---|
| AP6 | patch in good condition; <sup>b</sup><br>sealant around patch perimeter | none | |

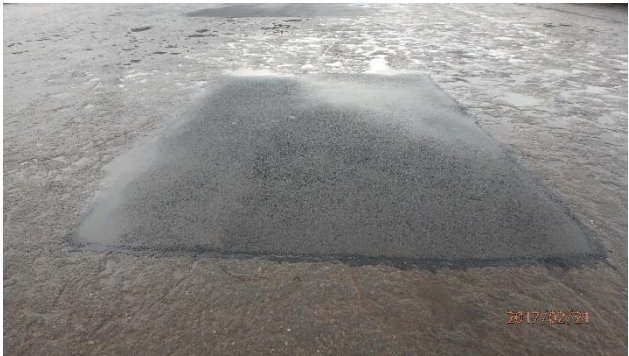
| Location ID <sup>a</sup> | Observations | Recommended Actions | Photos |
|---|---|---|---|
| AP7 | patch in good condition; <sup>b</sup><br>sealant around patch perimeter | none | |

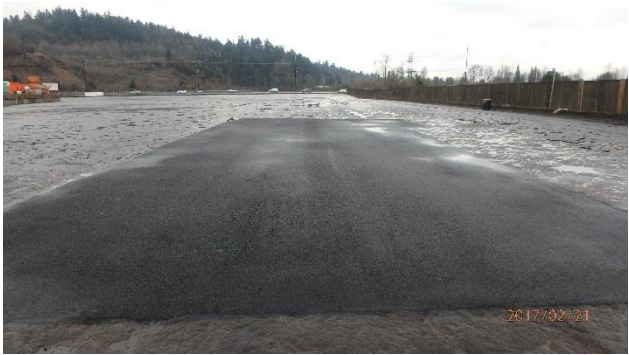
| Location ID <sup>a</sup> | Observations | Recommended Actions | Photos |
|---|---|---|---|
| AP8 | patch in good condition; <sup>b</sup><br>sealant around patch perimeter | none | |

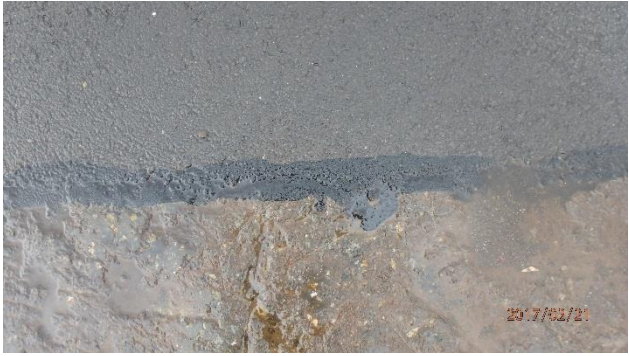
| Location ID <sup>a</sup> | Observations | Recommended Actions | Photos |
|---|---|---|---|
| AP9 | patch in good condition; <sup>b</sup><br>sealant around patch perimeter | none | |

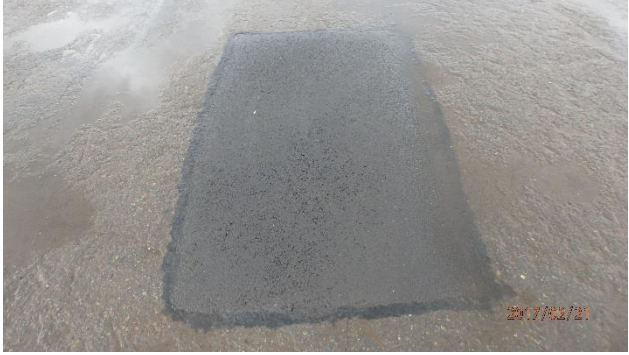
| Location ID <sup>a</sup> | Observations | Recommended Actions | Photos |
|---|---|---|---|
| AP10 | patch in good condition; <sup>b</sup><br>sealant around patch perimeter | none | |

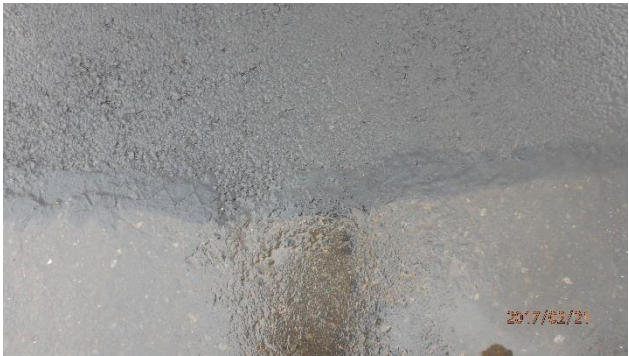
| Location ID <sup>a</sup> | Observations | Recommended Actions | Photos |
|---|---|---|---|
| AP11 | patch in good condition; <sup>b</sup><br>sealant around patch perimeter | none | |

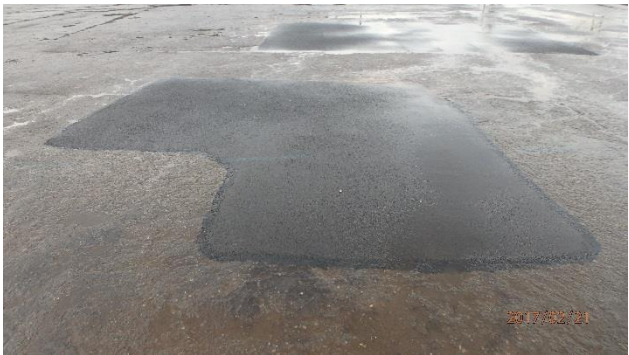
| Location ID <sup>a</sup> | Observations | Recommended Actions | Photos |
|---|---|---|---|
| AP12 | patch in good condition; <sup>b</sup><br>sealant around patch perimeter | none | |

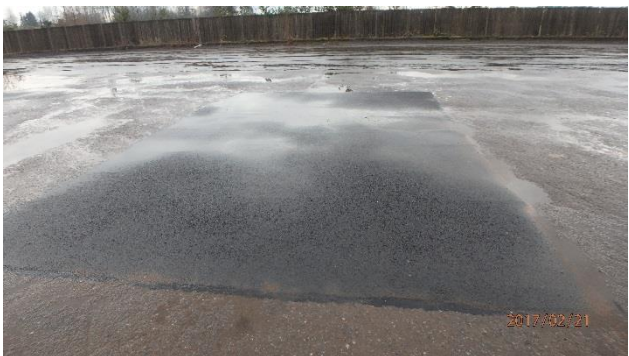
| Location ID <sup>a</sup> | Observations | Recommended Actions | Photos |
|---|---|---|---|
| AP14 | patch in good condition; <sup>b</sup><br>sealant around patch perimeter | none | |

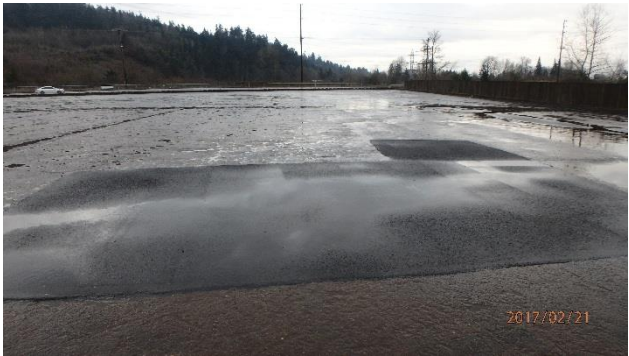
| Location ID <sup>a</sup> | Observations | Recommended Actions | Photos |
|---|---|---|---|
| AP15 | patch in good condition; <sup>b</sup><br>sealant around patch perimeter | none | |

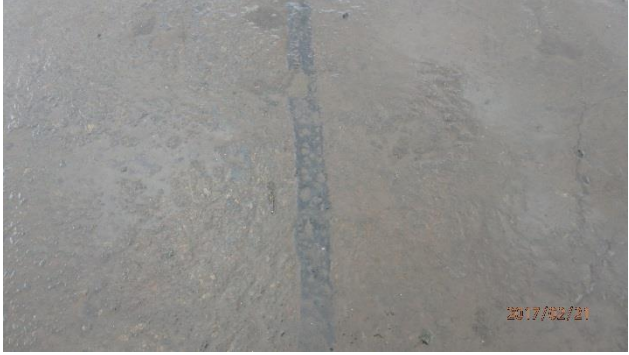
| Location ID <sup>a</sup> | Observations | Recommended Actions | Photos |
|---|---|---|---|
| Seam line 1 | sealed; seals in good condition | none | |

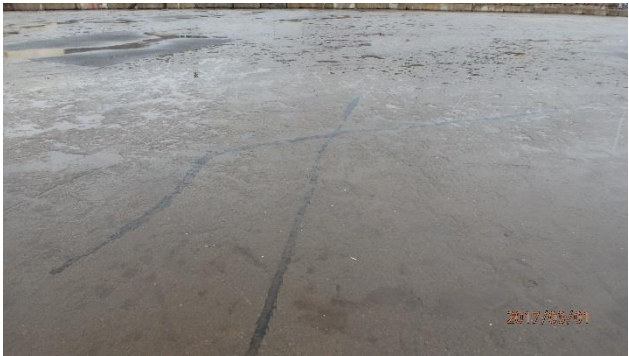
| Location ID <sup>a</sup> | Observations | Recommended Actions | Photos |
|---|---|---|---|
| Seam lines 2 | sealed; seals in good condition | none | |

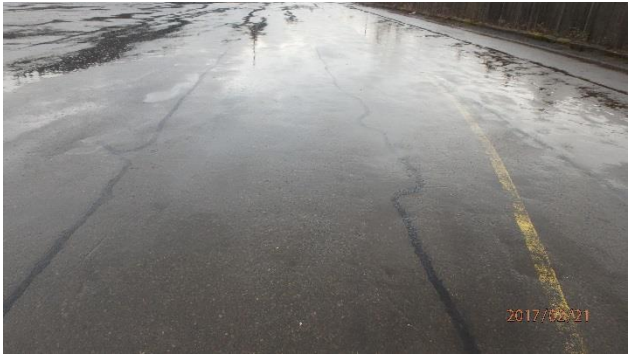
| Location ID <sup>a</sup> | Observations | Recommended Actions | Photos |
|---|---|---|---|
| Seam lines 3 | sealed; seals in good condition | none | |

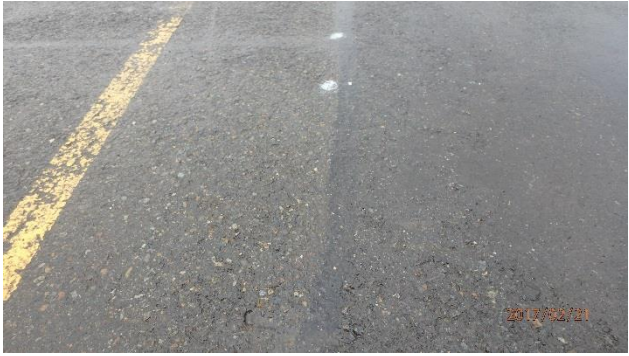
| Location ID <sup>a</sup> | Observations | Recommended Actions | Photos |
|---|---|---|---|
| Seam lines 4 | sealed; seals in good condition | none | |

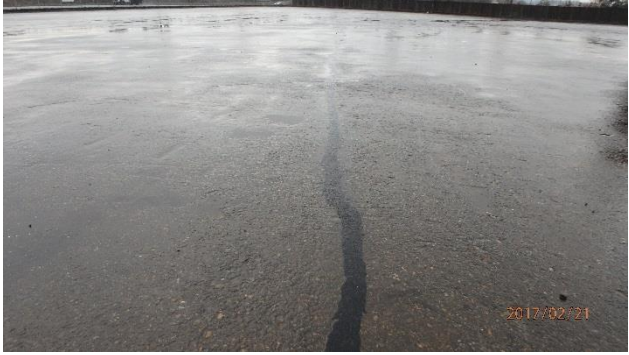
| Location ID <sup>a</sup> | Observations | Recommended Actions | Photos |
|---|---|---|---|
| Seam line 5 | sealed; seal in good condition | none | |

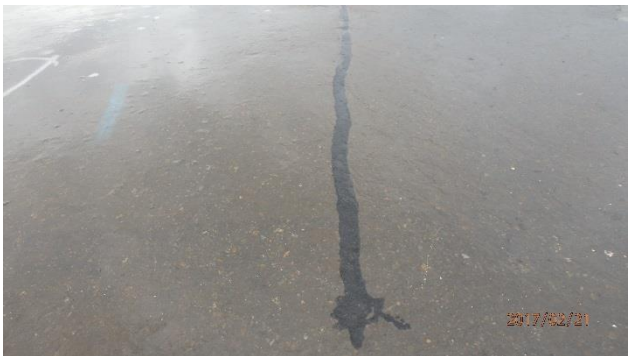
| Location ID <sup>a</sup> | Observations | Recommended Actions | Photos |
|---|---|---|---|
| Seam lines 6 | sealed; seals in good condition | none | |

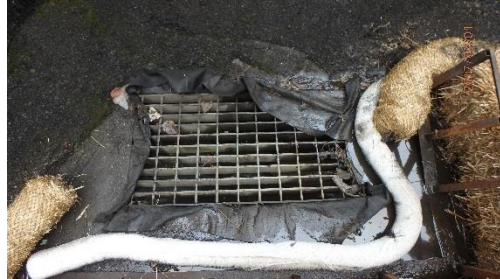
| Location ID <sup>a</sup> | Type of Structure | Observed Condition | Sediment Accumulation (in.) | Additional Observations | Recommended Actions | Photos |
|---|---|---|---|---|---|---|
| CB1 | catch basin | functioning normally | 0 | insert in catch basin; hay bales, straw wattles, and boom around grate | none | |

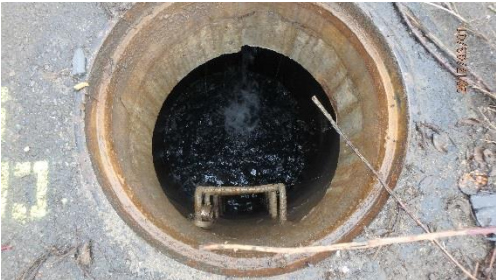
| Location ID <sup>a</sup> | Type of Structure | Observed Condition | Sediment Accumulation (in.) | Additional Observations | Recommended Actions | Photos |
|---|---|---|---|---|---|---|
| MH3 | manhole | functioning normally | 0 | discharging normally | none | |

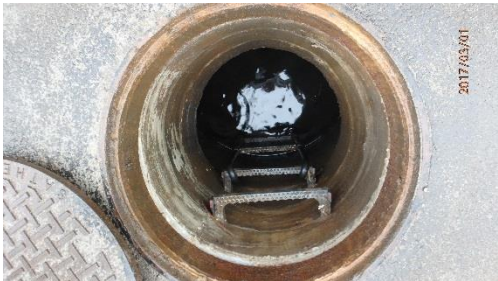
| Location ID <sup>a</sup> | Type of Structure | Observed Condition | Sediment Accumulation (in.) | Additional Observations | Recommended Actions | Photos |
|---|---|---|---|---|---|---|
| MH5 | manhole | functioning normally | 0 | none | none | |

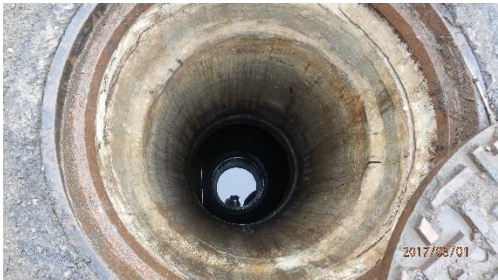
| Location ID <sup>a</sup> | Type of Structure | Observed Condition | Sediment Accumulation (in.) | Additional Observations | Recommended Actions | Photos |
|---|---|---|---|---|---|---|
| OWS | oil/water separator | functioning normally | nm | concrete structure | none | |
