## PERIODIC REVIEW

**Weyerhaeuser Everett East Site**

**TOXICS CLEANUP PROGRAM**

**July 9, 2012**

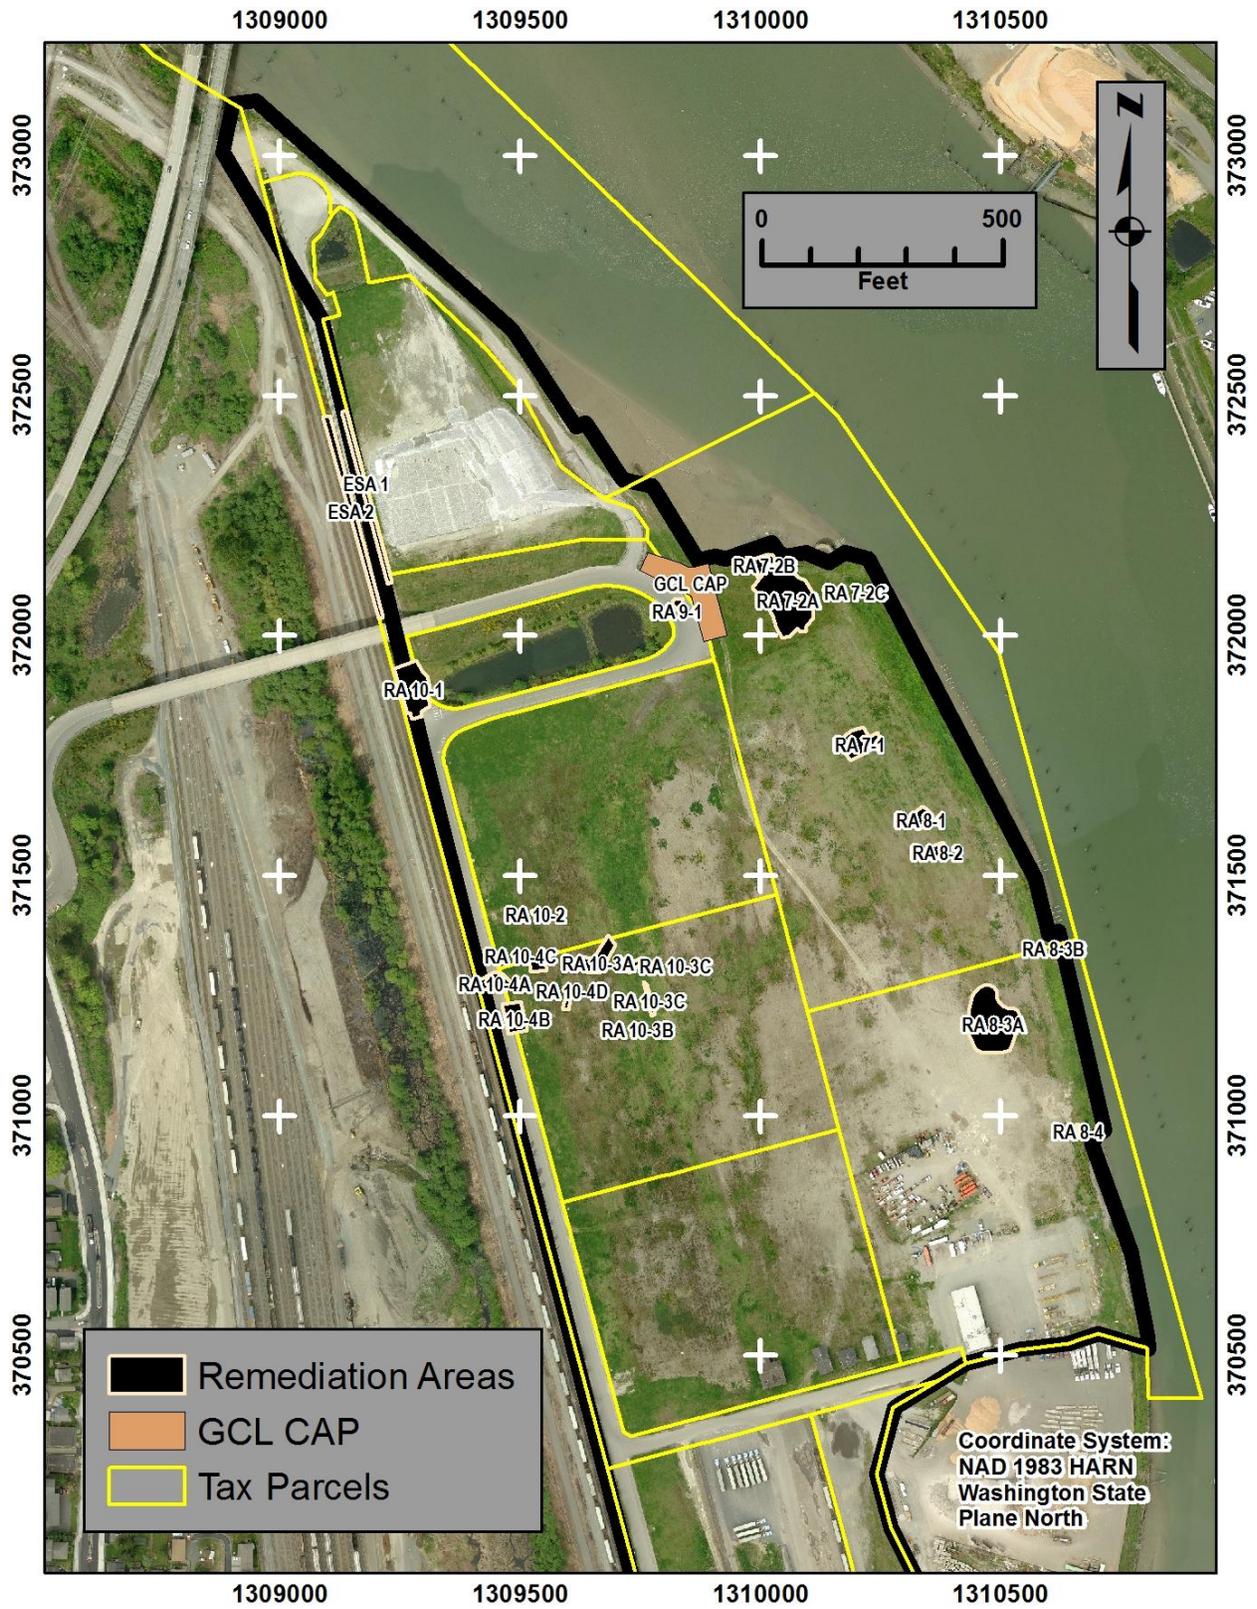
Figure 5: Remediation Areas, North

- Arsenic-contaminated soil is contained beneath a GCL cover on the north part of the site, as shown on Figure 5 and Figure 7. This is the only engineered cover on site. Work in the subsurface should avoid this area. If work in the subsurface needs to be performed in this area it will have to properly manage the underlying soils and reconstruct the GCL cover.

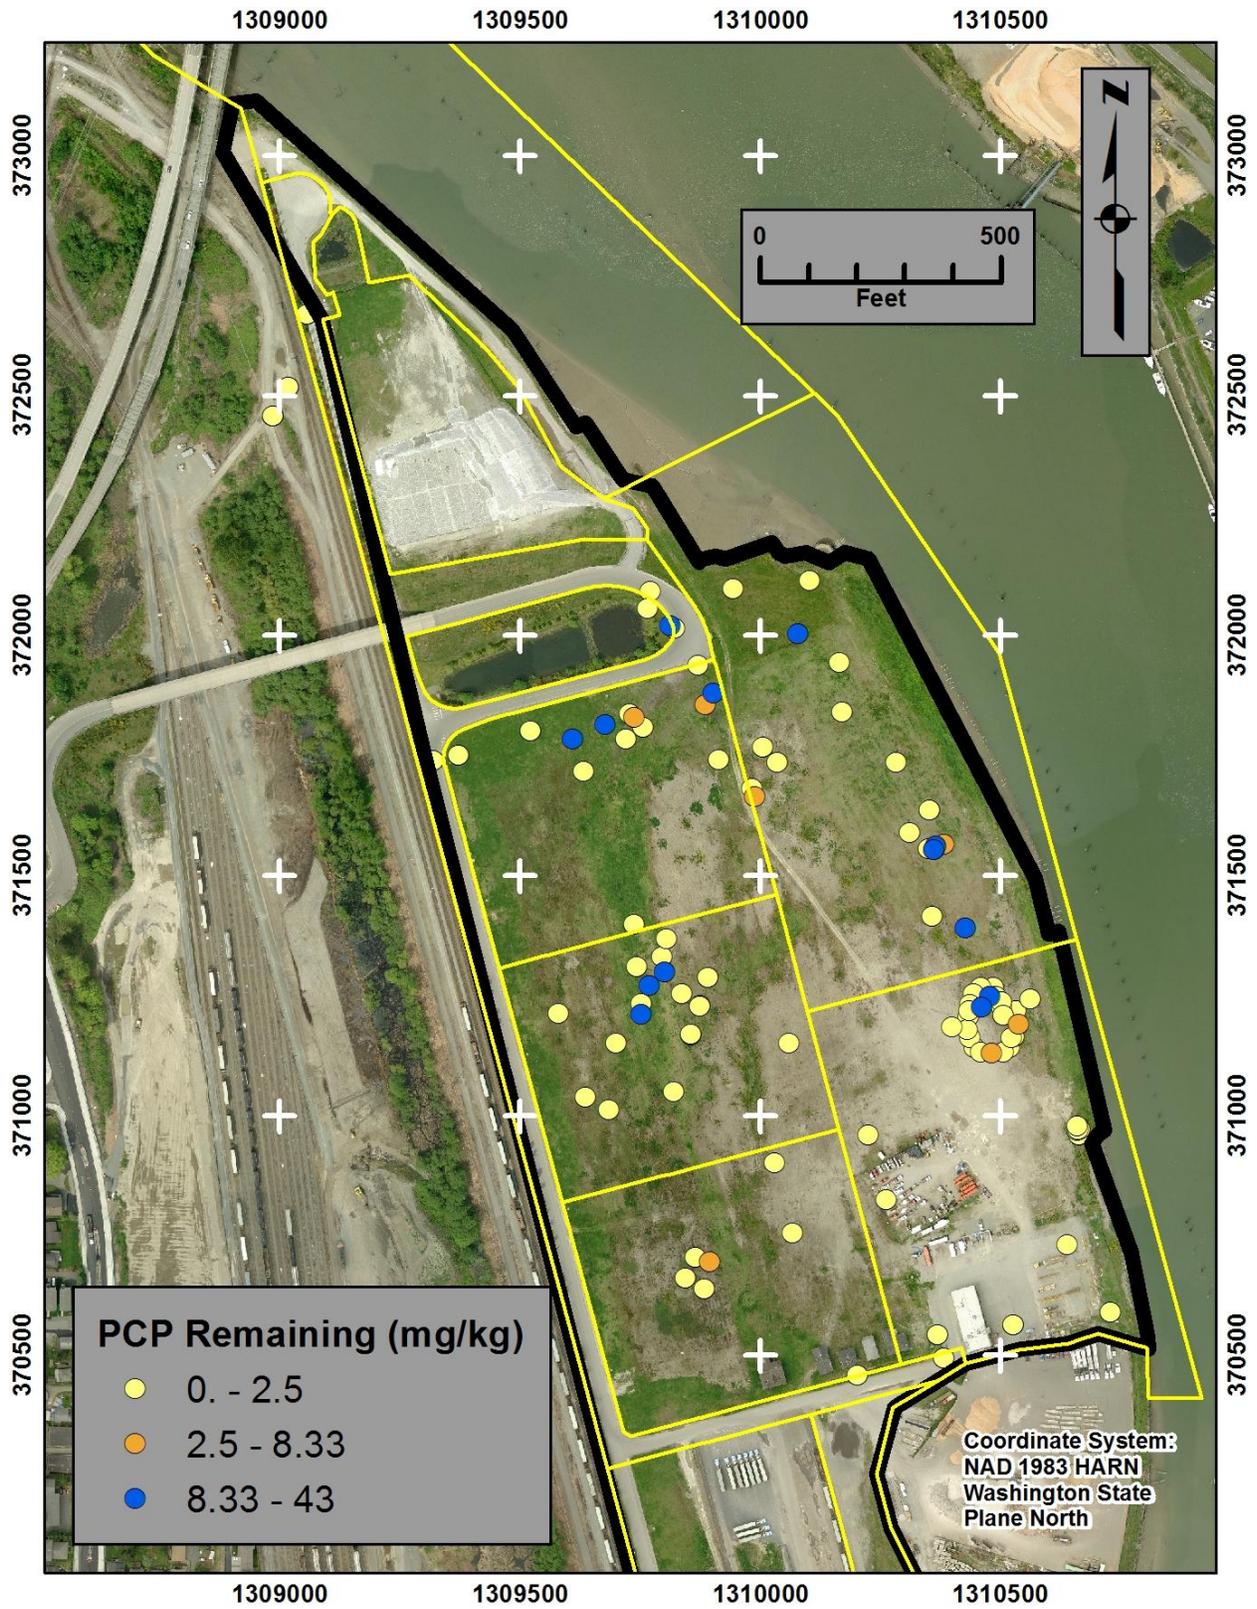
Figure 9: PCP Remaining in Soil, North.

Figures 9 through 16 show concentrations of the chemicals of concern remaining in soil at the Site. These figures were prepared by compiling the soil data collected at the site and mapping them according to the following categories (except for TPH):
