Hilton Hotel Parking
Garage

**Closure Services Related to
Hilton USTs
Seattle, Washington**

July 1998

**RE: CLOSURE SERVICES RELATED TO HILTON USTS,
SEATTLE, WASHINGTON**

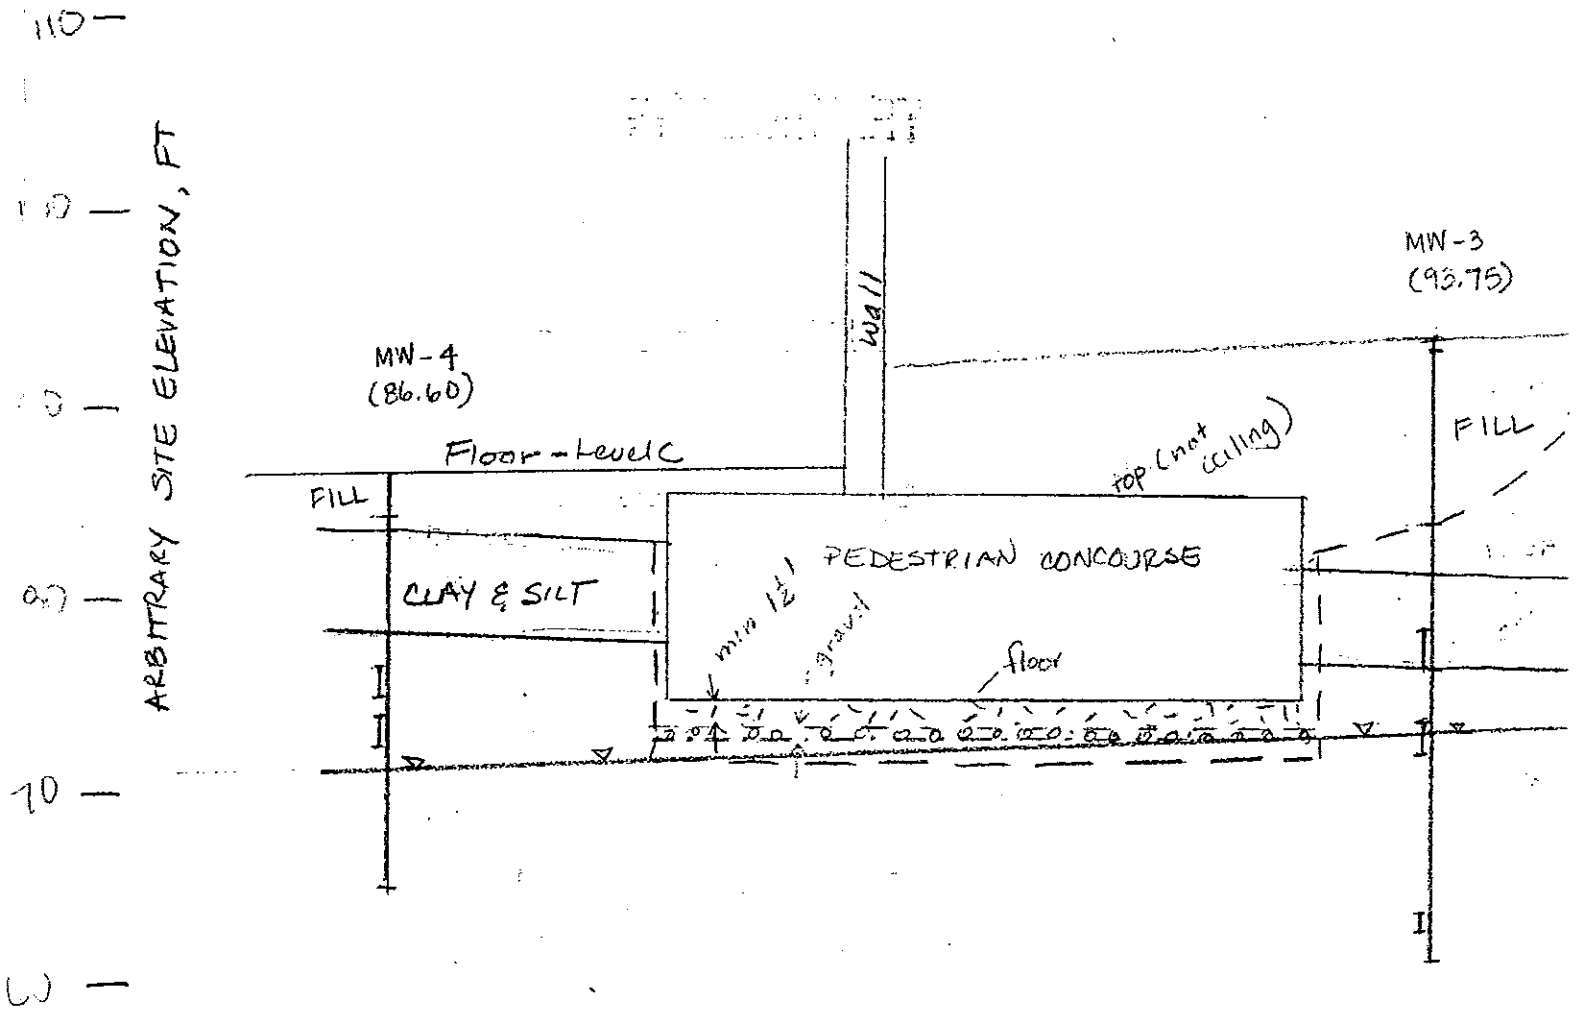
T-1772-02
CROSS SECTION A-A'
SKW
Fig 4 (2082)

- ▶ Migration to groundwater is retarded by a hard silt/clay layer. Figures 4 and 5 are cross sections through the UST area. As shown on the cross sections, the USTs are bedded in sandy fill that overlies a hard silt/clay layer. The native soil adjacent to the UST area is sand. The silt/clay layer appears to be continuous beneath the site and the street and is 3 to 6 feet thick. Soil samples were collected and analyzed from above and below the silt/clay layer at locations as shown on Figures 4 and 5. A sample from above the silt/clay layer at B-1 (drilled in 1994) did have gasoline contamination at 2,000 mg/kg. At MW-2 and MW-3 (drilled in 1998), samples from immediately above (and below) the silt/clay layer did not contain measurable concentrations of gasoline. The lack of soil contamination (and the lack of water) on top of the silt/clay layer indicates that contamination is not migrating along the layer.

- ▶ Groundwater does not flow through the UST area. No water was observed above the silt/clay layer during either of the subsurface investigations (1994, 1998). Groundwater is present at 3 to 7 feet below the silt/clay layer as shown on Figures 4 and 5.

We have also enclosed hand-drawn cross-sections showing the distribution of potential confining layers in the subsurface. As you can see on Section A-A' (location shown on the Site Plan, Figure 1), a fine-grained layer is present beneath the USTs but above the groundwater table. The free-product layer in MW-5 is located below this layer. This separation further supports the conclusion that the groundwater contamination is predominantly, if not all, from an off-site source.
