Subject: Phase I Environmental Site Assessment for Dodge of Bellevue Property, 126 through 316 116th Avenue NE, Bellevue, WA

**Phase I Environmental Site Assessment
Report**

**Dodge of Bellevue Property
126 through 316 116th Avenue NE
Bellevue, WA 98004**

ASTM E 1527-00

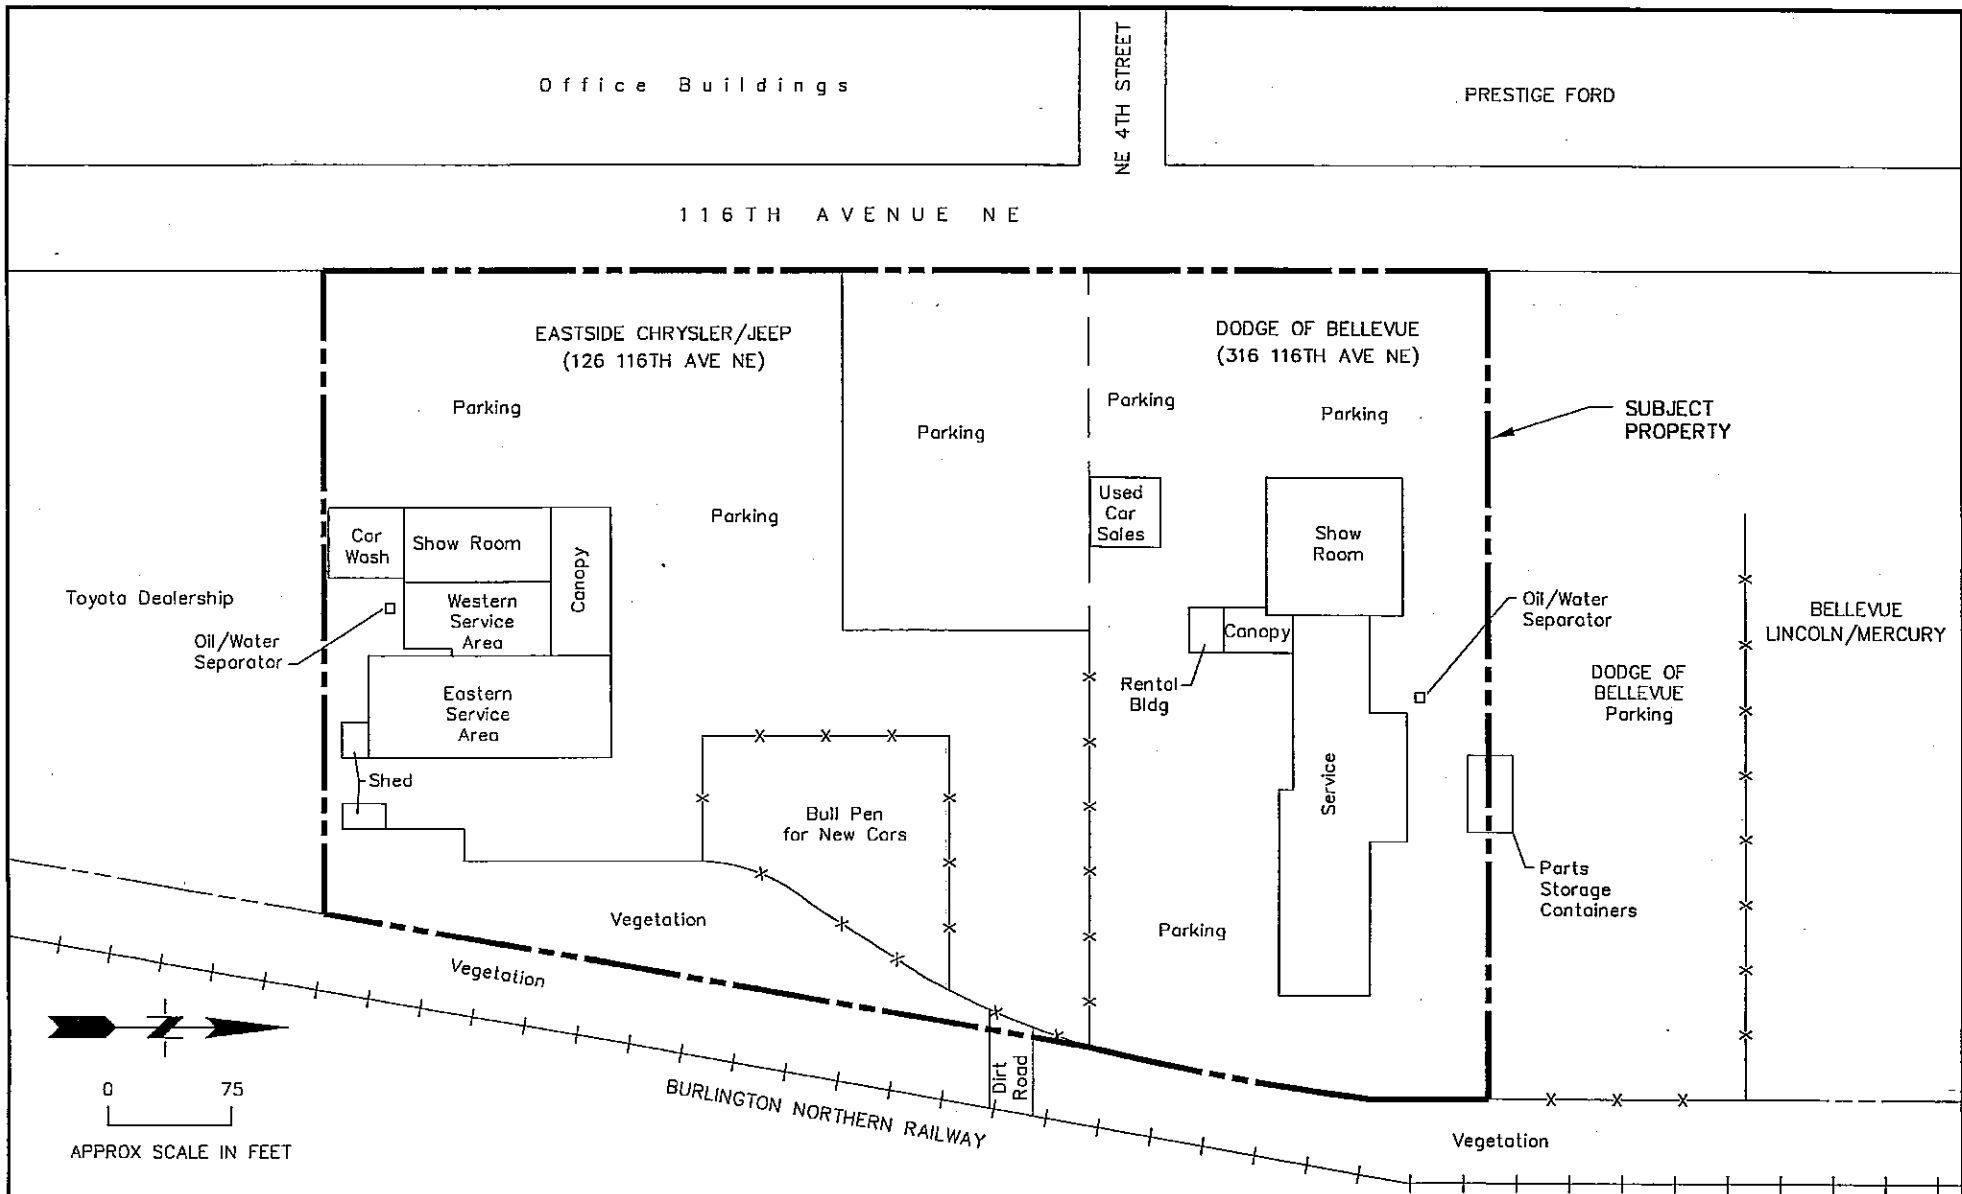
The showrooms for the two automotive dealerships are located on the western end (front) of the buildings, facing 116th Avenue NE (Figure 2). The parts and service departments and associated storage areas are located in the eastern portions (rear) of the buildings. Notable features in the two service departments include above-ground hydraulic automotive lifts, new and used oil storage, parts cleaning equipment, and small quantities of maintenance fluids. Any observed evidence of hazardous materials use or hazardous waste generation is discussed in Section 5, Site Reconnaissance.

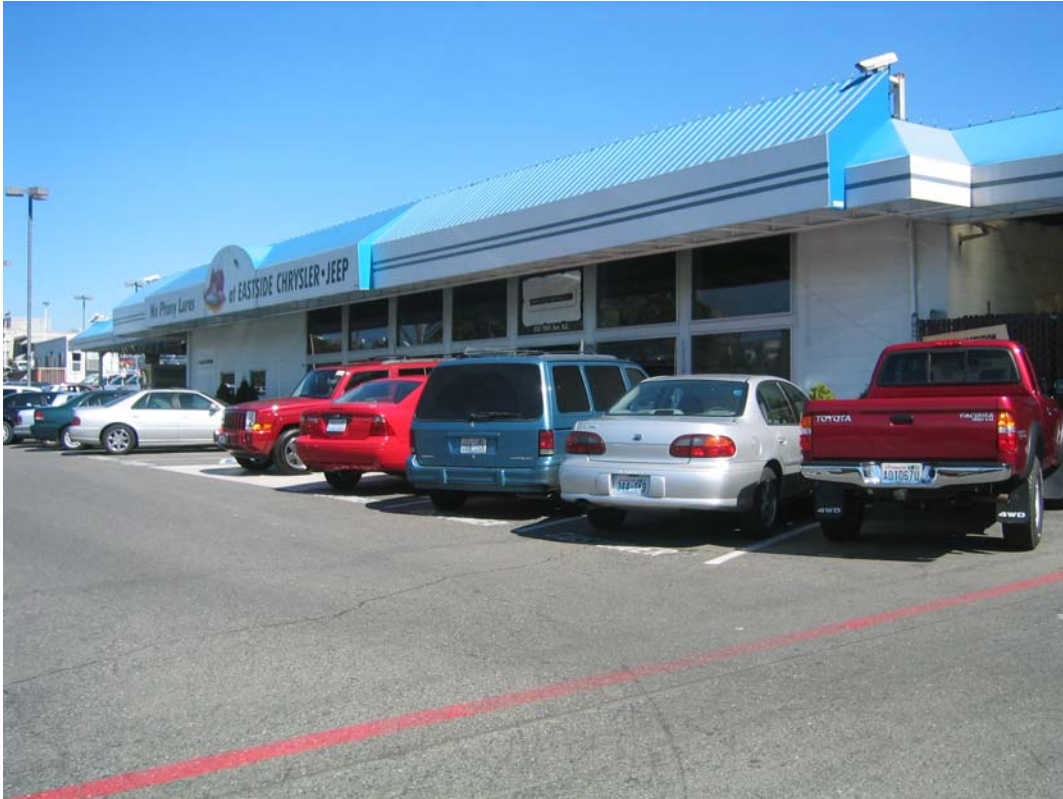
Photo 1. View looking northeast toward the Eastside Chrysler-Jeep showroom in the south portion of the subject property (126 116th Avenue NE).

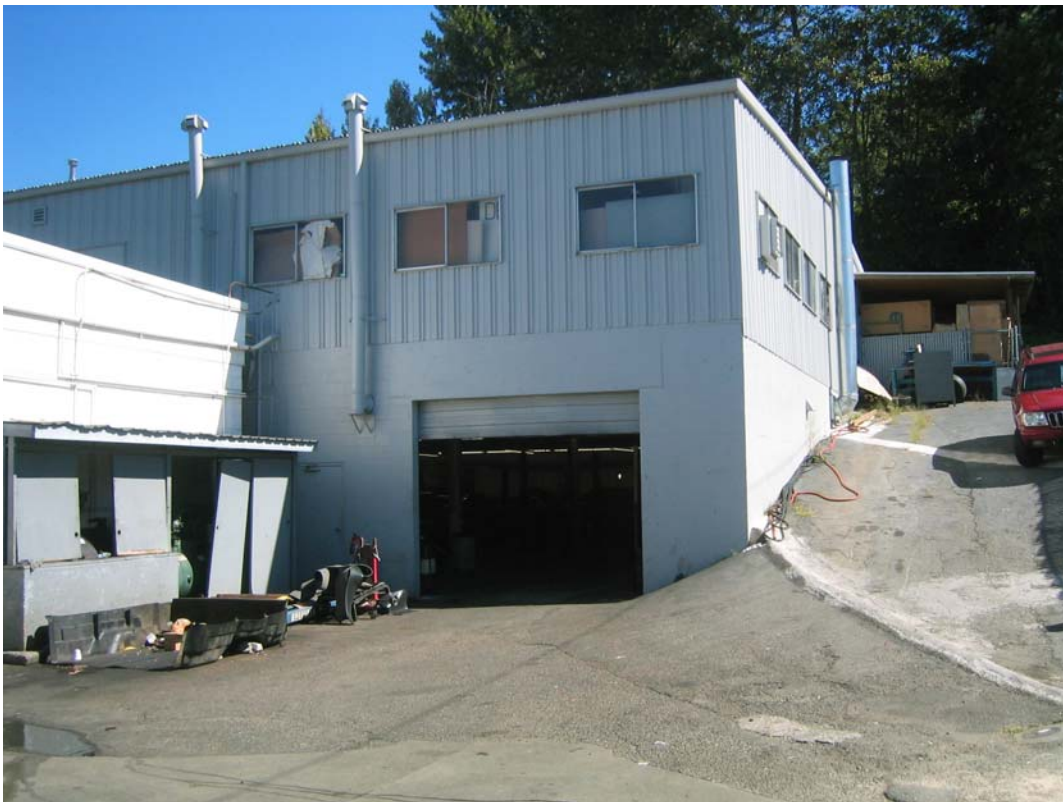
Photo 2. View looking east-northeast at the rear portion of the Eastside Chrysler-Jeep dealership. The top floor is occupied by offices and the parts department. The lower floor includes 19 service bays. An additional nine service bays are present in the building visible to the left.

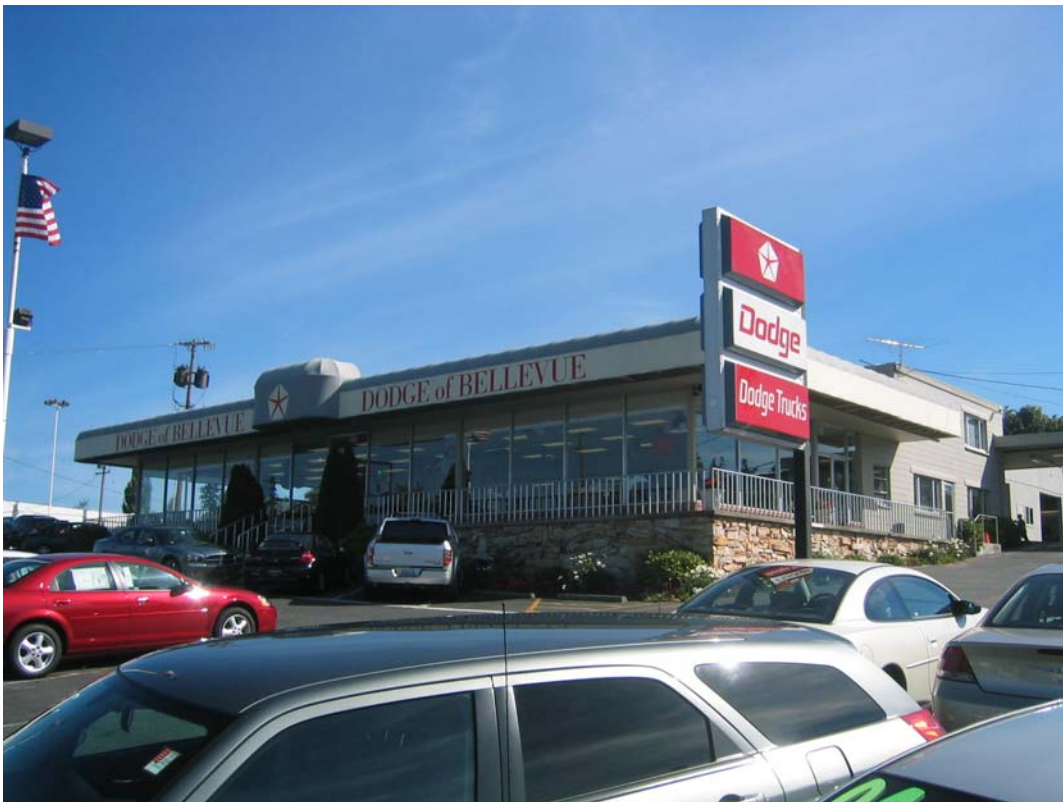
Photo 6. View looking northeast toward the Dodge of Bellevue showroom in the north portion of the subject property (316 116th Avenue NE).

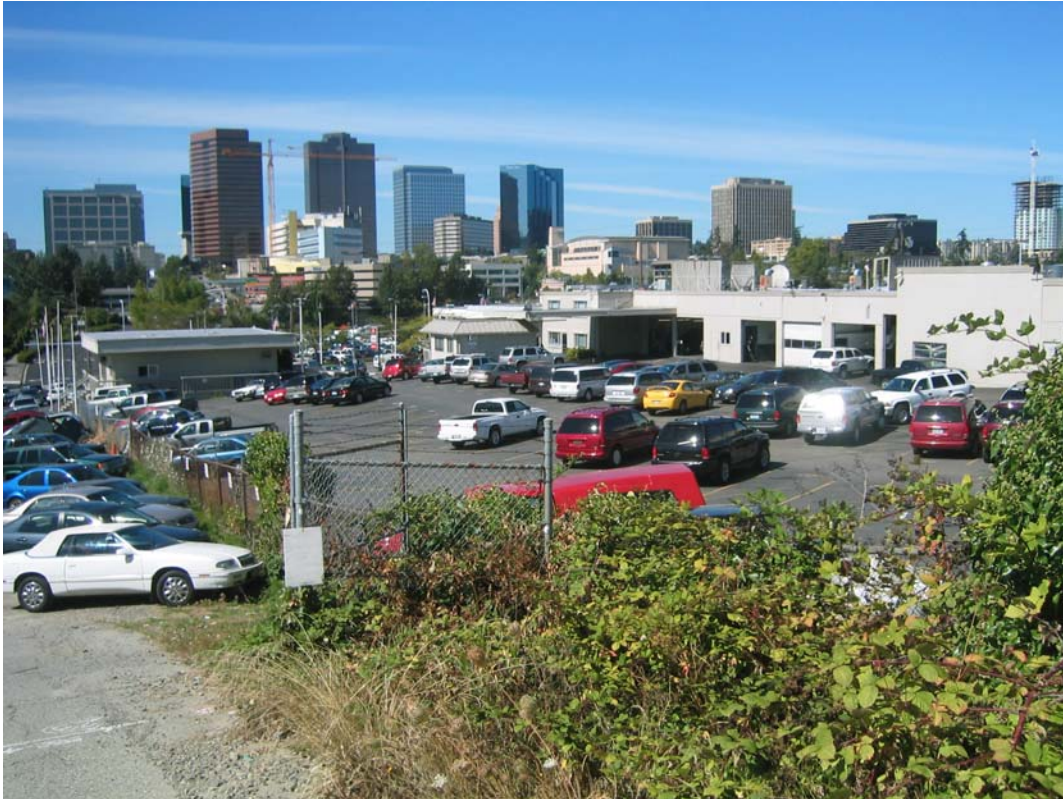
Photo 7. View looking west-northwest toward the Dodge of Bellevue dealership from near the center of the property. Note difference in topography due to the northern parcel (Dodge) being graded relatively level.
