WASHINGTON RANKING METHOD

ROUTE SCORES SUMMARY AND RANKING CALCULATION SHEET

Site name: Holden Mine Tailings Region: CR0
 City, county: Holden, Chelan

SUMMARY SCORE SHEET	
Site Name: Holden Mine Tailings	ID No:
Site Location: (City, County, or Section/Township/Range) Holden Village, Chelan, Section 7, T21N, R17E	
Site Description: (Attach a sketch/map) Eight million tons (80 acres) of mine tailings from copper/zinc/gold/silver mining corporation. Adjacent to Railroad Creek which feeds into Lake Chelan 12 miles to the east. Located at Holden Village. Within the Wenatchee National Forest, elevation 3,200 feet.	
Special Considerations: Railroad Creek is eroding the base of the piles. Especially during high flow. Physical siltation and dissolved copper and zinc (& arsenic) have knocked out aquatic insects for several miles downstream and reduced fish population directly or indirectly. Large flooding/erosion would make this much worse. Railroad Creek feeds Lake Chelan. There is runoff and probably constant seepage through the tailings that enters the creek, and a small stream with high dissolved Cu & Au. An air route environmental score can be generated and other route scores can be

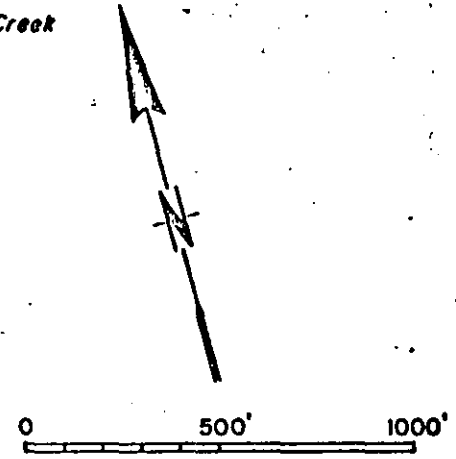
FIGURE 1

The tailings disposal site is located on Federal land, along the south bank of Railroad Creek downstream from the mine area (see map, Fig. 1, and photo No. 1). Over an area of 80 acres, approximately 8 million tons of mill tailings are spread to a maximum depth of about 130 feet.

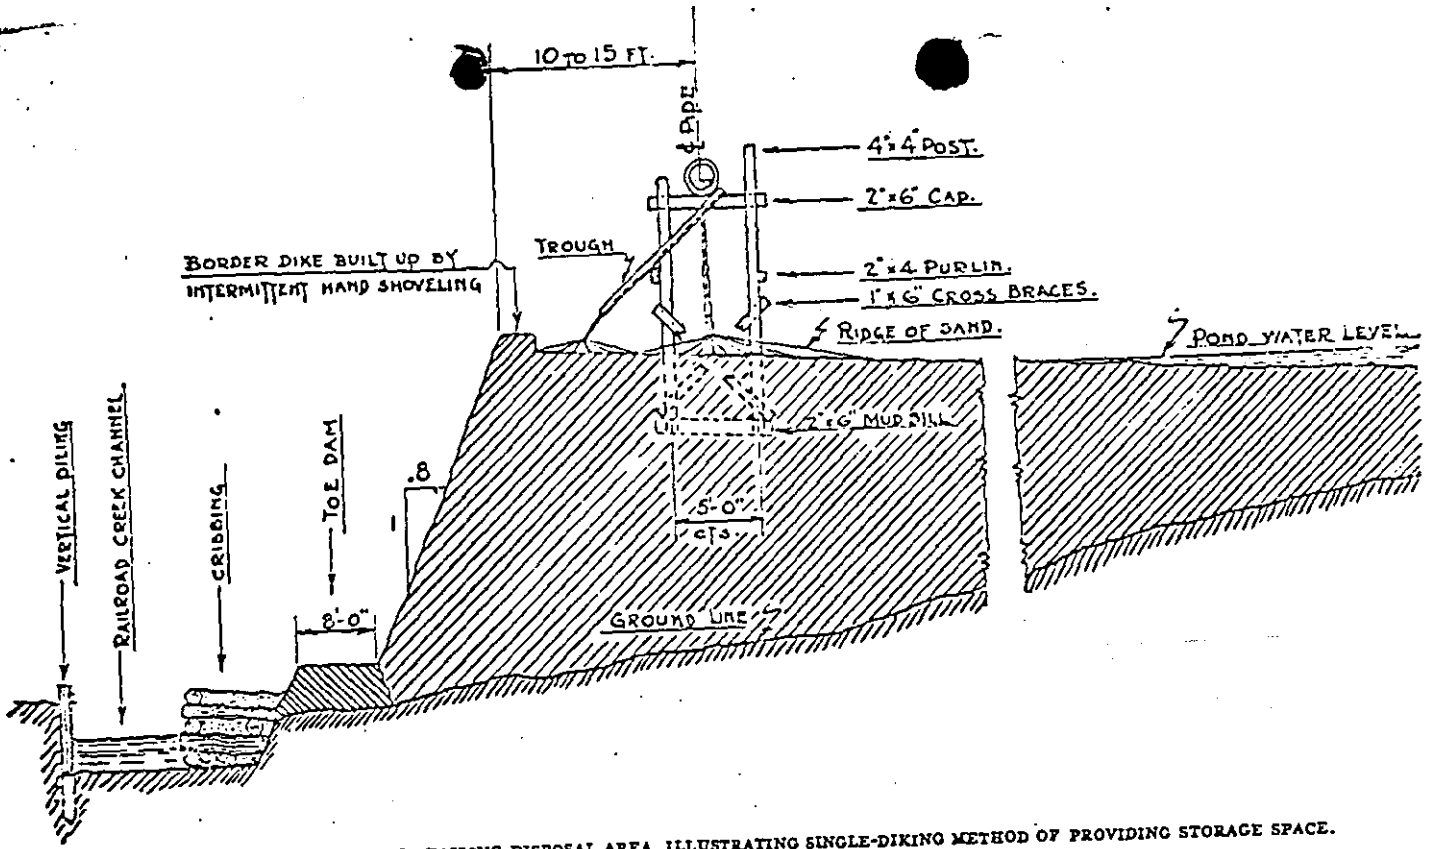
FIG. 2.—IDEALIZED SECTION OF TAILING-DISPOSAL AREA, ILLUSTRATING SINGLE-DIKING METHOD OF PROVIDING STORAGE SPACE.

The dikes that maintained the central settling pond, drained by these risers, were built as shown in Figures 2 and 3. The double dike method (Fig. 2) was used to provide extra storage capacity over the winter when it was impossible to build dikes due to the heavy snowfall. Most of the diking was done with "thickened" tailings from which the bulk of the extreme fine mud-size particles were removed (see Physical Characteristics). This enabled construction of a stable dike at slopes averaging 0.8 to 1 or about 52 degrees (Zanadvoroff, p. 690).

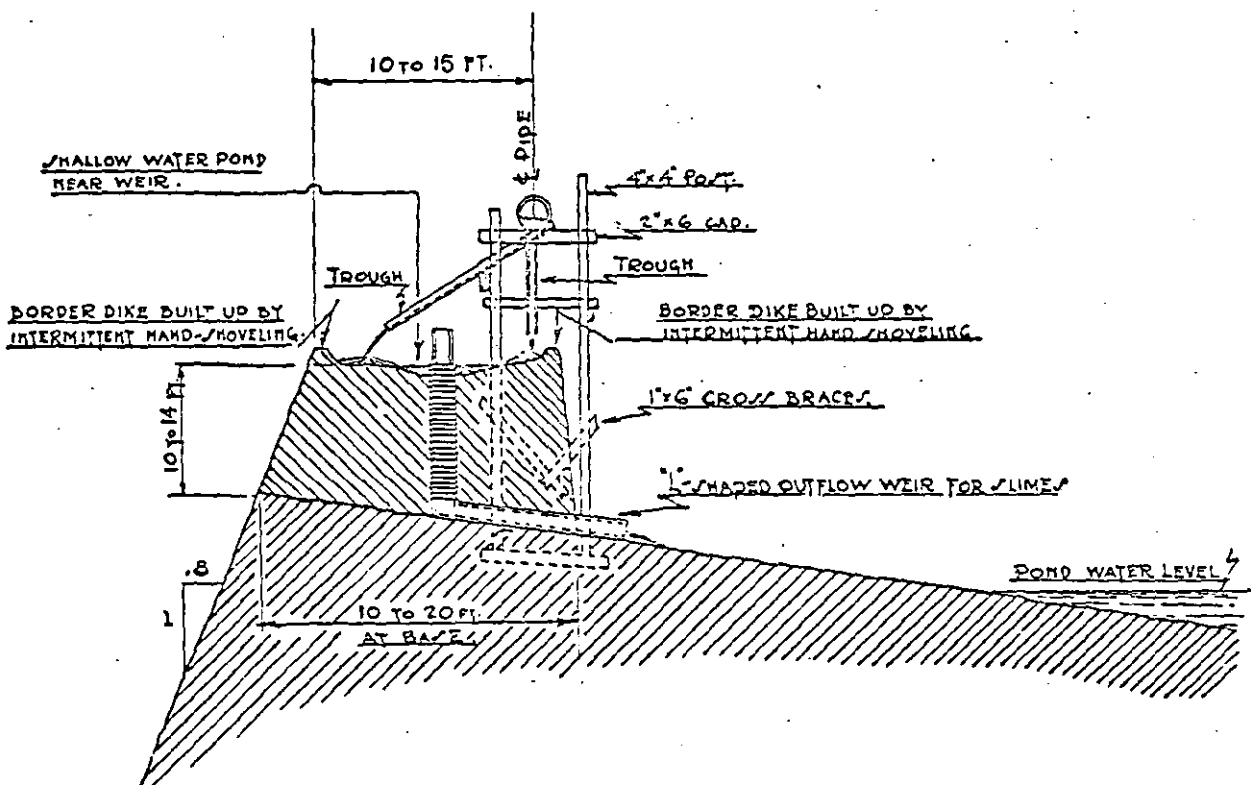
FIG. 3.—IDEALIZED SECTION OF TAILING-DISPOSAL AREA, ILLUSTRATING DOUBLE-DIKING METHOD OF PROVIDING STORAGE SPACE.
