DEPARTMENT OF
ECOLOGY
State of Washington

Monitoring, Sampling and Analysis Report

Spokane River Shoreline Sediment Sites Heavy Metals (As, Cd, Pb, Zn) Post-Remediation Monitoring

June 2019

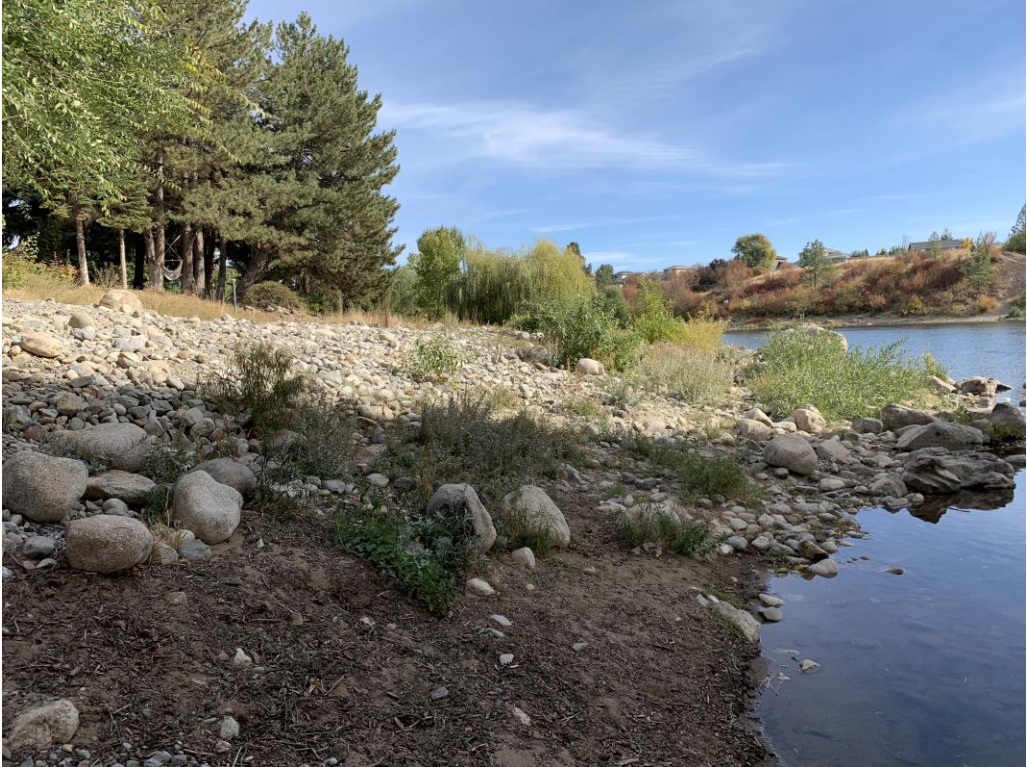
IMG_3908

Photo ID	Description
IMG-3908	standing at waters edge under bridge looking east towards site
" 3909	same spot looking towards pedestrian access pathway
" 3910	Sample 1
" 3911	" 2
" 3912	" 3
" 3913	" 4

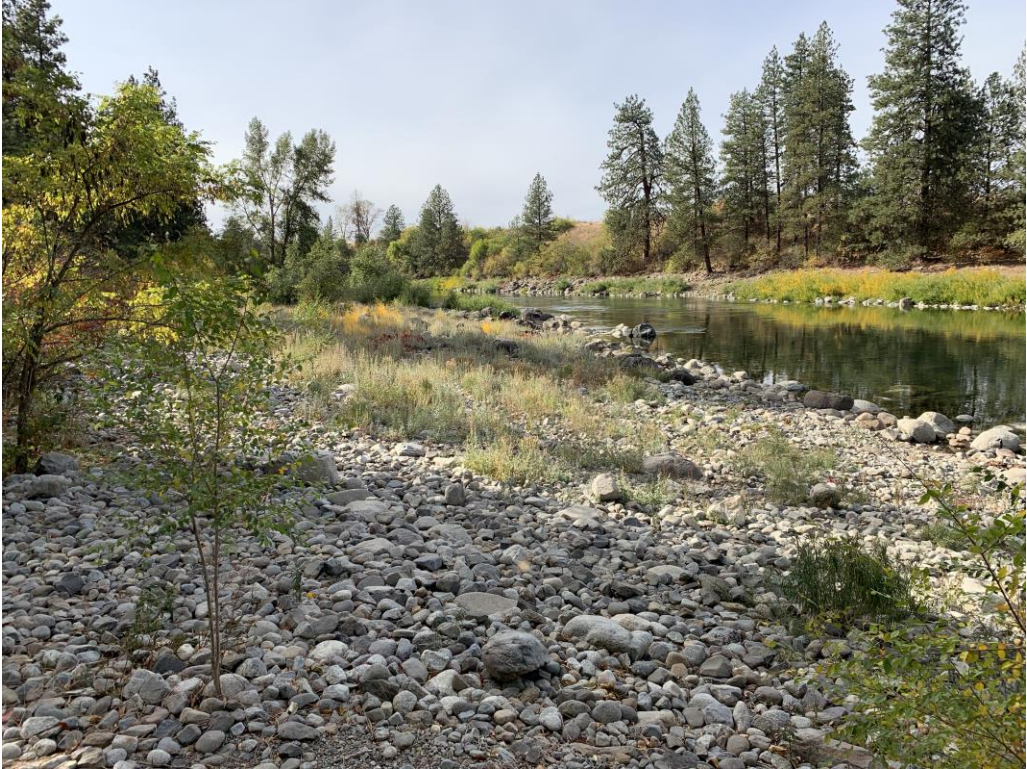
Signage and Pedestrian Access
Condition of pedestrian access pathways and signage if placed as a part of the remedial action: <u>- usage noted but intact</u>

Photo ID	Description
IMG_3914	standing at eastern most edge of the site looking west
IMG_3915	standing at eastern most edge of the site ^{near} near the water looking west

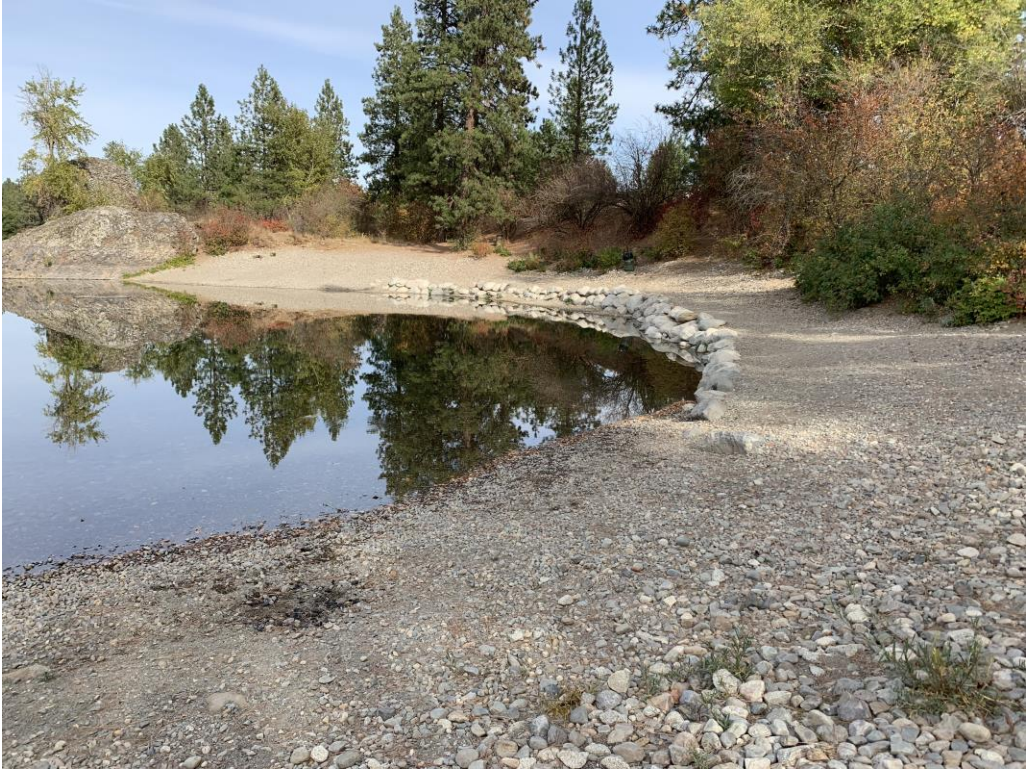
IMG_3918

- minor erosion from usage but remedy still effective and in good condition

Photo Log	
Photo ID	Description
IMG - 3918	Standing western most edge of the site looking east towards the site
" " 3919	same spot with more focus on eastern part of the cliff
" " 3920	Sample 1
" " 3921	" " 2
" " 3922	" " 3
" " 3925	" " 4
" " 3926	" " 5
" " 3927	" " 6
IMG - 3928	Sample 7

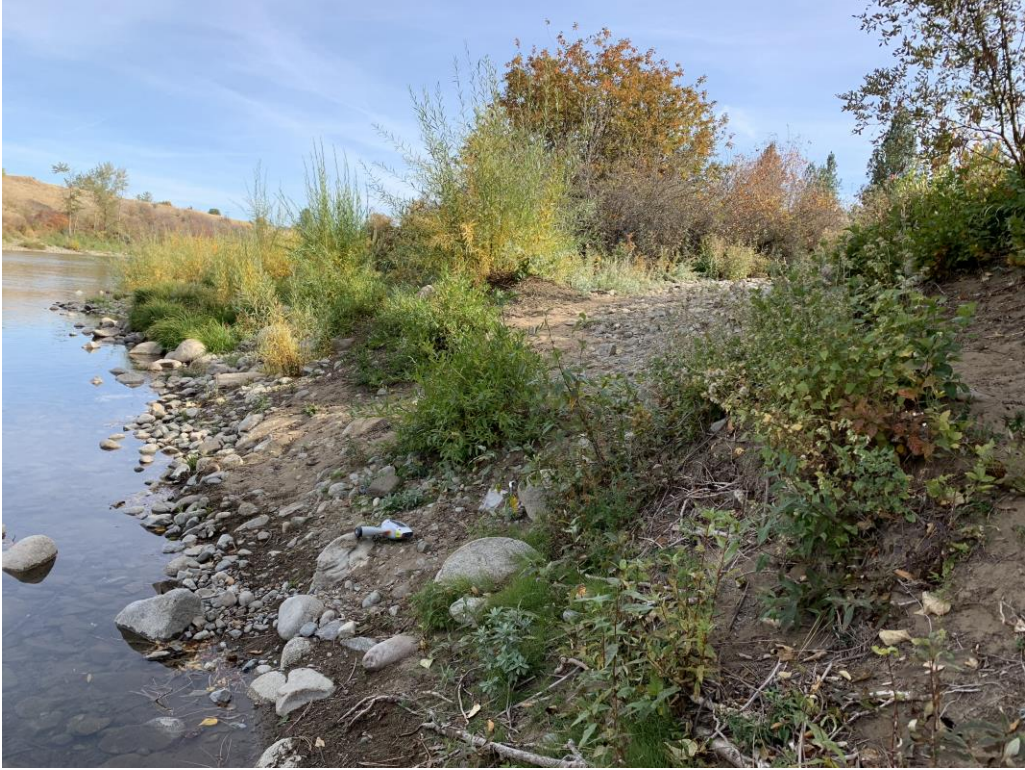
IMG_3929

Photo Log	
Photo ID	Description
IMG-3928	Sample 1
" " 3929	Standing downstream of site looking upstream towards the site
" " 3930	Sample 2
" " 3931	Sample 3
" " 3932	Sample 4
