SITE HAZARD ASSESSMENT

SITE NAME: Texaco 211577 Monterey

Completed on 5/7/2019 for inclusion

on the August 2019 Hazardous Sites List.

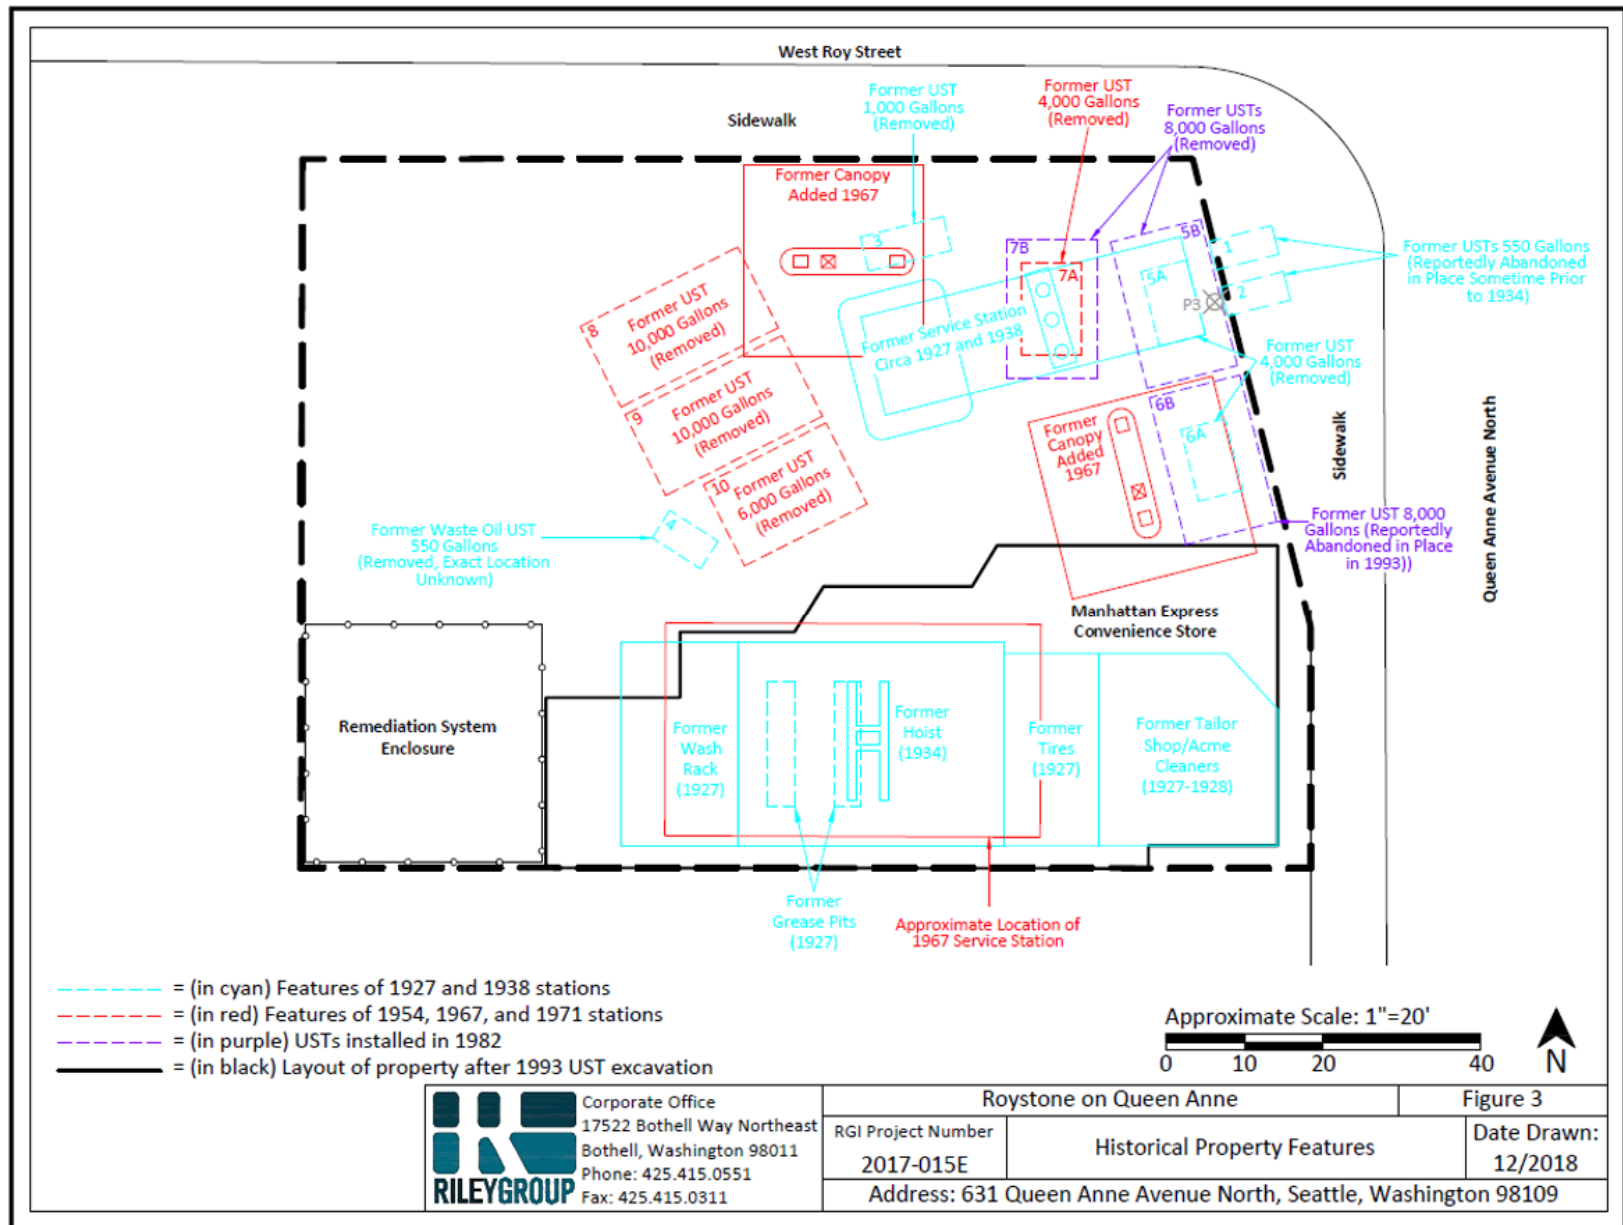
The configuration of buildings and underground storage tanks (USTs) on the source parcel has changed multiple times since the initial development as a gas station. The station was built in 1927, with redevelopments in 1954 and 1967. See Figure 2 for specific locations of buildings and USTs. Generally, fueling activities have been located on the eastern portion of the parcel, and a retail building has been located in the southern portion of the parcel. The station was decommissioned in 1993. Since that time, the property has housed one building in the southern portion of the parcel. Demolition of this building is planned as part of a proposed site redevelopment into a mixed-use building with retail spaces and apartments.

In 1993, the eight USTs remaining in use on the Texaco property were closed. Seven of the eight tanks were removed from the property, and the eighth tank was abandoned-in-place and filled with cement. There are also two concrete tanks from the 1927-era gas station that may remain in place under the Queen Anne Avenue North sidewalk, immediately east of the northeastern property boundary. Contaminated soil was observed in the area of tank excavations, but remained on the property and was used to backfill the excavation areas. Also in 1993, the first interim remedial action was put into use at the Site. This was a spray aeration vapor extraction (SAVE) system, installed by SAIC and Glacier to remediate soil and groundwater. This system was later determined to be insufficient for the Site, and in 1996 Groundwater Technologies Inc. replaced the SAVE system with a catalytic oxidizer in conjunction with the vapor extraction system. The catalytic oxidizer system operated intermittently between September 1996 and December 1997, when operation was ceased due to lack of funds.

Figure 2. Approximate configurations of gas station USTs and structures on the Texaco property. (figure from Riley 2018 Cleanup Action Work Plan)

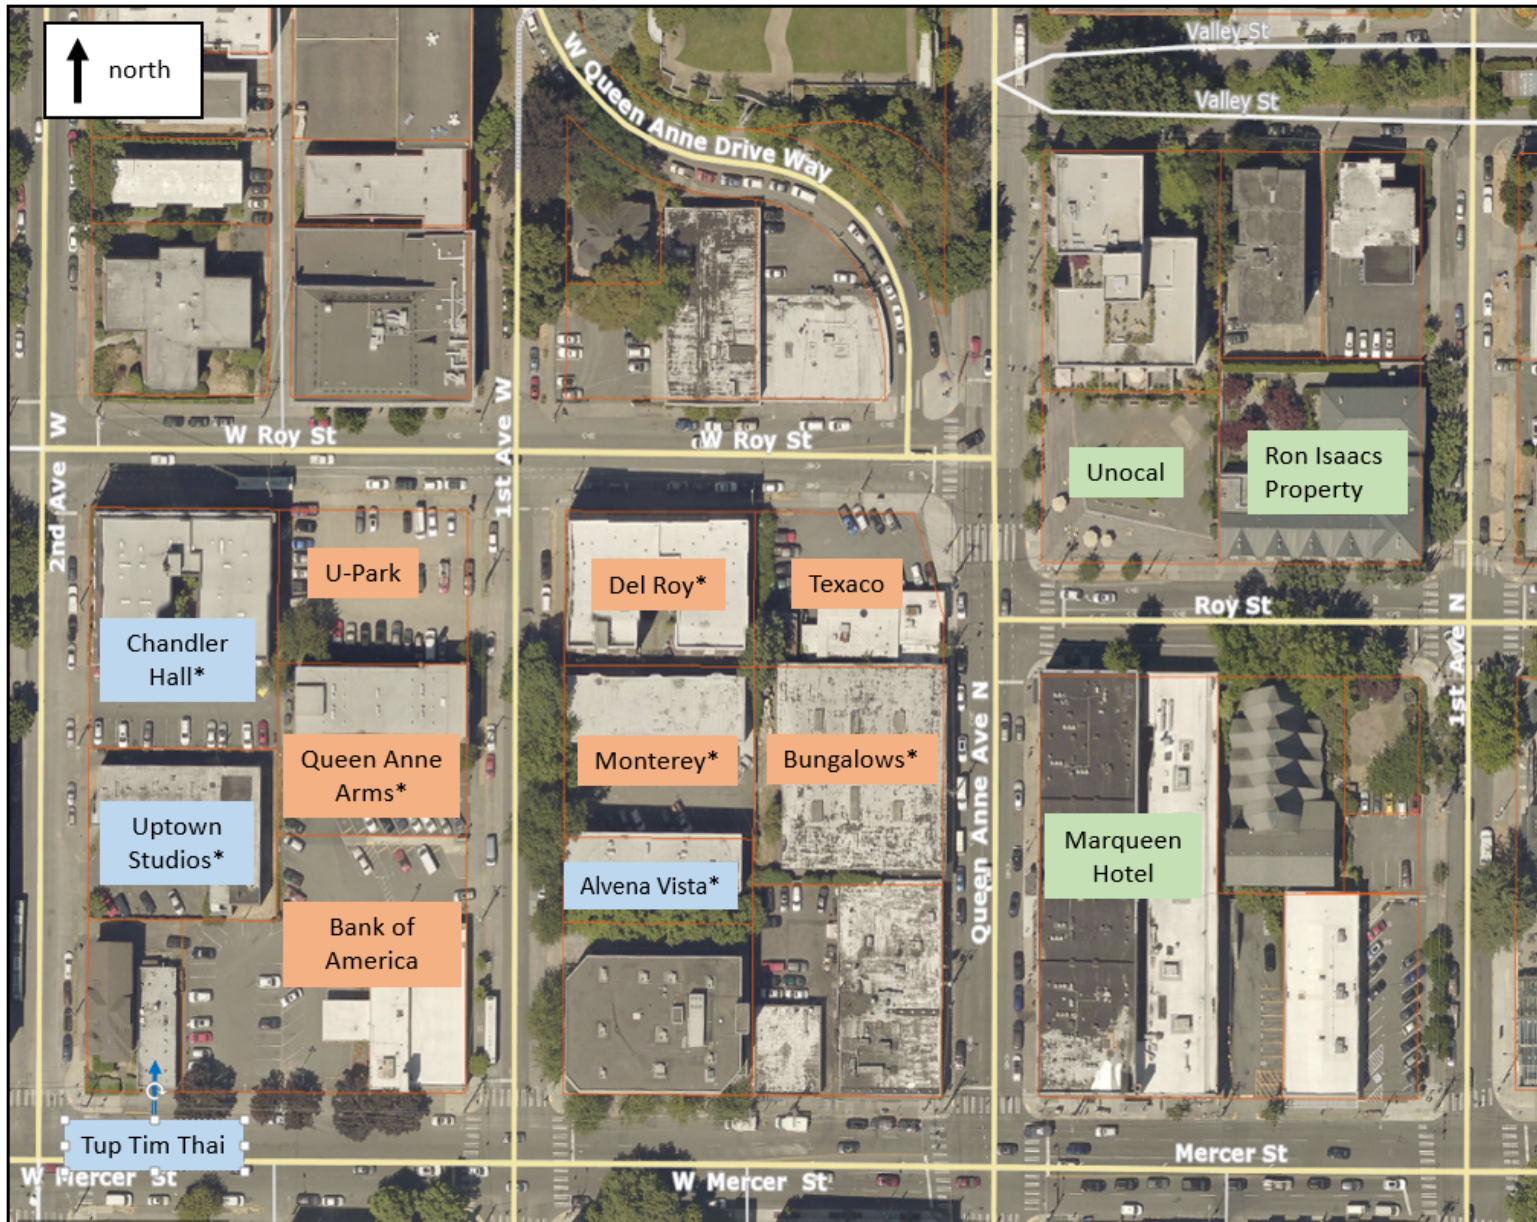
Contamination has migrated off of the source property onto multiple downgradient parcels that are also considered part of the Site. Current occupants, addresses, and parcel numbers for these properties are included in the next section of this report, and are shown on Figure 3. These include parcels used for both multi-family residential and commercial uses. Contamination has also been detected under West Roy Street and Queen Anne Avenue North, the right-of-ways north and east of the source parcel, as well as under 1st Avenue West. Based on historical sampling locations on the Site, it is possible that contamination above cleanup levels extends onto additional parcels that have not been fully characterized, such as parcels 3879900485 (Alvena Vista Apartments), 3879900570 (Tup Tim Thai restaurant), 3879900580 (Uptown Studios Apartments), and 3879900590 (Chandler Hall Apartments).

Figure 3. Location of properties mentioned in the SHA. An asterisk (*) indicates an apartment building. Red lines indicate tax parcel boundaries. Properties within Site boundaries are indicated by orange text boxes. Blue text boxes are used for properties that contamination may have reached that have not been extensively investigated. Green text boxes indicate upgradient Ecology sites and other buildings of note in the area. Some properties have been identified by multiple names, and are identified here by the one used most often in the SHA. (base figure from King County iMap)
