**SITE CHECK
PORTAL WAY STATION
6000 PORTAL WAY
FERNDALE, WASHINGTON**

June 26, 2019

Whatcom Environmental Services
228 East Champion Street #101
Bellingham, Washington 98225

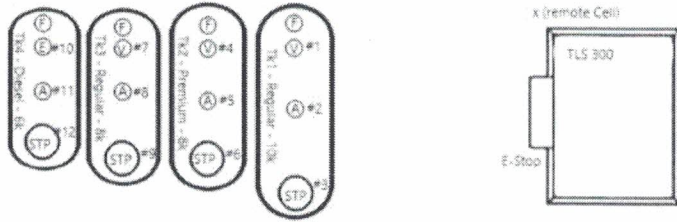
Performed line test on regular tank #3 , Core drilling hit line . line is leaking , shut ball valve down

Comments - Line is leaking , needs repair

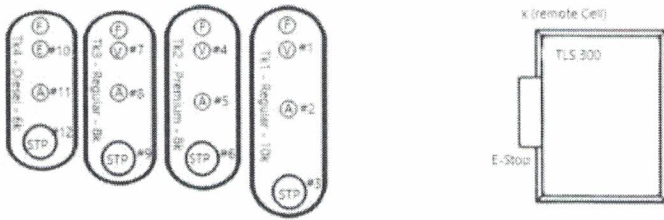
VIII. SITE DIAGRAM -- include description and/or locations of equipment tested --

WA Leak Testing Checklist:
Comments - Line is leaking , needs repair
