**A PHASE I
ENVIRONMENTAL SITE ASSESSMENT**

Rainier Mall
(Former Safeway Store No. 441)
4208 Rainier Avenue S
Seattle, Washington

May 23, 2000

Project No. 4936

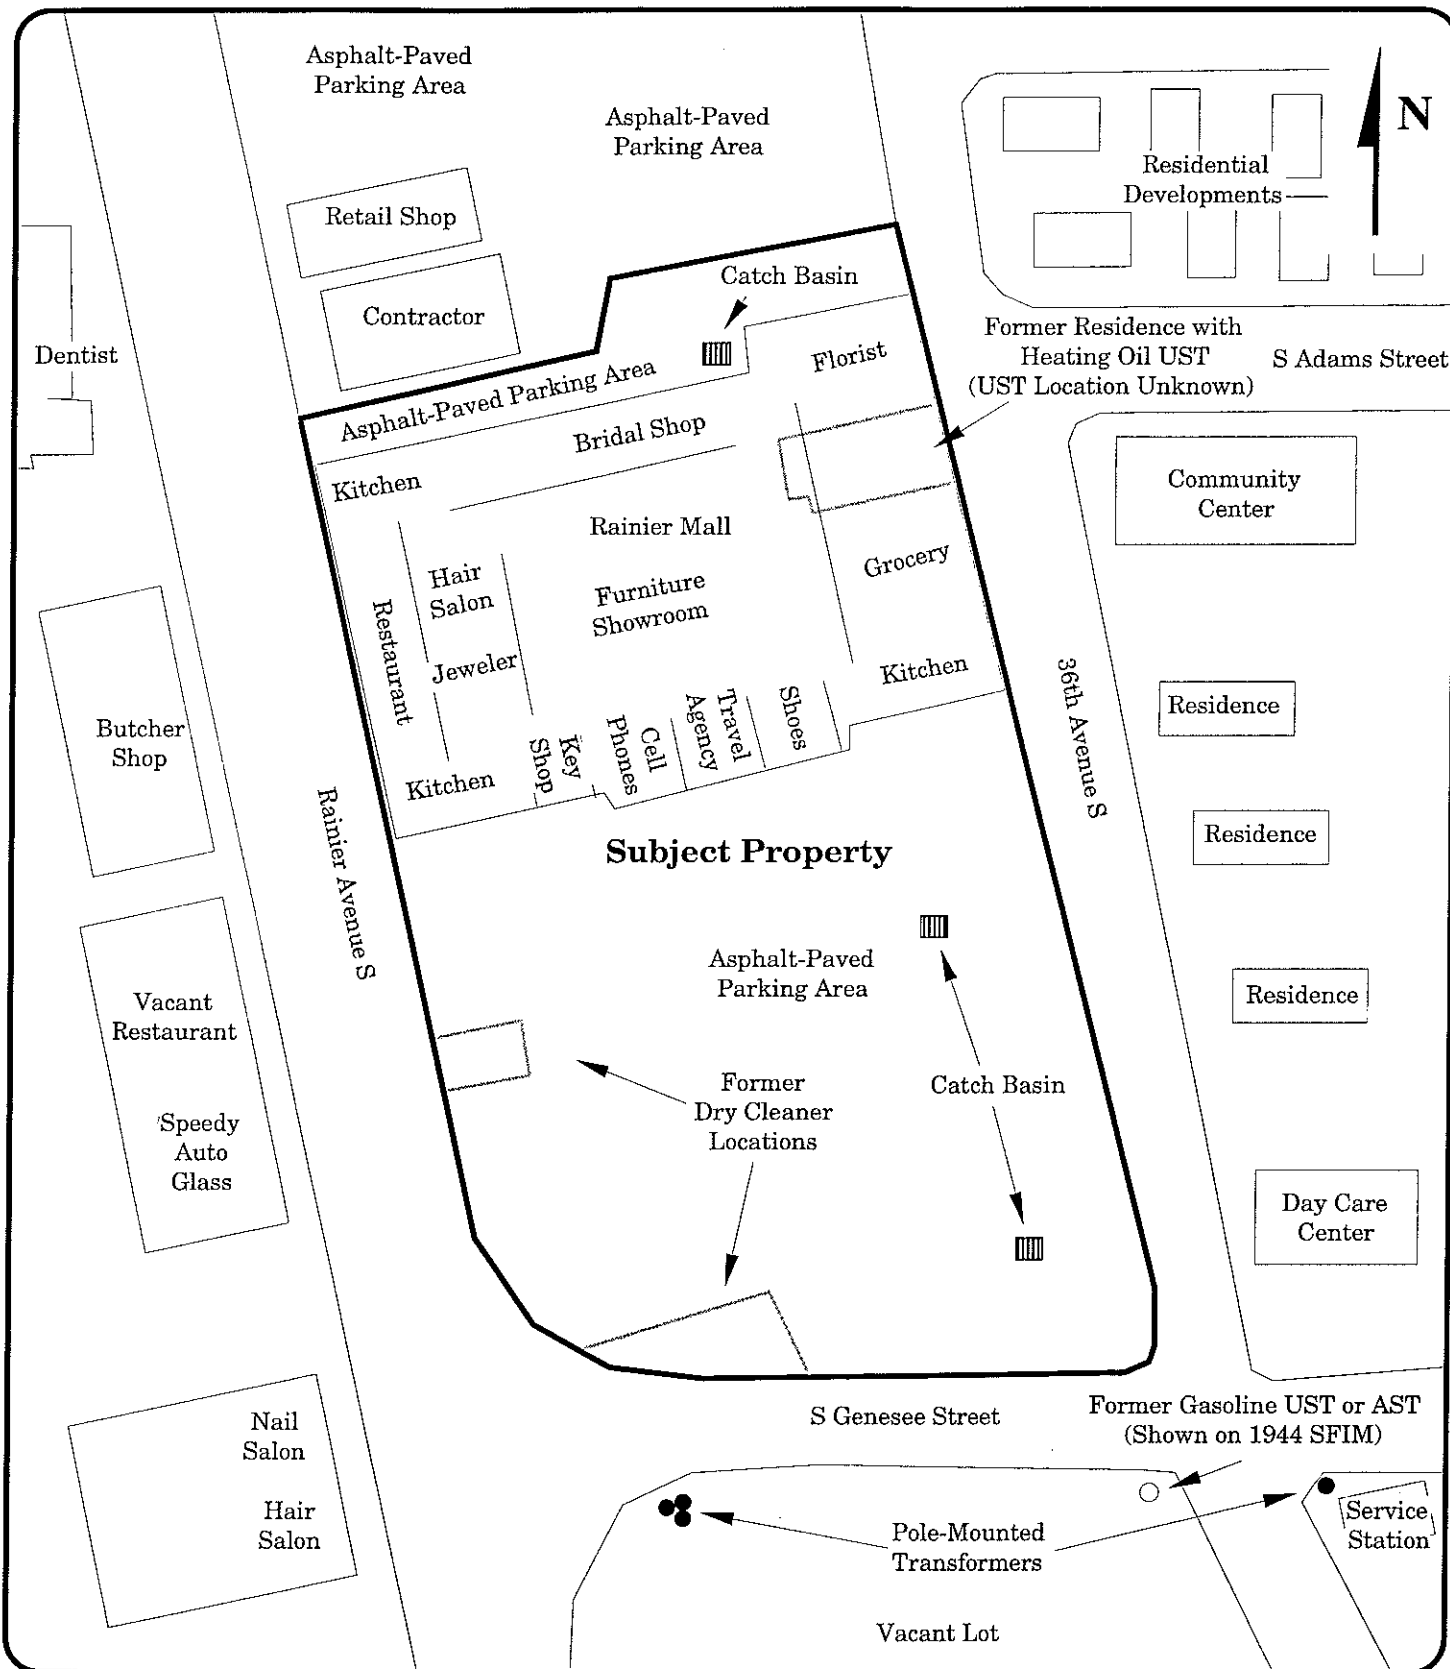
HAI Project No. 4936	Hahn & Associates INCORPORATED	Site and Surrounding Land Use Map	FIGURE
May 2000 Not to Scale	ENVIRONMENTAL MANAGEMENT 434 NW SIXTH AVENUE, SUITE 203 PORTLAND, OREGON 97209 503/796-0717	Rainier Mall (Former Safeway Store 441) 4208 Rainier Avenue S Seattle, Washington	2

The 1944 SFIM indicated that the subject property and surrounding properties did not change significantly, with the exception of the addition of a residence and retail store on the southern portion of the subject property, and the presence of a gasoline UST located to the south of the property, beneath the sidewalk on the south side of S Genesee Street (Figure 2).
