LEVEL 1 ENVIRONMENTAL SITE ASSESSMENT

Subject Property:
2119 Mildred St. West
Tacoma, Washington

May 7, 1999

Creative Environmental Technologies, Inc.

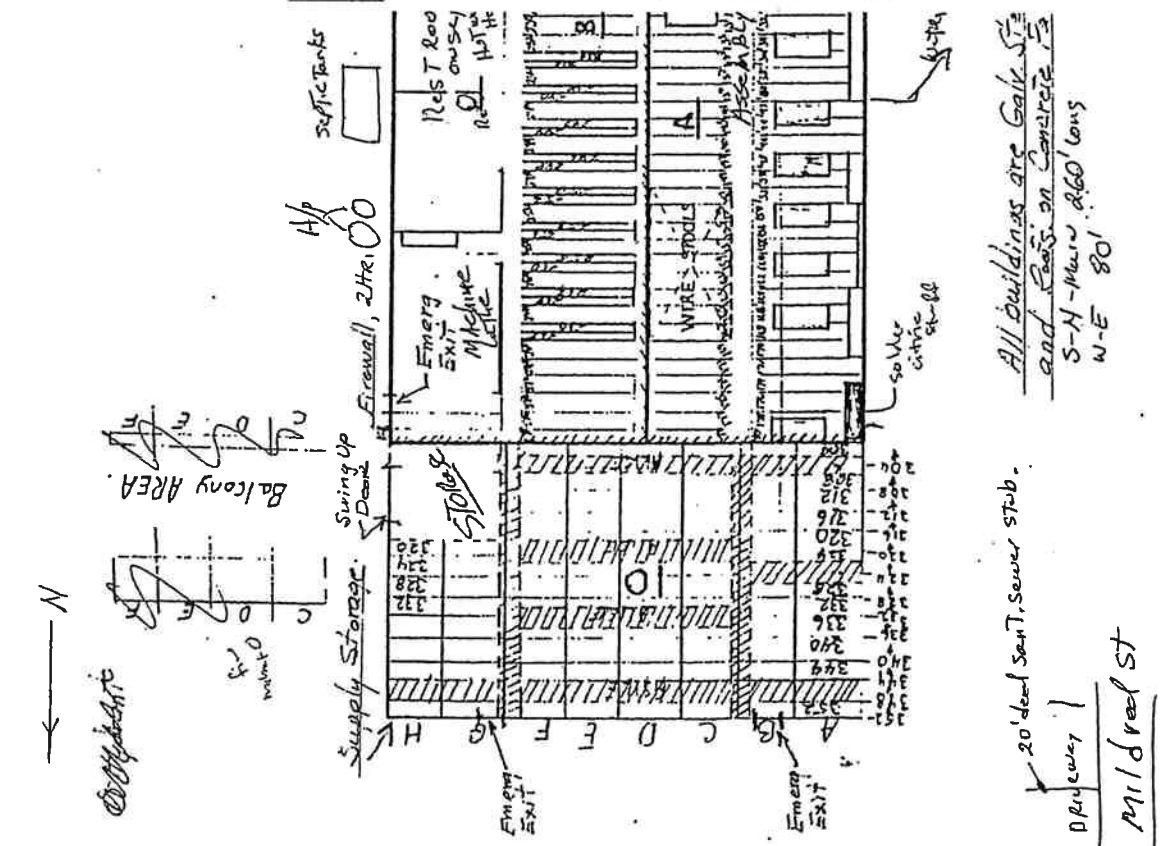
All buildings are Galv. St. and Rests on Concrete. S-N - Main 260' long W-E 80'

20' deep Sanit. Sewer stub. Mild steel

- 1 - 5/8" Copper Line - under Eves - carries clean chevron 410 DSB - c
- 2 Underground - water heater 60 gal. Glass lined - used as catch to
- 3 Hydraulic's Room - Dexron II Fluid used - Floor cleaned w/che
- 4 w/s lube oil for cutting - Recycled at machines or portable pen
