# 2008 Skykomish Remediation – As-Built Completion Report

## Former Maintenance and Fueling Facility

AECOM, Inc.  
August 2009  
**Document No.: 01140-222-0500**

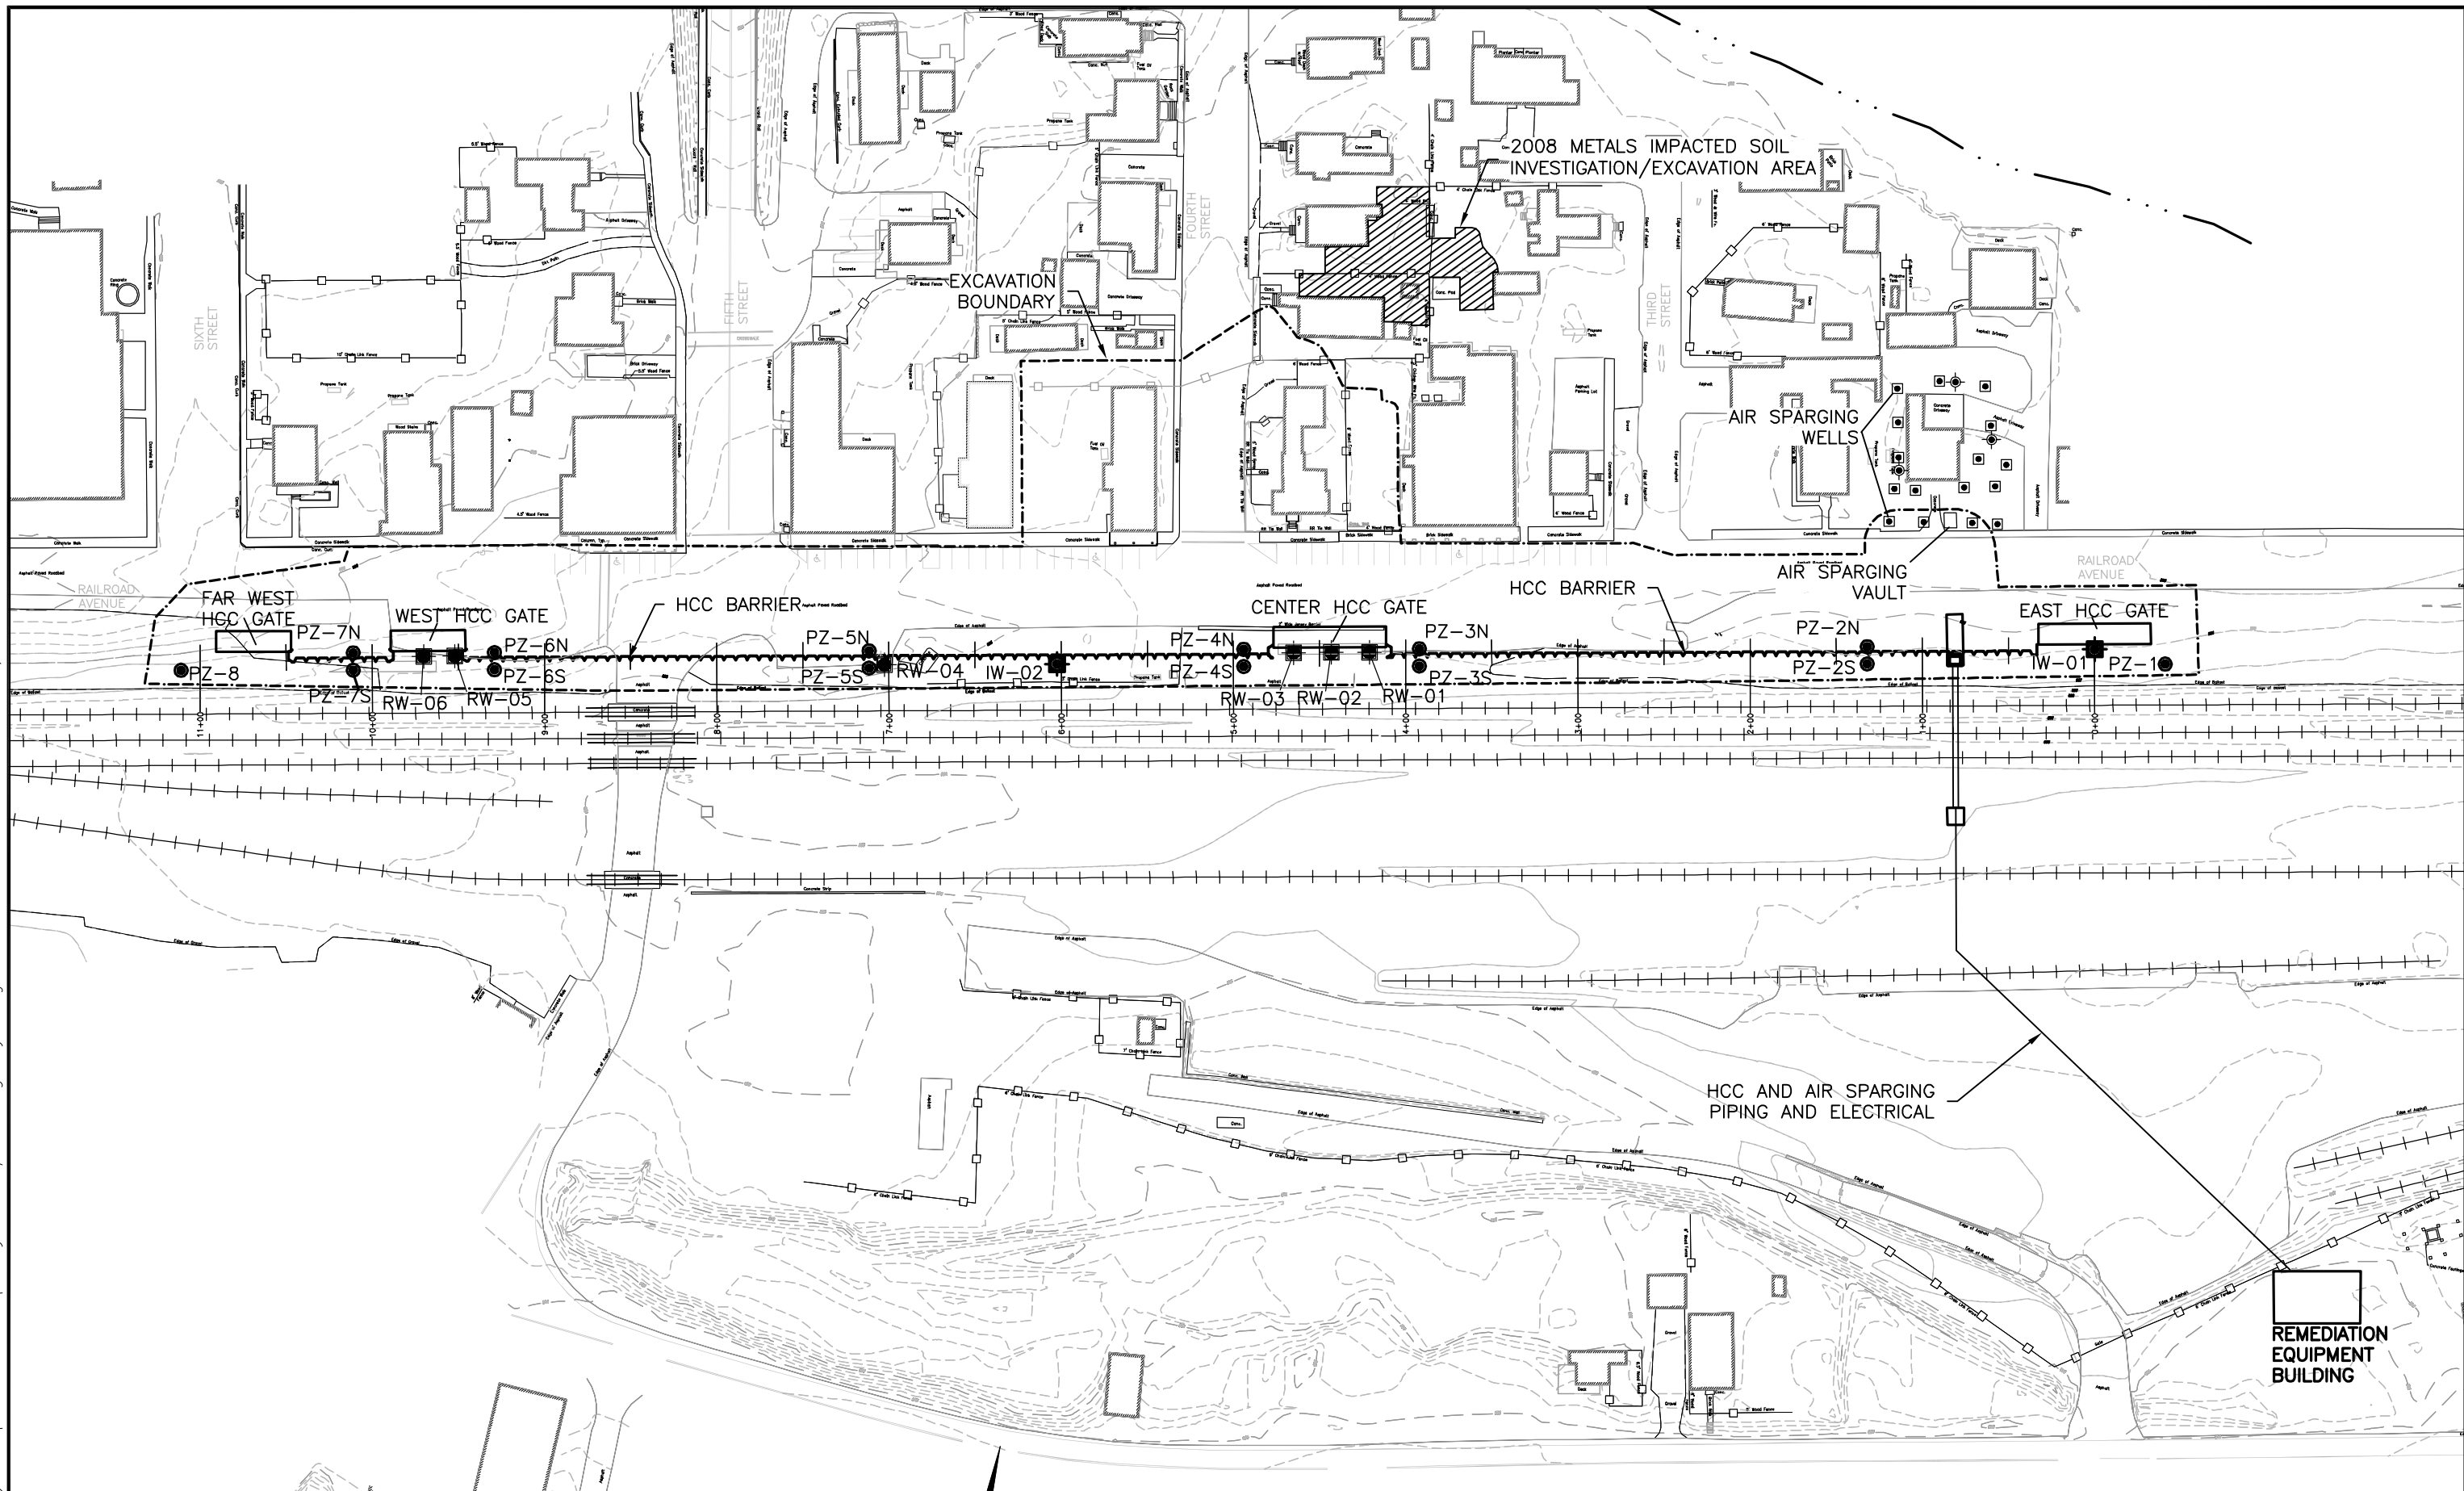
HYDRAULIC CONTROL AND  
CONTAINMENT AND AIR  
SPARGING COMPONENTS  
FIGURE 5-1

The HCC system consists of three main parts: 1) the HCC barrier; 2) recovery and injection wells to collect and manage fluids; and 3) a water treatment system located in the remediation building on BNSF property. The locations of the HCC system components are shown on Figure 5-1. The 1,123-foot long HCC barrier, installed

Construction of the HCC barrier required the driving of 309 temporary and permanent sheetpiles along the HCC alignment: those without driving tips and those with driving tips respectively. The sheetpiles are numbered from 1 to 309 from west to east, with each sheetpile being approximately 3.77 feet wide. Table 5-3 summarizes the HCC pile tip elevations and stationing. The stationing on Figure 5-1 shows the stationing for the sheetpile.

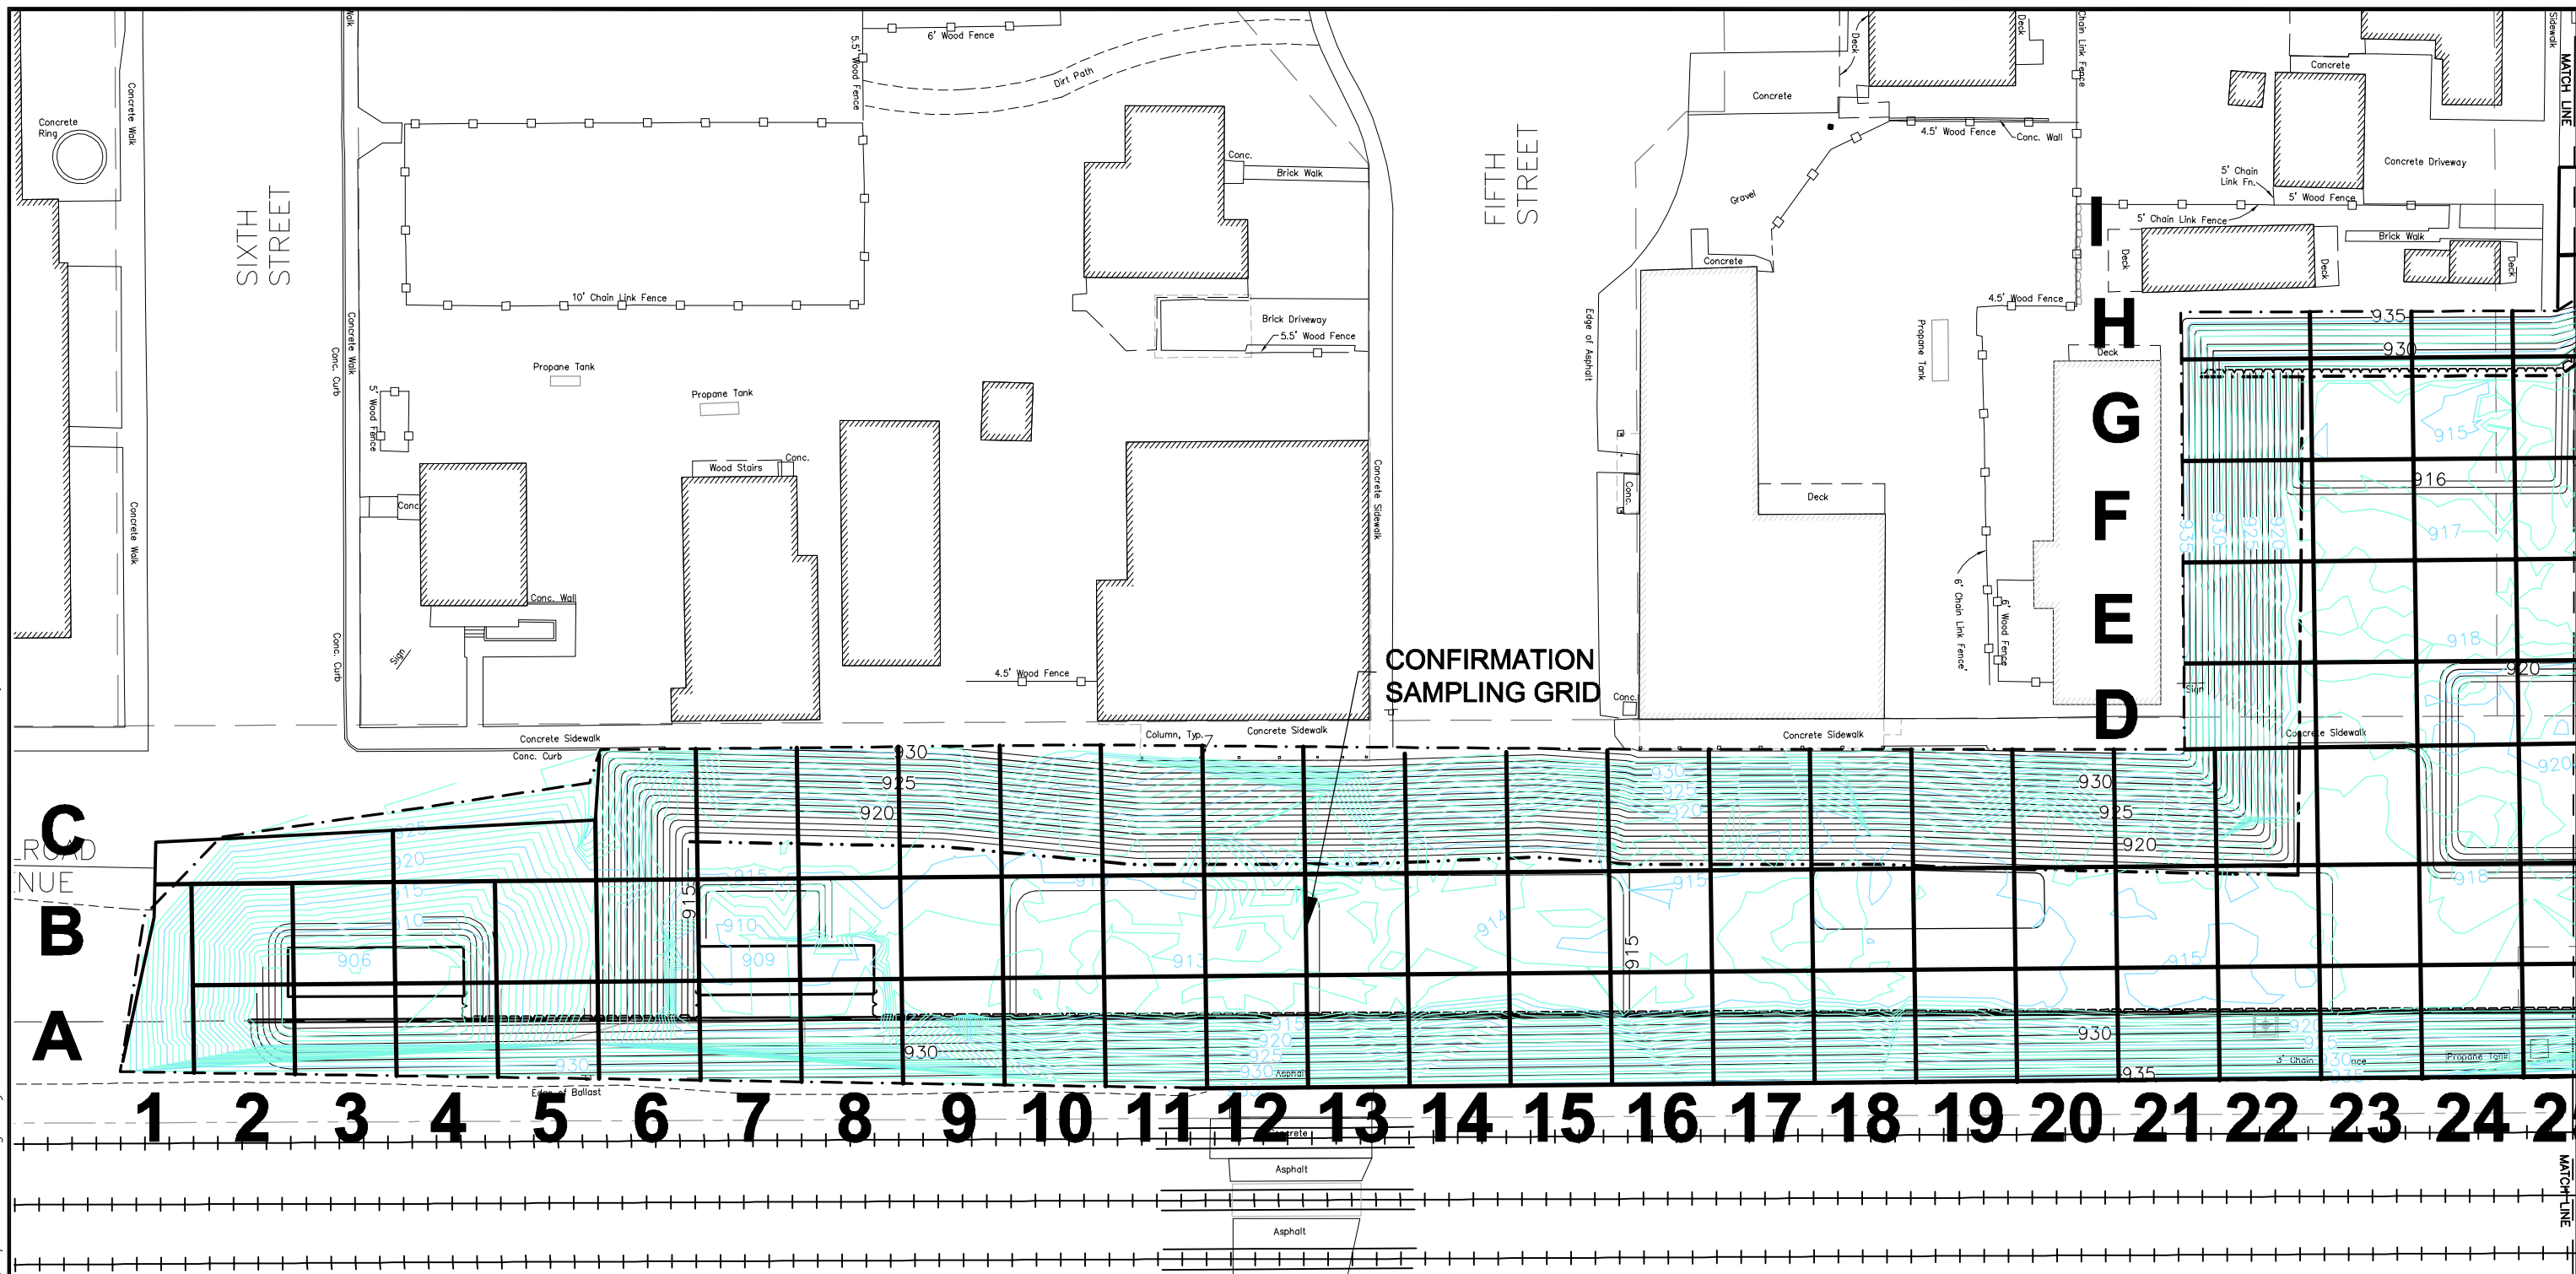
<b>BNSF RAILWAY - SKYKOMISH, WA.</b> 2008 SKYKOMISH REMEDIATION 01140-222-0500		<b>FINAL VS. PLANNED EXCAVATION CONTOURS WEST</b>
DATE: 3/20/09	DRWN: E.M./SEA	<b>FIGURE 5-2</b>

MSE walls were constructed from S-01 to S-05 and from S-05 to S-12, as shown on drawing C-202 (Rev. 2) of the CPS. A typical cross-section of the MSE wall is also shown on this plan sheet. In addition to the previously described MSE walls, another MSE wall was constructed west of the Cascadia Inn after completing the additional excavation in that area to remove impacted soils beneath their septic drainfield. The locations of all the MSE walls are shown on Figures 5-2 and 5-3.
