LOWER DISPOSAL AREA – INTERCEPTOR TRENCH PROJECT

CONSTRUCTION SUMMARY REPORT

RAVENSDALE SITE

January 8, 2014

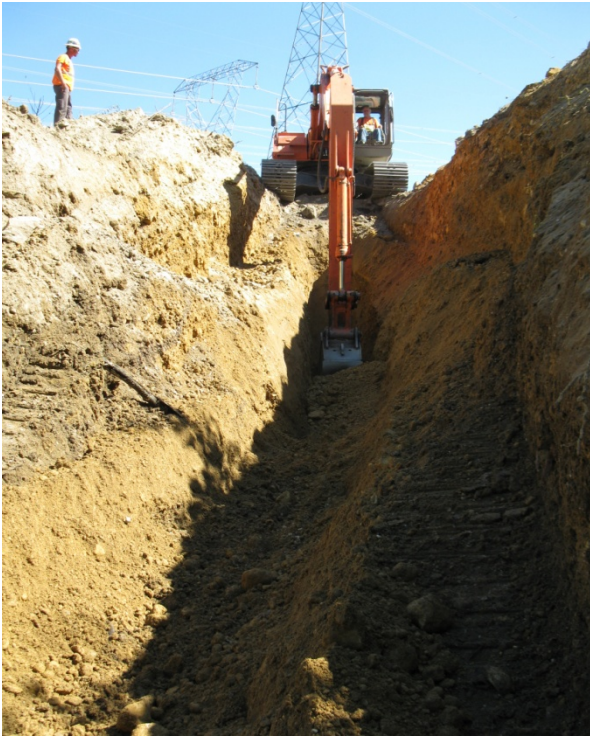
Material removed from trenching today down to 721' was primarily landfill-fill/debris most likely dumped over edge when placed due to lack of consolidation and frequent caving of trench during trench excavation today. Soil is described as a brownish-orange, silty-sand with gravel and cobbles, compact to loose, damp. First 2' below road surface quarry spalls 4" to 6" in diameter.

Trench excavation through plug zone looking north-east.

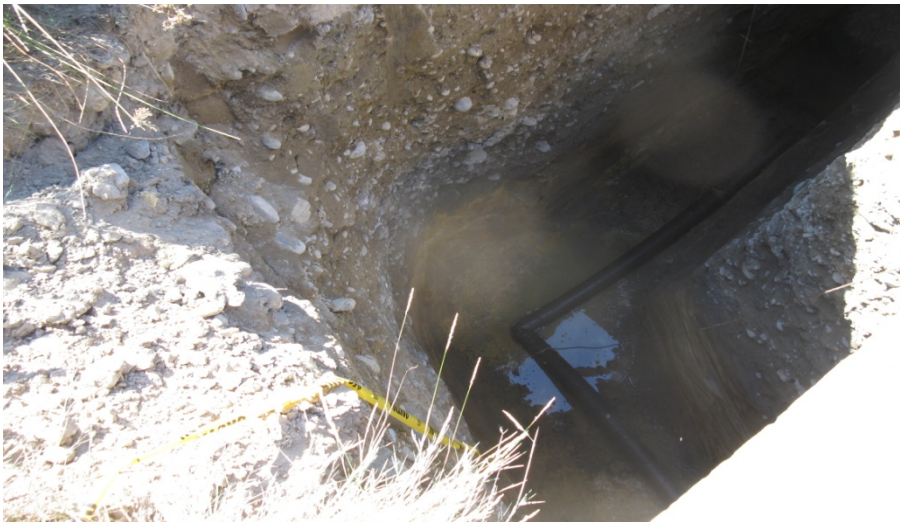
Water in trench near piezometer B-11.

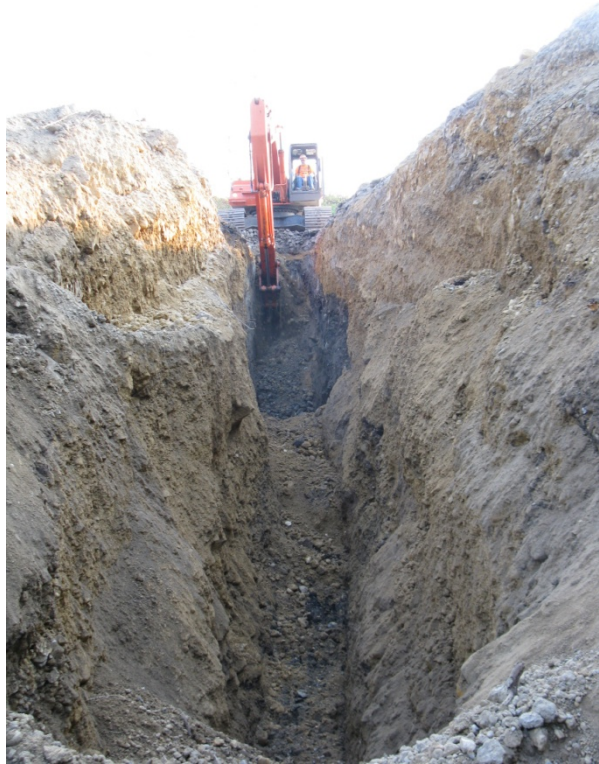
Trench looking north-east from discharge pipe outlet before collapse.

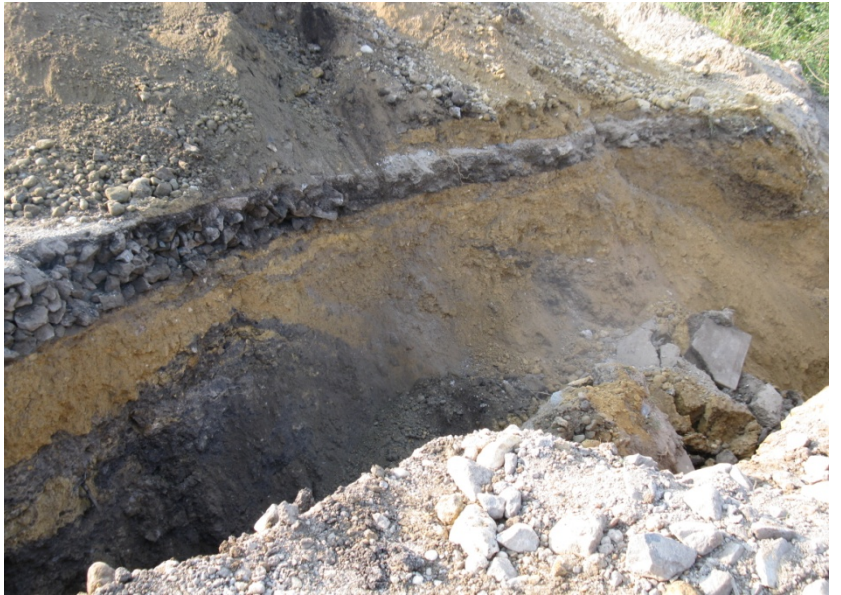
Area of trench collapse on south side of trench.

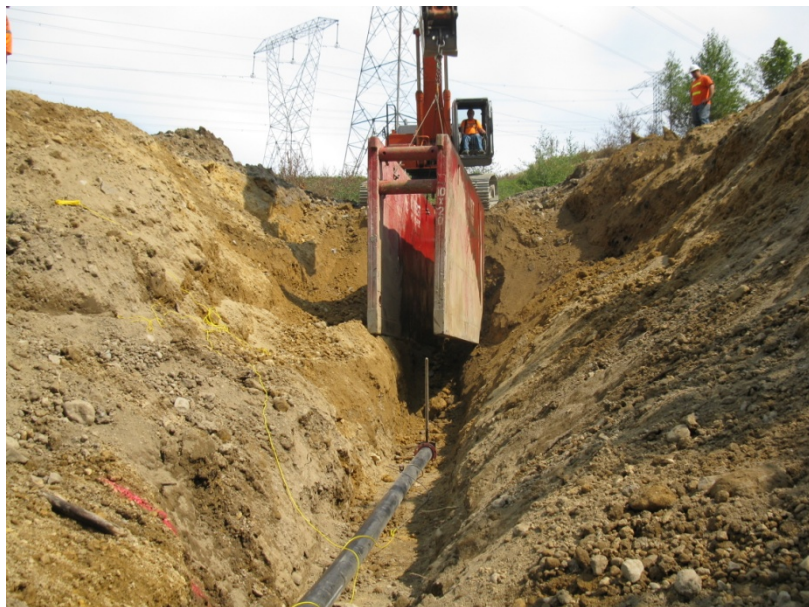
Large benched excavation looking north-east after collapse.

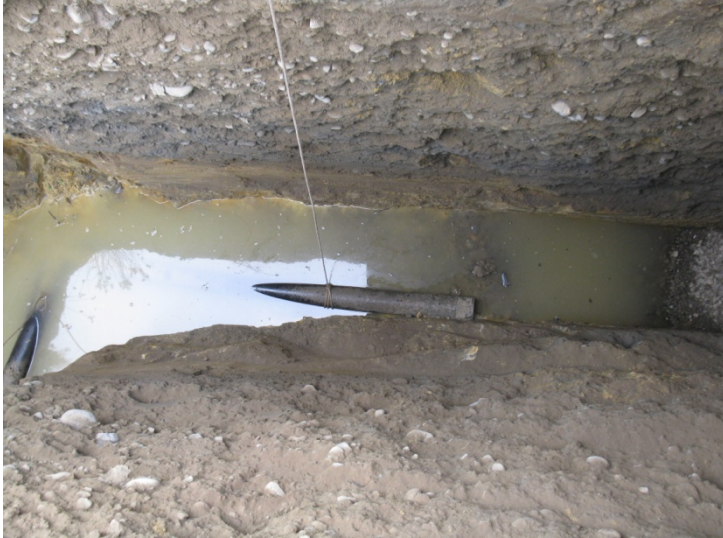
*amount of water observed in interceptor trench today in the corner of trench near piezometer B-11 has increased slightly. Water appears to have migrated through orange sandstone at bottom of trench. Water approx. 6"-7" deep and puddle was 3' x 5'

Water in trench today near piezometer B-11.

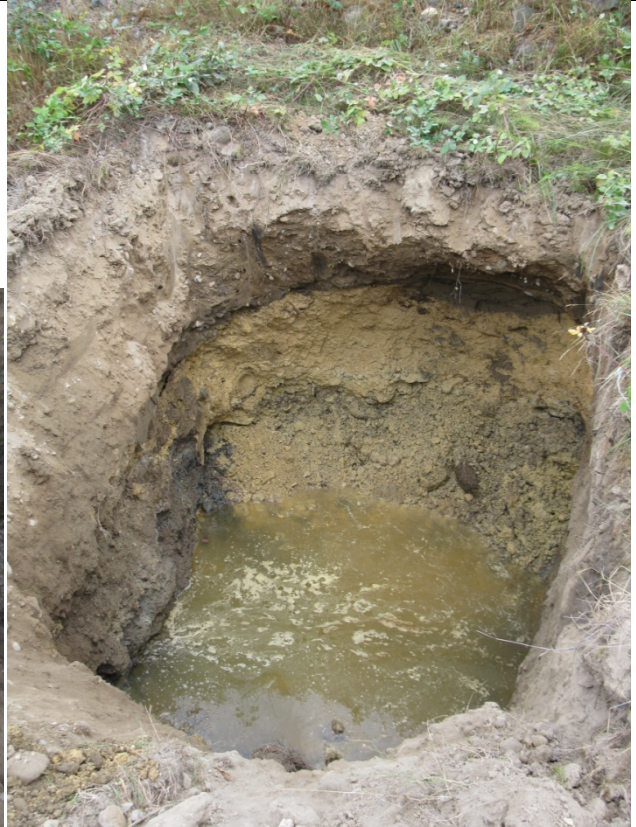
Water that infiltrated into the bottom of test pit #2 was tested for pH level to determine if it had been impacted by CKD area to the north. A Thermo Scientific Orion Star A211 pH meter was used to test water and was calibrated prior to use. Water level = 6' 10" from ground surface. Bottom of test pit measured at -7' 4" b.g.s.

Gravel lens and water in Test Pit #2 tested today.

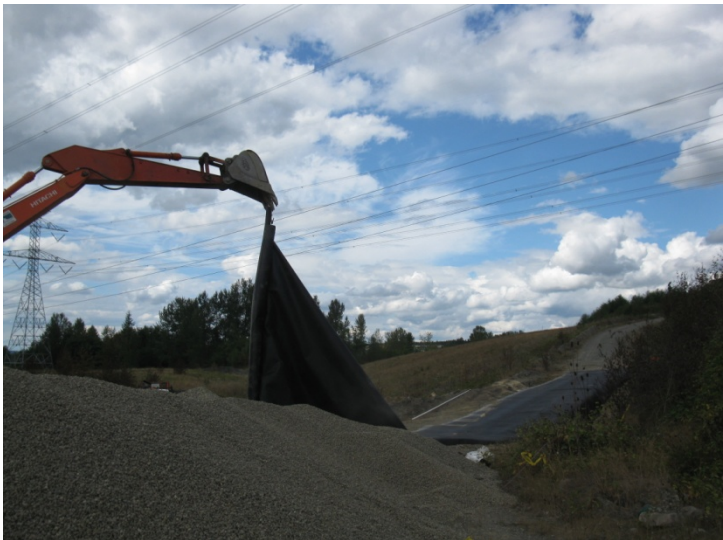
2:50pm contractor stages textured 80 mil LLDPE geomembrane at top of trench near clean out. Several holes were observed in liner, they appeared to be done at factory or warehouse with forklift. Holes were marked with spray paint and due to orientation of roll starting at shallow end of trench holes will be cut off roll and not used in construction.

Geomembrane staging along trench.

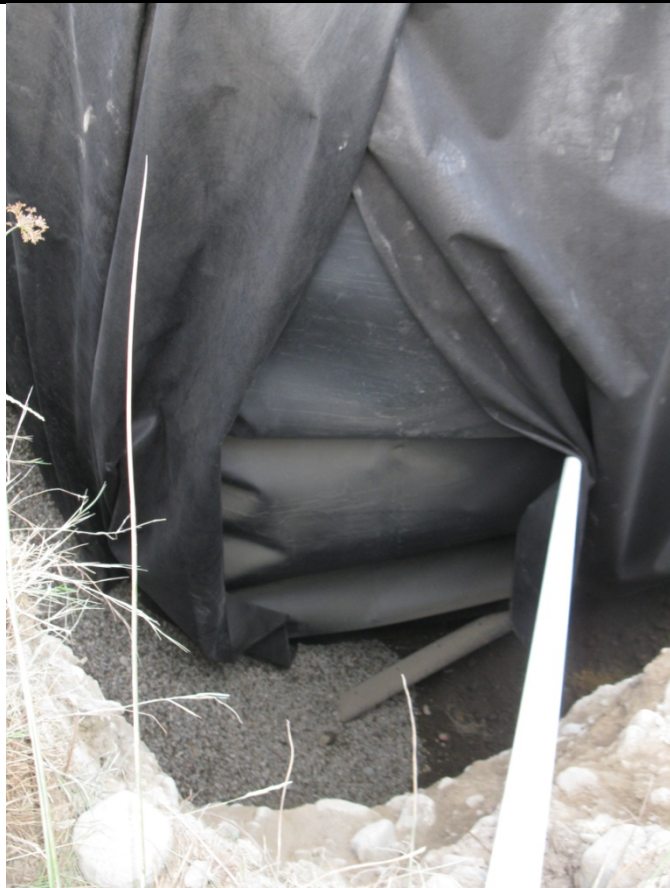
Geomembrane at corner of trench.

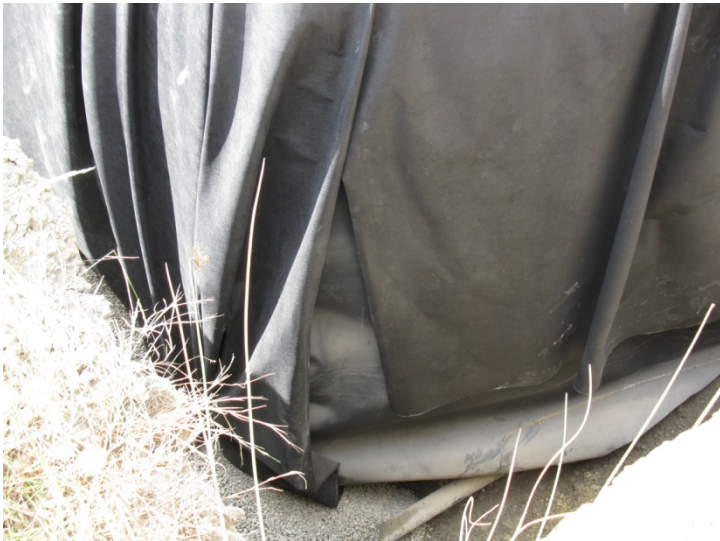
Geomembrane at corner of interceptor trench.

2:10pm contractor moves over to corner of trench near piezometer B-11 to attempt to pull up on liner with two excavators in tandem to remove/reduce wrinkles that were observed on 8/25/13. Once excavators were positioned correctly, majority of wrinkles on corner of trench were removed. Larger wrinkle at very bottom of trench could not be pulled out and will have to be cut out. (wrinkle most likely formed from upward slope of trench and some excess liner) Mitch stated that he would need an additional aluminum shoring box delivered to site to enter trench in this deep location near B-11.

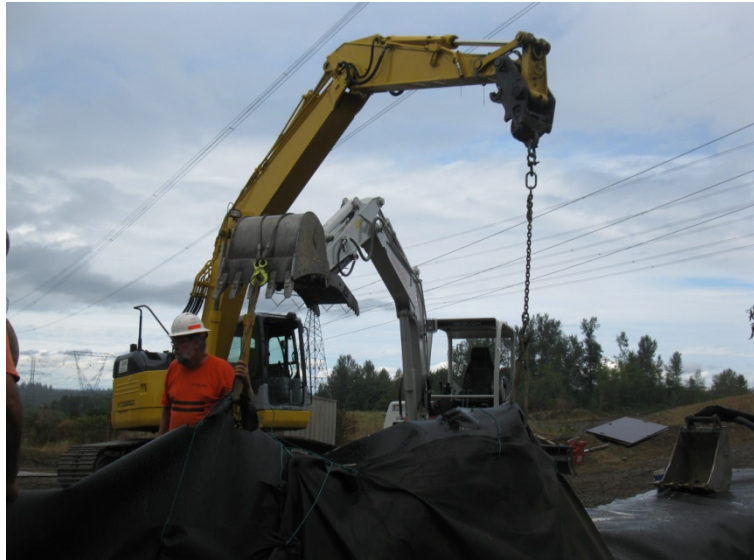
Two excavators pulling wrinkles from geomembrane.

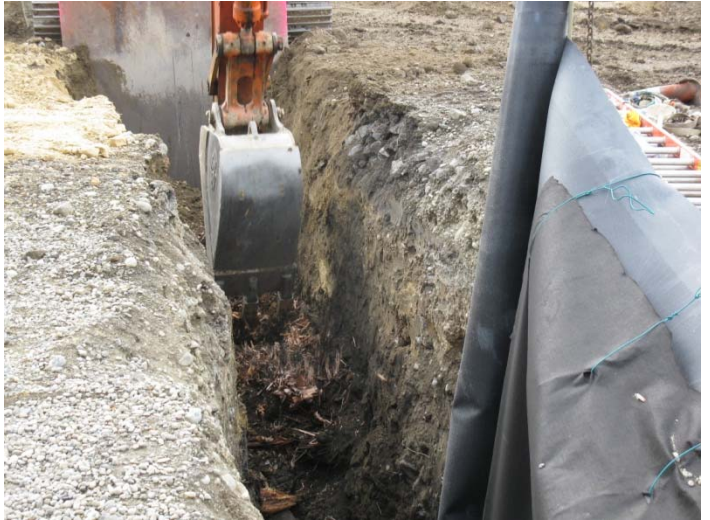
2:30 haul road re-route completed. Contractor began excavating interceptor trench working south-west towards plug zone in the same area that was collapsing on Saturday 8/24/13. Soil removed a mixture of light and dark colored fills/mine spoils and trench walls were collapsing as they did previously in this area. Large tree stump encountered -8' b.g.s., 20' east of plug zone. Operator having difficulties removing large stump, slowly chipping away at it with large excavator.

Large stump encountered in trench excavation today.

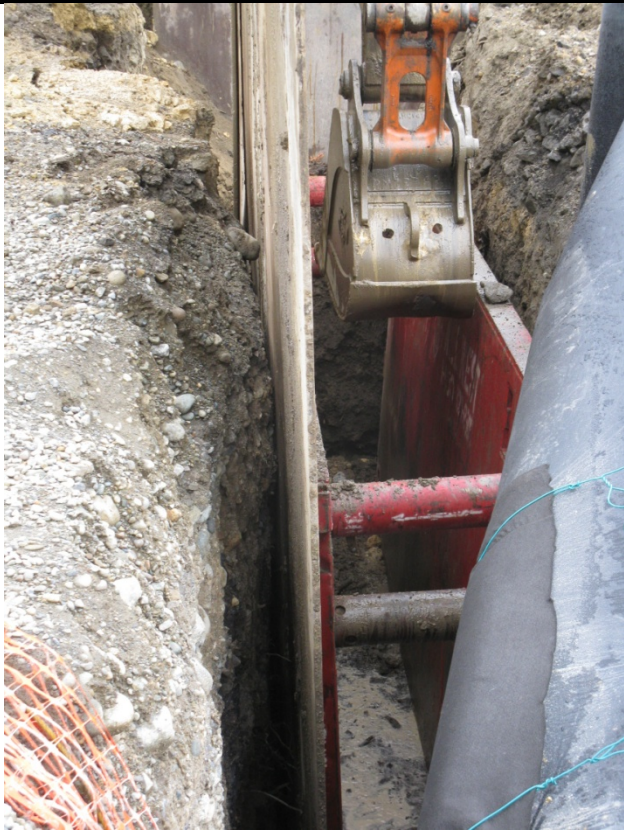
8:50am stump removed from trench, contractor begins installing trench box and supplemental steel sheeting to finish last remaining section of trench/perforated pipe. Water accumulation observed in bottom of trench, possible surface run off from rain today and last week. Contractor takes water sample so pH can be read to determine origin. A Thermo Scientific Orion Star A211 pH meter was used to test pH of trench water and was calibrated prior to usage.

Water in bottom of trench.

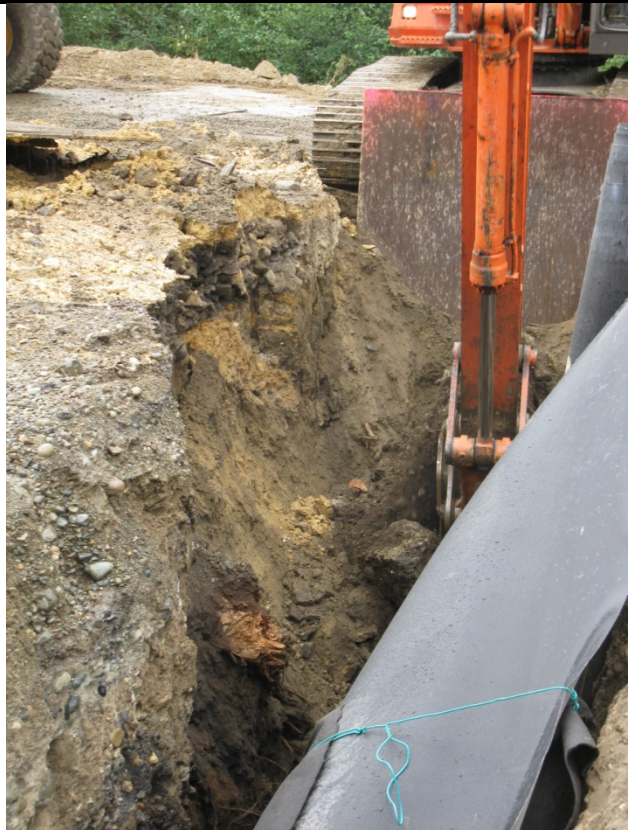
Trench caving on south wall.

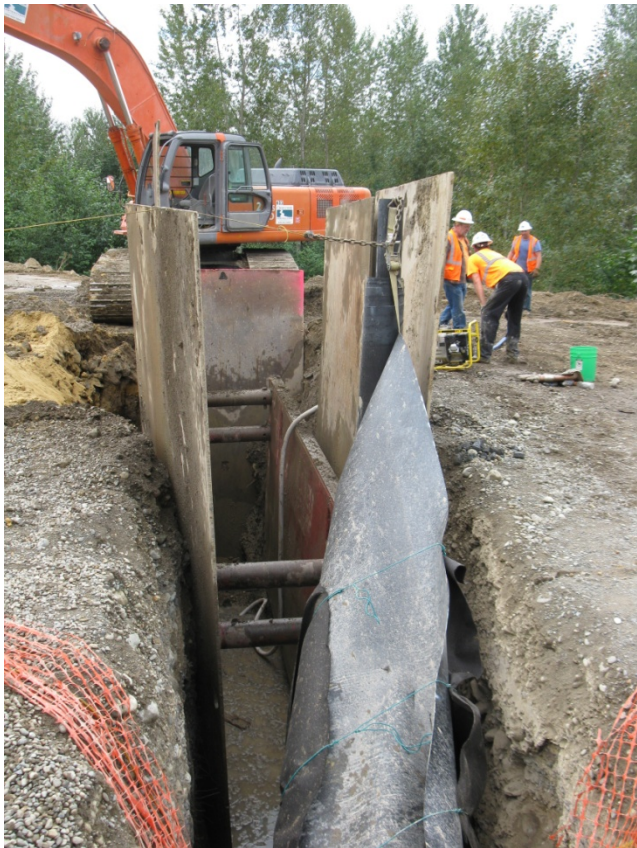
Shoring system in place.

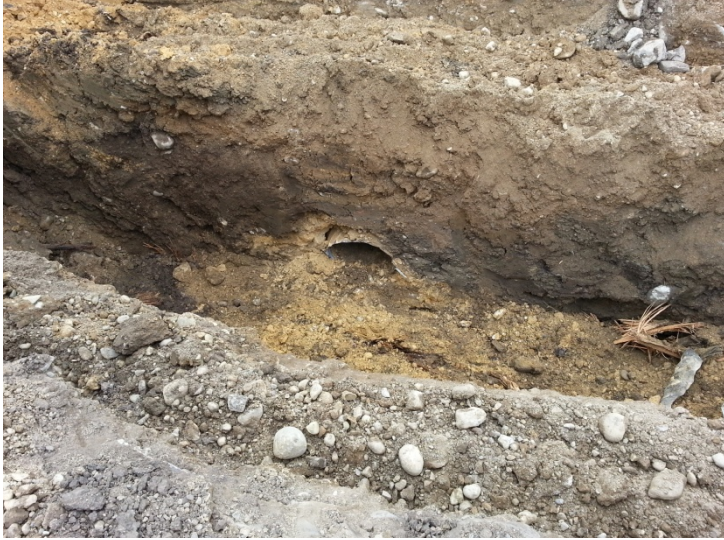
Culvert encountered in test pit 2 drainage trench.

Offset for 14" steel corrugated storm pipe that was hit when digging t.p. 2 drainage trench is 59' south piezometer P-9. Frank Shuri was called about culvert, since pipe was 1/3 to 1/2 full of hardened sediment/rocks and appeared not have seen any water in some time, Frank's instructions were to backfill trench without repairing or capping culvert.

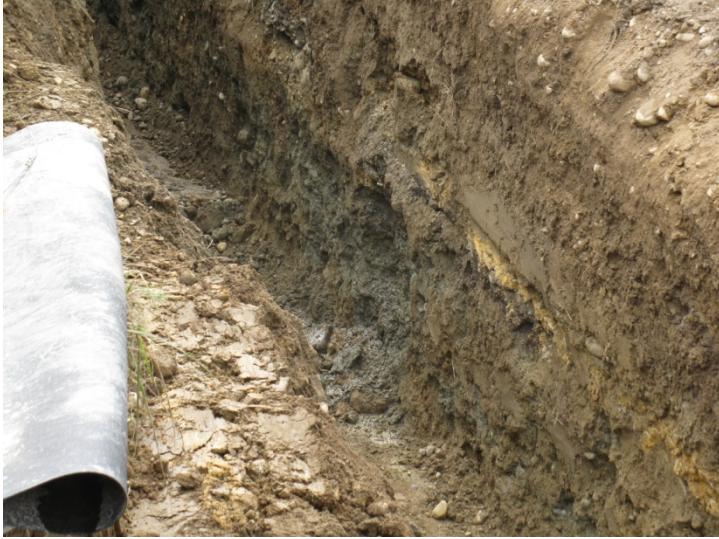
Water producing gravel seep in test pit 2 trench. (center of photo)

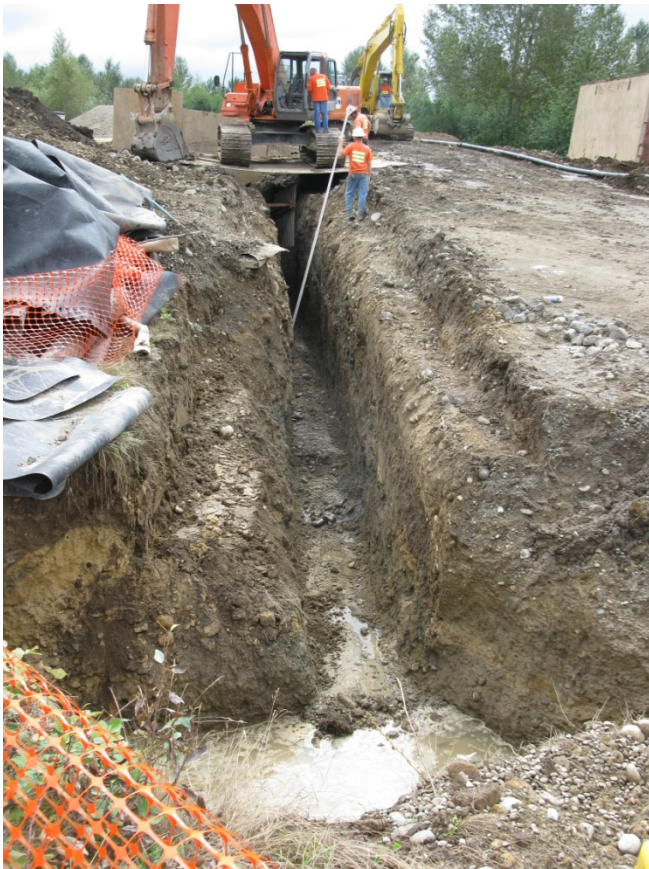
Test pit 2 drainage trench. Seep is large cobbles on trench bottom. (center)

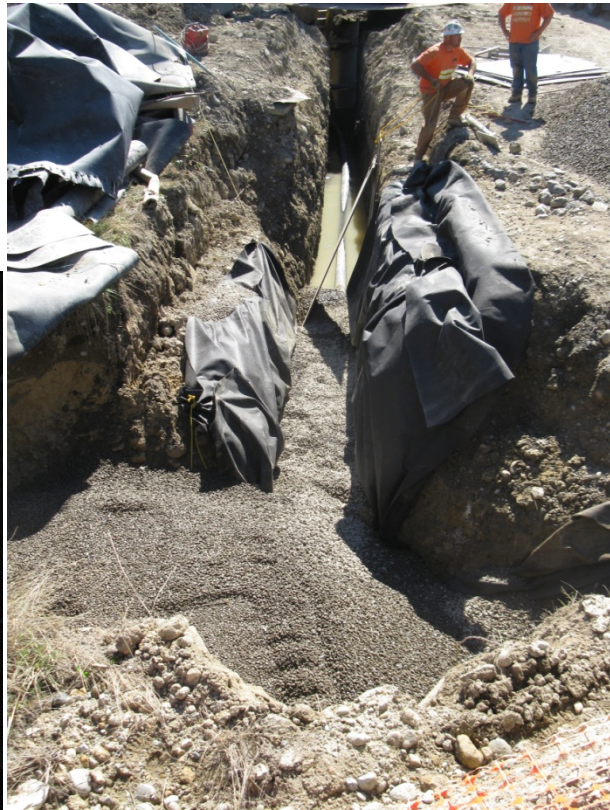
Drainage rock in test pit #2 and trench seep.

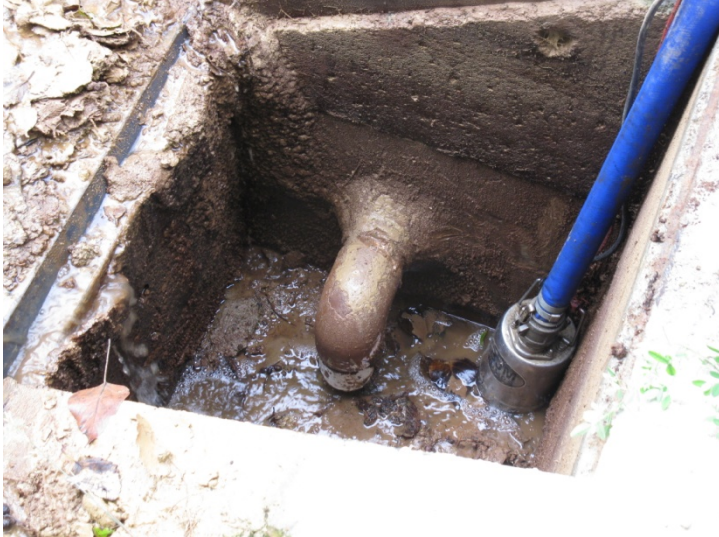
Sediment level in plugged catch basin on travertine bench.

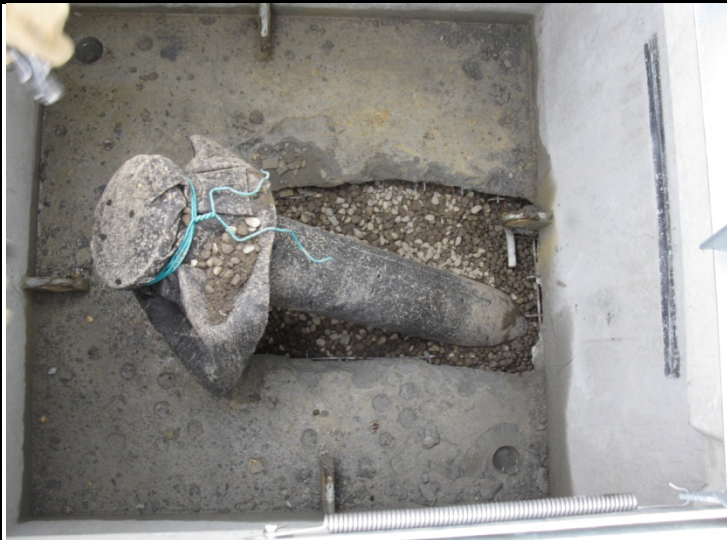
6" pipe penetration into concrete clean out vault.

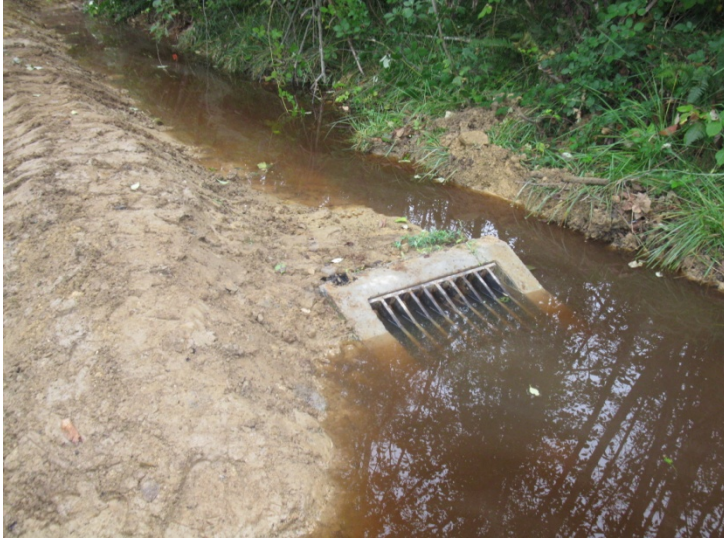
Travertine bench catch basin plugged.

11:40am begin constructing berm near plugged catch basin. Soil was mined from road shoulder south of catch basin near travertine bench and was a moist, orange-brown sandy-silty with gravel. Soil was placed with Takeuchi mini-excavator and was bucket tapped in place.

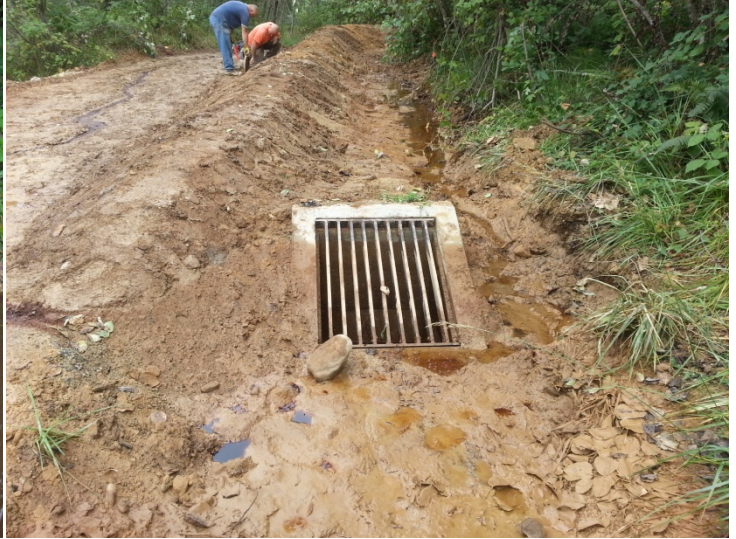
Travertine bench catch basin unplugged after work.

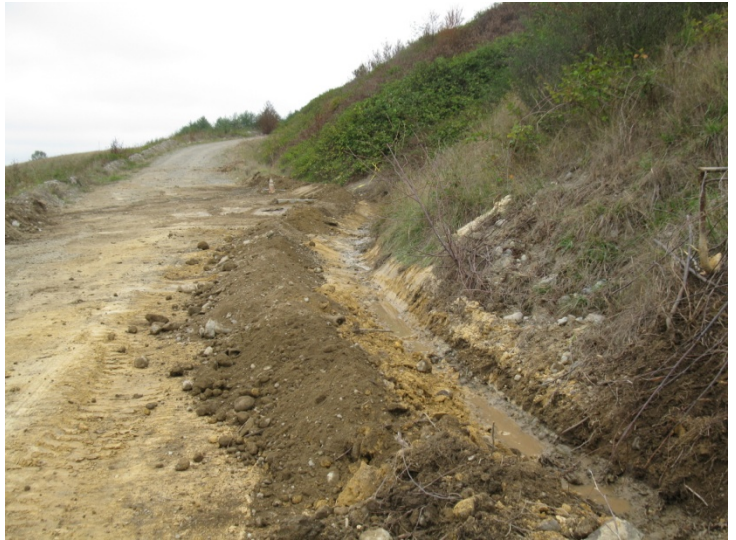
Ditch/berm restoration along upper haul road.

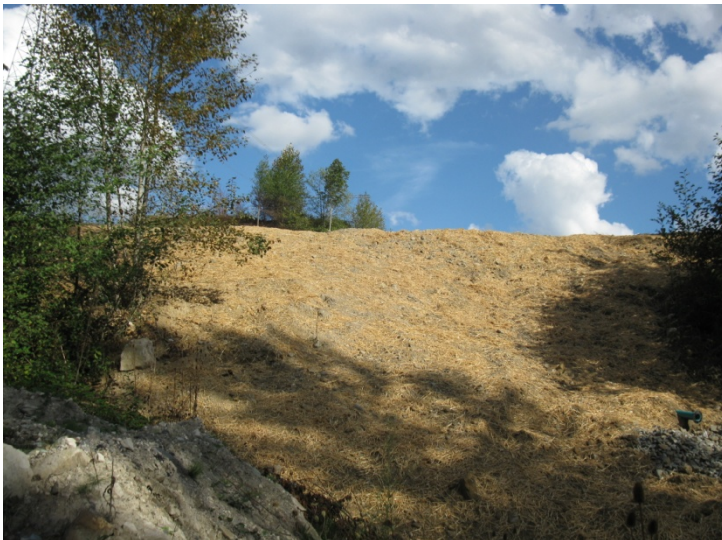
Outfall slope grass seeded and mulched.

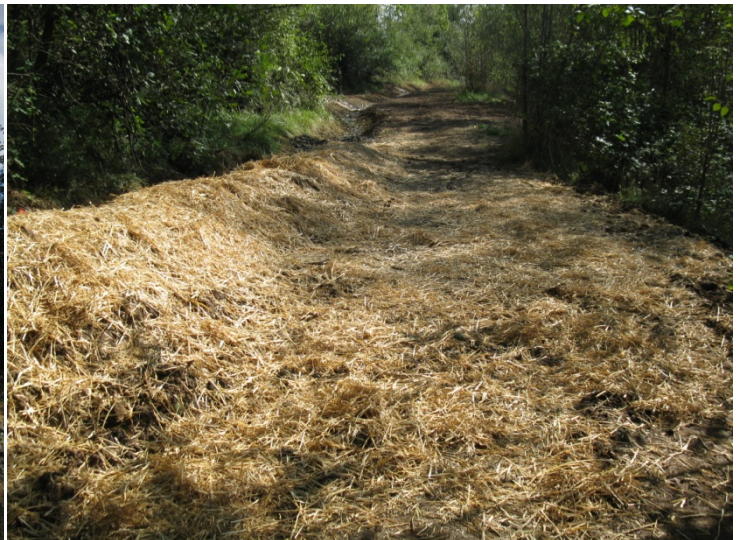
Travertine bench berm and road grass seeded and mulched.
