STATE OF WASHINGTON
DEPARTMENT OF ECOLOGY

Re: Opinion pursuant to WAC 173-340-515(5) on Remedial Action for the following Hazardous Waste Site:

- **Site Name:** Rainier Mall
- **Site Address:** 4208 Rainier Avenue South, Seattle, WA 98118
- **Facility/Site No.:** 88987973
- **Cleanup Site ID:** 4187
- **VCP Project No.:** NW3261

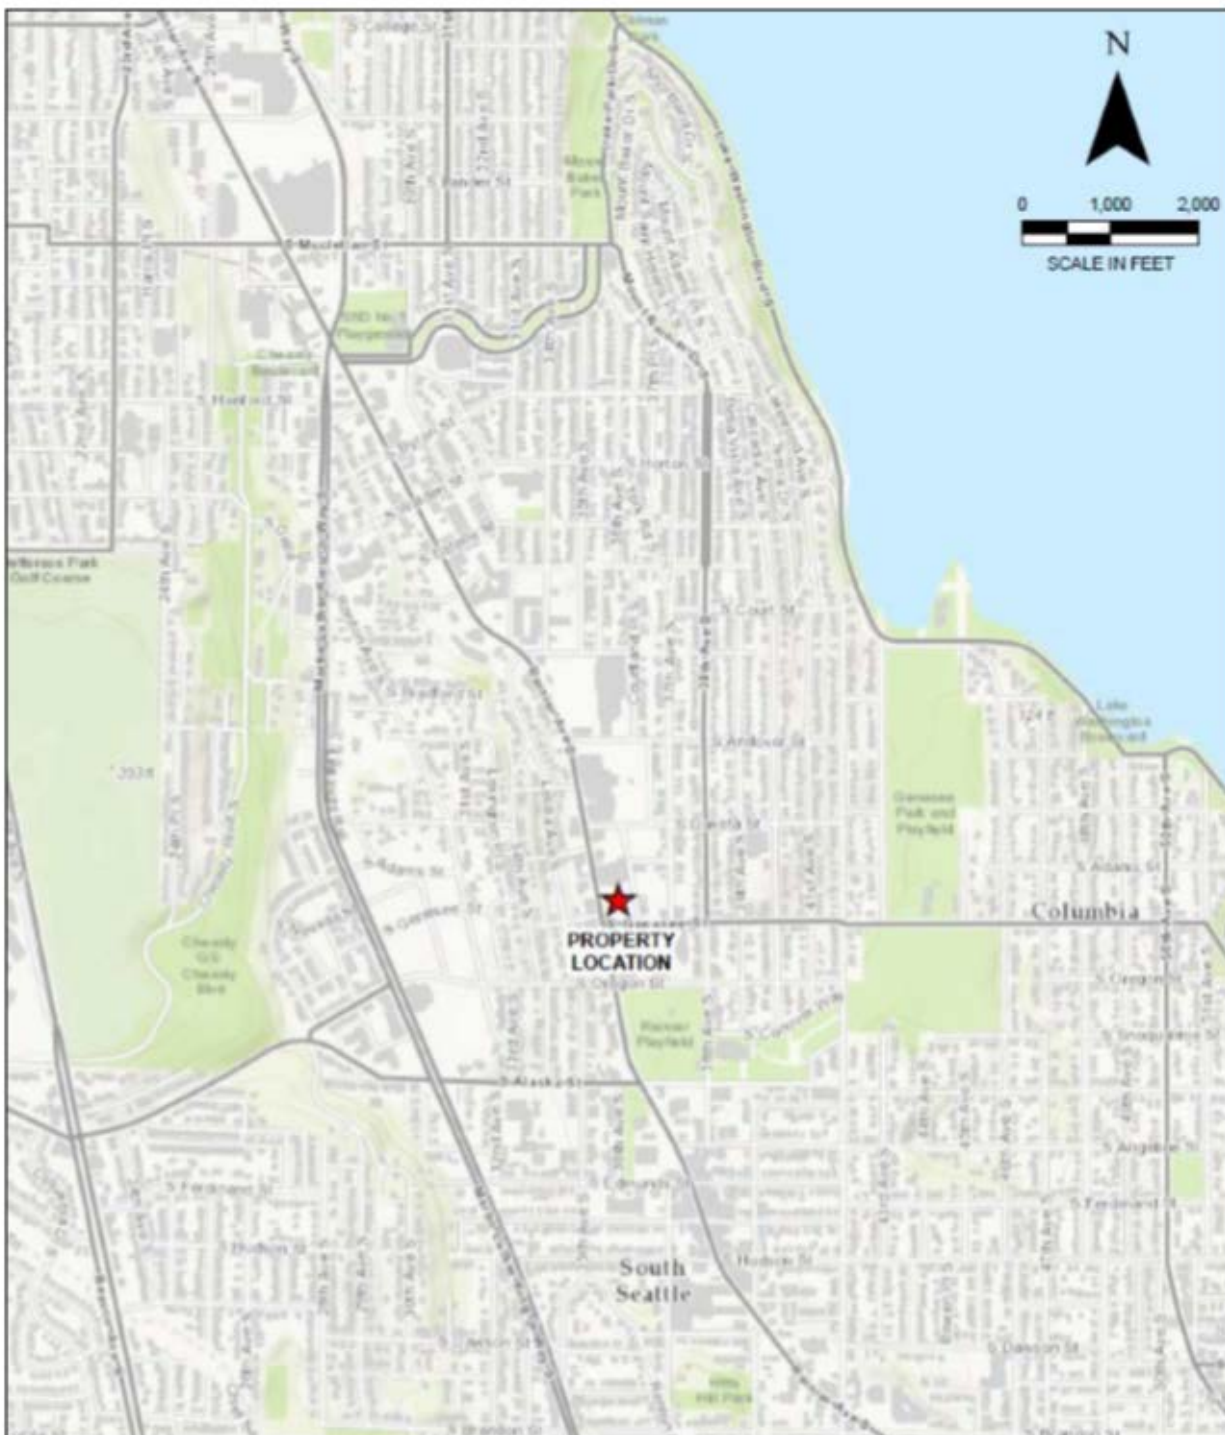
Figure 1: Site location diagram. From Sound Earth Strategies (October 2018).

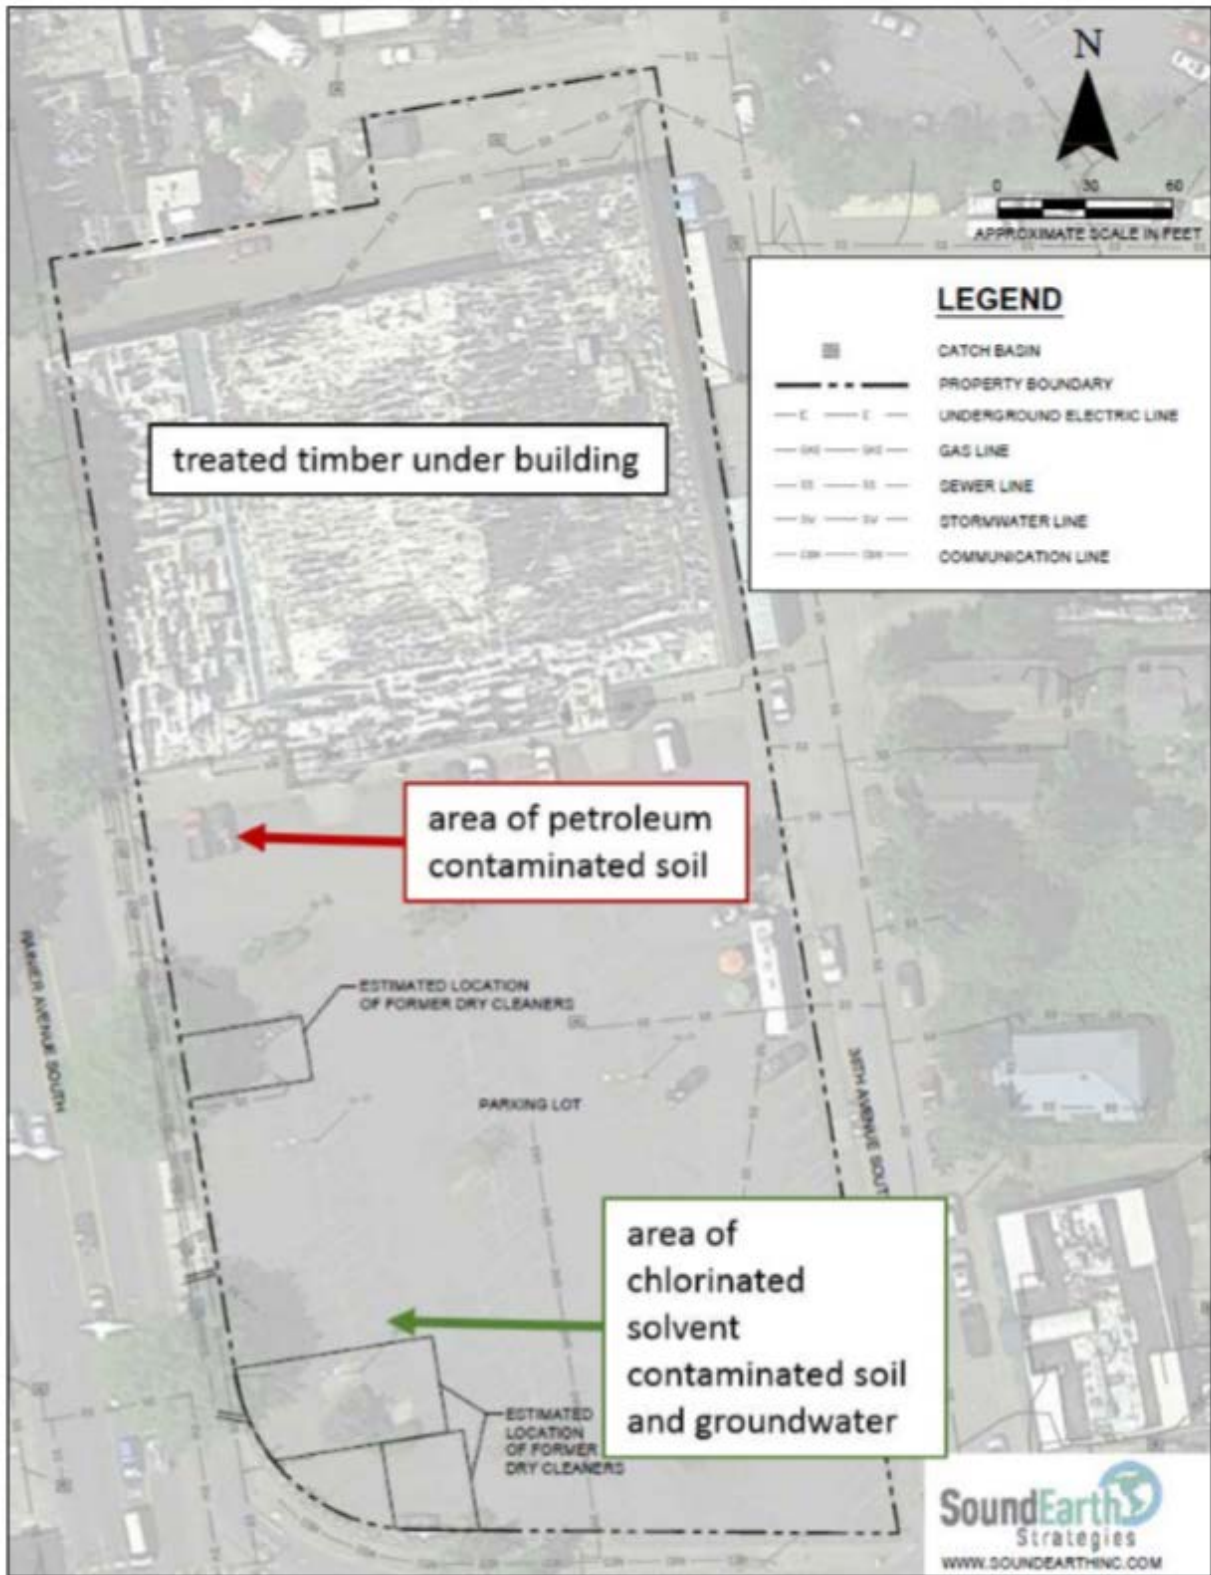
Site: The Site is defined as PCE and related degradation products and suspected cPAH contamination from subsurface timber piles impacting soil and groundwater, and TPH-O impacting soil. Passive soil gas samples suggest chlorinated and petroleum VOCs vapors are present in the soil. The Site is located on King County tax parcels 7950301480 at the intersection of Rainier Avenue S and S Genesee Street in Seattle, Washington (**Figures 1 and 2**).

Figure 2: General location of area of contamination on Site. Base map from Sound Earth Strategies (October 2018).
