Phase I Environmental Site Assessment North Marina Redevelopment Project Port of Everett Everett, Washington

November 28, 2001

LANDAU ASSOCIATES, INC.

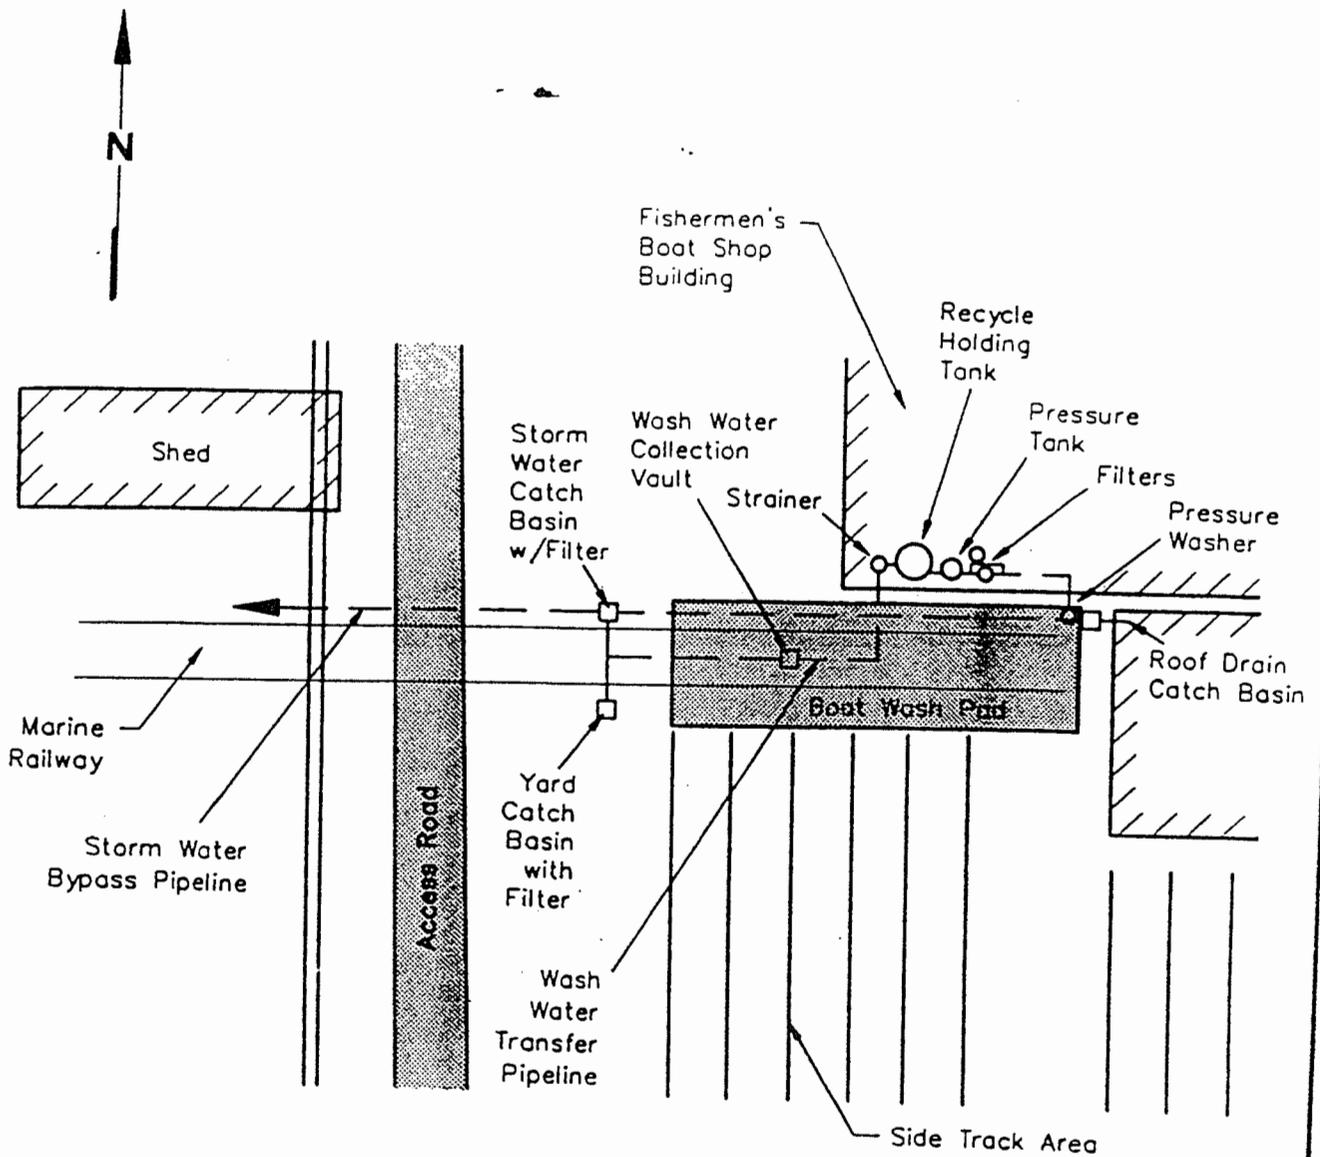
A - Storm Water Catch Basins
001 & 002 are Storm Water Outfalls
The entire yard is paved with the exception of the shaded area and everything south of the transfer rails
All Storm Water North of Marine Railway Drains thru Outfall #001, with the exception of 002
