# Final Closure Report

## Juanita Village Kirkland, Washington Prospective Purchaser Consent Decree 00-2-16556-1SEA

**May 21, 2012**

**Project Number: 01007**

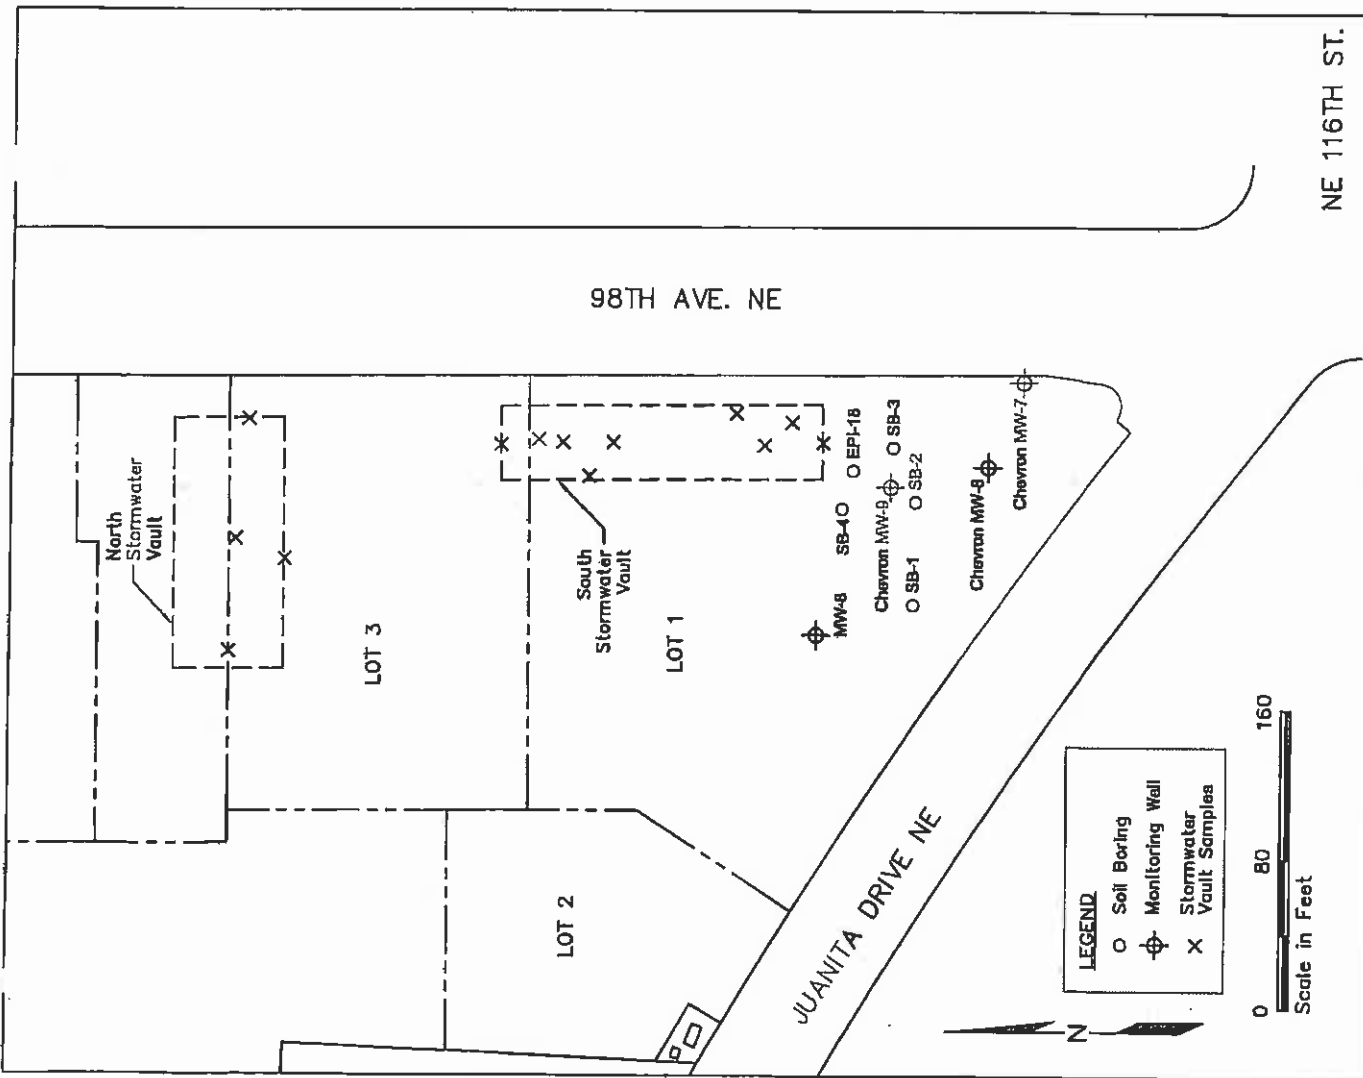
Figure 4  
Soil Borings  
Total Petroleum Hydrocarbons and  
Tetrachloroethylene Sampling Results

The soil sample collected from soil boring EPI-18 at an interval of 7-10 feet bgs had a concentration of TPH-gasoline at 190 ppm, above the MTCA Method A Cleanup Level for soil of 100 ppm. Ethylbenzene and total xylenes were detected at concentrations of 0.059 ppm and 0.29 ppm respectively, both below MTCA Method A Cleanup Levels for soil of 20 ppm. The sample collected at 10-13 feet bgs had non-detectable concentrations for ethylbenzene and total xylenes. See Figure 4 for analytical results.

A soil sample collected from EPI-39 at 8-10 feet bgs had non-detectable concentrations of TPH-gasoline, TPH-diesel, TPH-oil and BTEX. See Figure 4 for analytical results.

All samples had non-detectable concentrations for analytes described above, with the exception of SB-2-5, which had a concentration of TPH-diesel at 11.9 ppm, below the Interim TPH Method A Cleanup Level for Soil of 2,000 ppm. See Figure 4 for analytical results.
