Seattle Steam Outfall Pipe Measurement FINDINGS REPORT

Pier 57, 1301 Alaskan Way
Seattle, Washington

Muir Job No. 12010035

Report Issue Date: November 2, 2012

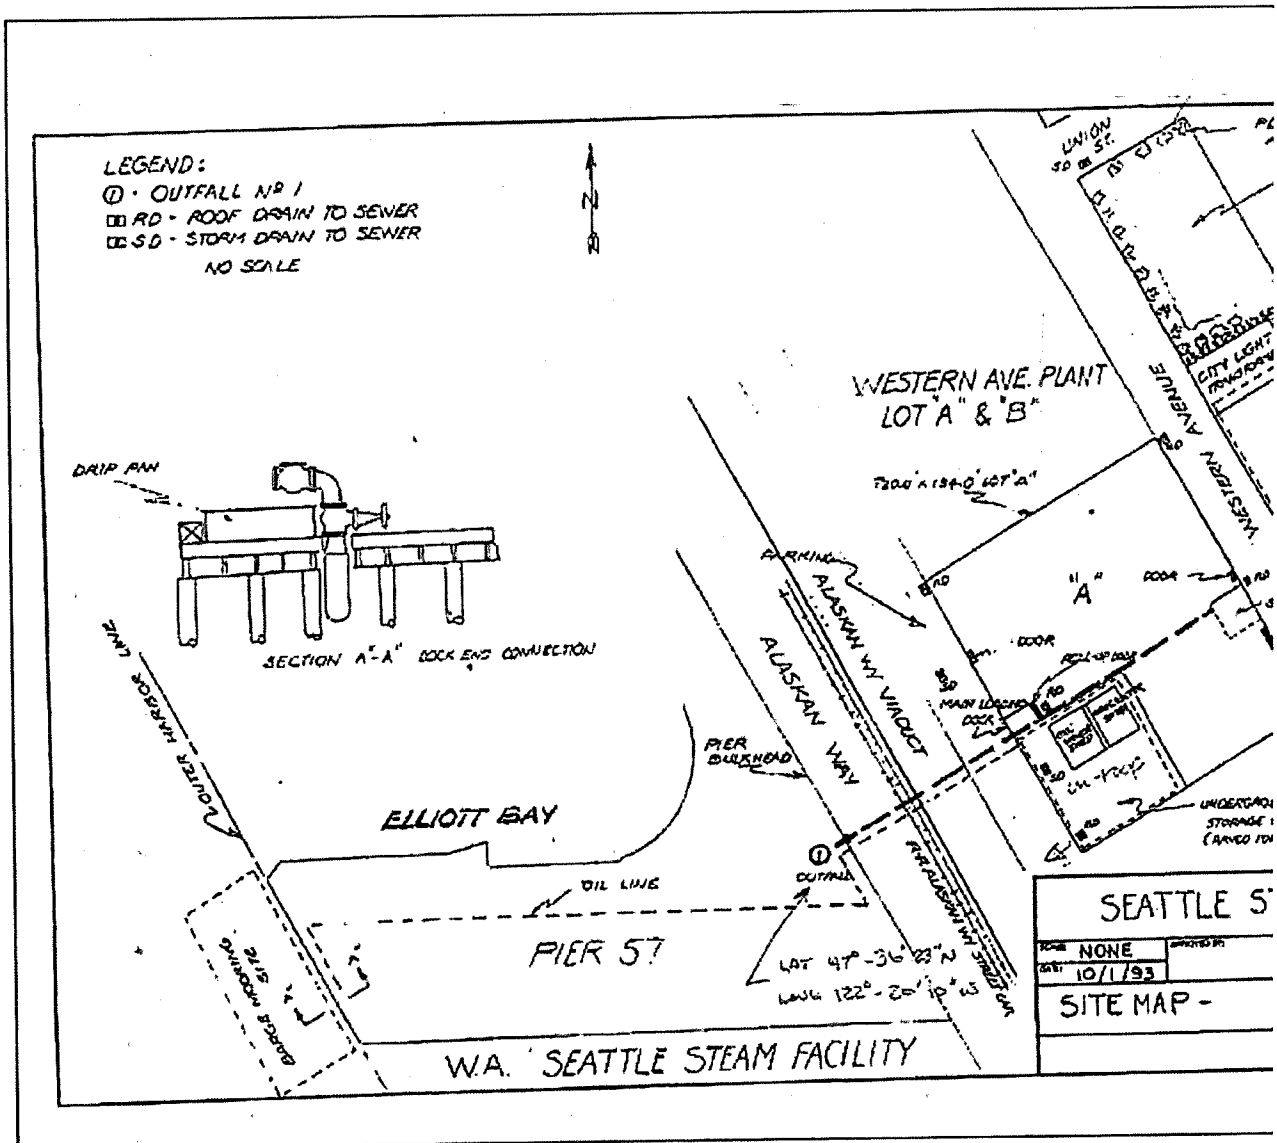
Figure 1. Existing Site Map

According to an existing site map (Figure 1, below), the outfall pipe was presumed to be located beneath Pier 57, where it crosses in a straight line under Alaskan Way to the steam plant on Western Avenue. The site plan references the following coordinates for the outfall pipe location: Latitude 47°-36'23"N and Longitude 122°-20'10"W.

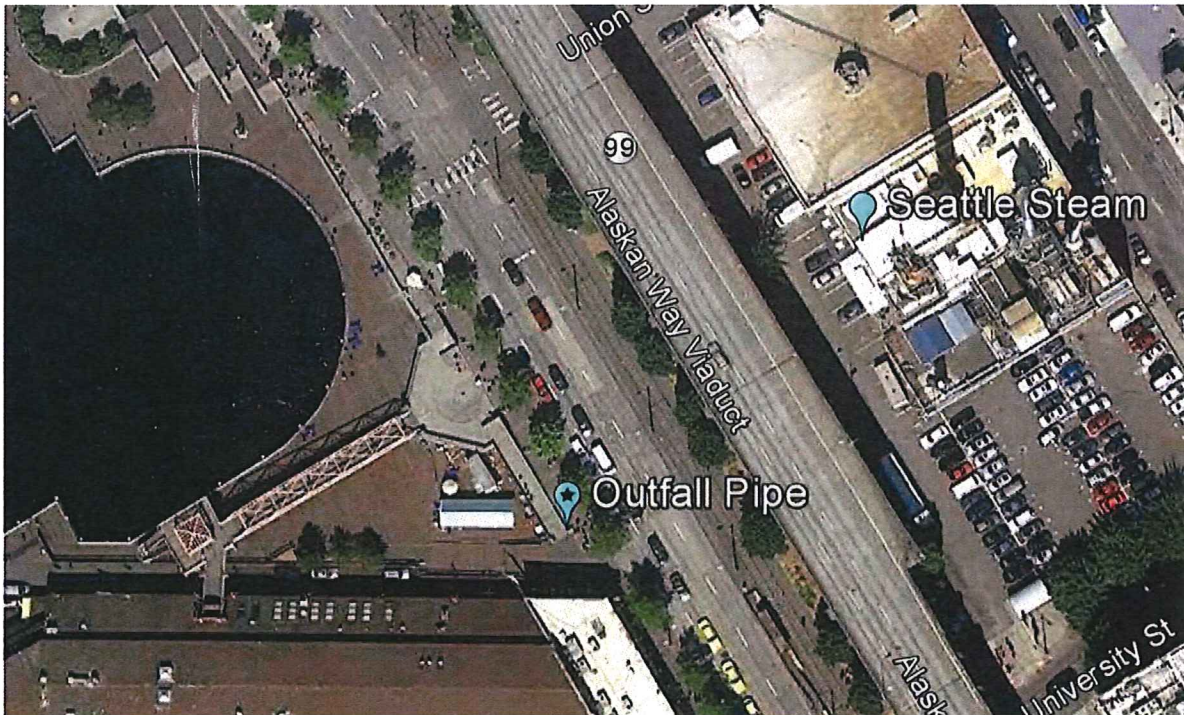
Figure 2. Google Earth Map – Outfall Pipe Location

The outfall pipe was located easily within minutes of arrival. (There were no other pipes similar to the outfall pipe within the vicinity). The exact pipe location is very close to the location shown on the existing site map. The confirmed Lat/Long is: 47°-36'22.77"N and 122°-20'27.56"W. Figure 3 below shows the location of the pipe on Google Earth.

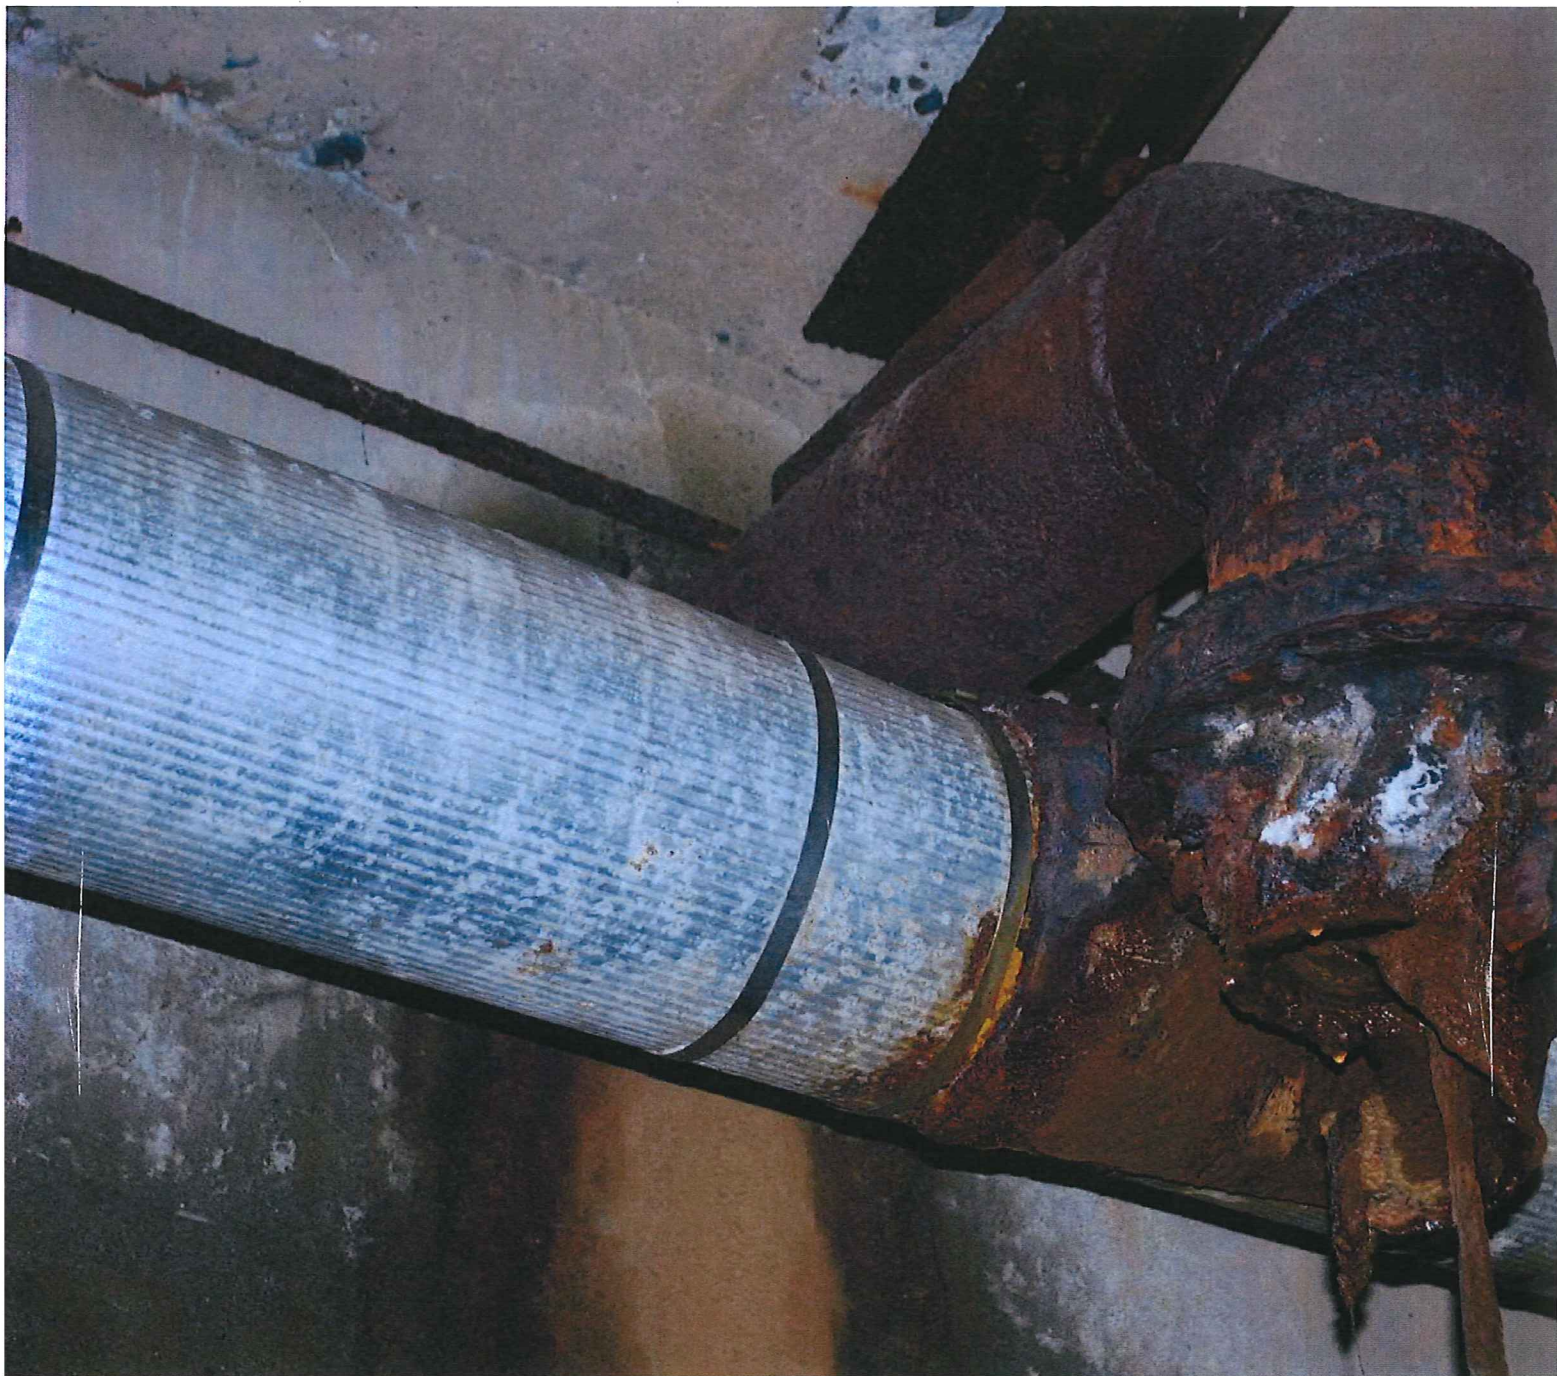
Pipe Facing East

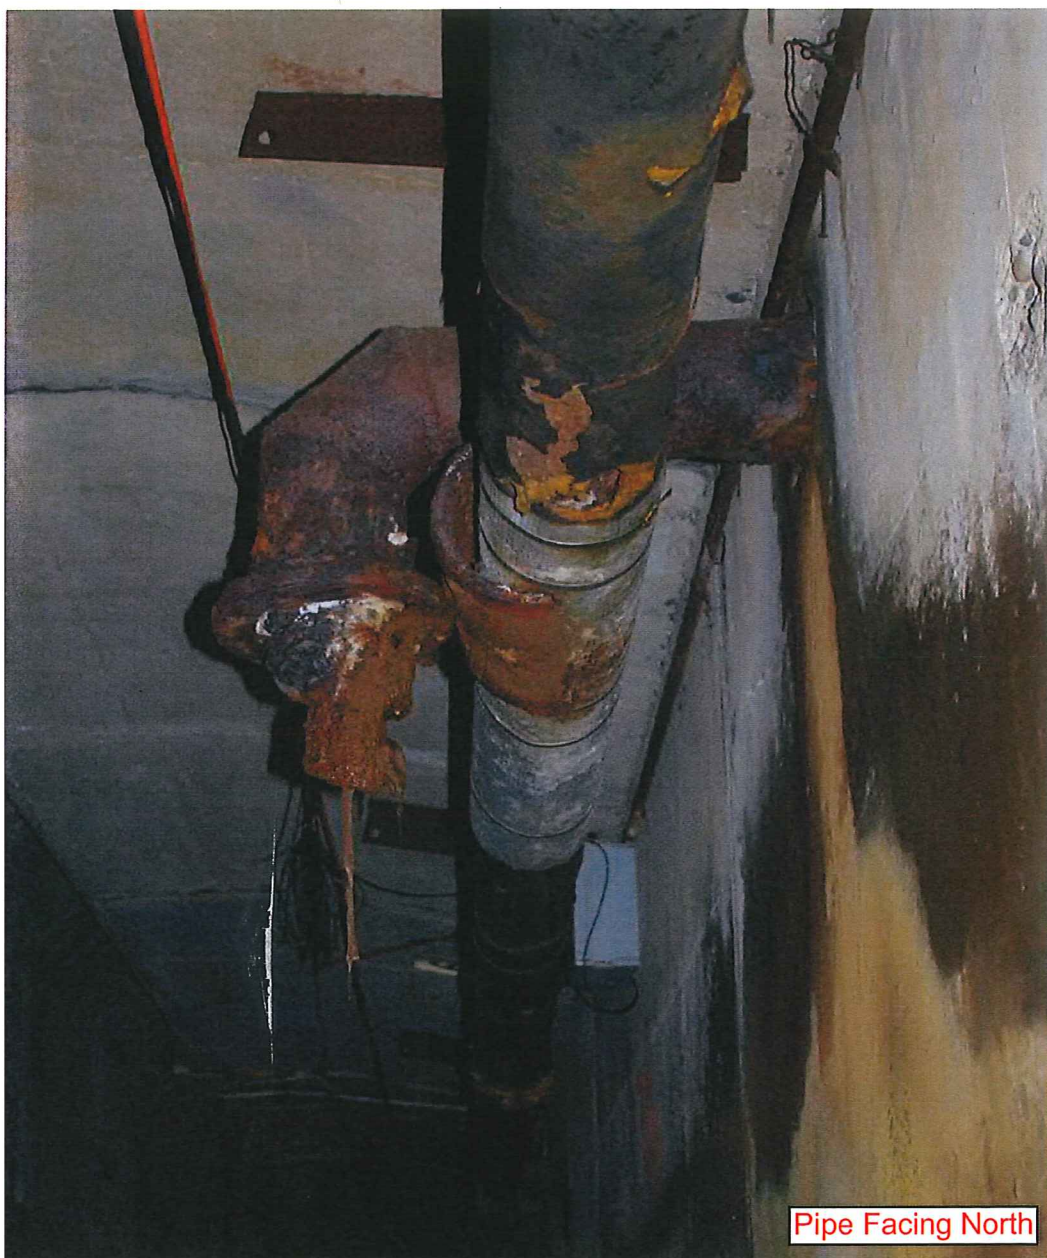
Pipe Facing North
