State of Washington Department of Ecology
Northwest Regional Office
**STORMWATER COMPLIANCE INSPECTION
REPORT**

Facility Type:
 Industrial Boatyard
 Construction S & G

Name and Location of Facility Inspected Iron Mountain Quarry 20800 Wayside Mine Road Granite Falls, WA 98252	Entry Time 0900	Permit Effective Date 2/14/2005
	Exit Time 1145	Permit Expiration Date 2/14/2010

UNANNOUNCED Inspection

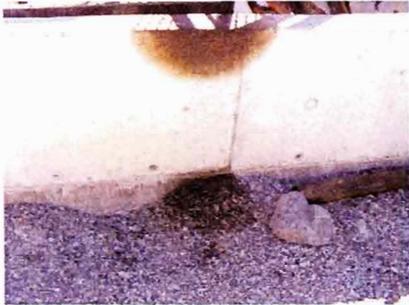
- All parts which contain fluids and oils as well as the fluids oil and fuels themselves must be stored in such a manner to prevent their release into the environment. They must be stored under cover and on a contained, bermed impervious area. **This is a violation of S7.G.fuels, lubricants and petroleum products must be stored under cover and containment to prevent stormwater contamination....**

Photo #: 2
Description:
All parts which contain fluids and oils as well as the fluids oil and fuels themselves must be stored in such a manner to prevent their release into the environment. They must be stored under cover and on a contained, bermed impervious area. **This is a violation of S7.G.fuels, lubricants and petroleum products must be stored under cover and containment to prevent stormwater contamination....**

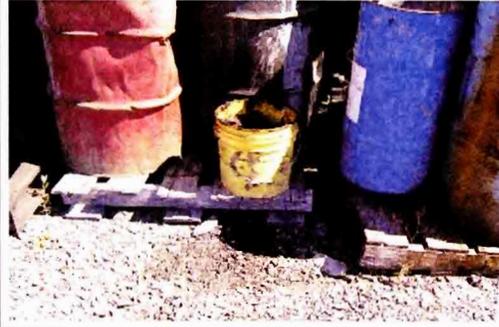
- Contaminated soil and other waste products are being stored in barrels in the storage yard. The barrels were found uncovered and without proper containment. Discharges to ground were observed. Proper and full containment must be put in place along with BMP's to avoid any discharge of any contaminants. This must be addressed immediately. **This is a violation of RCW. 90.48.080.**

Contaminated soil and other waste products are being stored in barrels in the storage yard. The barrels were found uncovered and without proper containment. Discharges to ground were observed. Proper and full containment must be put in place as well as BMP's to avoid any discharge of any contaminants. This must be addressed immediately. **This is a violation of RCW. 90.48.080.**

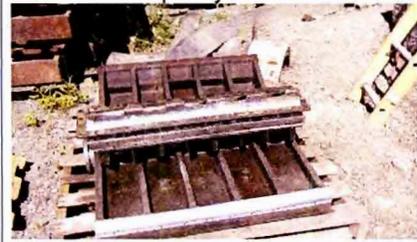
A crusher in the yard was being taken apart. Open barrels of oil and spills and parts with petroleum products were found left open for stormwater intrusion. This area must be maintained so there is no potential to discharge to ground or surface water. The oil and fuel as well as parts that can leak must be stored under cover with proper containment. Some type of containment must be implemented under the crusher as well to trap any leaks.

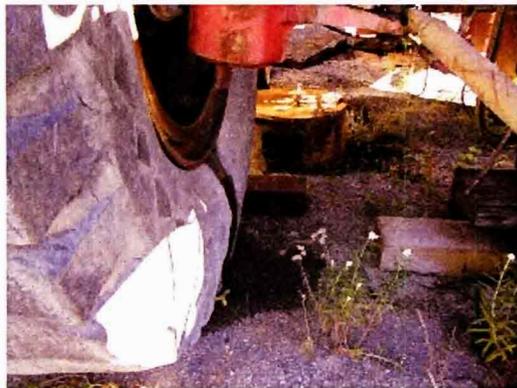
Description:
Oil and hydraulic leaks were observed throughout the site. Pictured here is a discharge which has penetrated more than a few inches down into the soil. This must be cleaned up immediately. This is a violation of RCW 90.48.080.
