State of Washington Department of Ecology  
Northwest Region Office  
**WATER QUALITY COMPLIANCE  
INSPECTION REPORT**

Name and Location of Facility Inspected PACIFIC COAST COAL COMPANY (John Henry Mine No. 1) 30500 Lake Ginder Road Black Diamond, WA 98010	Entry Time 9:56 am	Permit Effective Date March 01, 2008
	Exit Time 10:48 am	Permit Expiration Date January 11, 2013 Permit extended
Name(s) of On-Site Representative(s)/Title(s)/Phone and Fax Number(s)  Erik Wheeler, Project Manager – Wheeler Construction Co. EWheeler@wheelercc.net		Other Participants:  Jay Fennell Sand and Gravel Inspector Washington State Dept. of Ecology
Name, Address of Responsible Official/Title/Phone and Fax Number. David Morris General Manager - Pacific Coast Coal Co. P.O. Box 450 Black Diamond, WA 98010 Email: djmorris@aol.com		Cleo Neculae TMDL Lead Washington State Dept. of Ecology
Phone Number 206.321.5984 Fax Contacted? <input checked="" type="checkbox"/> Yes <input type="checkbox"/> No		Samples Taken? Yes <input type="checkbox"/> No <input checked="" type="checkbox"/> Photos Taken? <input checked="" type="checkbox"/> <input type="checkbox"/>

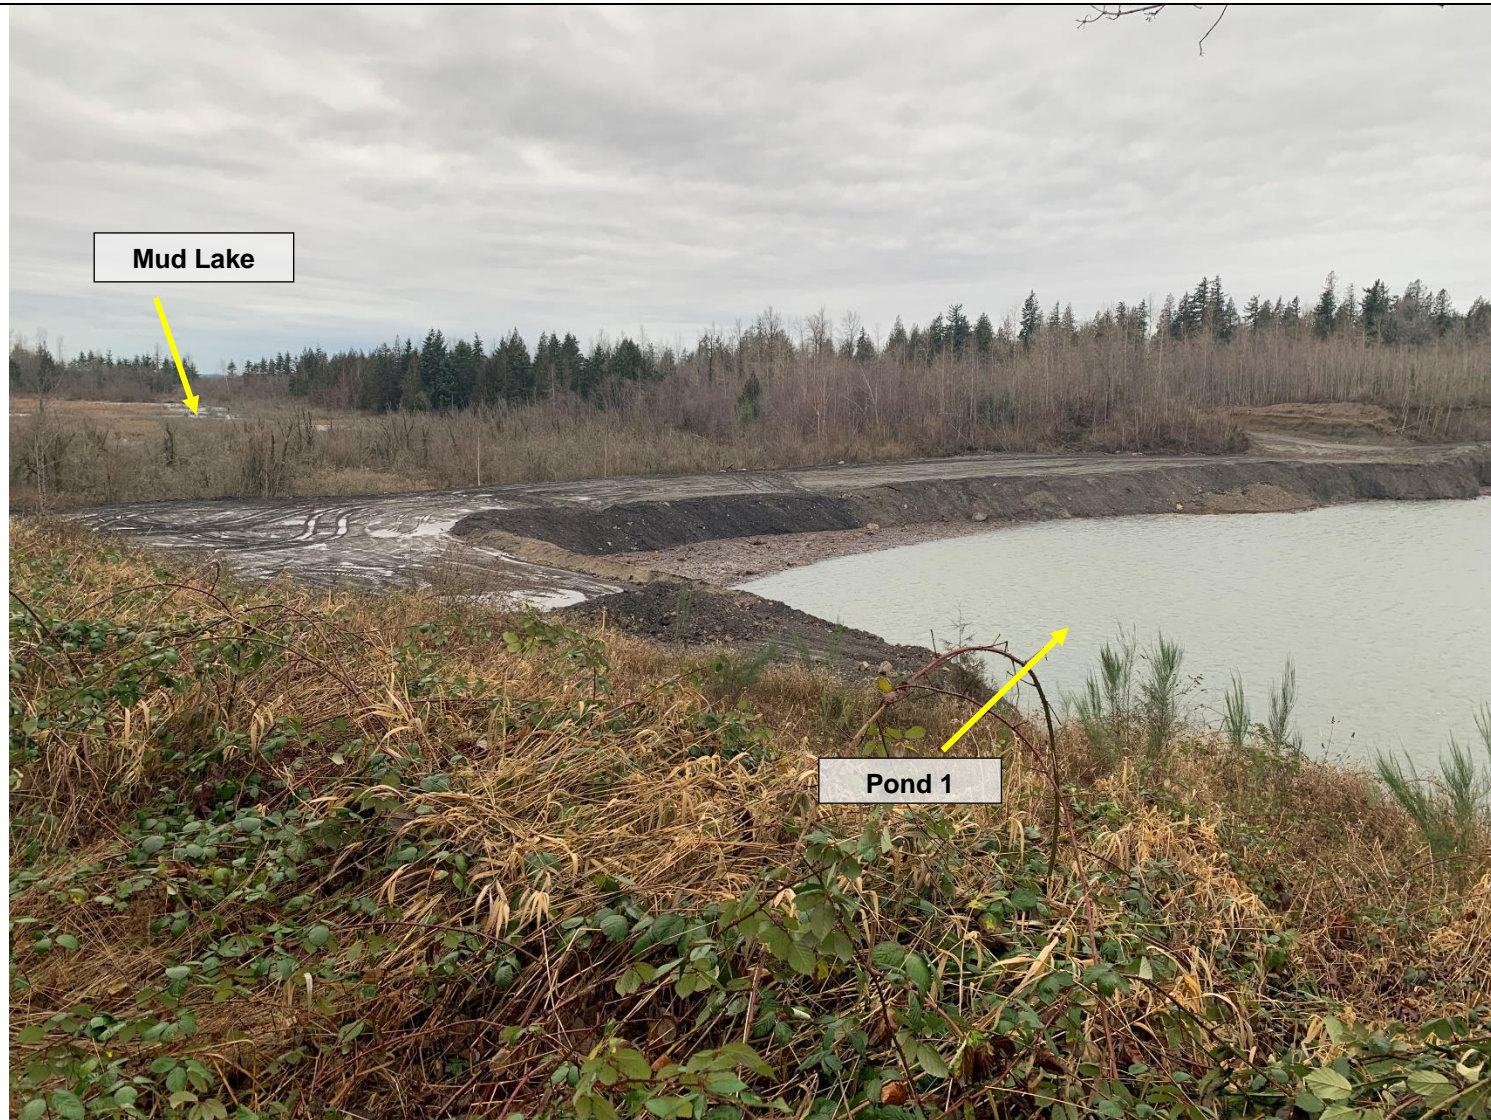
**Photo 1 [IMG\_3619, taken by J. Fennell on Jan. 12, 2023]**

When asked about Pond 1 dewatering when considering additional influent from the spoil pile impoundments, E. Wheeler stated that the mine recently constructed a roughly 20-foot high dike, to prevent discharges from Pond 1 into the neighboring Mud Lake (photo 1).

**Description:** View looking northwest from the south side of Pond 1 at the John Henry Mine. Earthen dike constructed to prevent discharges from Pond 1 into Mud Lake. Dike also provided haul access to south side of Pond 1 for continued back filling and reclamation.
