## Germany Creek Photo Points and Channel Stability Evaluation: 1990 – 2000

November 2000 Publication No. 00-10-038

Joanne Schuett-Hames Washington State Department of Ecology Southwest Regional Office Water Quality Program

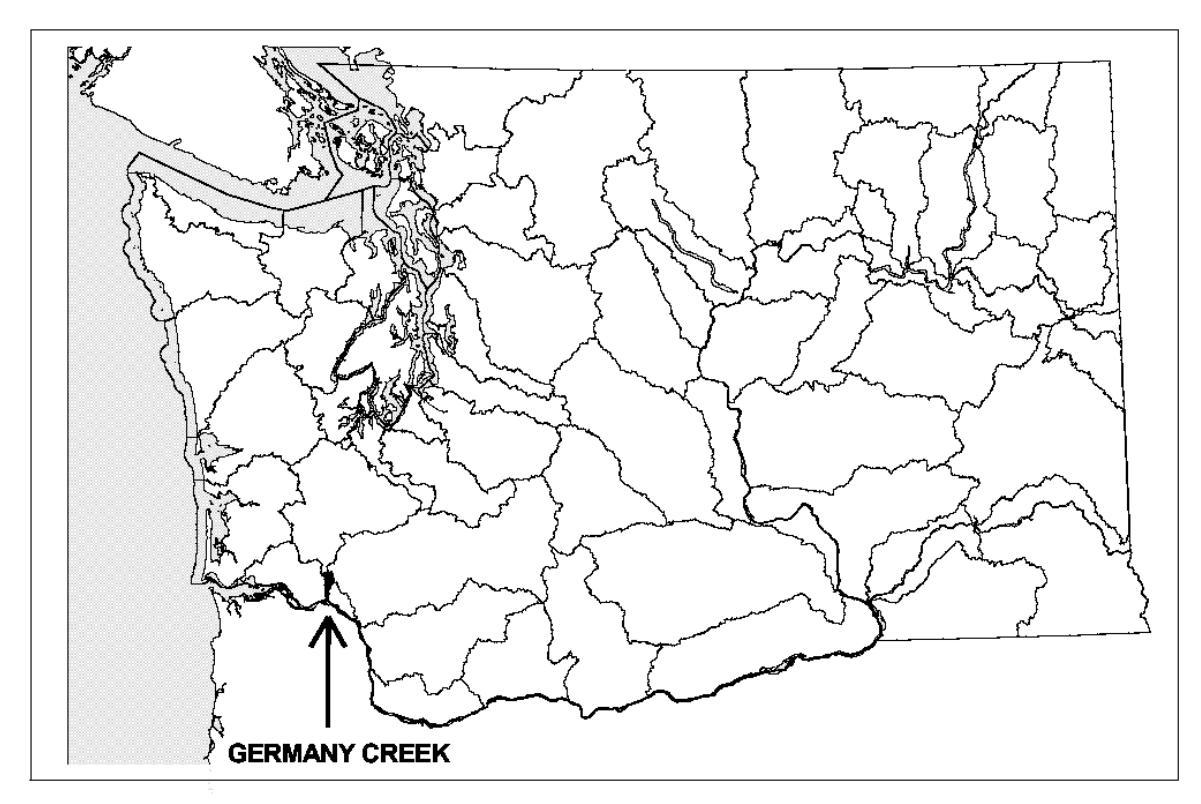
Germany Creek is located in Cowlitz County, Washington, and is a tributary to the Columbia River west of Longview (Figure 1). The upper watershed of the creek is managed for forest products. Unstable terrain coupled with extensive forest harvest in the 1960's through 1980's led to accelerated mass wasting and channel impacts. In 1990 a process was set up to begin addressing these impacts and to begin recovery of the channel. At that time photo points along the channel system were set up and channel stability conditions were evaluated. These same photo points and channel evaluations were redone in 2000. This report summarizes findings from the ten-year interval and provides the photos, photo point locations and stability evaluation data, and locations in a manner that will allow repeatability in the future.
