REPORT OF FIELD STUDIES ON THE WILLAPA RIVER
August 29-31, 1972 and September 19-20, 1972Introduction

STATE OF WASHINGTON
 LOWER WILLAPA RIVER
 SAMPLING POINT LOCATIONS
 SURVEY OF AUG. - SEPT. 1972

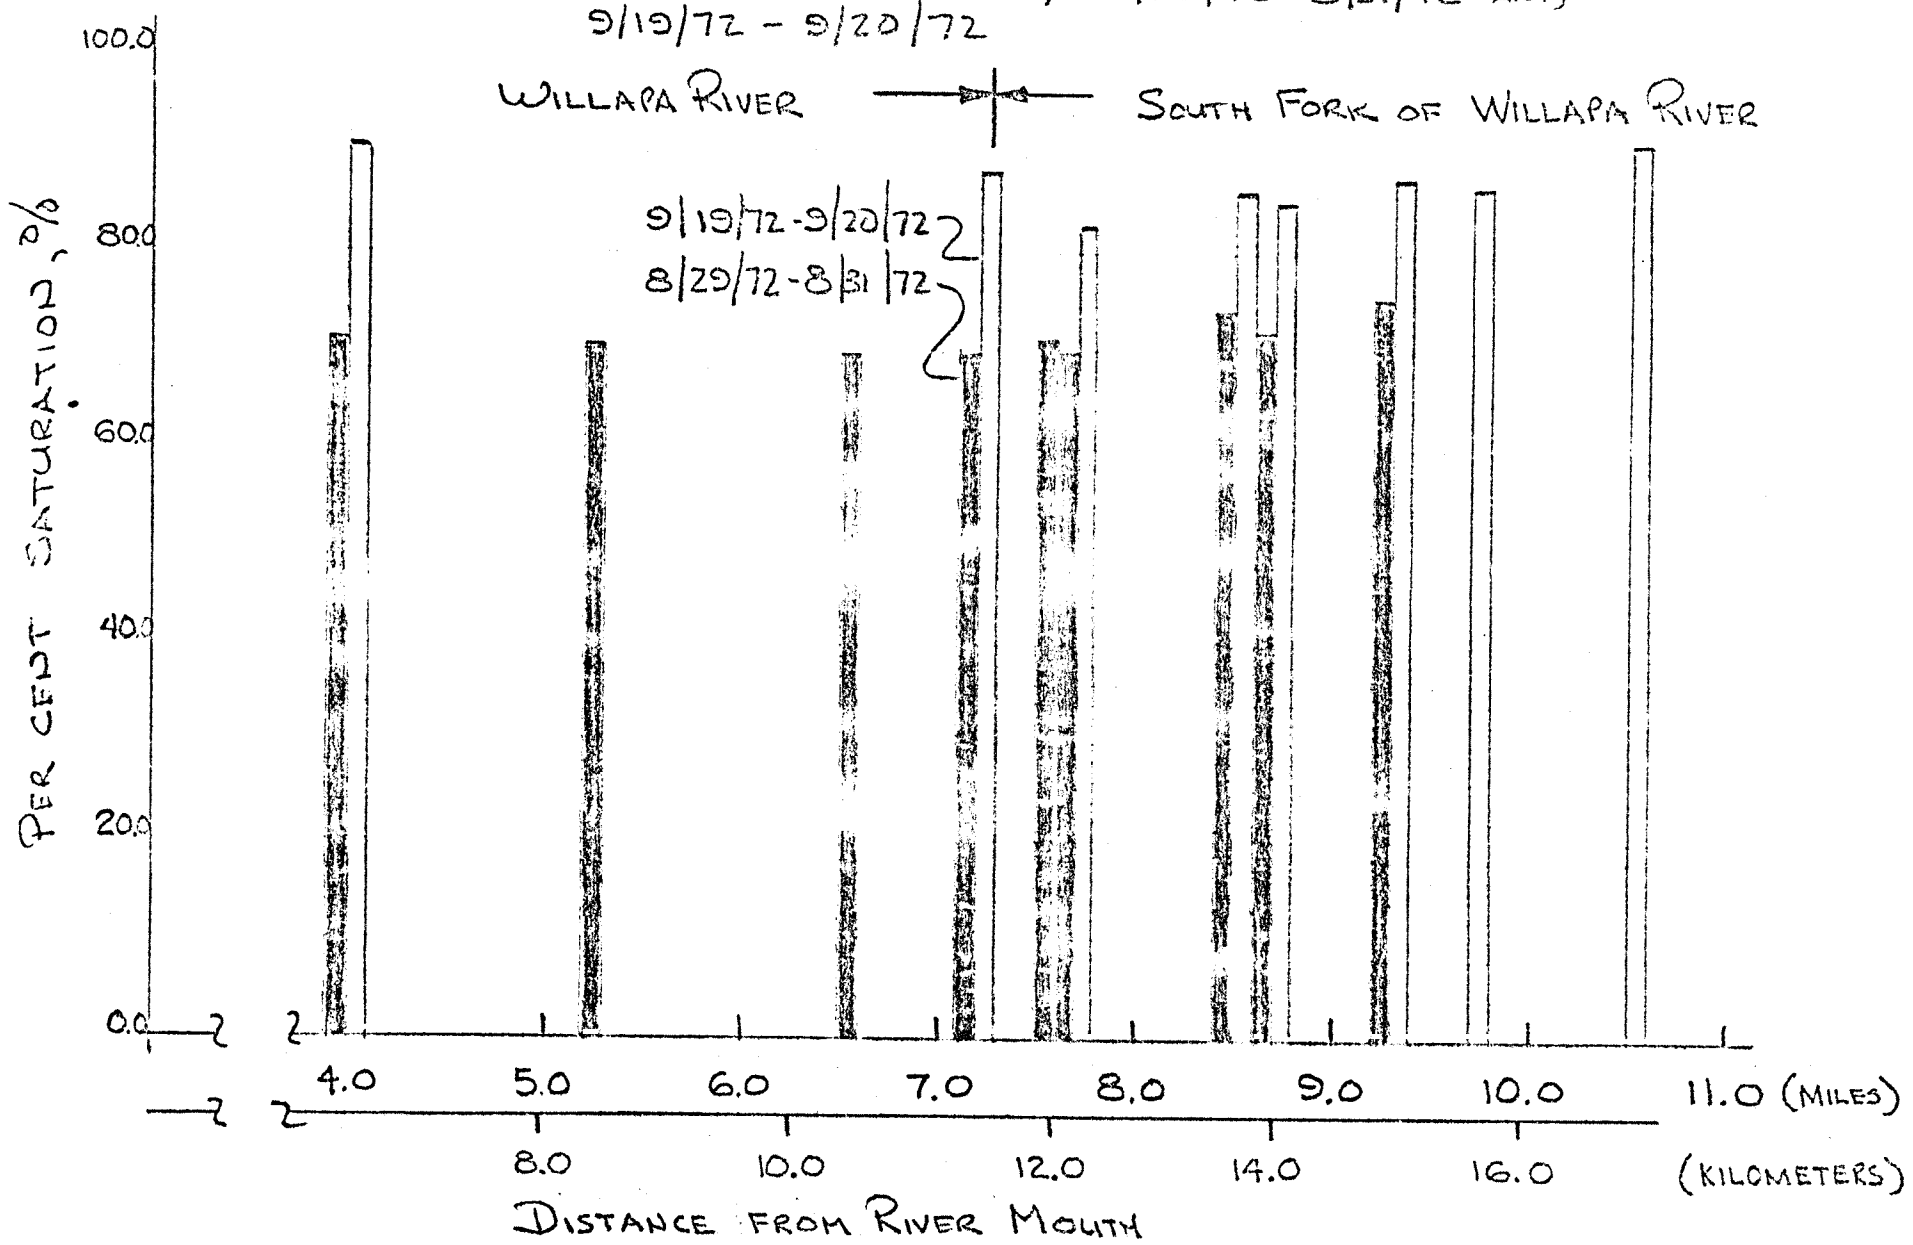
Average dissolved oxygen during each of the surveys are plotted in Figure 6. At individual stations the average dissolved oxygen values during the September 19-20 survey were from 1.7 to 2.2 mg/l greater than corresponding values from the August 29-31 survey. In addition, the ratio of the instream dissolved oxygen to the saturation value of dissolved oxygen (percent saturation) (Figure 1) increased between 10% and 20% from August 29-31 and September 19-20. Dissolved oxygen deficit (Figure 8) decreased between 0.8 mg/l and 1.4 mg/l.

Lower river temperatures, resulting in higher saturation levels for dissolved oxygen, were the cause of part of the increase in dissolved oxygen. However, the significant change in deficit implies that a large amount of dissolved oxygen was added to the river during the period of higher discharge (September 9-12) and/or a large demand on the oxygen resource was removal. A possible source of this demand is the low dissolved oxygen appears along the Washington coast in late summer due to upwelling. However, there is no data from the Willapa Bay area which indicates that upwelling was a major factor during the survey period.

FIGURE 7. PER CENT SATURATION (DISSOLVED OXYGEN) IN THE WILLAPA RIVER, 8/29/72-8/31/72 AND 9/19/72-9/20/72
