STATE OF
WASHINGTON

DEPARTMENT OF ECOLOGY

M E M O R A N D U M

To: John Hodgson
From: John Bernhardt and Tim Determan
Subject: Omak Groundwater Contamination

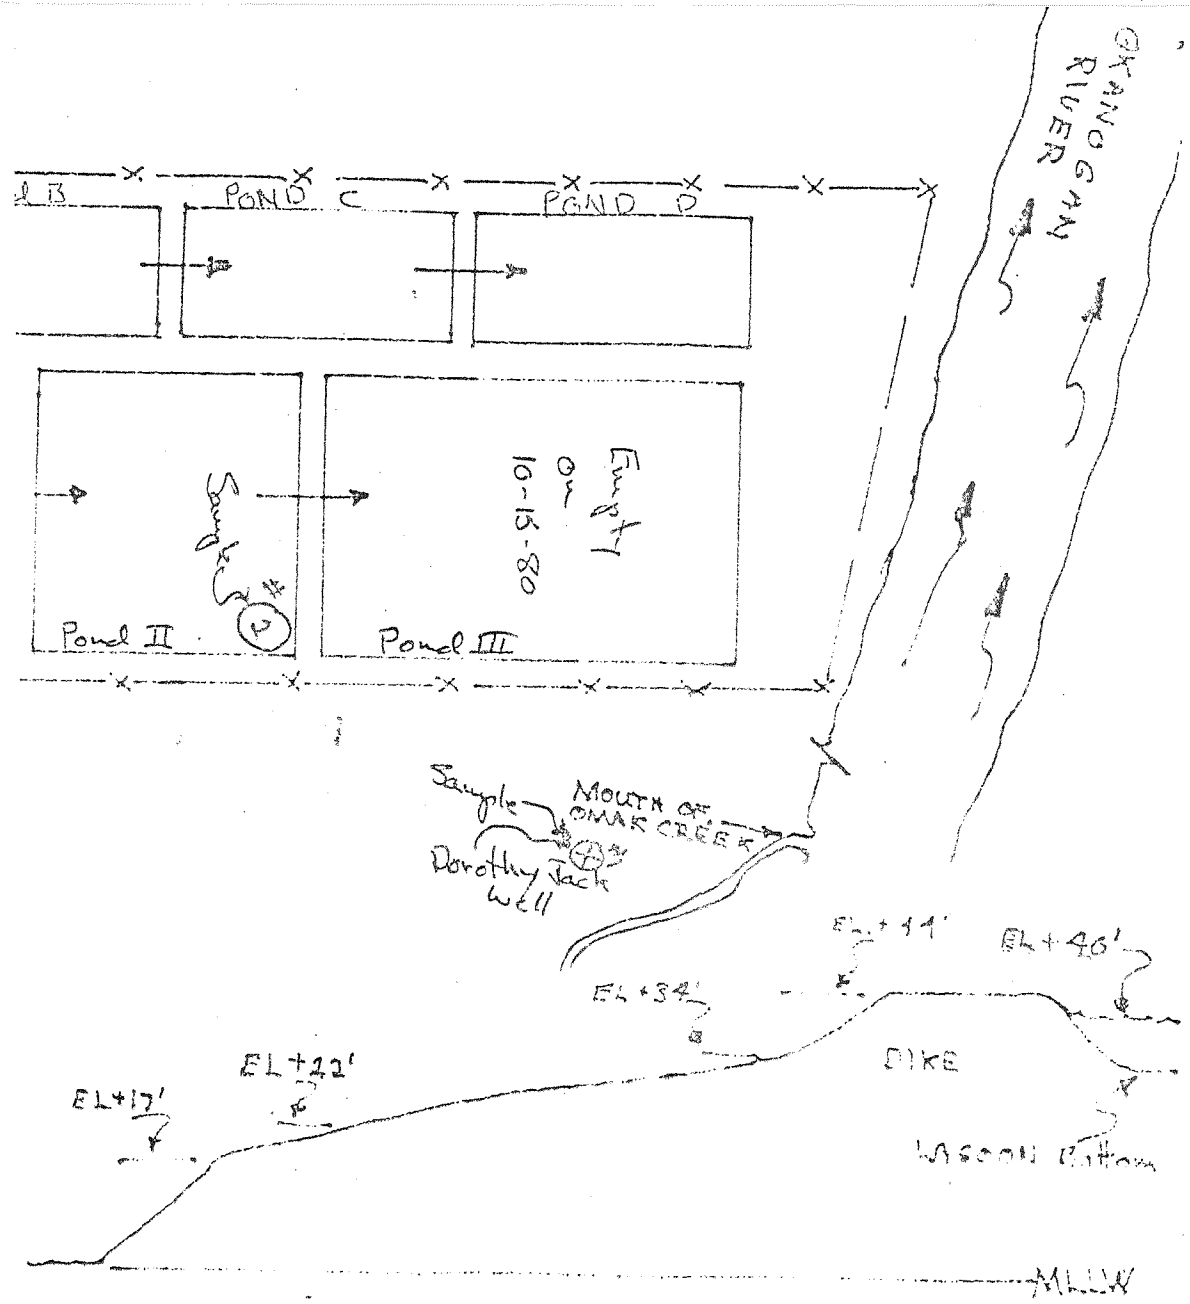
Our understanding is that Crown Zellerbach's sawmill/furniture operation in east Omak is suspected of contaminating the underlying groundwaters (Figure 1). The facility's wastewaters containing phenolic glues and other woodwaste materials are discharged to a series of earthen ponds for disposal via ground seepage. The problem is that these ponds are located within 30 feet of a private residence (Dorothy Jack). Colville Indian tribal social workers feel that Mrs. Jack's ailing health while at the residence (now at a retirement home) and the apparent poor quality of her drinking water are due to contamination by Crown Zellerbach's wastewaters. There also is concern that other wells in the area are contaminated by the same ponds.

2nd Omak Lagoons
stations.
