Appendices I and J

Effectiveness of Forest Road and Timber Harvest Best Management Practices with Respect to Sediment-Related Water Quality Impacts

December 1999
Publication No. 99-350

by
Ed Rashin
Casey Clishe
Andy Loch
Johanna Bell

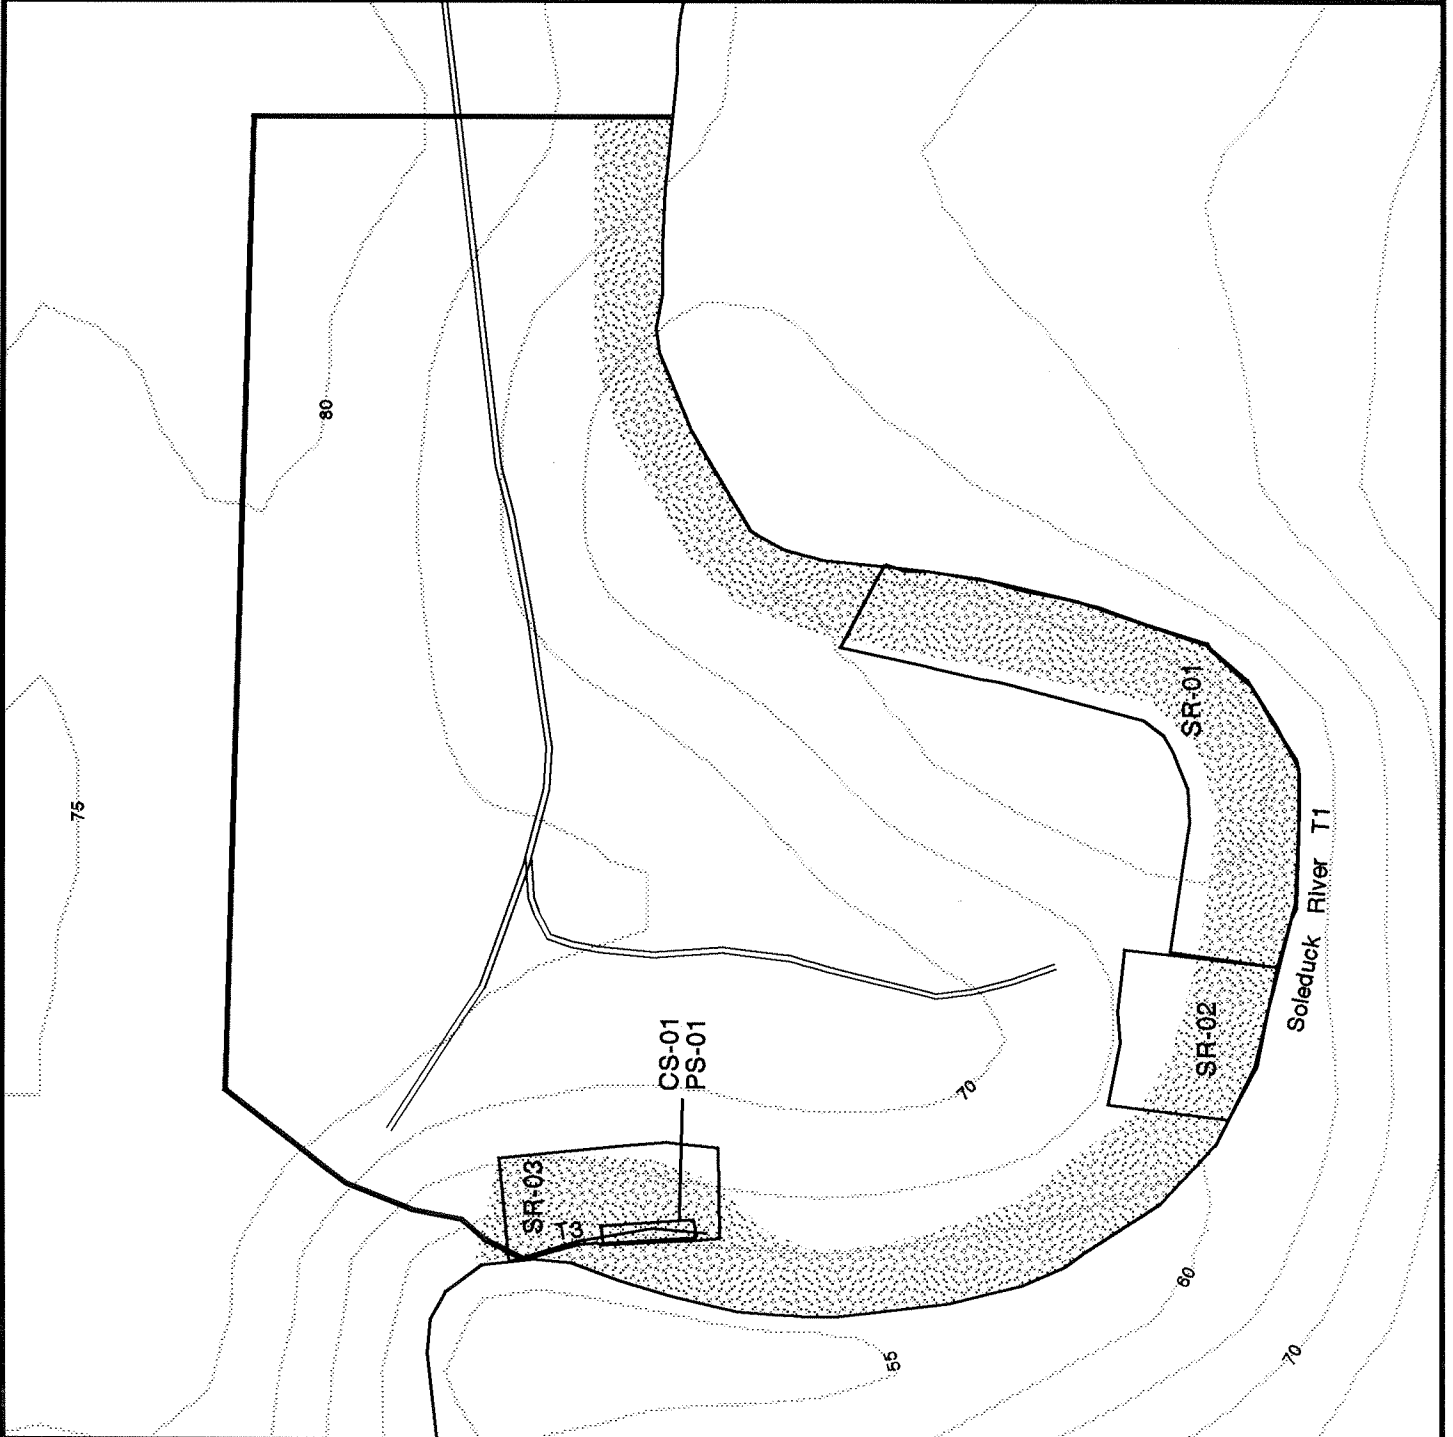
Site O-06 Whale

Study Site:	BMP Effectiveness Ratings			
O-06: Whale - Clearcut harvest, with RMZ	Harvest w/ RMZ & Streambank Integrity BMPs (WAC 222-30-020(2-4) & -030 & -040 & 050)	Harvest with no buffers (Type 4 and/or 5 Waters)	Harvest with RLTA's (Type 4 and/or 5 Waters) (WAC 222-30-020(5))	Harvest with RLTA's (Type 4 and/or 5 Waters) (WAC 222-30-020(5))
Survey Employed	Ground-based Yarding WAC 222-30-070	Cable Yarding WAC 222-30-060	Ground-based Yarding WAC 222-30-070	Cable Yarding WAC 222-30-060
<p>ASPECT 1: Effectiveness in terms of chronic erosion with delivery to surface waters.</p>	<p>Sediment Routing: SR-01 Effective SR-02 Effective SR-03 Effective</p>			
<p>Case Narrative: There was no sediment delivery to the Soleduck River or its type 3 tributary associated with logging disturbances. Soil disturbance measured 8 months following timber harvest ranged from 2-4% of the survey areas. The RMZ was not yarded across, and was not entered for harvesting in the vicinity of steeper streamside slopes. Erosion features that delivered sediment to the type 3 or the Soleduck were associated with either river bluff erosion, windthrown trees, or wildlife activities.</p>

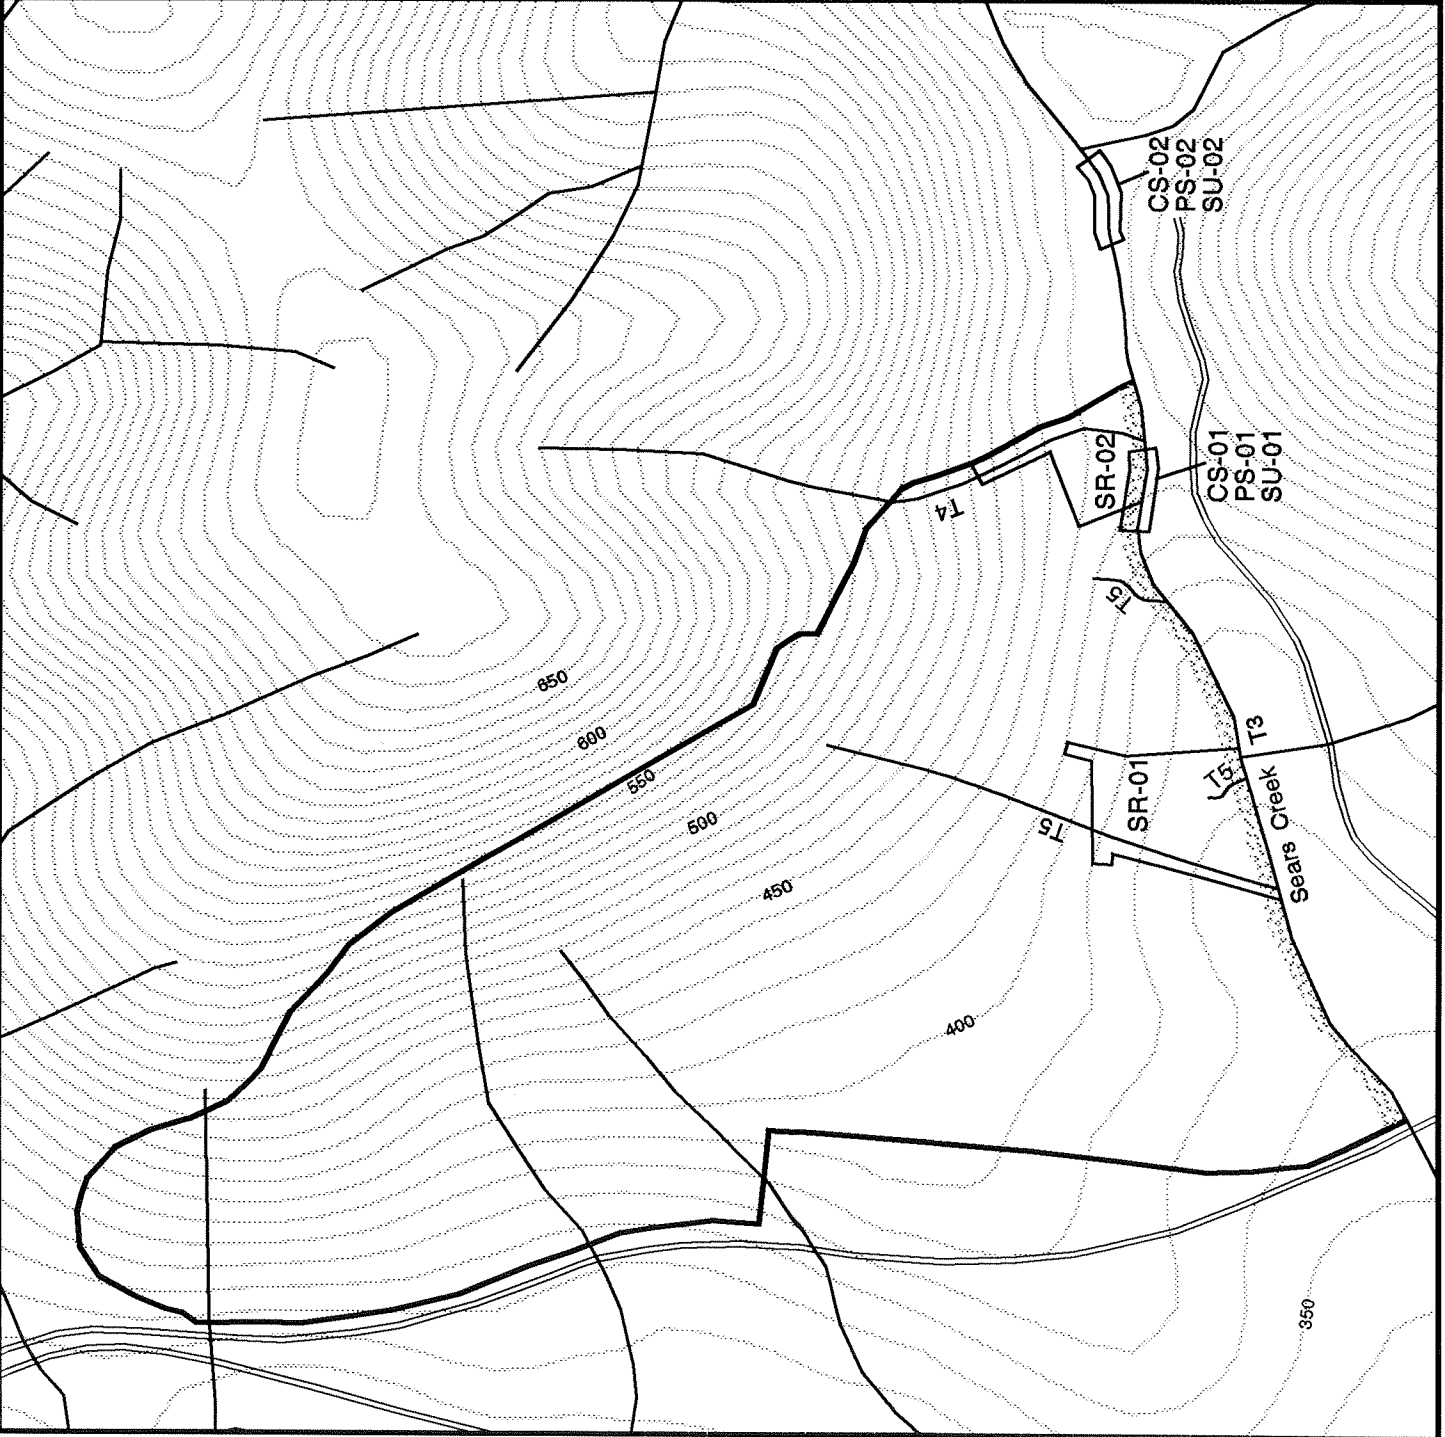
Site W-01 Sears Creek

Study Site:	BMP Effectiveness Ratings			
	Survey Employed	Harvest w/ RMZ & Streambank Integrity BMPs (WAC 222-30-020(2-4) & -030 & -040 & 050)	Harvest with no buffers (Type 4 and/or 5 Waters)	Harvest with RLTA's (Type 4 and/or 5 Waters) (WAC 222-30-020(5))
ASPECT 1: Effectiveness in terms of chronic erosion with delivery to surface waters.	Sediment Routing			
	SR-01BU	Effective	Ground-based Yarding WAC 222-30-070	Ground-based Yarding WAC 222-30-070
	SR-01NB	Effective	Ground-based Yarding WAC 222-30-070	Ground-based Yarding WAC 222-30-070
	SR-02BU SR-02NB	Effective	Not Effective	Not Effective
Case Narrative:	The BMPs applied at this site for harvest with RMZ were effective at preventing direct sediment delivery to the Type 3 stream. The RMZ was not entered by heavy equipment in the survey areas. There was substantial chronic sediment delivery to and disturbance of the Type 4 and 5 tributaries to Sears Creek due to timber falling/yarding activities. Indirect sediment delivery to Sears Creek was observed, via the Type 4 tributary. In addition, the physical integrity of aquatic habitat within the Type 4 and 5 streams was degraded by direct disturbance from yarding as well as sediment deposition.

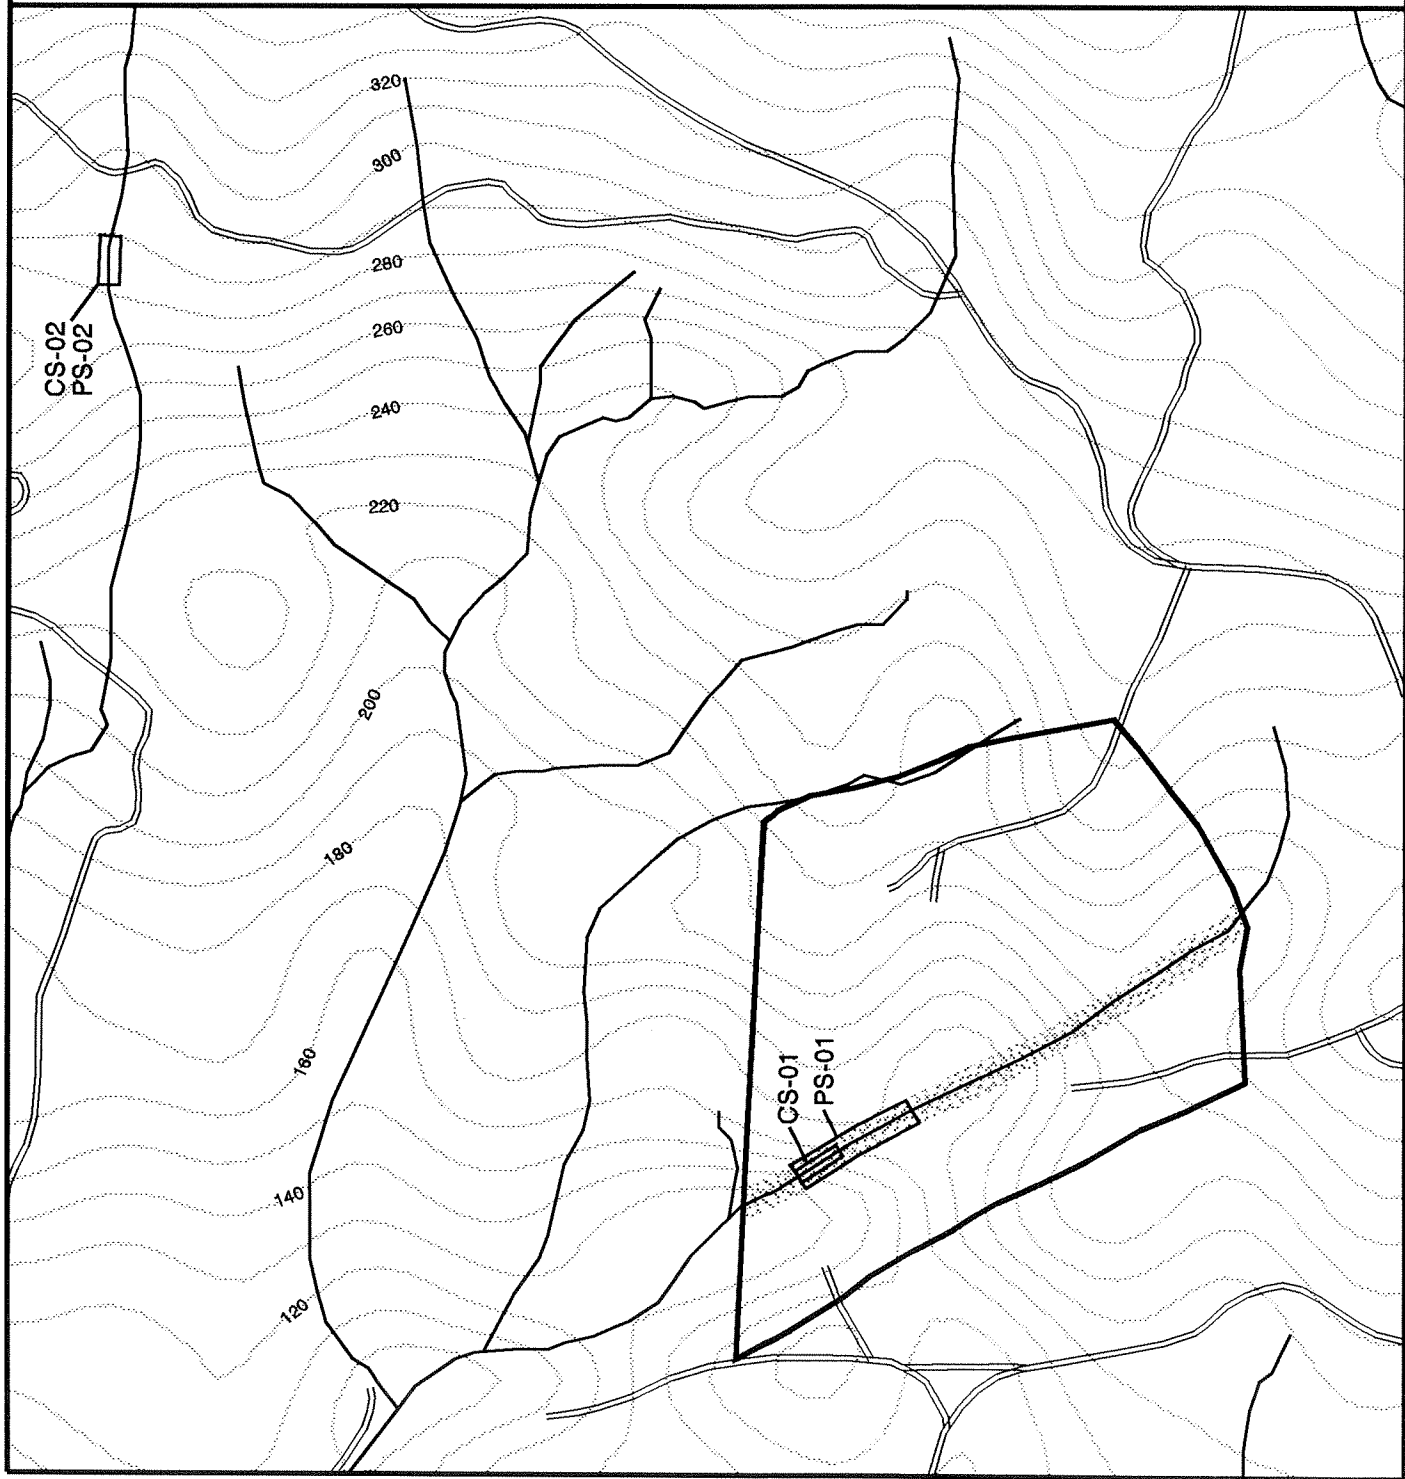
<p>Study Site: W-07: Night Dancer - Clearcut harvest with RMZ</p>	<p style="text-align: center;">BMP Effectiveness Ratings</p>

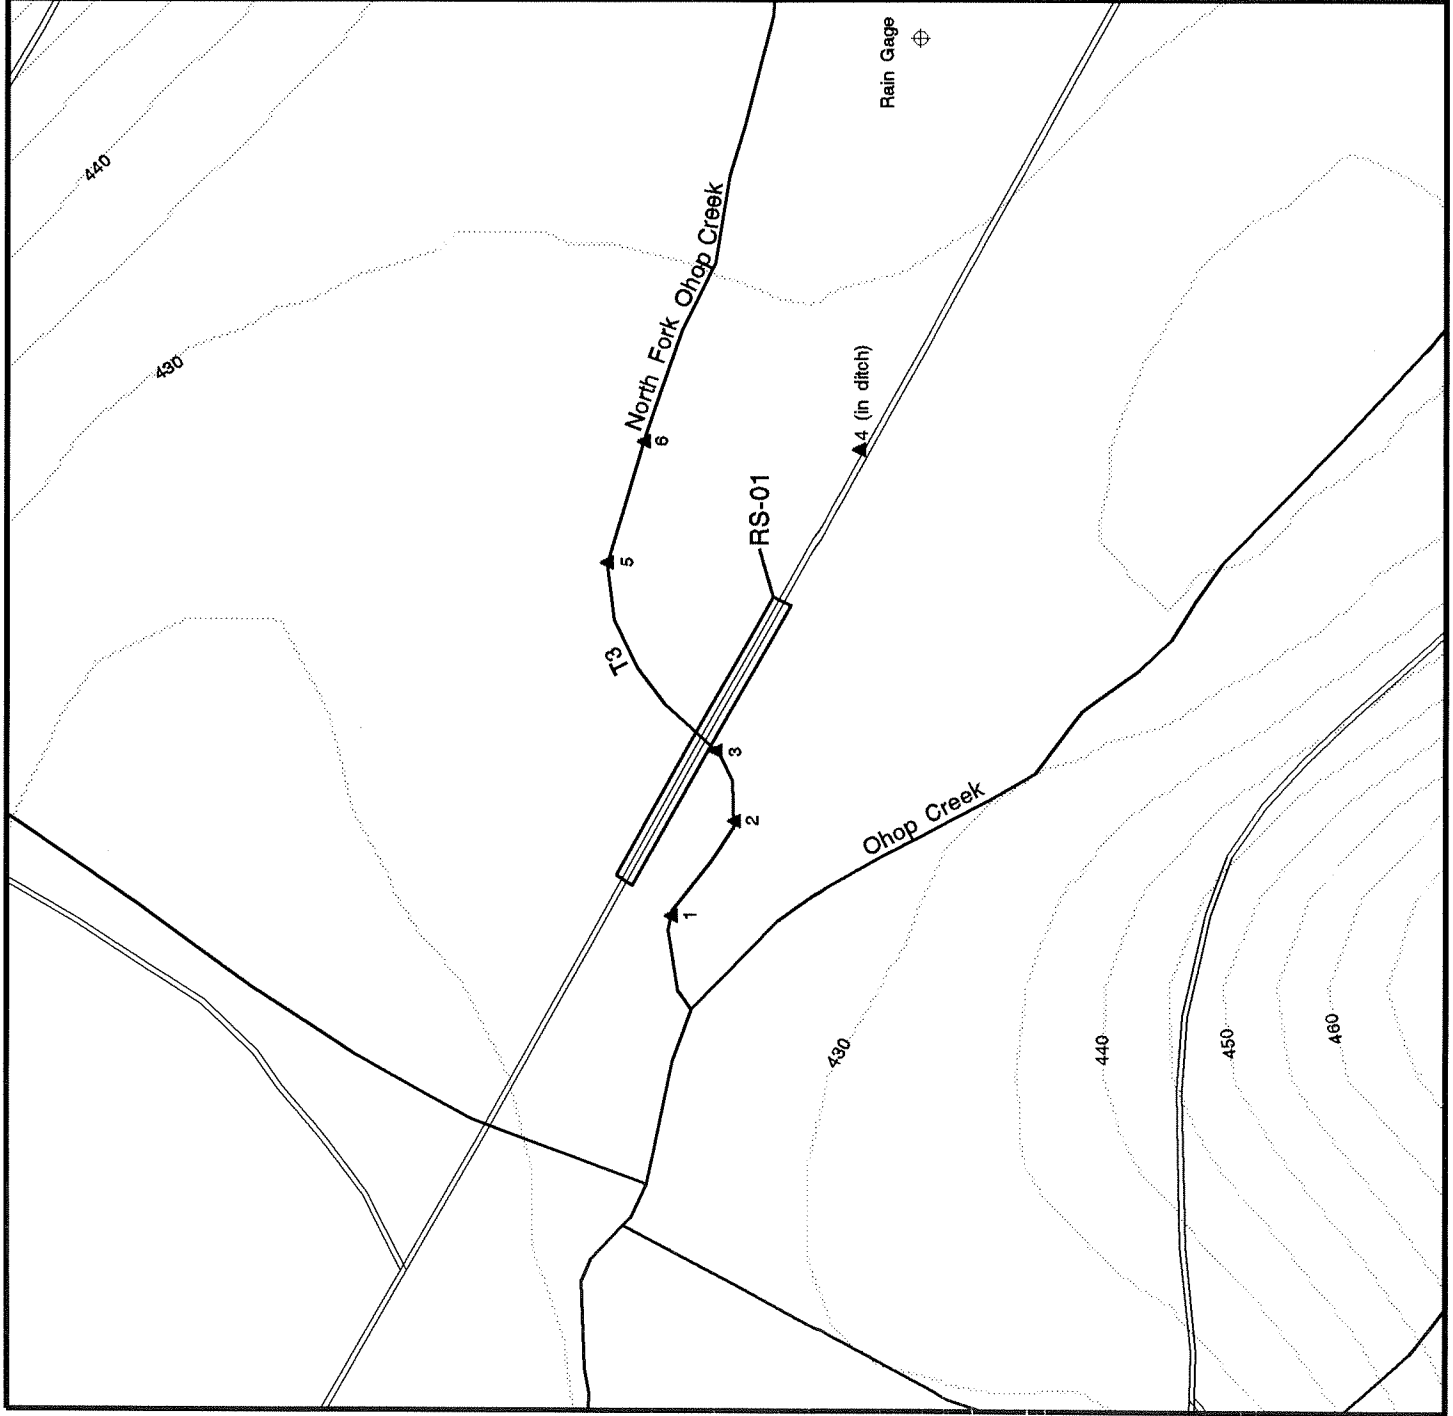
Site S-01 Camp One Road

<p>Study Site:</p>	<p>S-01: Camp One Road</p>	<p>BMP Effectiveness Ratings Active Haul Road Maintenance WAC 222-24-050(2) & (4)</p>
<p>Survey Employed</p>		
<p>ASPECT 1: Effectiveness in terms of chronic erosion with delivery to surface waters.</p>	<p>Road Surface Condition: RS-01</p>	<p>Indeterminate</p>
<p>Case Narrative:</p>	<p>The effectiveness call is indeterminate because the survey results are not representative of active runoff conditions. The road segment surveyed was the near-stream portion of a very flat drainage segment that included 1150 meters to the nearest discernible drainage divides (with discontinuous ditch drainage along this length due to the flat topography), and potential drainage from portions of two spur roads. This road segment was surveyed during a light rainfall event over a two day period during April 1993, with more intense rainfall occurring during the night before the two-day sampling period. The on-site rain gauge recorded only 0.3 mm (a single tip) over a 7-hour precipitation monitoring period. Surface flow was observed in a roadside ditch, but this would best be characterized as inter-storm baseflow. Measurements of fines on the road surface and other observations of road surface conditions are indicative of a well-maintained road, with the thickness of fines on the road surface less than 2 cm (most measurements less than 0.5 cm.) in the center of the road, and generally 3-13 cm along the edges of the travelway. No rutting or rilling of the road surface was apparent. Grading of the road segment was observed the day prior to the road surface condition survey, during the runoff sampling period. Ditchlines and fill slopes were well-vegetated, and there were no cut-slopes due to the flat topography of the site on a main valley floor. The sampled segment was crowned, with a ditch on one side and with berms in sections farther away from the stream. Traffic on the day of road surface sampling included 23 heavy vehicles (log trucks, dump trucks, etc.) and 15 light vehicles over a 3 hour period. On the previous day during runoff sampling there were 51 heavy trucks and 31 light vehicles over a 6-hour period.</p>

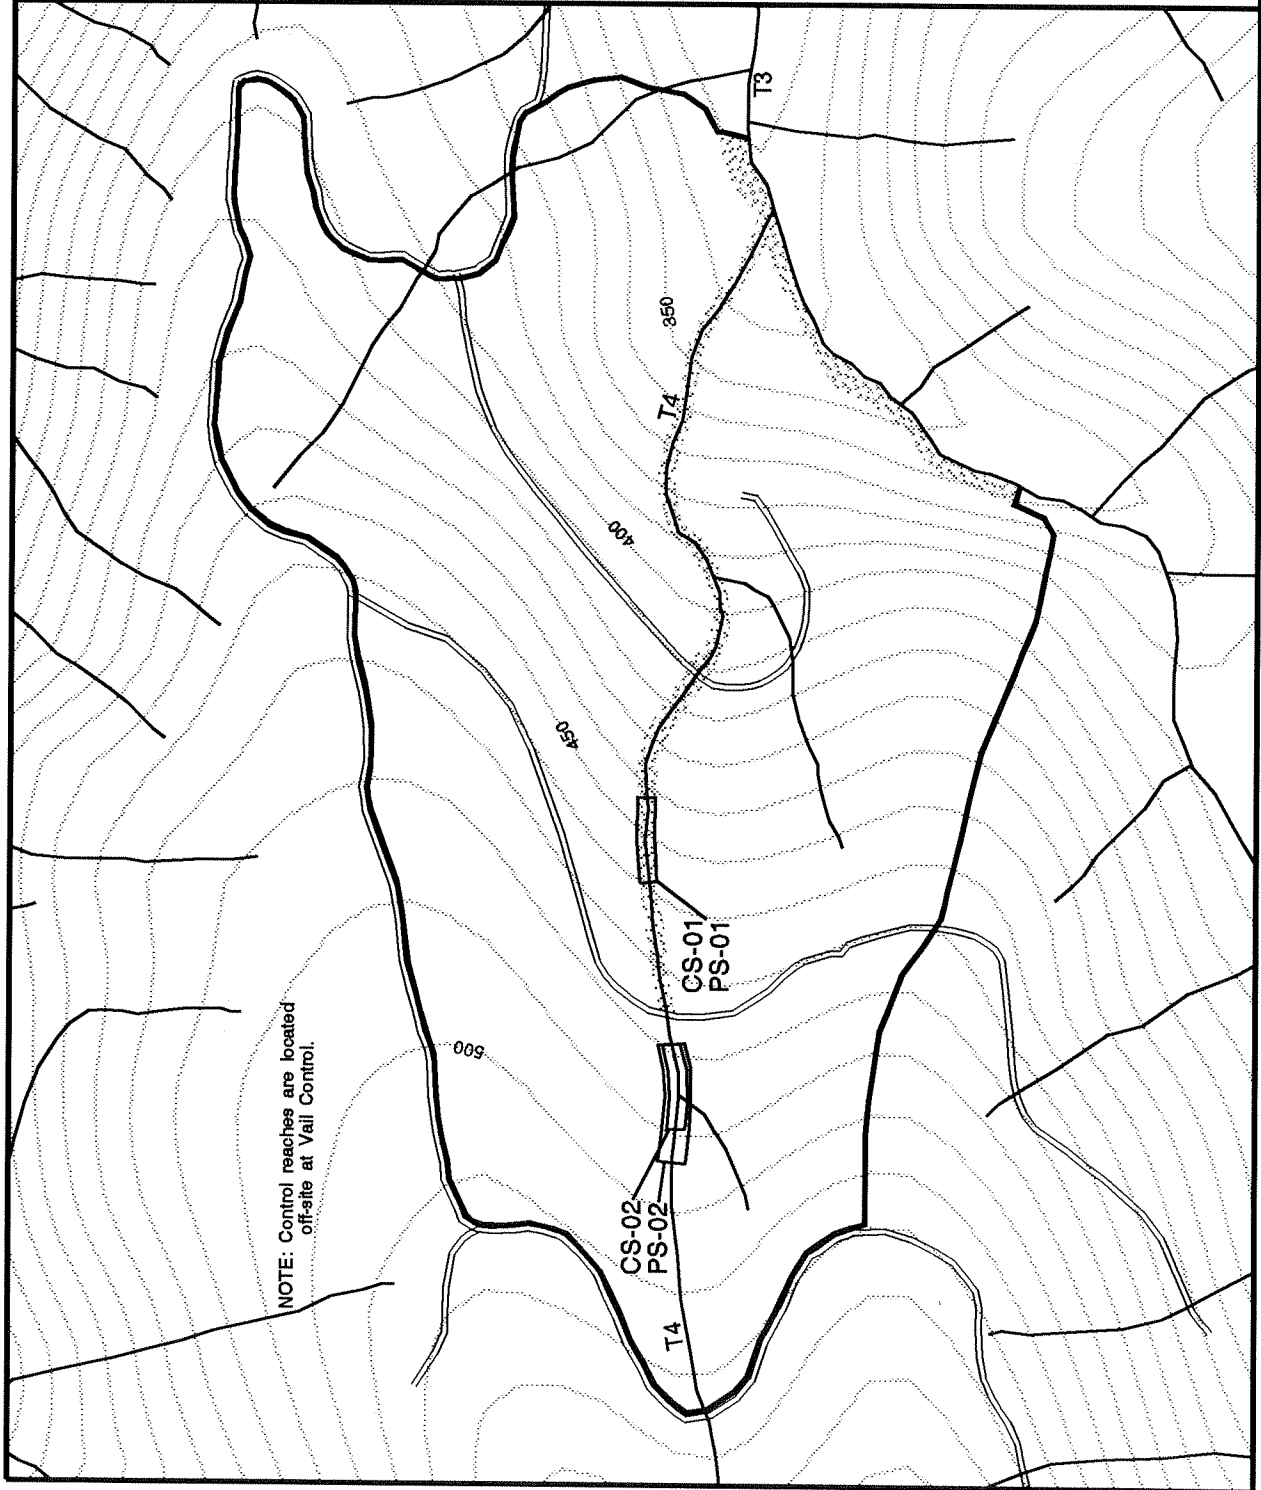
Study Site:	BMP Effectiveness Ratings			
	Survey Employed	Harvest w/ RMZ & Streambank Integrity BMPs (WAC 222-30-020(2-4) & -030 & -040 & 050)	Harvest with no buffers (Type 4 and/or 5 Waters)	Harvest with RL TAs (Type 4 and/or 5 Waters) (WAC 222-30-020(5))
<p>S-07: Eleven Creek 32 - Clearcut harvest with RMZ, and harvest without stream buffers</p>	Ground-based Yarding WAC 222-30-070	Cable Yarding WAC 222-30-060	Ground-based Yarding WAC 222-30-070	Ground-based Yarding WAC 222-30-070
<p>ASPECT 1: Effectiveness in terms of chronic erosion with delivery to surface waters.</p>	No separate erosion/delivery surveys were conducted.			
<p>Case Narrative: The RMZ was not yarded across in the vicinity of the survey areas; erosion features observed within the RMZ were associated with windthrow. Ground-based yarding across the type 4 stream occurred in the upper survey reach where the stream was not buffered.</p>

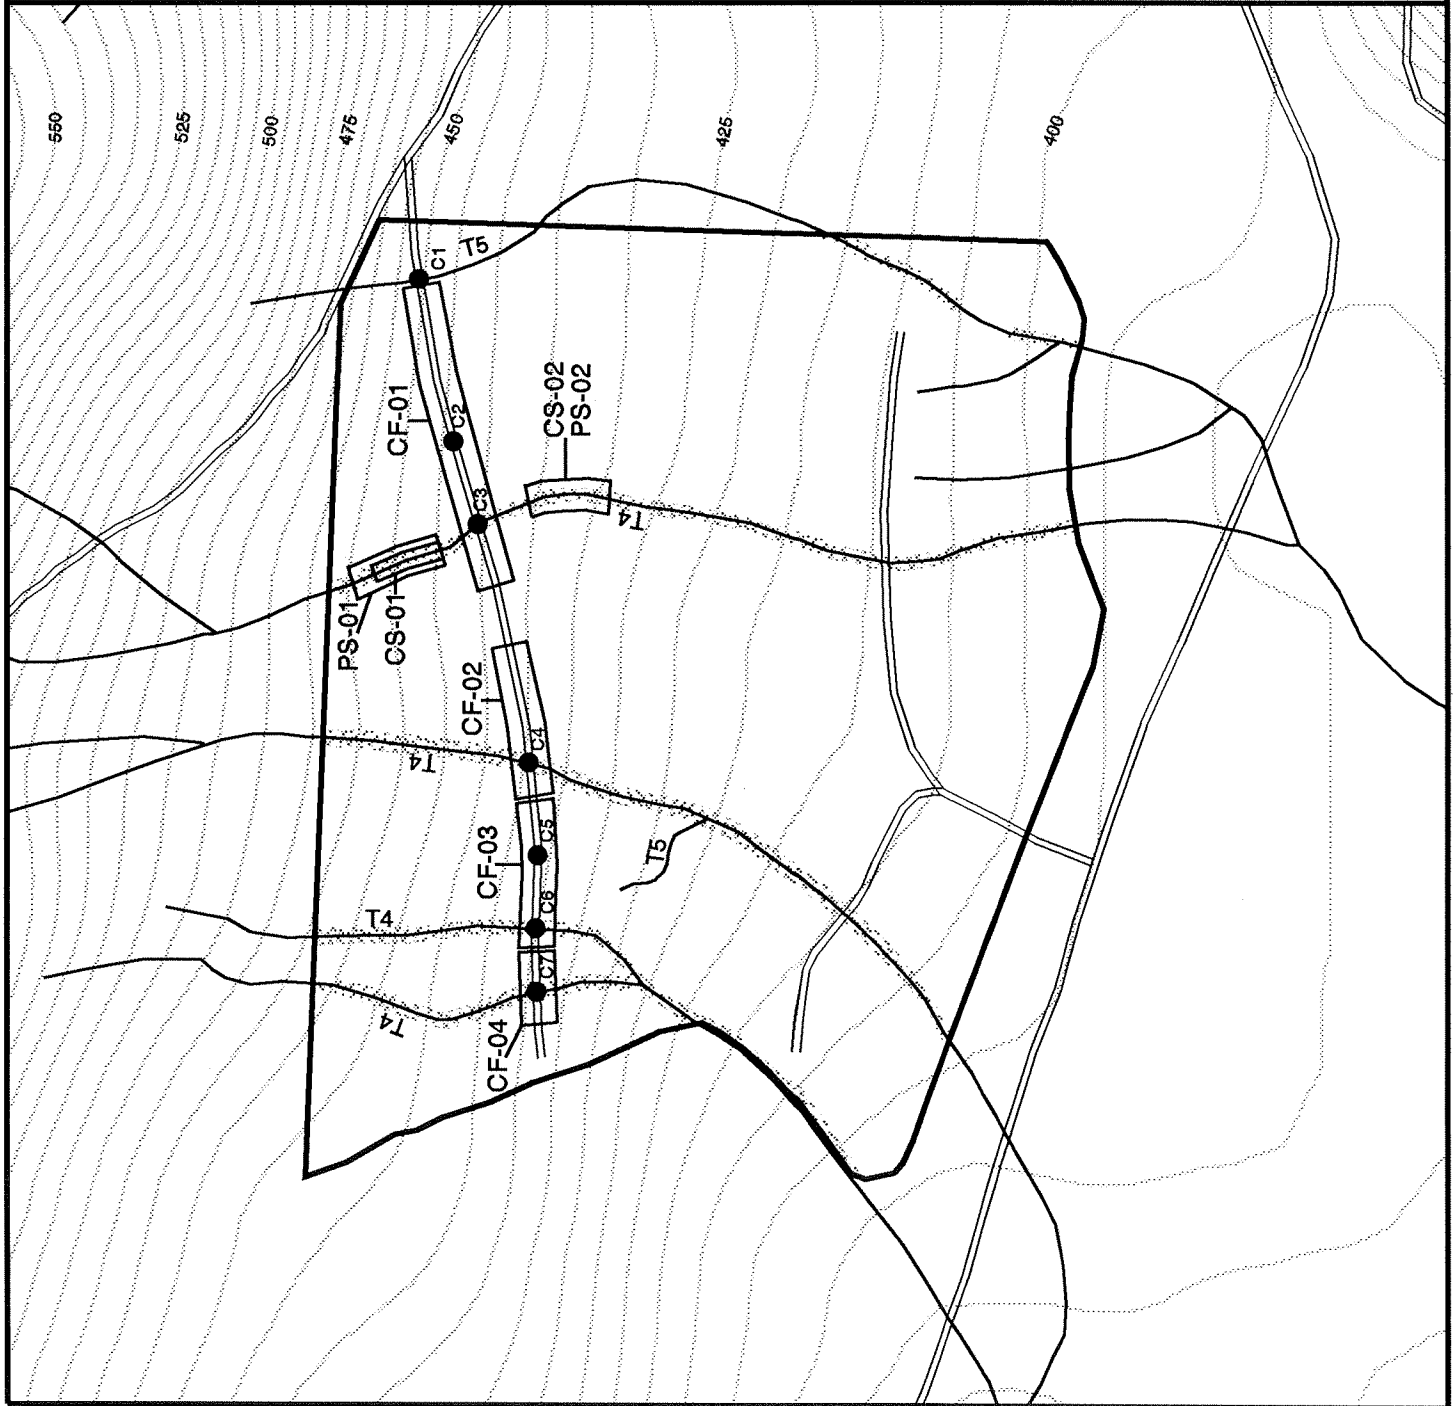
Site N-01 Upper Shop

Study Site: N-01: Upper Shop - Clearcut harvest with RLTA		BMP Effectiveness Ratings			
Survey Employed	Harvest w/ RMZ & Streambank Integrity BMPs (WAC 222-30-020(2-4) & -030 & -040 & 050)	Harvest with no buffers (Type 4 and/or 5 Waters)	Harvest with RLTA's (Type 4 and/or 5 Waters) (WAC 222-30-020(6))		
	Ground-based Yarding WAC 222-30-070	Ground-based Yarding WAC 222-30-070	Ground-based Yarding WAC 222-30-070	Cable Yarding	Cable Yarding
				WAC 222-30-060	WAC 222-30-060
ASPECT 1: Effectiveness in terms of chronic erosion with delivery to surface waters.	No separate erosion/delivery surveys conducted.				
Case Narrative:	There was no evidence of yarding across the RLTA in the vicinity of stream surveys. Along the study reaches, the RLTA appeared to be a no-cut buffer that extended to the slope break of the inner gorge.				
ASPECT 2: Effectiveness in terms of local stream impacts and response (sedimentation, physical integrity, and/or biological integrity).	Channel Condition: CS-01 CS-02 Photo Point: PS-01 PS-02				Effective Effective Effective Effective

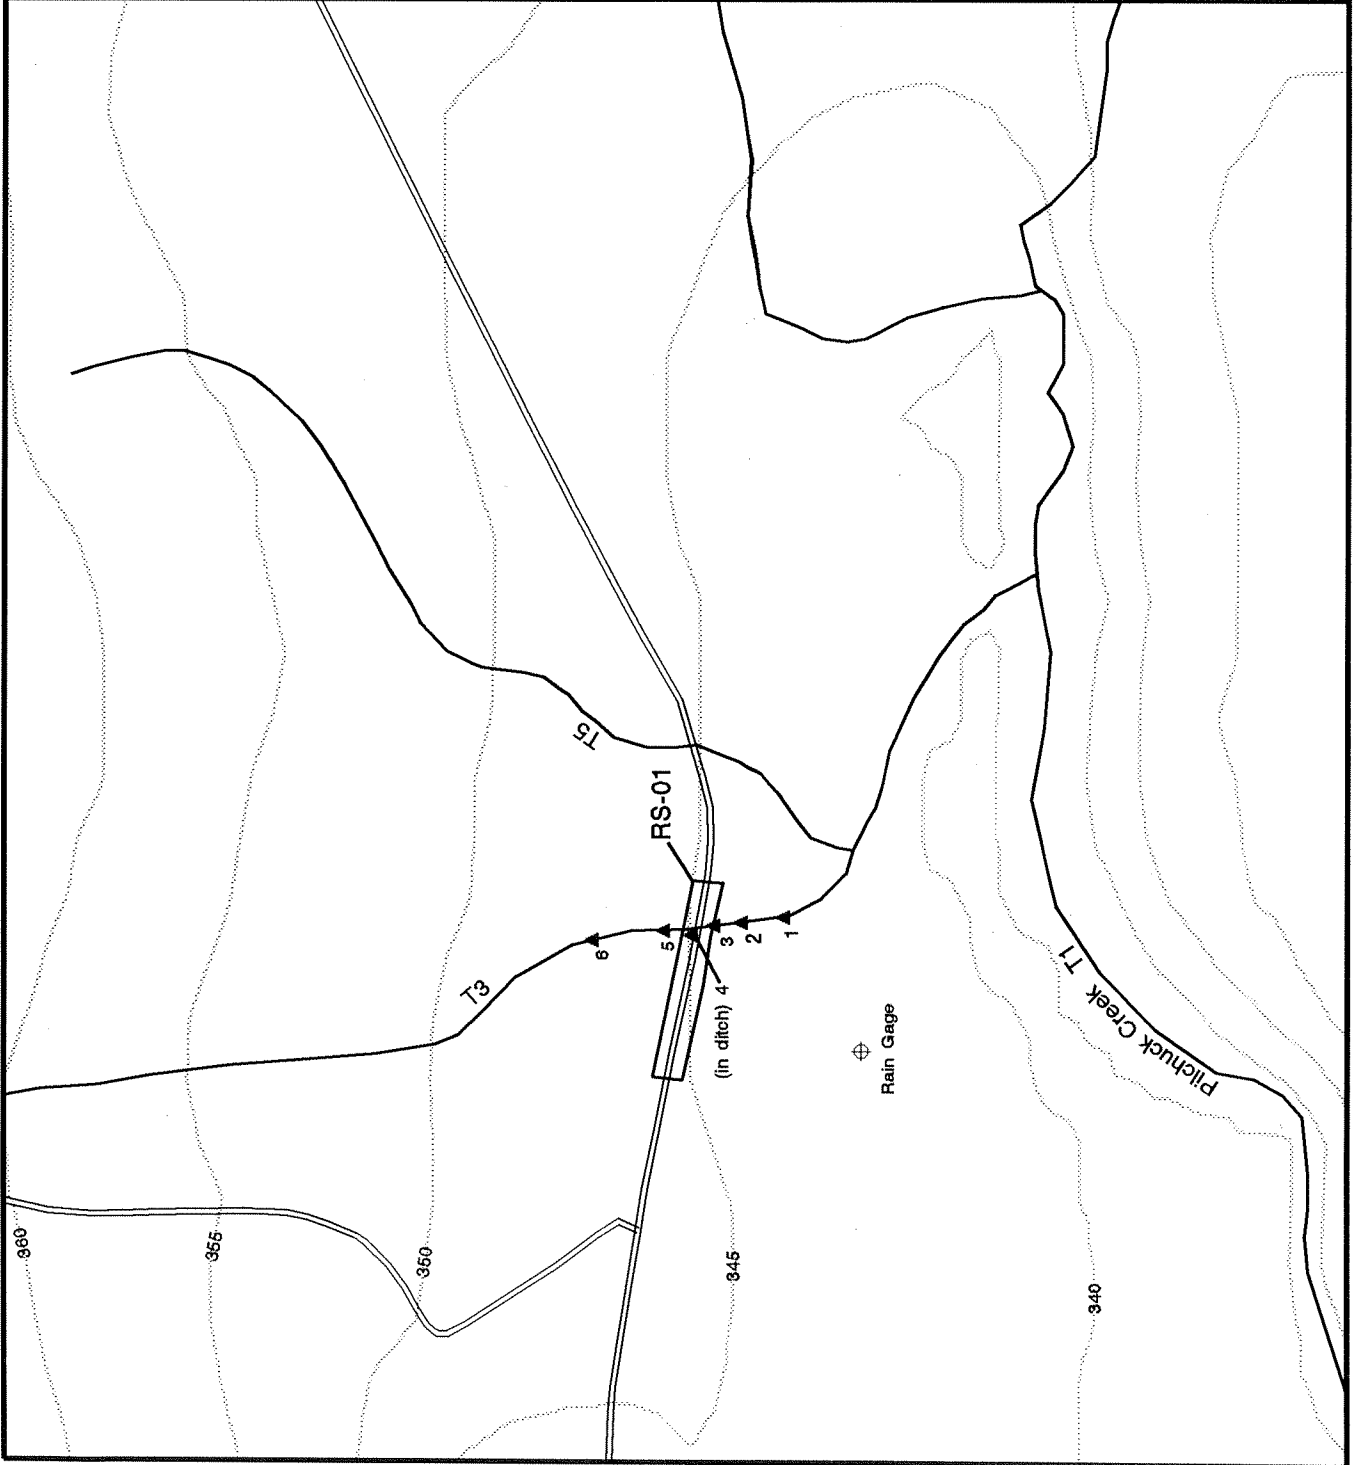
Site N-02 Pilchuck Mainline

<p>Study Site: N-02: Pilchuck Mainline</p>	<p>Survey Employed</p>	<p>BMP Effectiveness Ratings</p>	<p>Active Haul Road Maintenance WAC 222-24-050(2) & (4)</p>
<p>ASPECT 1: Effectiveness in terms of chronic erosion with delivery to surface waters.</p>	<p>Road Surface Condition: RS-01</p>	<p>Effective</p>	<p>The road segment surveyed was the near-stream portion of a drainage segment that included 186 m of mainline road, plus some additional drainage from a spur road. This road segment was surveyed during a single runoff event during April 1994. Weather conditions during the survey were characterized by intermittent heavy rain and periods of light rain. The on-site rain gage recorded a cumulative total of 20.1 mm falling over a 7 hour period. During one part of the day 18 mm of rain was recorded in just over 2 hours. Runoff on the road surface and in ditches was observed. The road did not have a competent gravel surface at the time of the survey. The travelway surface consisted of a layer of sand that had been temporarily placed to cover a layer of abrasive rock surfacing that had caused problems by damaging tires. However, the road surface condition survey resulted in a call of "Effective" because excessive generation of fines or other problematic conditions leading to water quality impacts were not observed. The thickness of fines on the road surface ranged from less than 0.5 cm to 5 cm, but the majority of measurements were less than 0.5 cm. on the travelway. Minor potholes (<0.2 m) and minor rutting were noted at some transects. The outer sides of ditches and fill slopes were well-vegetated. There were no appreciable cut slopes due to the flat topography of the site. The sampled segment was crowned, with a berms running along the side that was slightly downslope. Traffic on the day of sampling included 12 loaded log trucks, 10 unloaded log trucks and 12 light vehicles over a 7 hour period.</p>

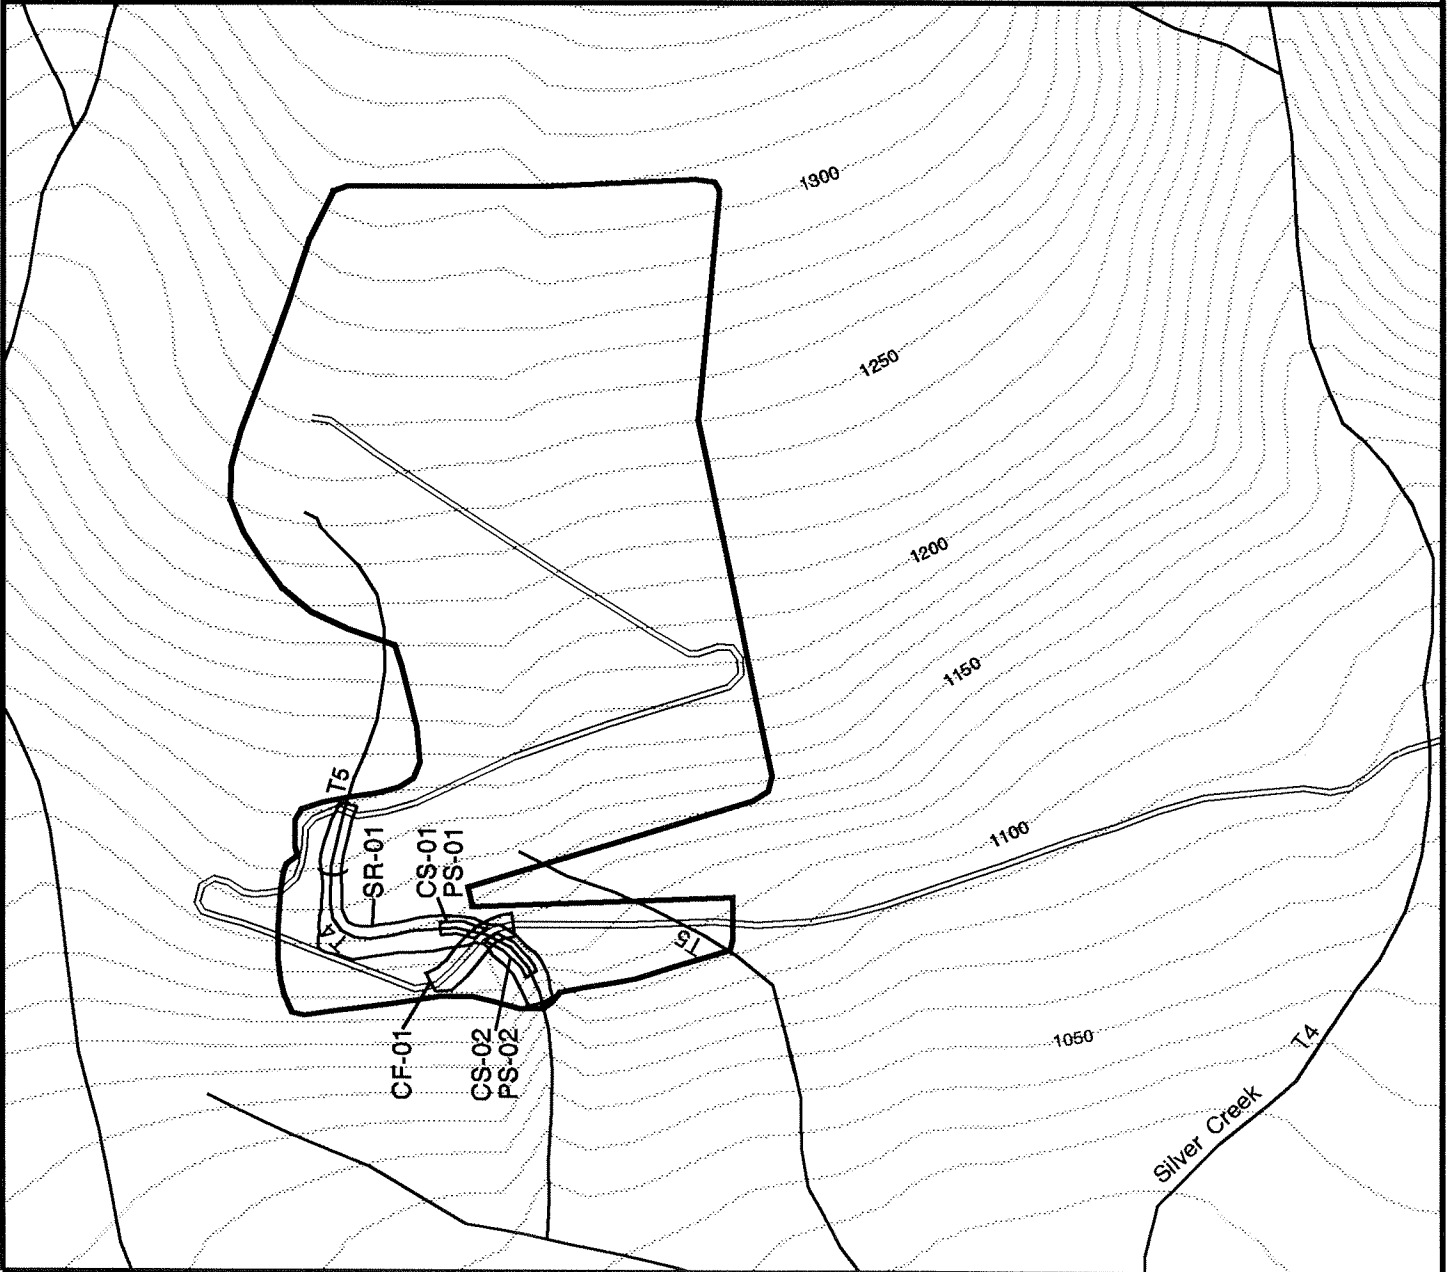
Site E-01 Fishlake Mine

<p>Study Site: E-01: Fish Lake Mine - Partial cut harvest without stream buffers.</p>	<p>Survey Employed</p>	<p>Harvest w/ RMZ & Streambank Integrity BMPs (WAC 222-30-020(2-4) & -030 & -040 & 050)</p> <p>Ground-based Yarding WAC 222-30-070</p> <p>Cable Yarding WAC 222-30-060</p>	<p>BMP Effectiveness Ratings</p> <p>Harvest with no buffers (Type 4 and/or 5 Waters)</p> <p>Ground-based Yarding WAC 222-30-070</p> <p>Cable Yarding WAC 222-30-060</p>	<p>Harvest with RL TAs (Type 4 and/or 5 Waters) (WAC 222-30-020(5))</p> <p>Ground-based Yarding WAC 222-30-070</p> <p>Cable Yarding WAC 222-30-060</p>
<p>ASPECT 1: Effectiveness in terms of chronic erosion with delivery to surface waters.</p>	<p>Sediment Routing: SR-01</p>	<p>Not Effective</p>	<p>Not Effective</p>	<p>Not Effective</p>
<p>Case Narrative:</p>	<p>The sediment routing surveys documented substantial sediment delivery to and disturbance of the Type 4 stream (Type 5 in the upper reaches within the harvest unit). Erosion and sediment delivery was greatest in two zones where timber was yarded diagonally across the stream, disturbing banks and valley walls. At the time of the first survey (9 months following harvest), disturbed soils covered 24% of the survey area, with all but 0.5 m² of this erosion caused by timber harvest activity. A substantial amount of natural revegetation of disturbed areas had occurred by the follow-up survey conducted 25 months after harvest, with soil disturbance reduced to 4 % of the survey area, but half of the harvest erosion features that were found to deliver the first year were continuing to deliver sediment to the stream, and stream bank sloughing was continuing in an area disturbed by falling and yarding activities.</p>

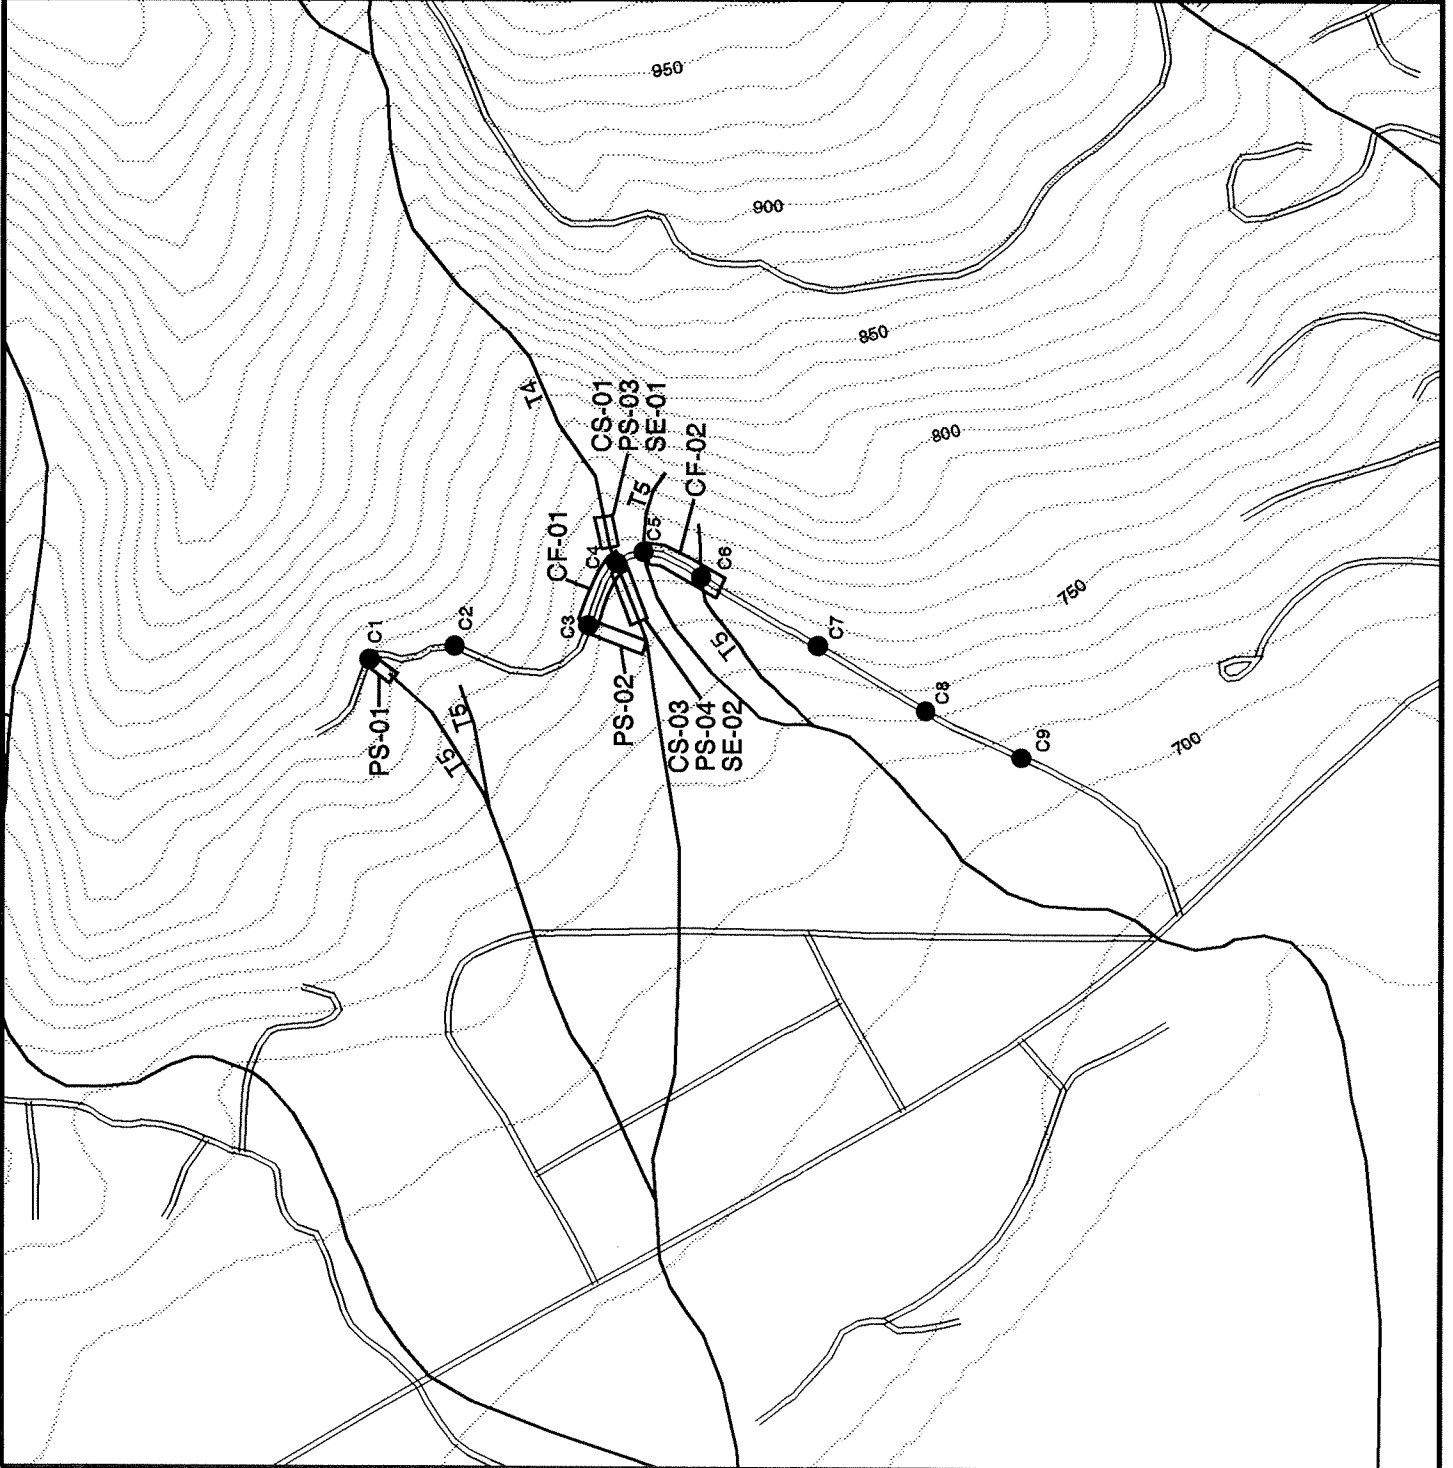
Site E-02 Plesha Road

Study Site: E-02: Plesha Road - New Road Construction		BMP Effectiveness Ratings			
Survey Employed	Culvert BMPs	Road Construction BMPs	Cutslopes	Fillislopes	
	Stream Xings WAC 222-24-040	Relief WAC 222-24-025		WAC 222-24-030	
Culvert Condition: CC-01	Not Effective	Effective			
Cutbank/Fillislope: CF-01			Not Effective	Effective	
CF-02			Effective	Effective	
Photo Point: PS-01 & PS-02		Effective			
Erosion Pin Network: EP-01					Indeterminate
Case Narrative:	Relief culverts did not deliver to streams over the 27 month post-construction monitoring period and are rated effective. Sediment transport distances downslope of relief outfalls ranged from less than 1 meter to 27 meters. Several of the relief culverts had functioning sediment traps. Maintenance/clean-out of ditches and sediment traps was noted in the 1993 culvert condition survey. Photo point surveys and channel profile and cross-section measurements made to evaluate effects of road drainage on a stream channel head just downslope of culvert C1 did not detect headward migration or other channel changes over the monitoring period. Erosion of culvert fills at stream crossings was continuing at moderate to severe levels 27 months following road construction, despite re-armoring of some culvert fills in 1993. Cutslope erosion continued at moderate to severe levels due to the highly erodible soils and a lack of adequate revegetation practices, resulting in chronic sediment delivery via sediment transport in the ditch draining to the type 4 stream crossing (CF-01 drainage segment). An erosion pin network installed to monitor cutslope erosion in the same drainage segment was rated indeterminate because the pins were lost as a result of sloughing of the road cut and/or ditch maintenance activities before follow-up measurements could be made. BMPs at another cutslope in the CF-02 drainage segment were rated effective because there was no evidence that eroded cutslope material was delivered to the type 5 stream. There was little evidence of surface flow in the ditch at this relatively flat drainage segment, and a small sediment trap appeared to have prevented sediment delivery to the stream. The fillislopes were not found to deliver sediment except at the immediate vicinity of culverts fills (with exception of minor amounts of ravel from the CF-02 segment), and are rated effective.
