Appendices I and J

Effectiveness of Forest Road and Timber Harvest Best Management Practices with Respect to Sediment-Related Water Quality Impacts

December 1999
Publication No. 99-350

by
Ed Rashin
Casey Clishe
Andy Loch
Johanna Bell

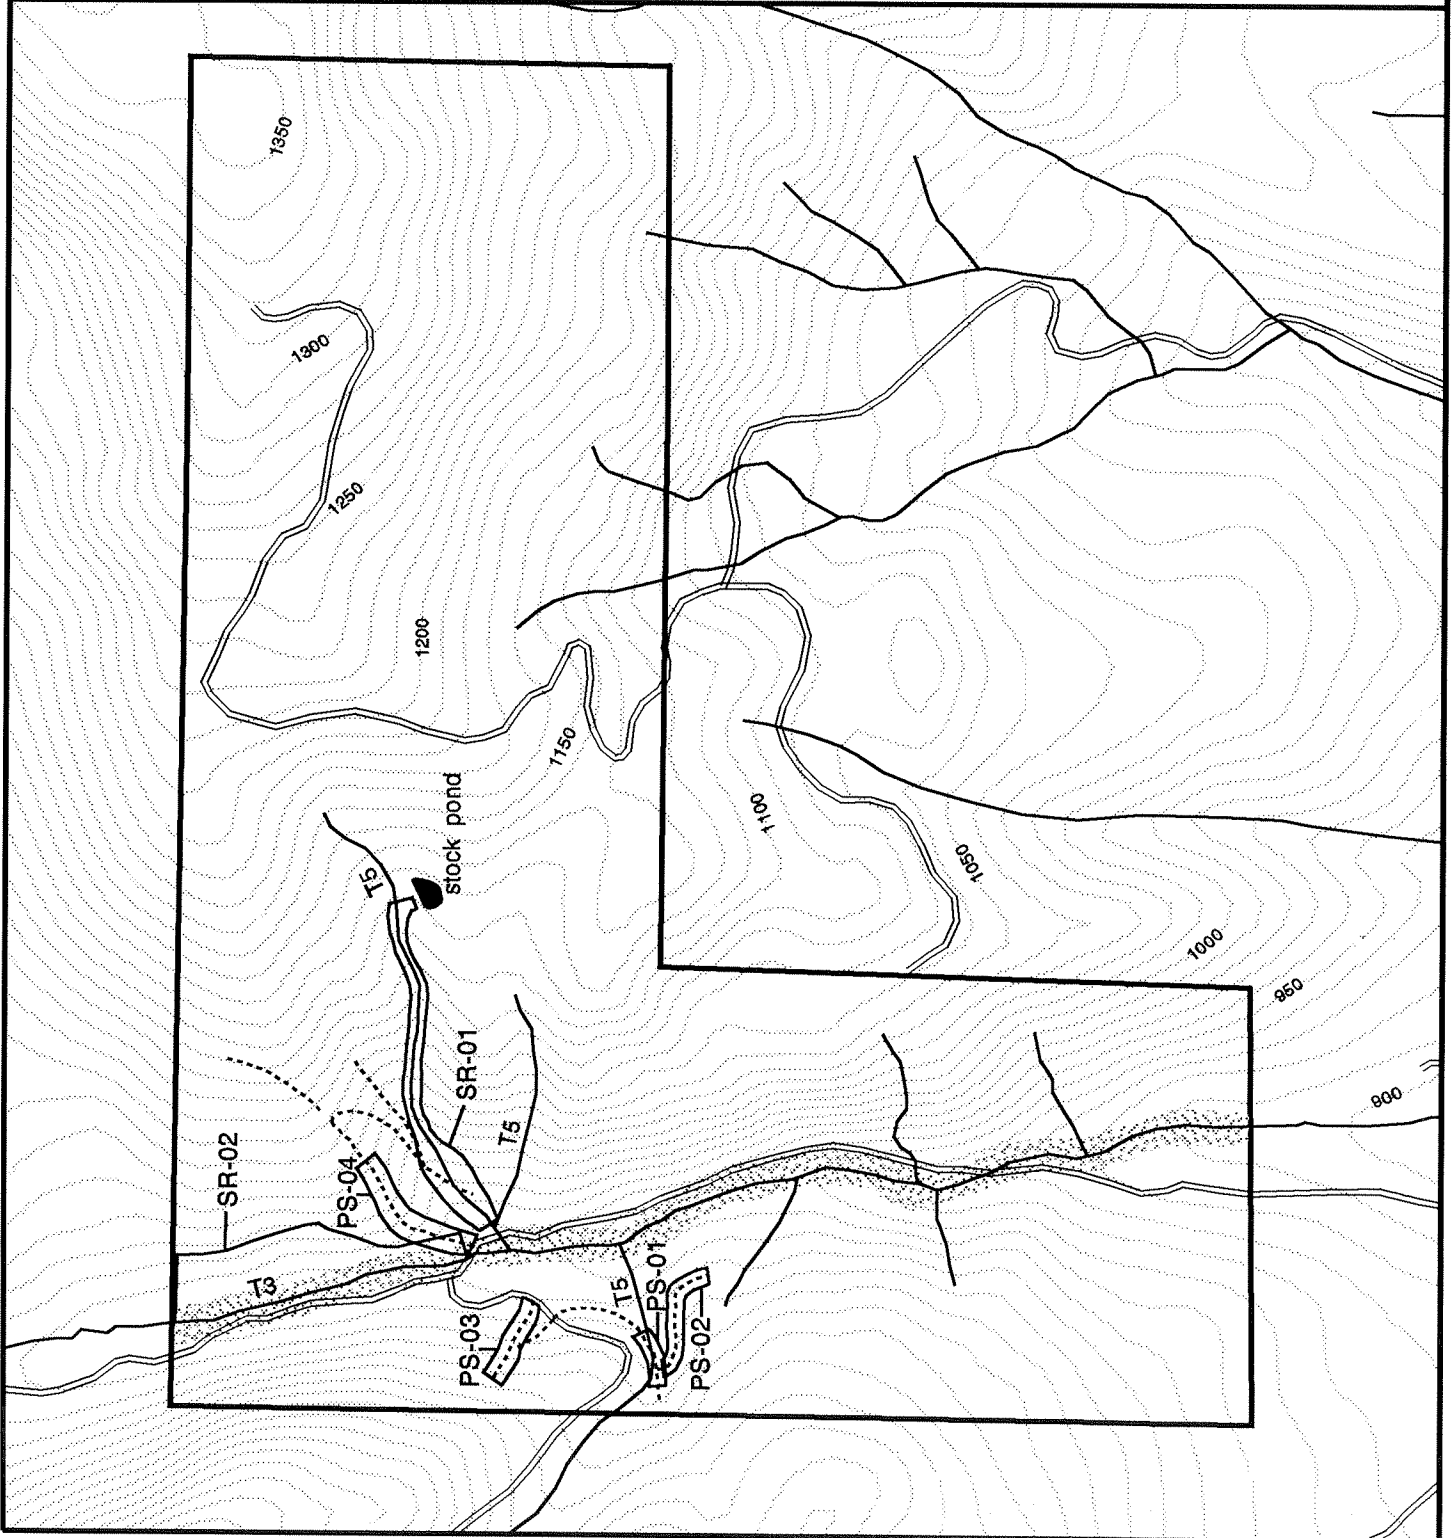
Study Site: E-04: Green Canyon - Partial cut harvest, with RMZ and harvest without stream buffers	BMP Effectiveness Ratings			
	Survey Employed	Harvest w/ RMZ & Streambank Integrity BMPs (WAC 222-30-020(2-4) & -030 & -040 & 050)	Harvest with no buffers (Type 4 and/or 5 Waters)	Harvest with RLTA's (Type 4 and/or 5 Waters) (WAC 222-30-020(5))
ASPECT 1: Effectiveness in terms of chronic erosion with delivery to surface waters.	Sediment Routing: SR-01 SR-02	Ground-based Yarding WAC 222-30-070	Ground-based Yarding WAC 222-30-070	Ground-based Yarding WAC 222-30-070
	Photo Point (Skid Trails): PS-01 PS-02 PS-03 PS-04	Effective	Partially Effective	Partially Effective
	Case Narrative: The RMZ was effective at preventing sediment delivery directly to the type 3 stream from erosion associated with harvest activities. In the vicinity of the survey areas, there was no timber harvest within the RMZ, which was sparsely vegetated due to historical grazing and land clearing activities. The SR-02 sediment routing survey, conducted 17 months following timber harvest, documented sediment delivery to the type 3 stream from erosion caused by wildlife activity (e.g., elk trails) and stream bank erosion, but not from skid trails. Photo point surveys evaluating skid trail erosion in the vicinity of the RMZ found that water bars constructed on the skid trails were effective at preventing gullies or other chronic erosion problems and storing or diverting sediment, so that no delivery to the type 3 stream was observed, even though one of the skid trails came within about 4 meters of the stream. Localized sediment delivery to an unbuffered Type 5 stream was documented at a skid trail crossing in the SR-01 survey. The trail crossing was made at a location on this intermittent stream where there was no defined channel, and there was no evidence of substantial amounts of sediment delivery beyond the immediate crossing area. However, the skid trial was not water-barred or revegetated, and potential exists for chronic sediment delivery to the stream system during snowmelt or runoff events. Photo point surveys evaluating skid trail erosion in the vicinity of another unbuffered type 5 stream found that water bars constructed on one of the skid trails were effective at preventing gullies or other chronic erosion problems, and storing or diverting sediment, thus preventing delivery to the stream located downslope of the trail. The PS-01 survey evaluated another skid trail that was located within a type 5 drainage swale that had intermittent flow in a discontinuous, ill-defined channel. There was localized disturbance and sediment routing within the drainage, but no evidence that sediment was routed downstream of the skid trail.	Effective	Partially Effective	Partially Effective

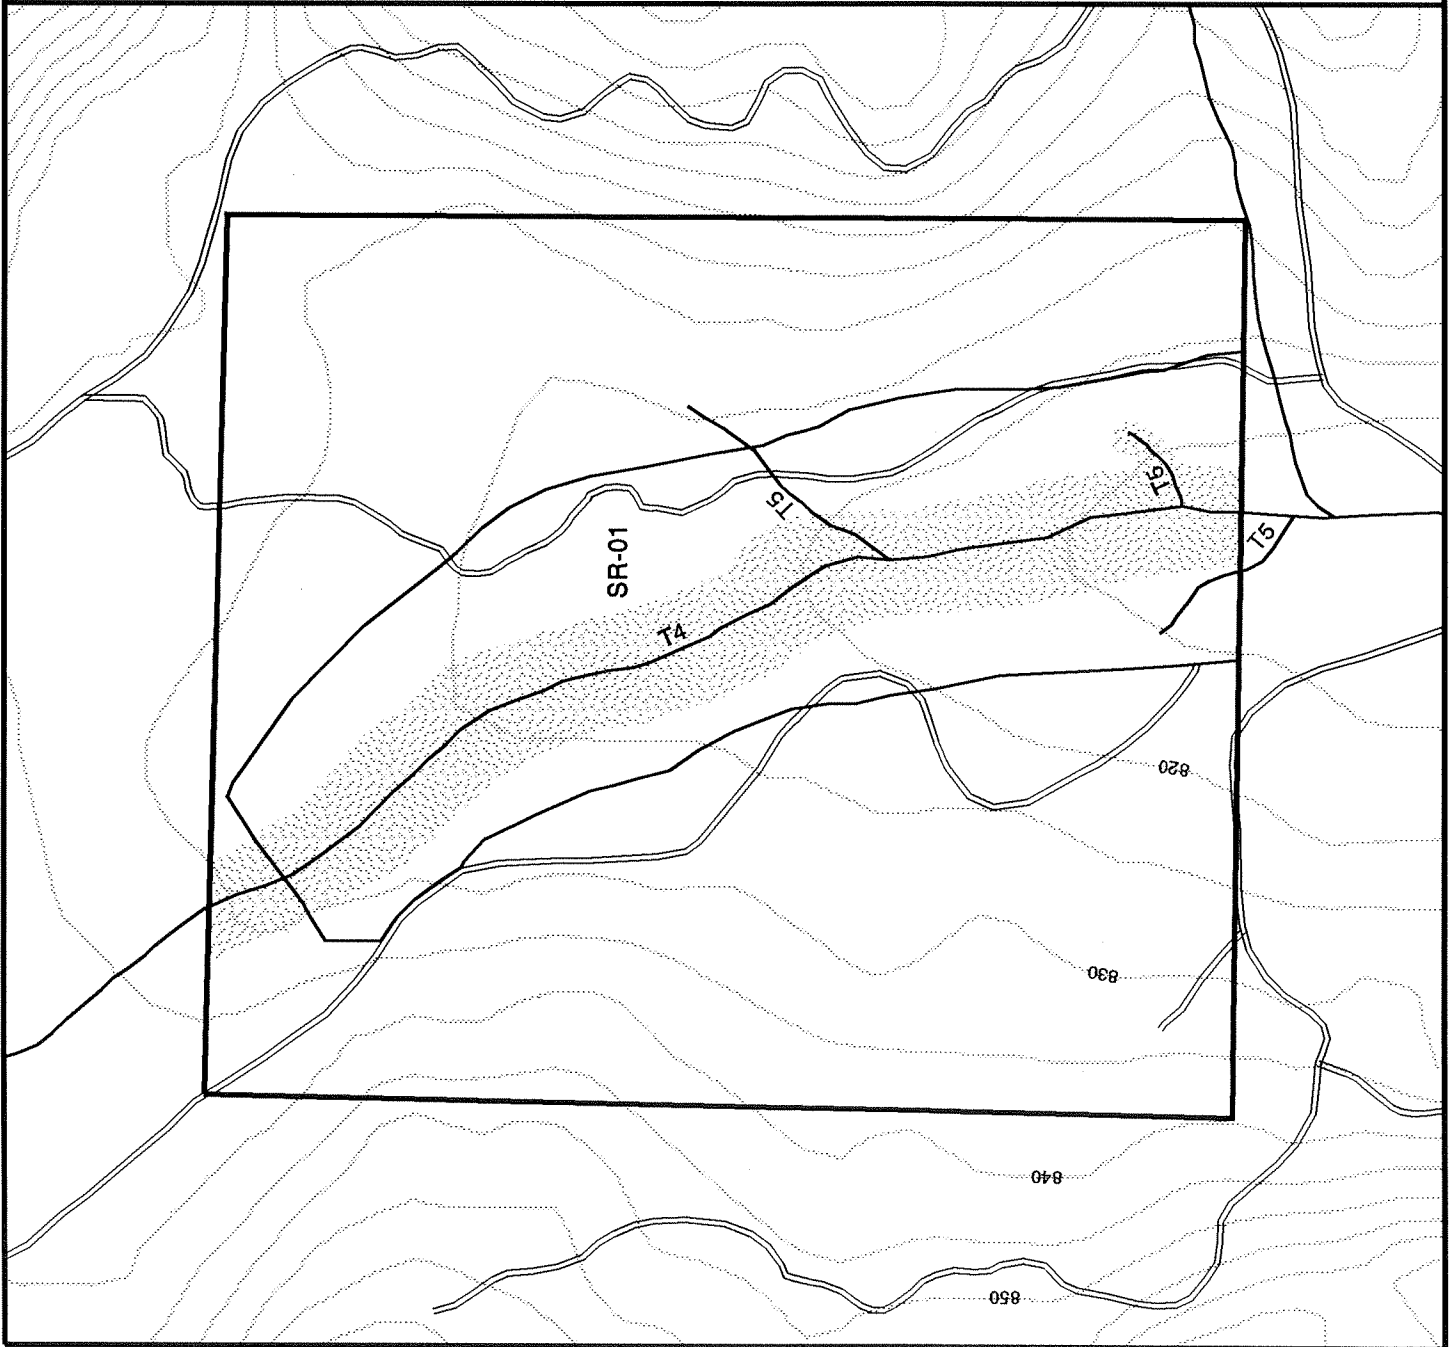
Site E-05 Aspen Patch

Study Site: E-05: Aspen Patch - Partial cut harvest with RMZ		BMP Effectiveness Ratings			
Survey Employed	Harvest w/ RMZ & Streambank Integrity BMPs (WAC 222-30-020(2-4) & -030 & -040 & 050)	Harvest with no buffers (Type 4 and/or 5 Waters)	Harvest with RLTA's (Type 4 and/or 5 Waters) (WAC 222-30-020(6))	Ground-based Yarding	Cable Yarding
	Ground-based Yarding WAC 222-30-070	Cable Yarding WAC 222-30-060	Ground-based Yarding WAC 222-30-070	Ground-based Yarding WAC 222-30-070	Cable Yarding WAC 222-30-060
ASPECT 1: Effectiveness in terms of chronic erosion with delivery to surface waters.	Sediment Routing: SR-01 Effective				
Case Narrative:	The BMPs evaluated in this case included a wide RMZ left to protect an intermittent type 4 stream and forested wetland from ground-based yarding activities on a partial cut harvest. There was no yarding across the stream or wetland, and no erosion features from timber falling, yarding, or site preparation activities were found to deliver sediment to the type 4 stream. 5 of 24 yarding-related erosion features identified in the sediment routing surveys caused localized disturbance of the perimeter of the wetland, but there was no evidence of surface flow or sediment transport to the stream. Some of the skid trail erosion features identified in the first survey (13 months following harvest) had revegetated by the time of the follow-up survey conducted 23 months following harvest. Two off-road vehicle trails within the survey area crossed the stream and wetland, with sediment delivery to the stream. It was also noted that a haul road crossing of a type 5 swale within the survey area delivered minor amounts of sediment to the type 5.

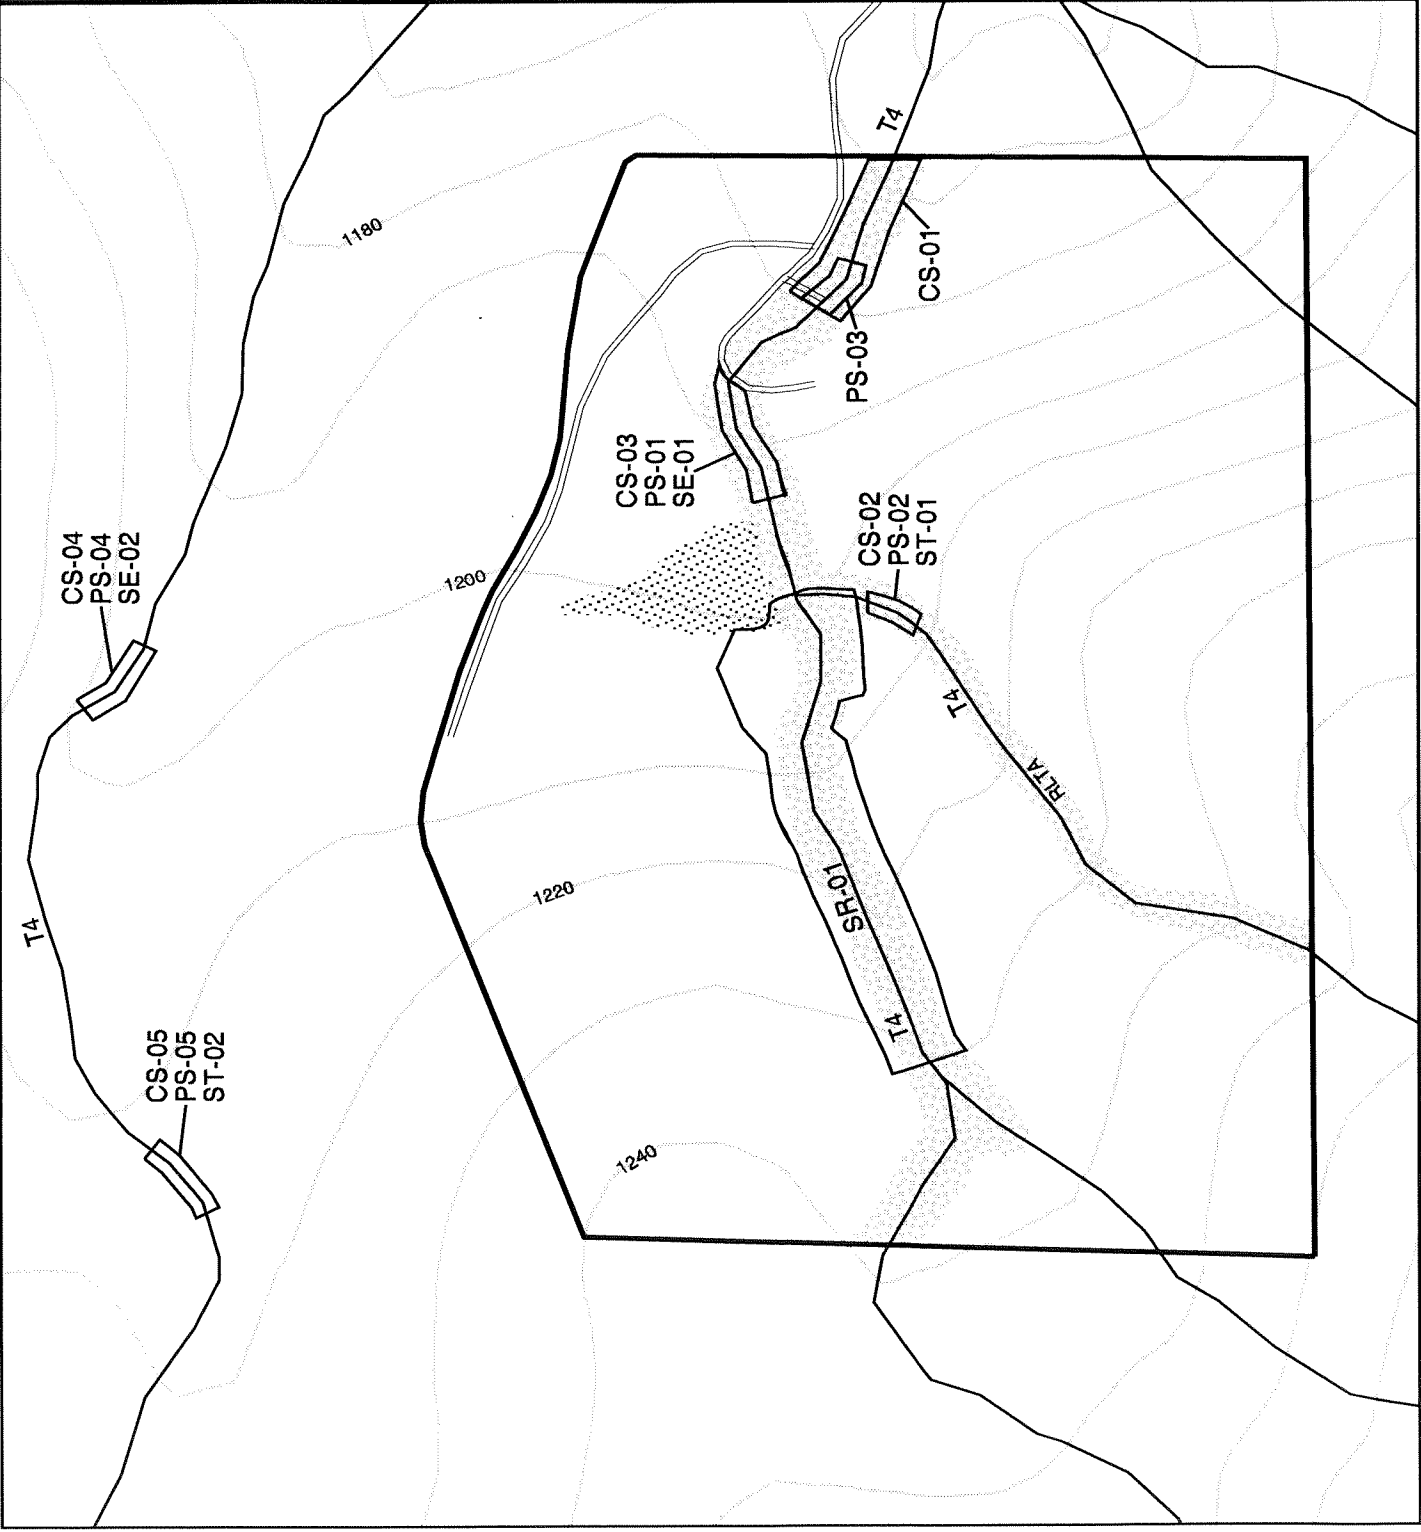
Site R-02 Muddy West

<p>Study Site: R-02. Mudy West - Partial cut harvest, with RMZ and with RLTA.</p>	<p>Survey Employed</p> <p>Harvest w/ RMZ & Streambank Integrity BMPs (WAC 222-30-020(2-4) & -030 & -040 & 050)</p> <p>Ground-based Yarding WAC 222-30-070</p> <p>Cable Yarding WAC 222-30-060</p>	<p>BMP Effectiveness Ratings</p> <p>Harvest with no buffers (Type 4 and/or 5 Waters)</p> <p>Ground-based Yarding WAC 222-30-070</p> <p>Cable Yarding WAC 222-30-060</p>	<p>Harvest with RLTA's (Type 4 and/or 5 Waters) (WAC 222-30-020(6))</p> <p>Ground-based Yarding WAC 222-30-070</p> <p>Cable Yarding WAC 222-30-060</p>
<p>ASPECT 1: Effectiveness in terms of chronic erosion with delivery to surface waters.</p>	<p>Case Narrative: The sediment routing survey evaluated erosion and sediment delivery from ground-based yarding on partial cut harvest areas on both sides of the main type 4 stream (referred to as the "Muddy West" stream) that was buffered by a RMZ. The RMZ was not crossed by timber yarding routes, although it was noted that a limited number of trees were harvested from the RMZ. At the time of the survey conducted 18 months following harvest, disturbed soils from skid trails and other yarding activity covered 5% of the survey area. None of the erosion features identified in the survey delivered sediment directly to the type 4 stream buffered by the RMZ. One main skid trail was associated with minor amounts of delivery to a type 4 tributary to the main stream. This occurred at a crossing of the tributary, which was buffered with a RLTA, but water bars on the skid trail limited sediment delivery to a localized area at the crossing.</p>	<p>Sediment Routing: SR-01</p> <p>Effective</p>	<p>Channel Condition: CS-01/CS-04 CS-02/CS-05 CS-03/CS-04</p> <p>Photo Point: PS-01/PS-04 PS-02/PS-05 PS-03/PS-04</p> <p>Stream Bank Erosion: SE-01B/SE-02</p> <p>Streambed Stability ST-01/ST-02</p>

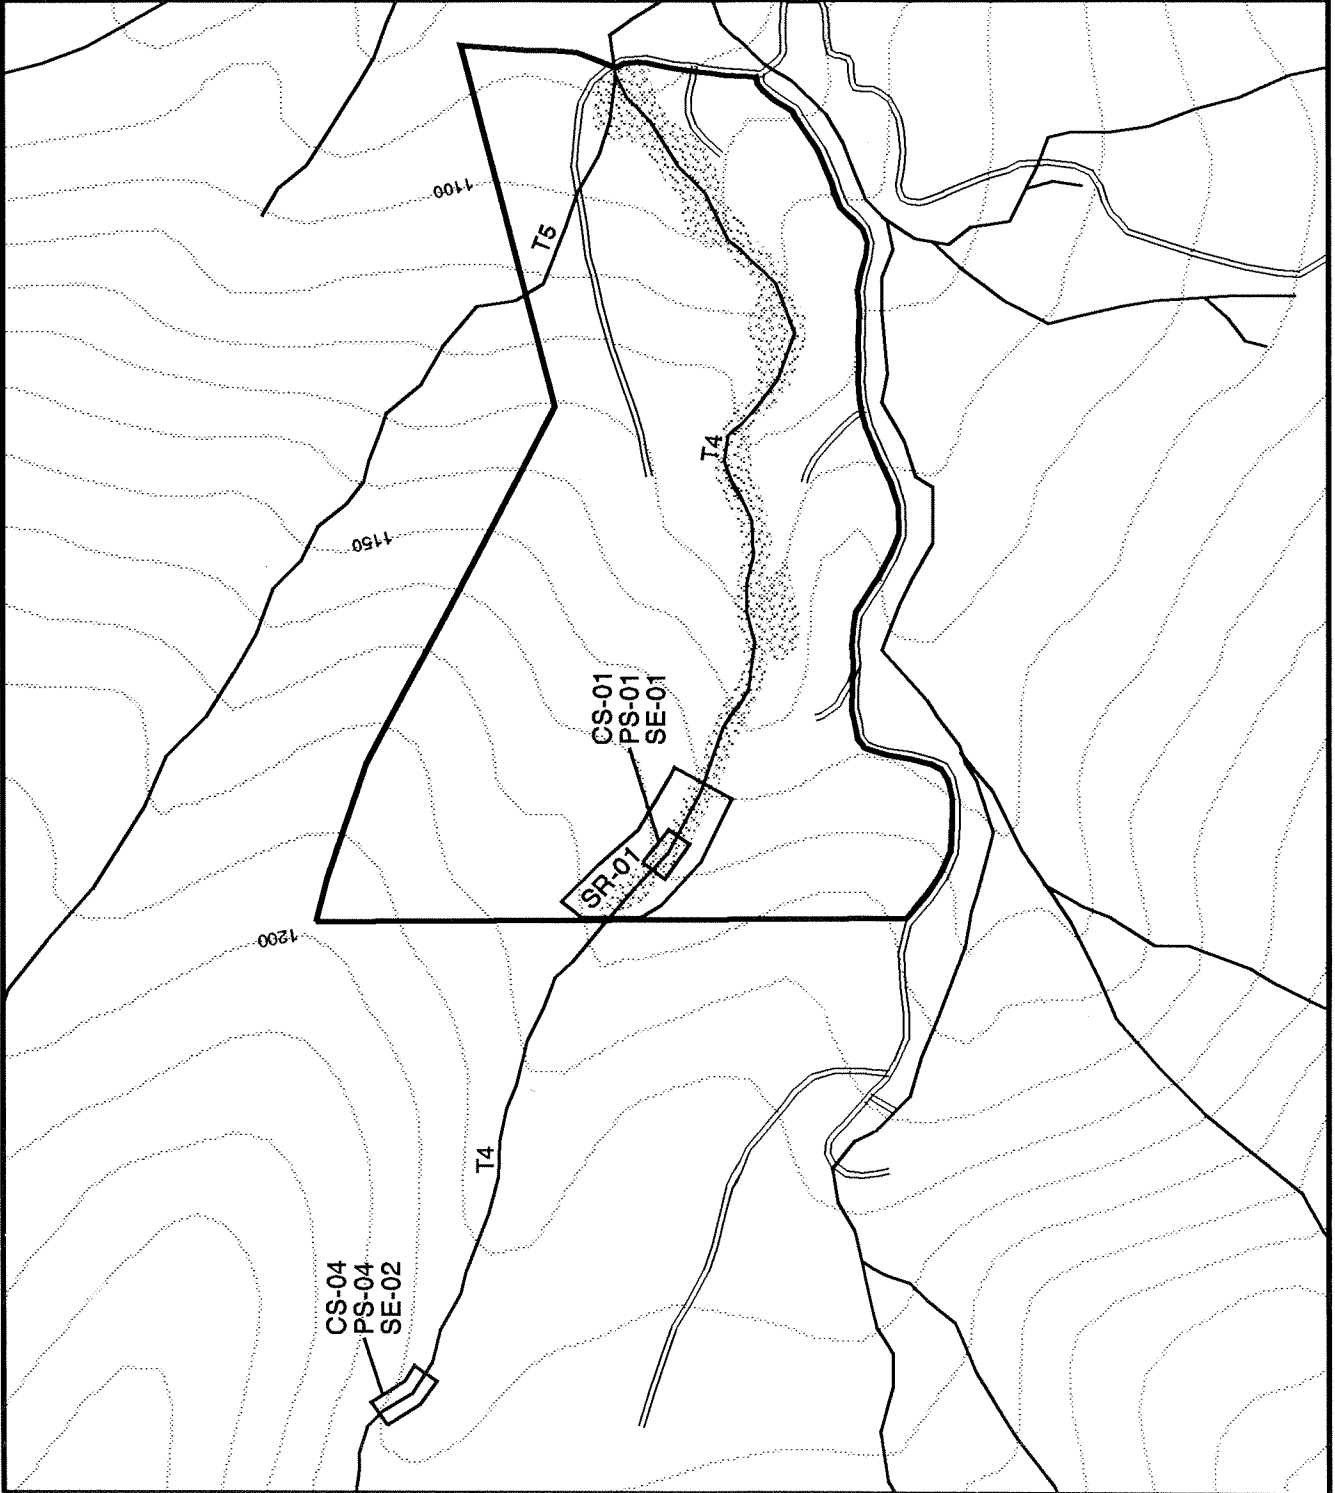
Site R-03 Muddy East

Study Site:	R-03: Muddy East - Partial cut harvest with RMZ	BMP Effectiveness Ratings			
		Harvest w/ RMZ & Streambank Integrity BMPs (WAC 222-30-020(2-4) & -030 & -040 & 050)	Harvest with no buffers (Type 4 and/or 5 Waters)	Harvest with RLTA's (Type 4 and/or 5 Waters) (WAC 222-30-020(6))	
Survey Employed		Ground-based Yarding WAC 222-30-070	Ground-based Yarding WAC 222-30-070	Cable Yarding WAC 222-30-060	Cable Yarding WAC 222-30-060
Sediment Routing: SR-01		Effective			
ASPECT 1: Effectiveness in terms of chronic erosion with delivery to surface waters.					
Case Narrative:	Although major skid roads ran parallel to and within 15 to 30 meters of the stream, no erosion features attributed to timber falling or yarding were found to deliver sediment to the stream buffered with a RMZ within the survey area on this partial cut unit. Disturbed soils covered 15% of the survey area in the survey conducted 9 months following harvest. The only erosion features delivering sediment to the stream within the survey area were associated with two windthrown trees.

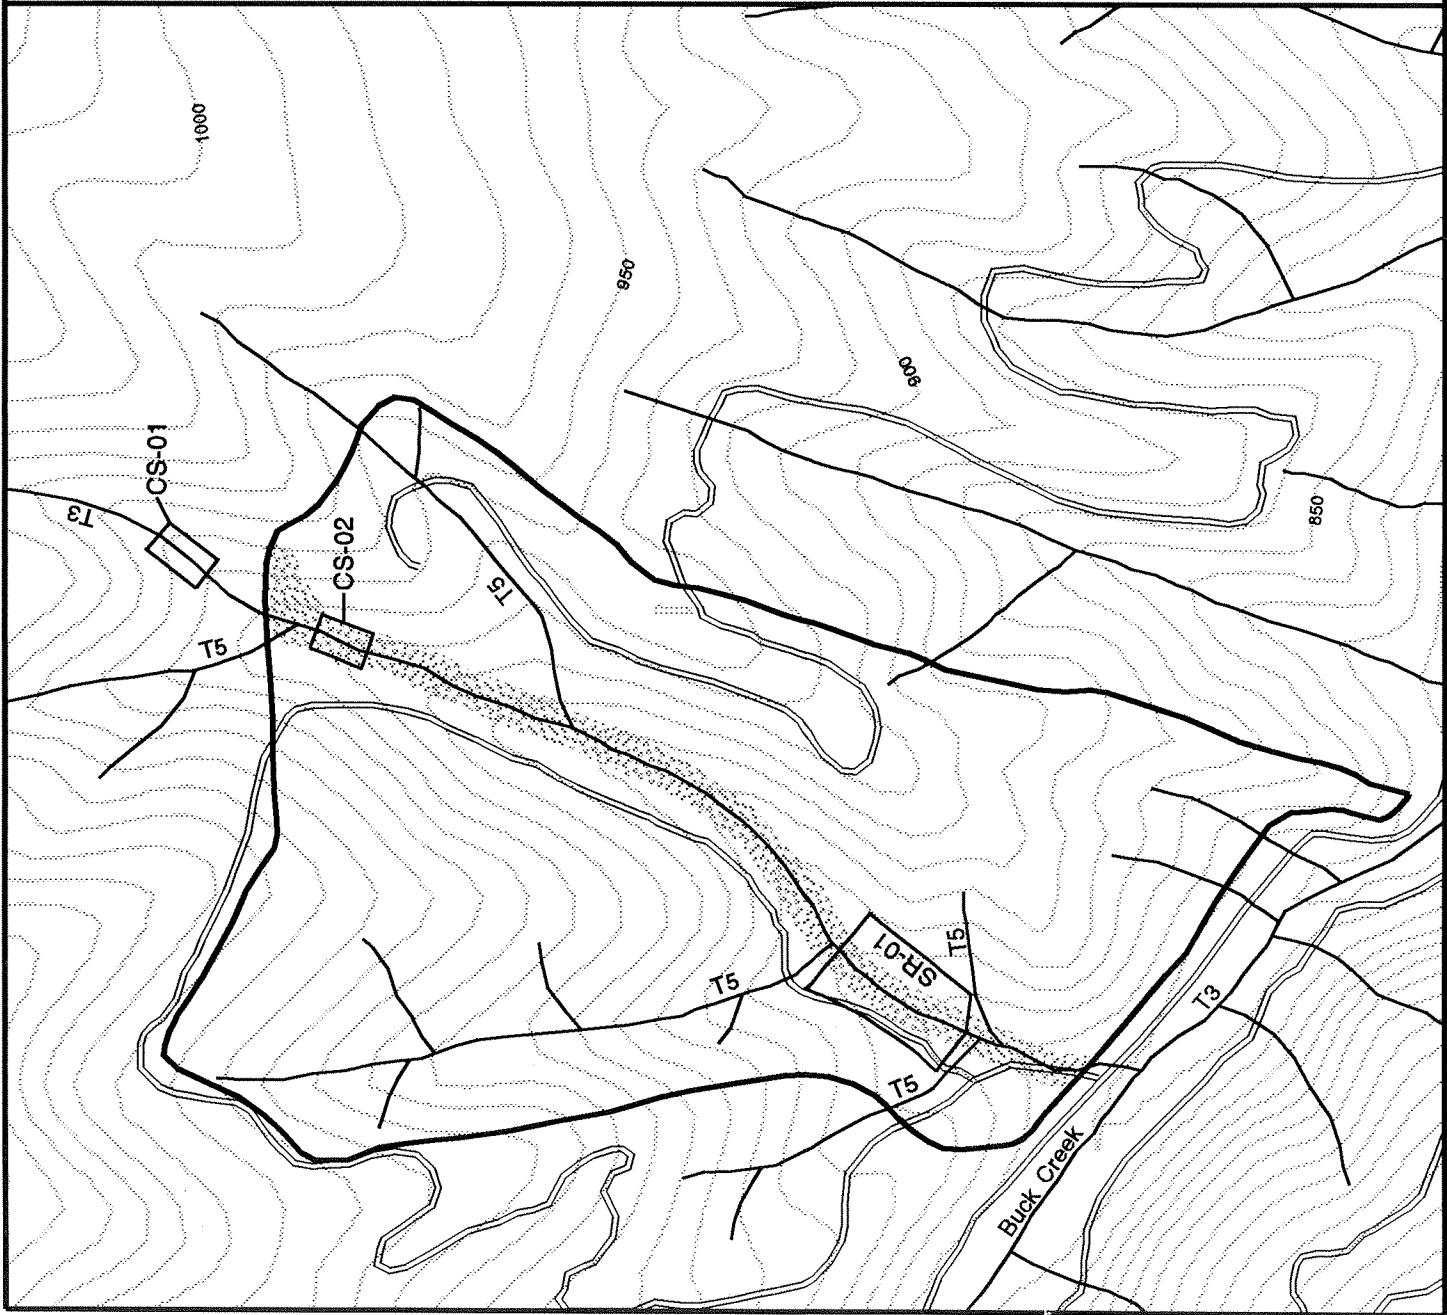
Site R-04 Buck East

Study Site:	R-04: Buck East - Partial cut harvest with RMZ	BMP Effectiveness Ratings			
		Survey Employed	Harvest w/ RMZ & Streambank Integrity BMPs (WAC 222-30-020(2-4) & -030 & -040 & 050)	Harvest with no buffers (Type 4 and/or 5 Waters)	Harvest with RLTA's (Type 4 and/or 5 Waters) (WAC 222-30-020(5))
ASPECT 1: Effectiveness in terms of chronic erosion with delivery to surface waters.	Ground-based Yarding	Cable Yarding	Ground-based Yarding	Cable Yarding	Ground-based Yarding
	WAC 222-30-070	WAC 222-30-060	WAC 222-30-070	WAC 222-30-060	WAC 222-30-060
Case Narrative:	Sediment Routing: SR-01	Effective			
	<p>Although major skid trails ran parallel to the stream, no erosion features attributable to timber harvest activities were found to be chronic sources of sediment to the stream buffered with a RMZ within the sediment routing survey area. However, several skid trail features were observed to be delivering sediment to the type 3 stream during the initial survey conducted 6 months following harvest. This temporary sediment delivery was associated with drainage from several skid trail spurs that concentrated surface runoff at a skid trail that paralleled the stream. The concentrated drainage eroded cut and fill slopes and was subsequently routed to the stream via numerous small (<10 cm wide) channelized drainage paths across the RMZ. No channelized flowpaths or other evidence of routing from this skid trail was observed in the follow-up survey conducted 15 months following harvest. At another area in the harvest unit, upstream of the sediment routing survey area, a skid trail was constructed so close to the stream that sidecast from its fill slopes raveled into the type 3 stream. A 20 meter length of the stream was affected by sediment deposition from sidecast ravel and erosion, and although not included in the sediment routing survey results, this is more likely to be a chronic source of sediment to the stream.</p>

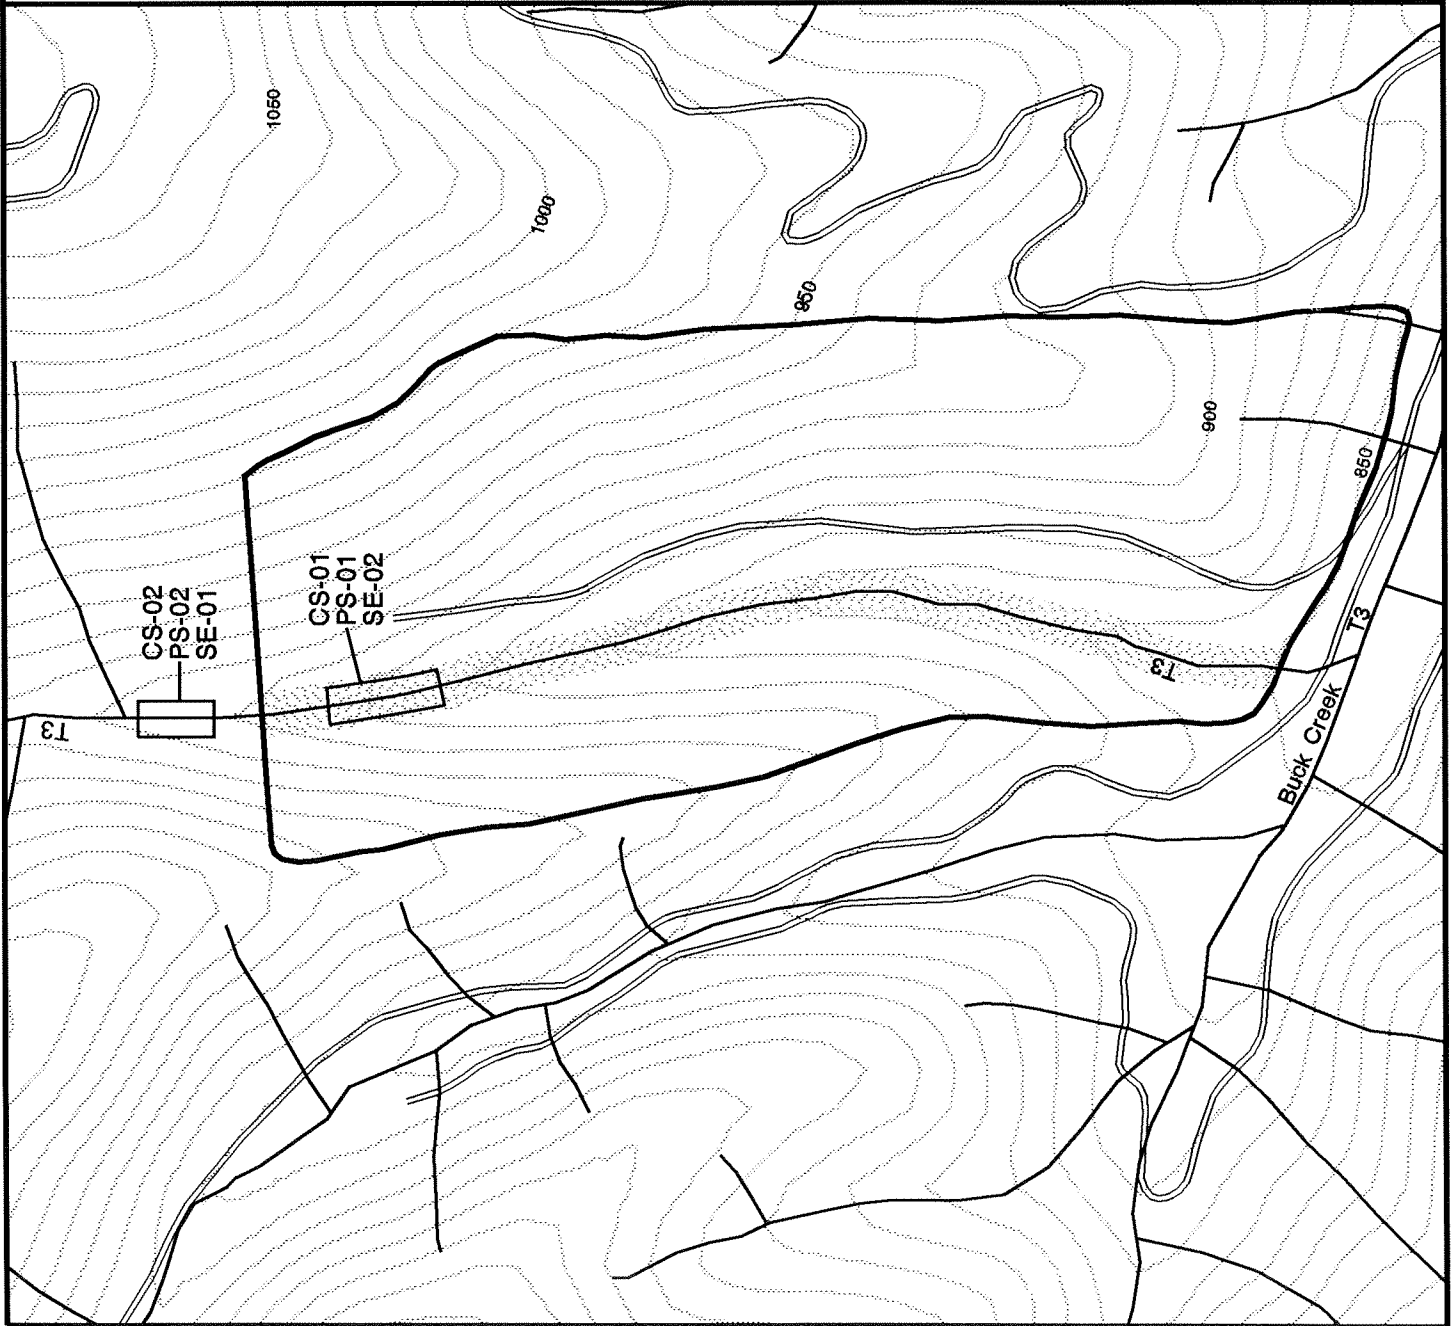
Site R-05 Buck West

Study Site: R-05: Buck West - Partial cut harvest with RMZ		BMP Effectiveness Ratings			
Survey Employed	Harvest w/ RMZ & Streambank Integrity BMPs (WAC 222-30-020(2-4) & -030 & -040 & 050)	Harvest with no buffers (Type 4 and/or 5 Waters)	Harvest with RL TAs (Type 4 and/or 5 Waters) (WAC 222-30-020(5))		
	Ground-based Yarding WAC 222-30-070	Cable Yarding WAC 222-30-060	Ground-based Yarding WAC 222-30-070	Cable Yarding WAC 222-30-060	Ground-based Yarding WAC 222-30-070
ASPECT 1: Effectiveness in terms of chronic erosion with delivery to surface waters.	No separate erosion/delivery surveys were conducted.				
Case Narrative:	While no separate erosion/delivery surveys were conducted to evaluate harvest practices at the Buck West site, it was noted during in-stream surveys that there was no evidence of direct delivery of sediment from harvest practices in the vicinity of the RMZ study reach. The upslope edges of the RMZ were roughly defined by two parallel skid trails constructed on both sides of the stream. Some trees were harvested from within the RMZ but entry by ground-based yarding equipment was very limited.

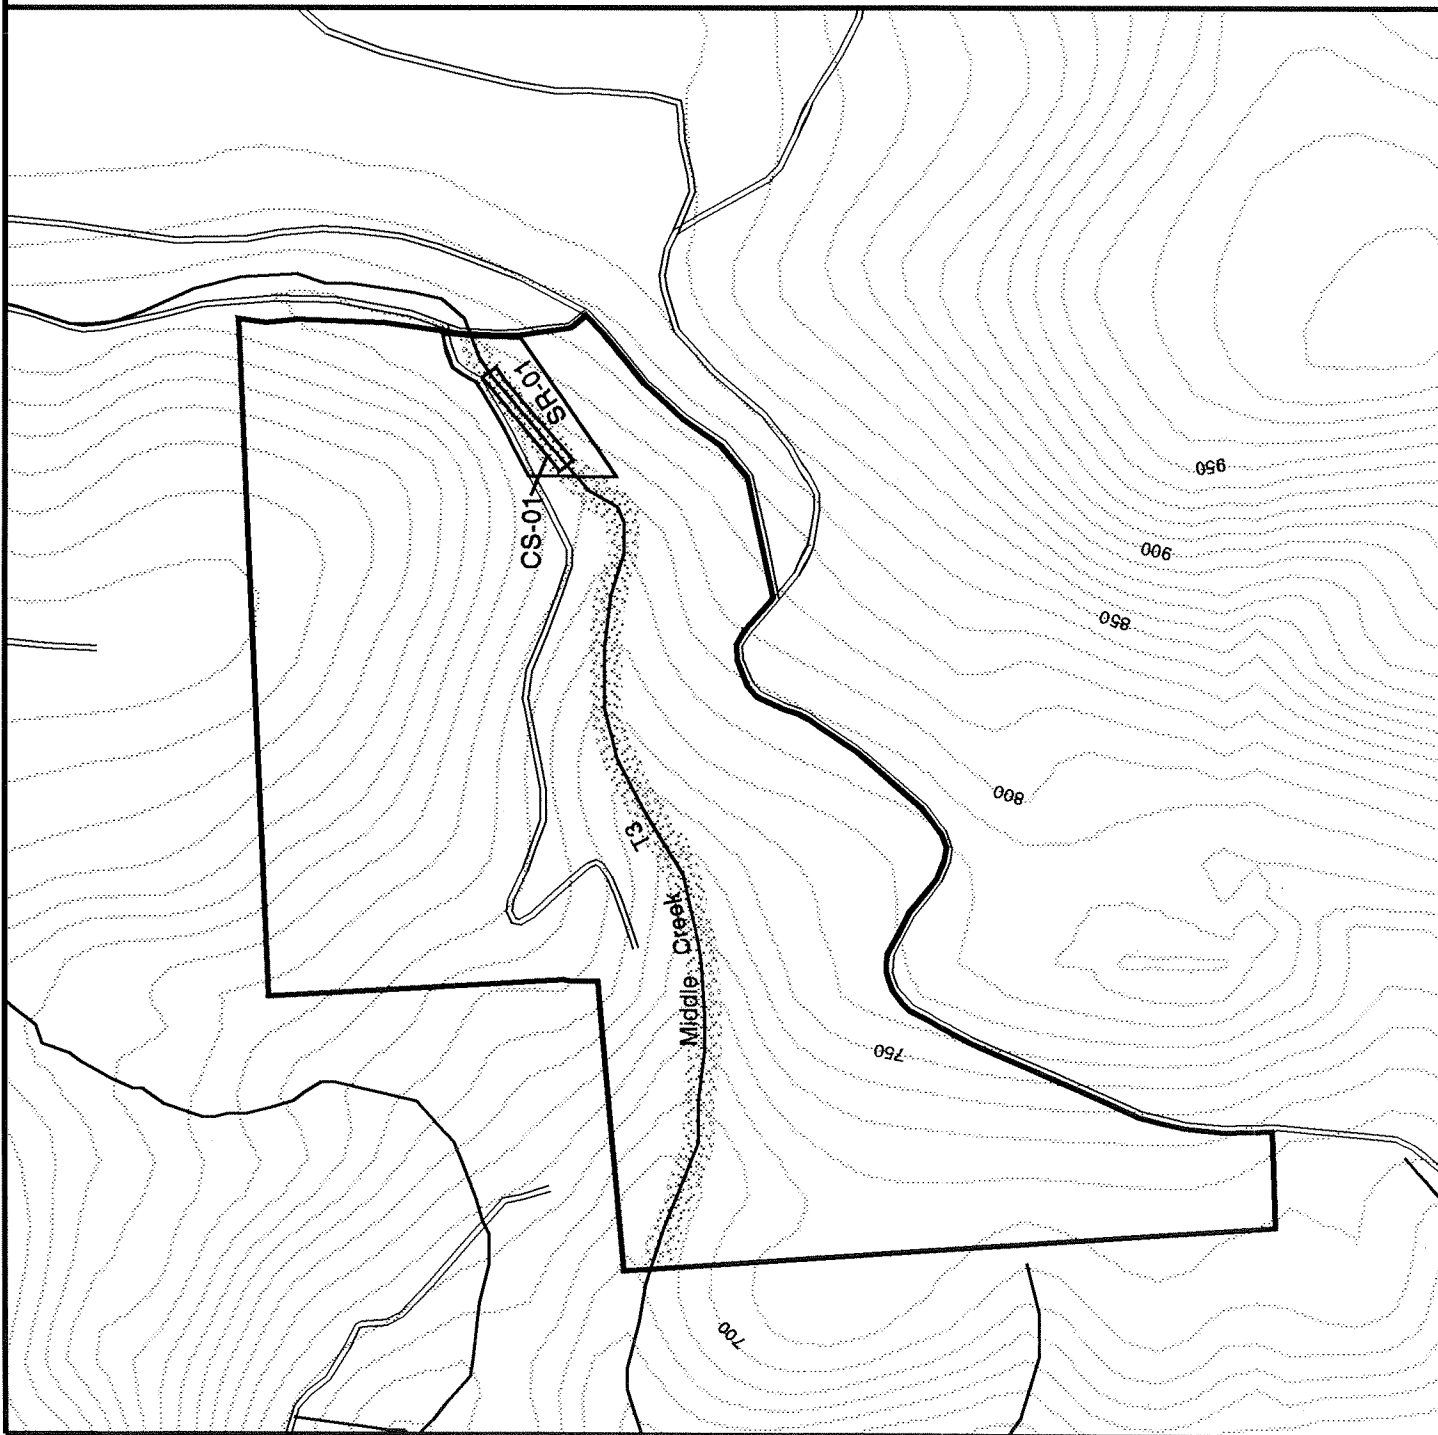
Site R-06 Middle

Study Site: R-06: Middle - Partial cut harvest with RMZ		BMP Effectiveness Ratings			
Survey Employed	Harvest w/ RMZ & Streambank Integrity BMPs (WAC 222-30-020(2-4) & -030 & -040 & 050)	Harvest with no buffers (Type 4 and/or 5 Waters)	Harvest with RLTA's (Type 4 and/or 5 Waters) (WAC 222-30-020(5))		
	Ground-based Yarding WAC 222-30-070	Ground-based Yarding WAC 222-30-070	Ground-based Yarding WAC 222-30-060	Ground-based Yarding WAC 222-30-070	Cable Yarding WAC 222-30-060
ASPECT 1: Effectiveness in terms of chronic erosion with delivery to surface waters.	Sediment Routing: SR-01 Effective				
Case Narrative:	The sediment routing survey evaluated a partial cut harvest area on both sides of a type 3 stream buffered by a RMZ, with harvest conducted using ground-based yarding methods. The survey was conducted 7 months following harvest. Disturbed soils covered only about 2% of the survey area, and the erosion features identified consisted of skid trails, yarding disturbance, and one tree falling scar. None of the erosion features identified delivered sediment to the stream or were located within 10 meters of the stream. Trees were harvested on relatively steep valley side slopes within the RMZ, including some trees directionally felled very near the stream bank, but there was no yarding across the stream. Minor disturbances associated with windthrow or individual tree falling divots were not surveyed as erosion features because there was either no soil exposure or they did not meet the minimum size criteria. The lack of soil disturbance associated with tree falling and yarding is attributed to the fact that the harvest was conducted during winter on frozen and/or snow-covered ground. On one side of the stream, timber was yarded up the steep valley side slopes using a jammer (truck-mounted winch and cable). Just downstream of the survey area, mass wasting erosion was observed on the steep valley walls, but this was un-related to harvest activities.

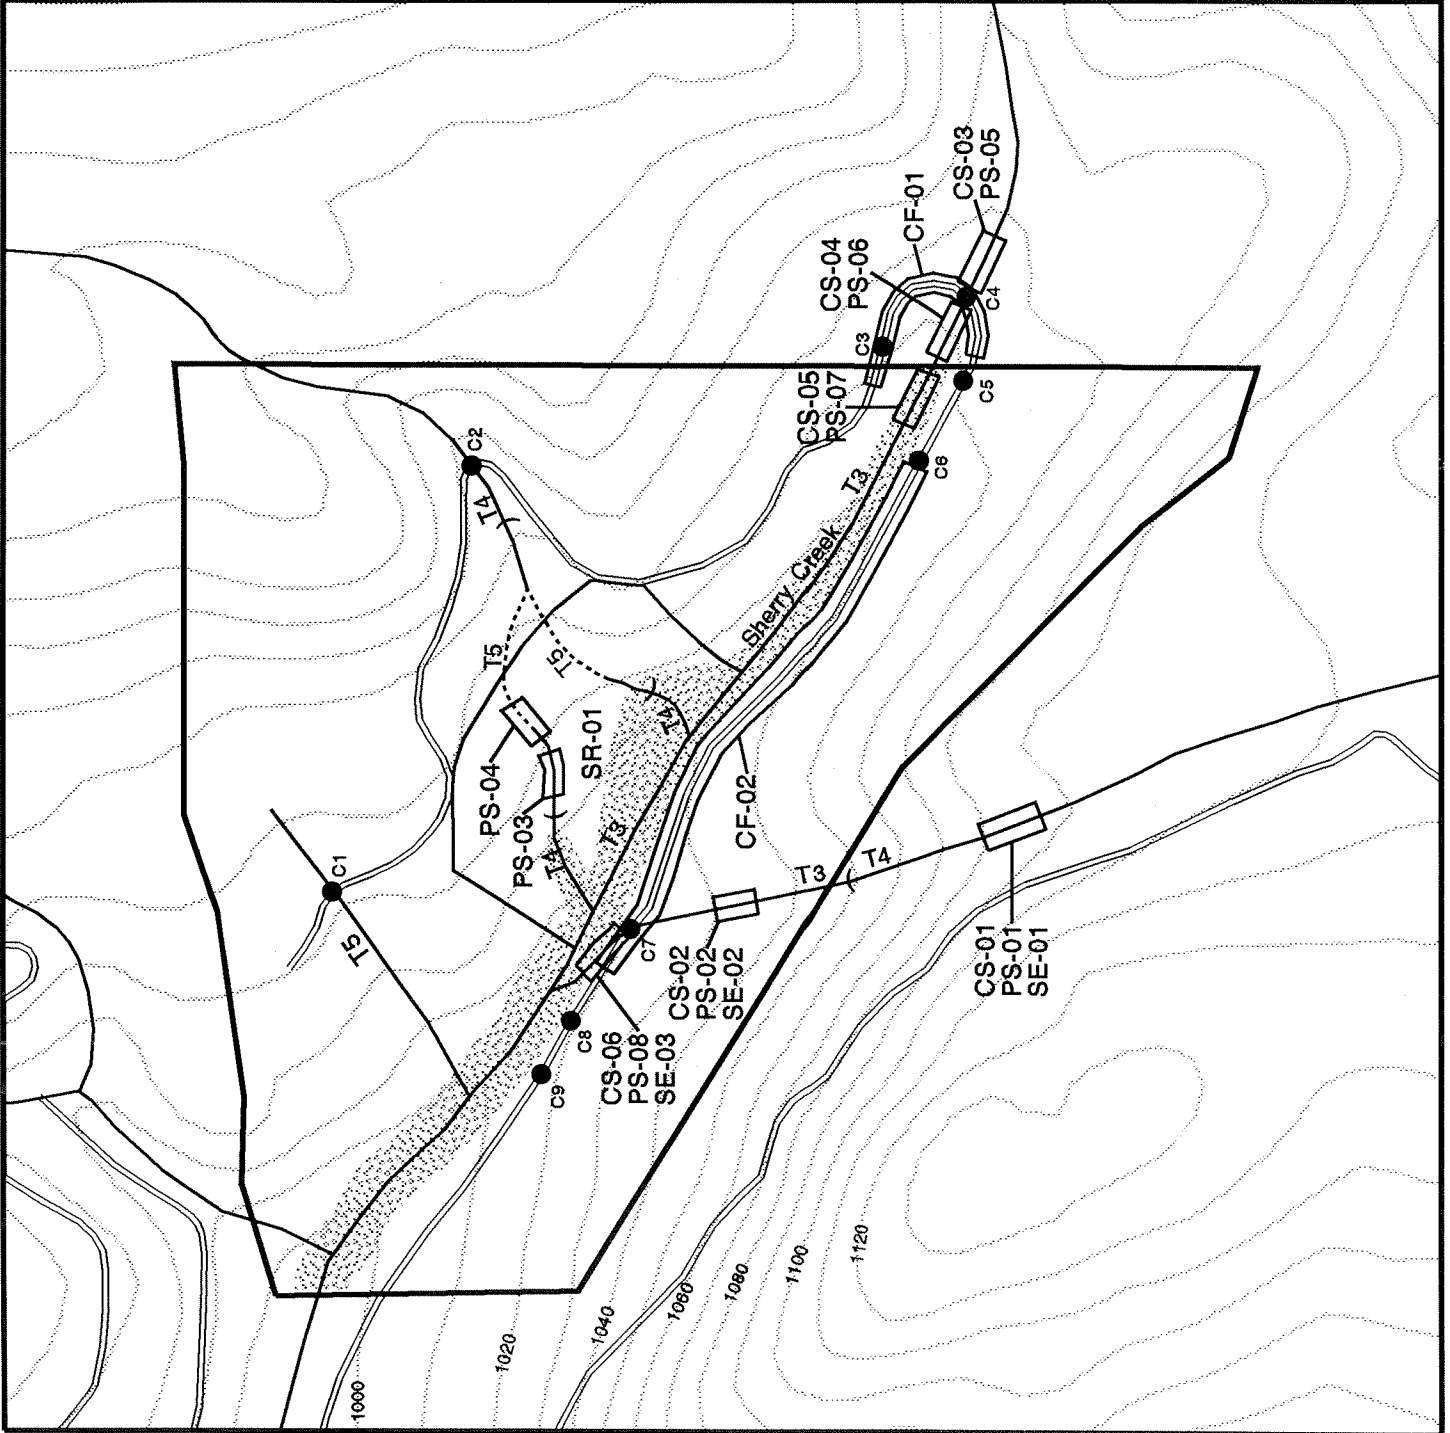
Site R-07 Sherry Creek

Study Site: R-07: Sherry Creek - Partial cut harvest, with RMZ and harvest without stream buffers.		BMP Effectiveness Ratings			
Survey Employed	Harvest w/ RMZ & Streambank Integrity BMPs (WAC 222-30-020(2-4) & -030 & -040 & 050)	Harvest with no buffers (Type 4 and/or 5 Waters)	Harvest with RL TAs (Type 4 and/or 5 Waters) (WAC 222-30-020(5))		
	Ground-based Yarding WAC 222-30-070	Cable Yarding WAC 222-30-060	Ground-based Yarding WAC 222-30-070	Cable Yarding WAC 222-30-060	Cable Yarding WAC 222-30-060
ASPECT 1: Effectiveness in terms of chronic erosion with delivery to surface waters.	Sediment Routing: SR-01BU SR-01NB Effective		Not Effective		
Case Narrative:	The sediment routing survey area included 1.7 hectares of harvest area draining to Sherry Creek (SR-01BU survey), which was buffered by a RMZ, and 1.3 hectares of harvest area on the north side of Sherry Creek where harvest occurred in the vicinity of type 4 and 5 streams without stream buffers (SR-01NB survey). The RMZ was not crossed by timber yarding routes, although a limited number of trees were harvested from the RMZ. At the time of the initial survey conducted 9 months following harvest, disturbed soils covered 2% of the SR-01BU survey area, with erosion features attributed to skid trails and other yarding activity and disturbance by wildlife/livestock. However, the only sediment delivery to Sherry Creek was associated with wildlife/livestock erosion within the RMZ. Soil disturbance associated with skid trails and other timber falling and yarding activity covered 6% of the SR-01NB survey area, and 4 of 11 harvest erosion features delivered sediment to the type 5 streams within the survey area. By the time of the follow-up survey conducted 18 months following harvest, disturbed soils covered less than 1% of the SR-01BU survey area, and 3% of the SR-01NB survey area. Several of the skid trails and yarding features had revegetated and/or were no longer delivering sediment to streams. One major skid trail crossing was continuing to deliver substantial amounts of sediment to an un-buffered type 5 stream. The RMZ was effective at preventing direct sediment delivery to Sherry Creek from harvest erosion features. Indirect delivery to Sherry Creek via the un-buffered tributary crossed by the skid trail is likely.
