The NOHO HELE

This bulletin was prepared to share lessons learned with industry and interested public, and to make recommendations to prevent similar occurrences. The company operating the NOHO HELE at the time of the incident was invited to provide comment on this bulletin. They did not provide comment.

OVERVIEW

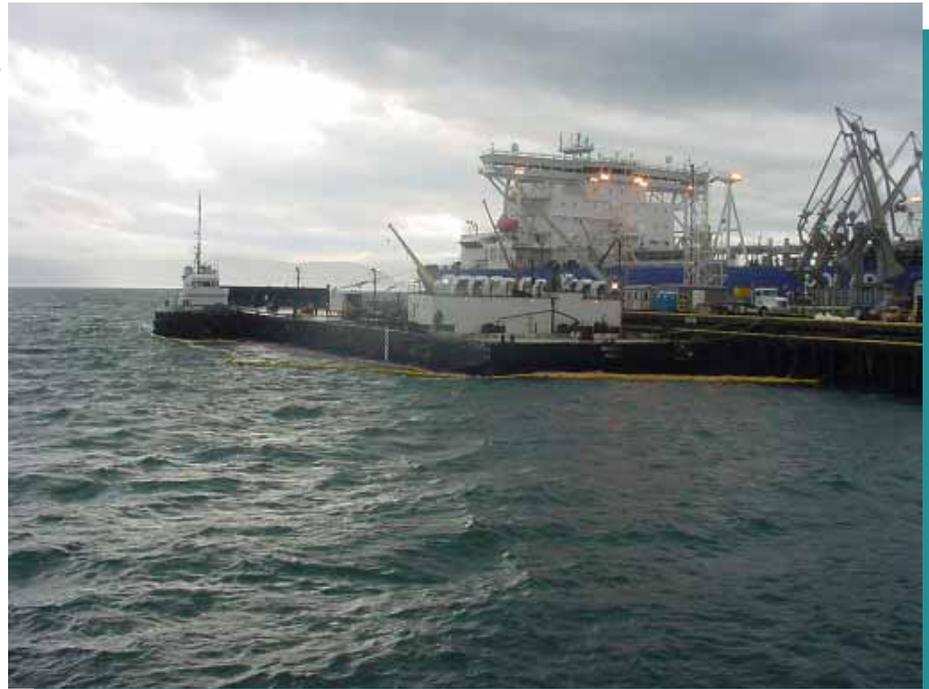
*Figure 1:
NA HOKU and
NOHO HELE tied
up at
ConocoPhillips
pier. (Blue hulled
ship on the other
side of the pier is
the Polar
Endeavor)*
