The SONGA HUA

Overview

This bulletin was prepared to share lessons learned with industry and oil spill specialists. Prevention recommendations are also made to prevent similar occurrences. Sharing lessons learned is important if Washington State is to achieve its "zero spills" goal.

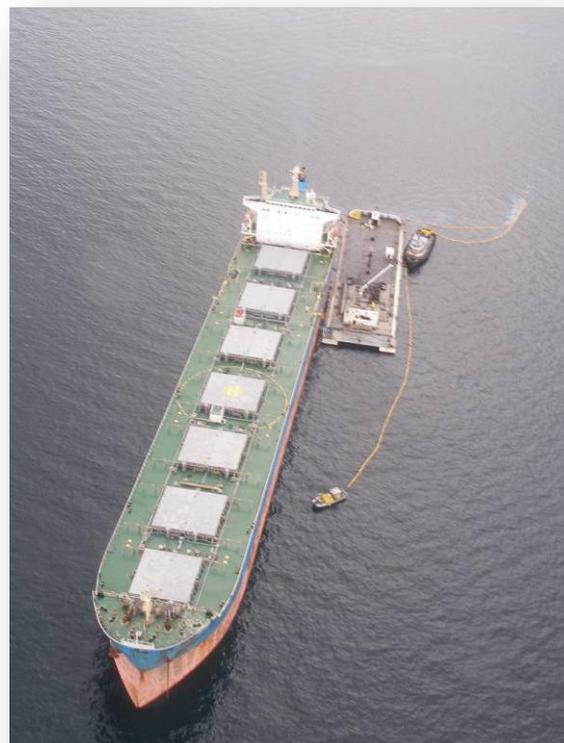
Figure 2 – SONGA HUA with SHAUNA KAY and ALYSSA ANN along side.

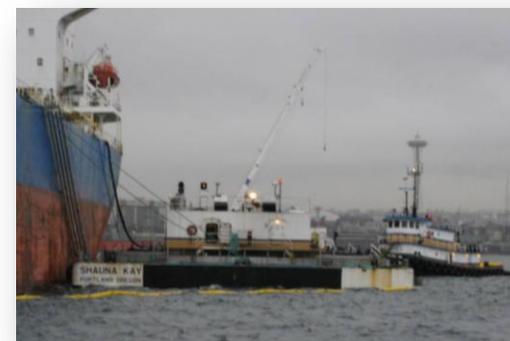
Figure 6 - SHAUNA KAY moored with its port side towards the port side of the SONGA HUA, and with tug ALYSSA ANN alongside on February 28, 2007.
