STATE OF WASHINGTON
DEPARTMENT OF ECOLOGY

Re: No Further Action at the following Site:

- **Site Name:** Bellevue Chrysler Plymouth
- **Site Address:** 126 116th Avenue, Bellevue, Washington
- **Facility/Site No.:** 2507
- **VCP Project No.:** NW 3226

Is further remedial action necessary to clean up contamination at the Site?

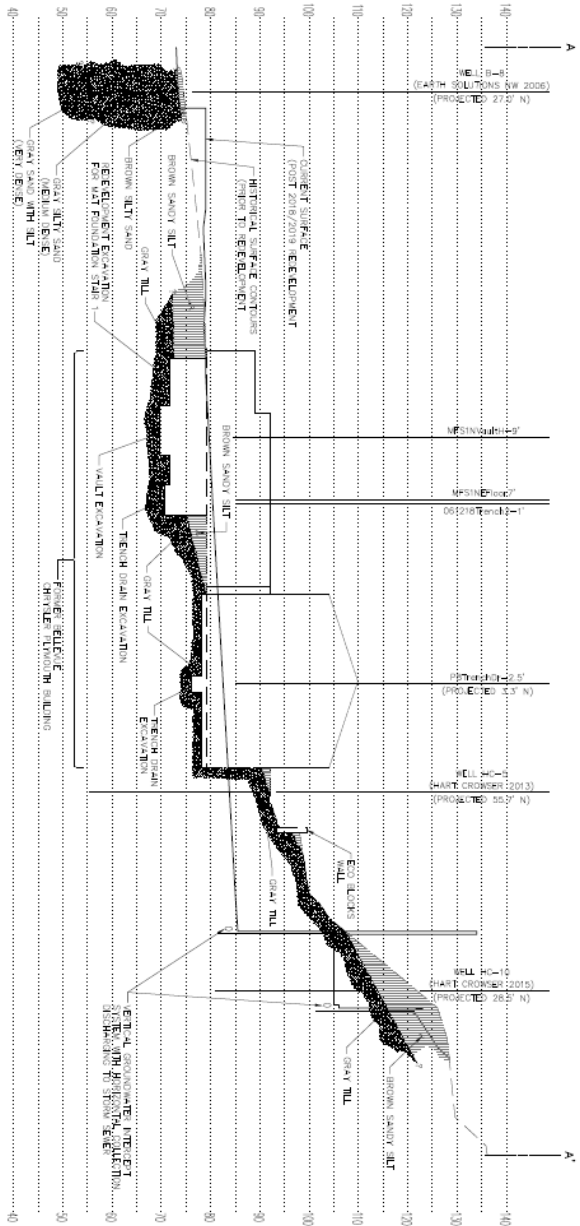
CROSS-SECTION
 FORMER BELLEVUE COURSE & YACHT
 1201 11TH AVENUE NE
 BELLEVUE WASHINGTON 98004
