SITE HAZARD ASSESSMENT
WORKSHEET 1
Summary Score Sheet

SITE INFORMATION:
Kitsap Rifle & Revolver Club
4900 Seabeck Hwy NW
Bremerton, WA 98312

Site scored/ranked for the August 2013 Hazardous Sites List update
August 7, 2013

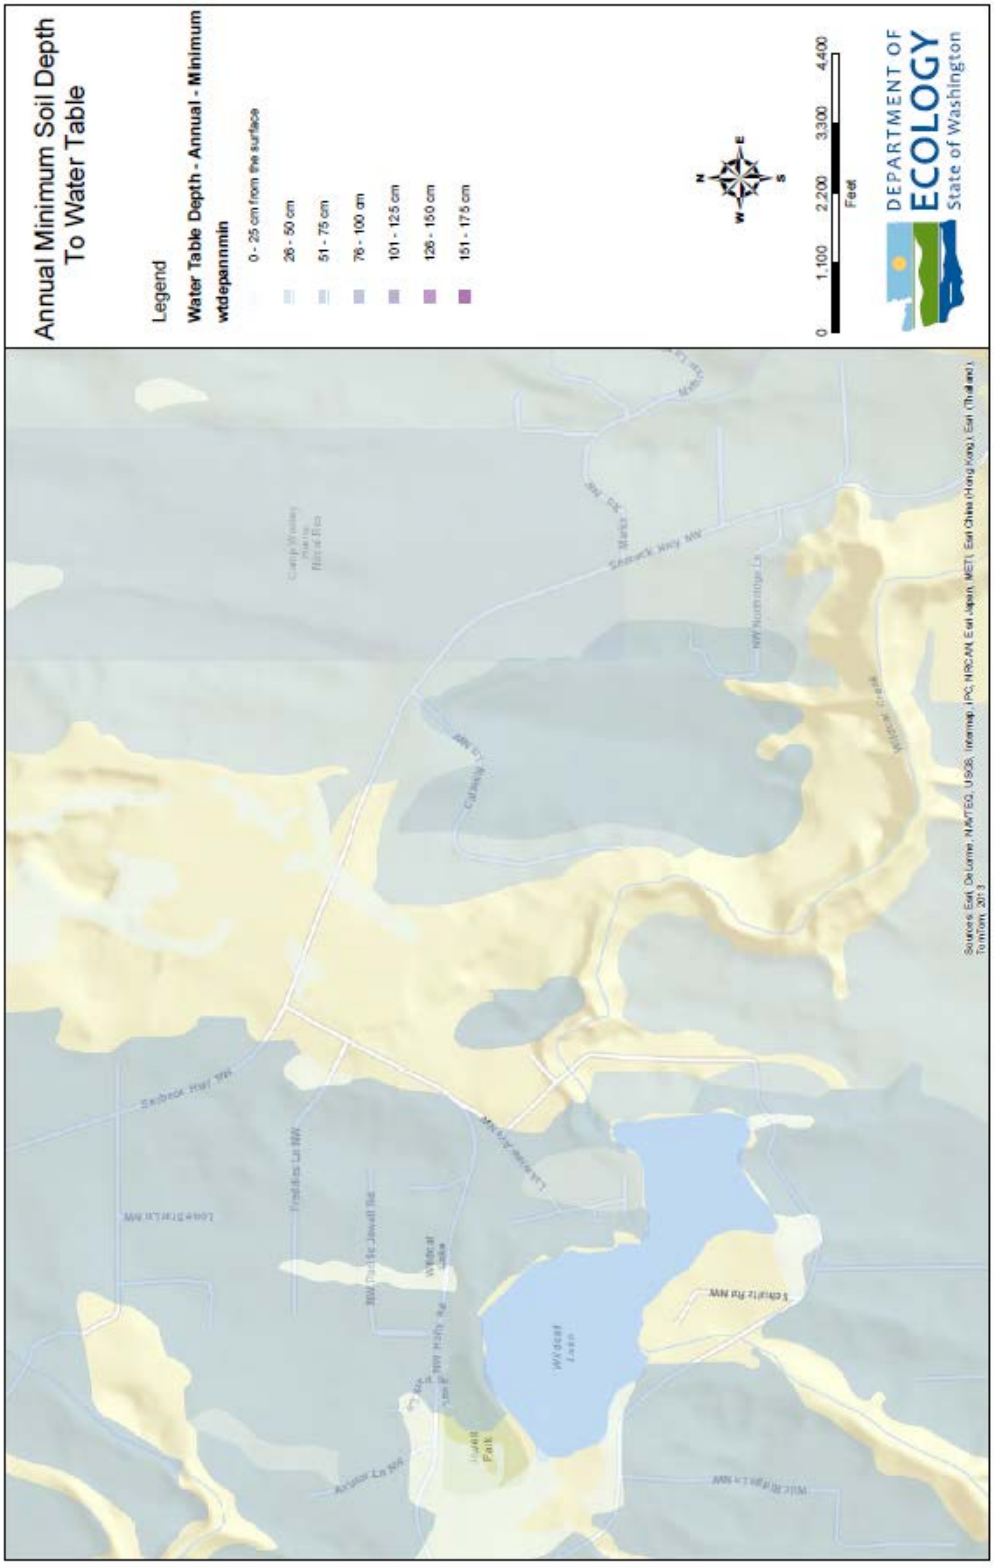
Figure 2.

3) Although the well log for the well placed on the KRRC does not indicate discovery of groundwater before a depth of 349 feet, information from the US Department of Agriculture, National Resource Conservation Service, indicates that groundwater lies at a minimum depth of 0 – 25 cm below ground surface. In addition to this is the presence of standing water in wetlands on the site. These two facts are used in the determination, for this SHA, of a depth to groundwater of 0 to 25 feet.

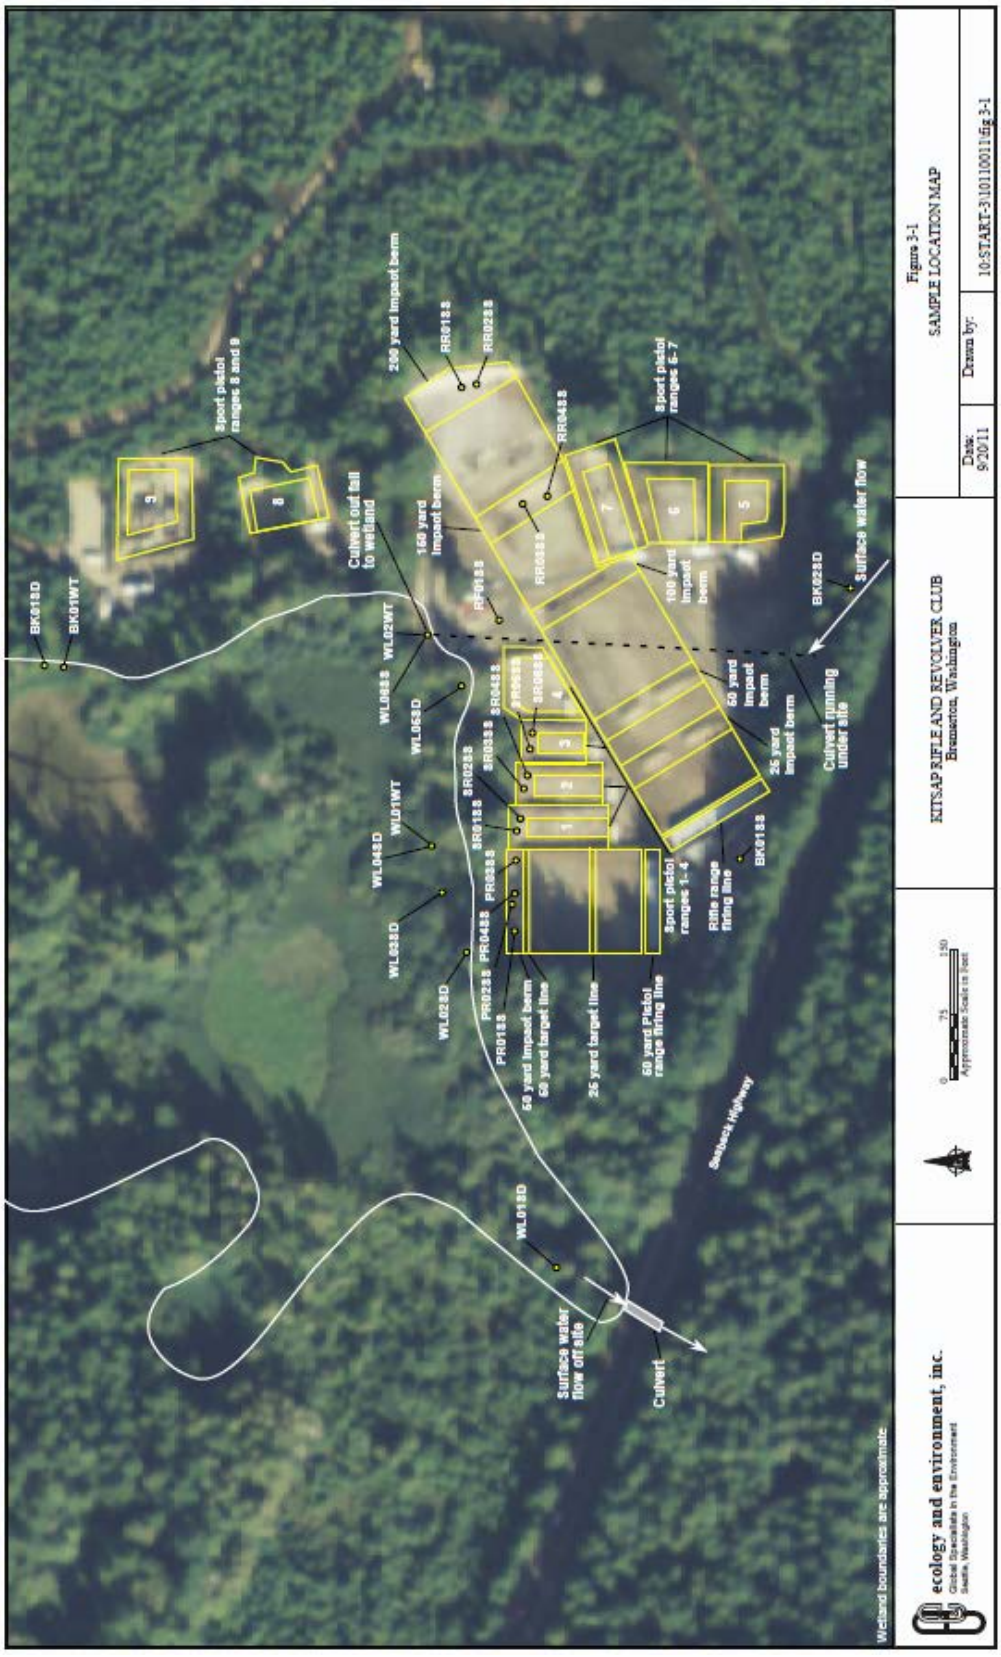
Figure 3.

See Table 1 for all samples that exceed MTCA levels in soil. Sediment exceedances were found for lead. See Table 2 for sediment exceedances.

Figure 3 attached shows the sampling locations from the EPA Site Assessment.

The results presented in Table 1 and 2 do not include all of the results in the record, but only those results where a sample showed a result exceeding MTCA.

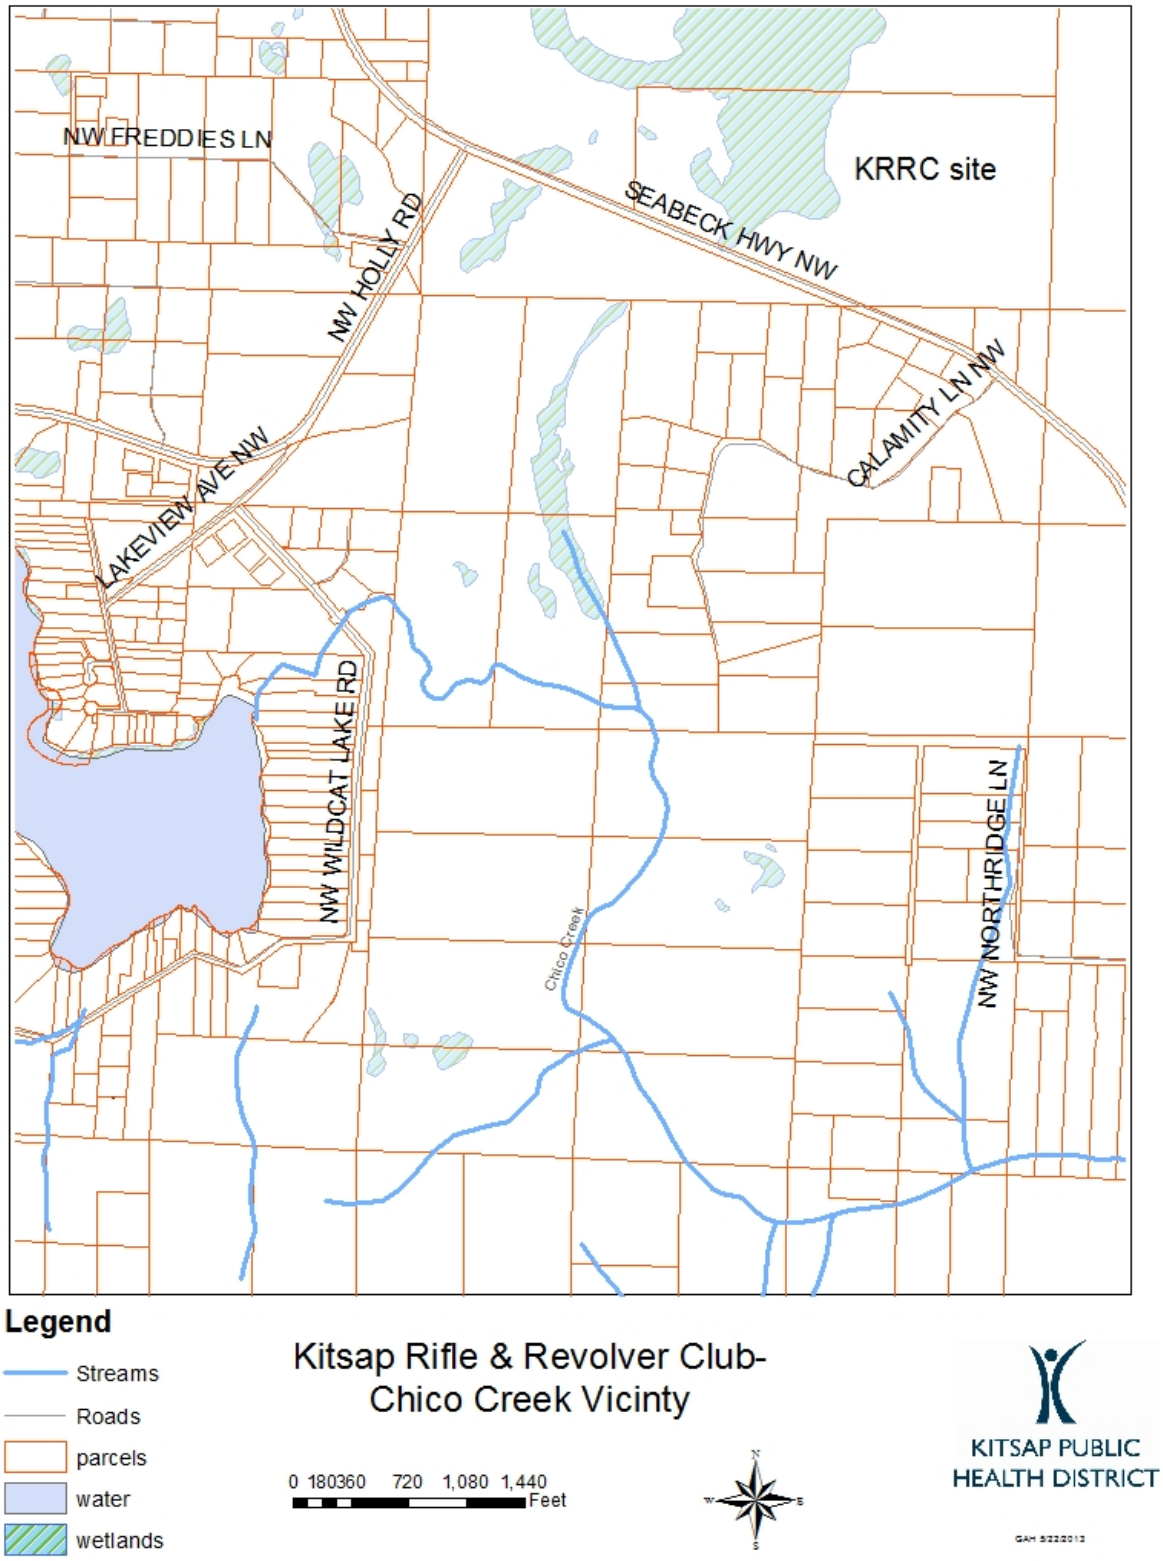
Figure 4.

Wetland areas are known to exist on the KRRC property. Wetlands are also located on the property to the north, and southwest of KRRC. Surface water generally flows to the west towards Hood Canal, and bends back to the east as headwaters to Chico Creek. Chico Creek is a salmon bearing stream. See the attached map for further details (Figure 4).
