Re: No Further Action at the following Site:

- **Site Name:** Amy's Cleaners
- **Site Address:** 3377 Bethel Road SE, Port Orchard, Washington
- **Facility/Site No.:** 28514228
- **VCP Project No.:** NW 3125

Site Plan and Vicinity
 Cleanup Action Report - Amy's Cleaners
 Bethel Junction Shopping Center
 Port Orchard, Washington

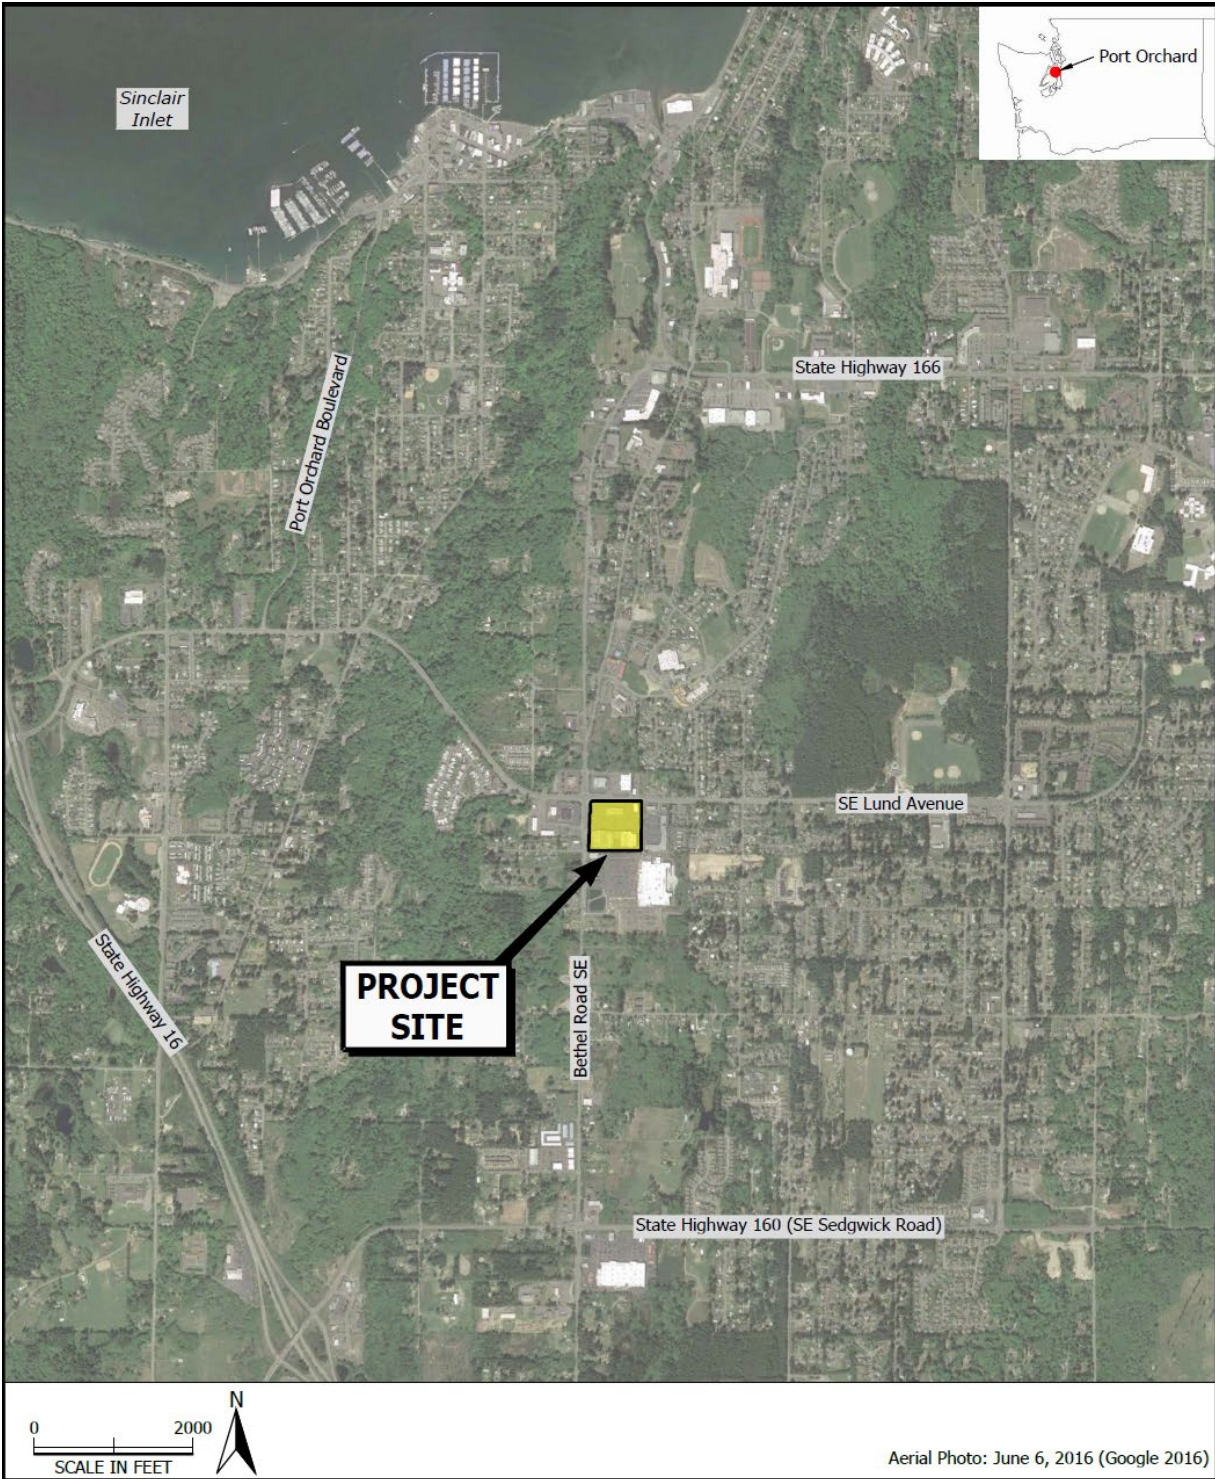
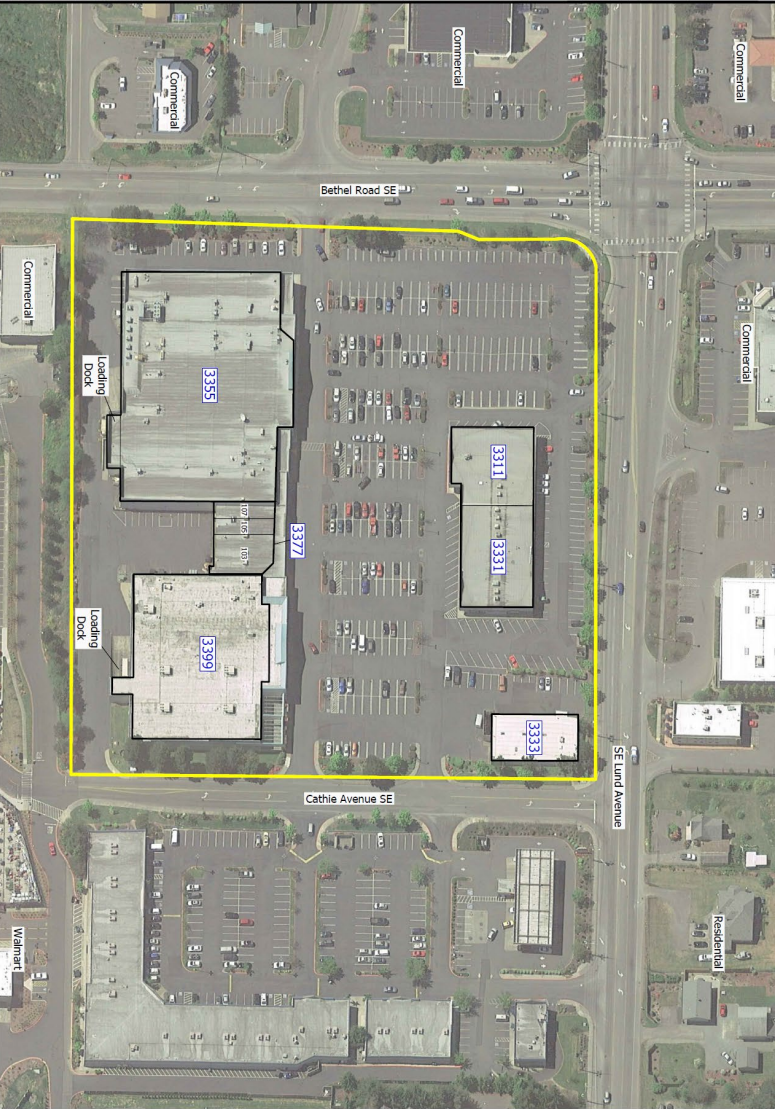
- Explanation**
- Approximate Property Boundary
 - 3333 Building Addresses on Bethel Road SE
 - 110 Building Site Number

Aerial Photos: Nov. 4, 2013 (Google 2014)

Enclosure A includes a detailed description and diagram of the Site, as currently known to Ecology.
