THIRD PERIODIC REVIEW REPORT
FINAL

MONTESANO FARM & HOME
Facility Site ID#: 31164291
Cleanup Site ID#: 5846

412 South Main Street
Montesano, Washington 98563

September 2022

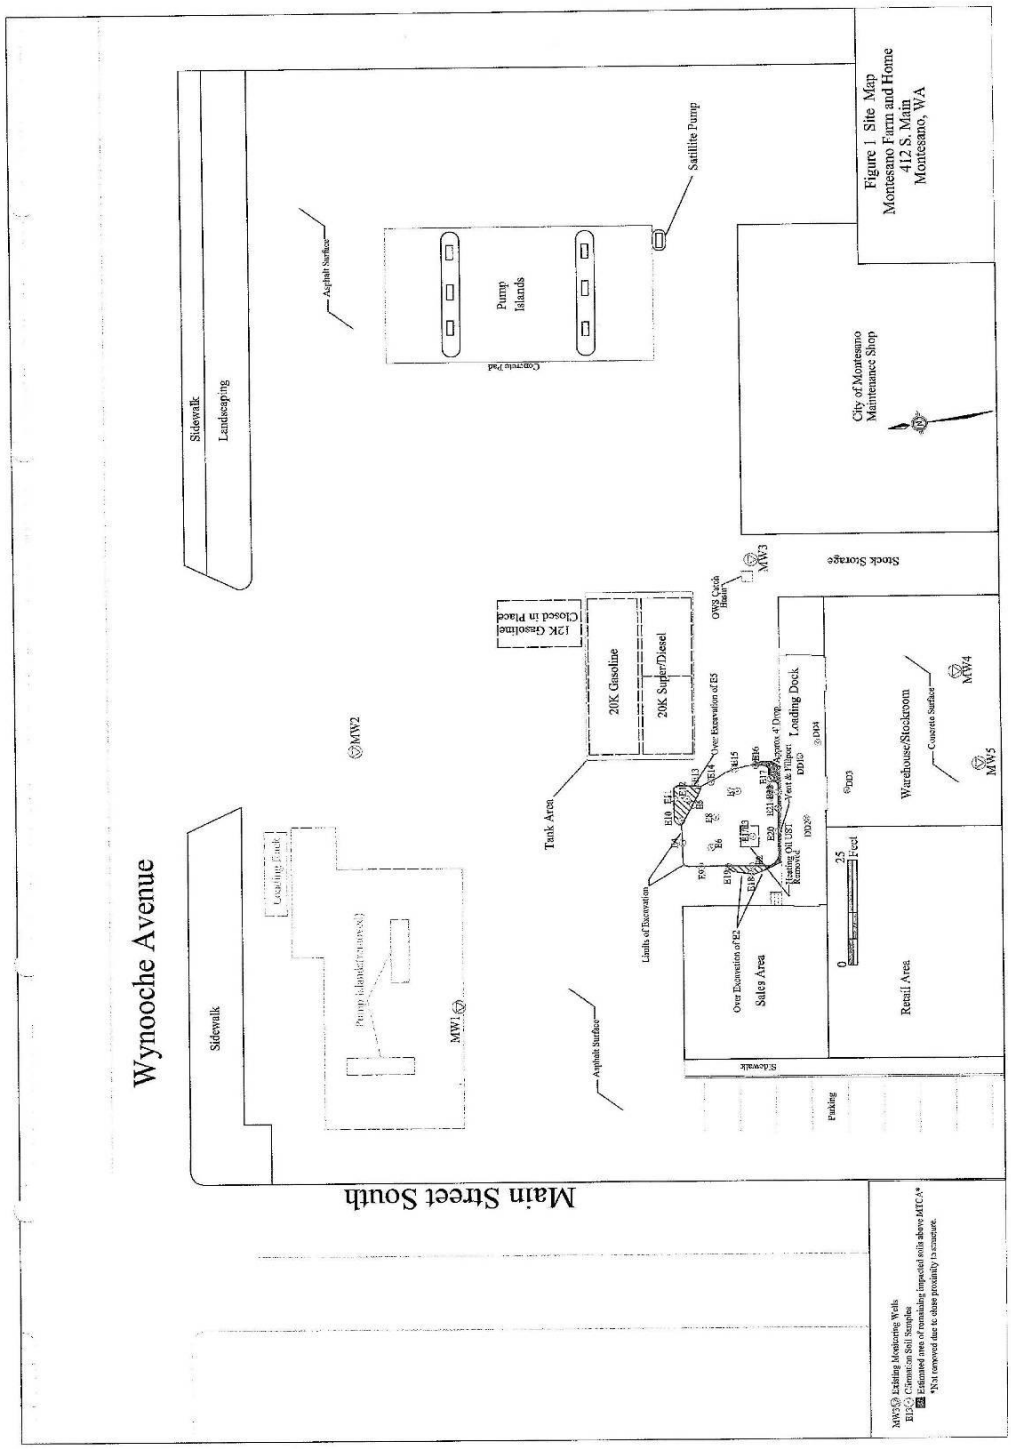
6.2 Site Plan

Figure 1 Site Map
Montesano Farm and Home
412 S. Main
Montesano, WA
Wynooche Avenue
Main Street South
Sidewalk
Landscaping
Asphalt Surface
Pump Islands
Satellite Pump
City of Montesano Maintenance Shop
Stock Storage
MW3
OWS Catch Basin
12K Gasoline Closed in Place
20K Gasoline
20K Super/Diesel
Over Excavation of ES
Tank Area
MW2
Loading Dock
Warehouse/Stockroom
Concrete Surface
MW4
MW5
Limits of Excavation
Over Excavation of E2
Sales Area
Retail Area
25 Foot
Sidewalk
Parking
MW1
Asphalt Surface
Existing Monitoring Wells
Confirmation Soil Samples
Estimated area of remaining impacted soils above MTCA*
*Not recovered due to: close proximity to structure.

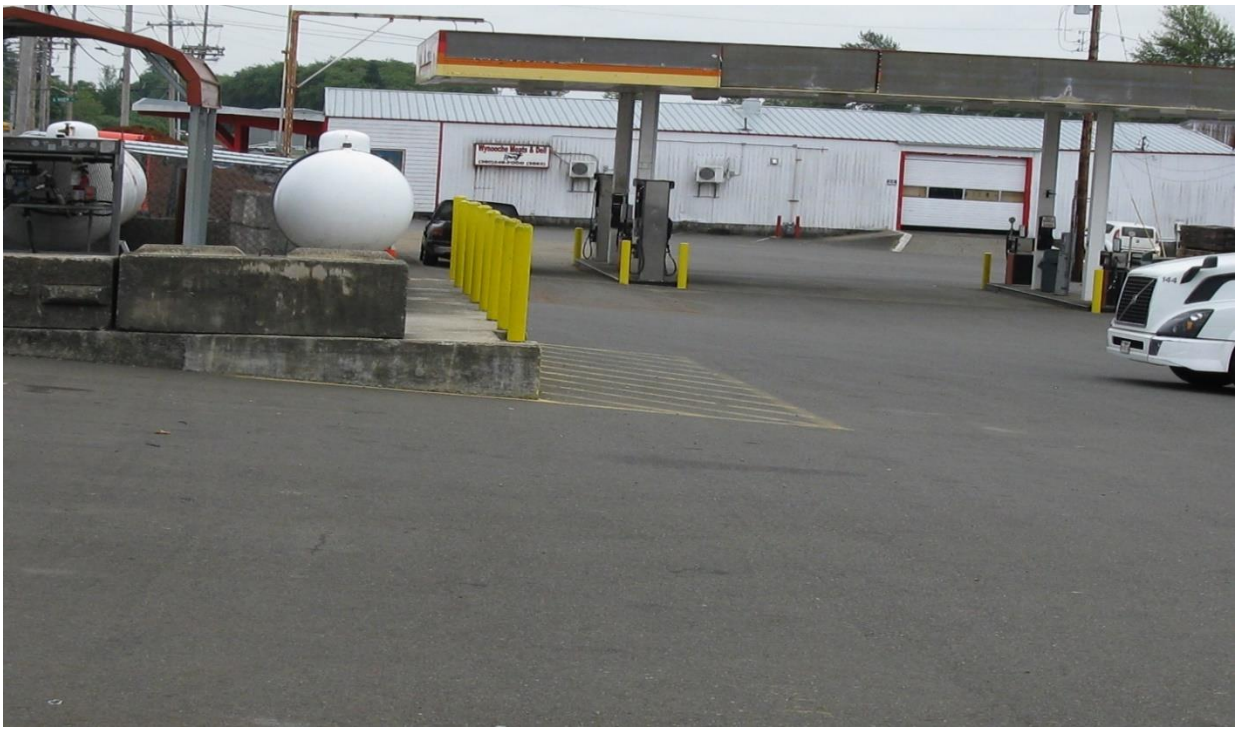
Based upon the Site visit conducted on July 13, 2021, the contaminated soils remain covered by asphalt, the Site loading dock, and the building footprint. These covers continue to provide an adequate barrier to direct exposure pathways (ingestion, contact) to contaminated soils. Additionally, these covers prevent water infiltration, which could increase the mobility of the contaminants to groundwater. A photo log is available as Appendix 6.7.

Photo 3: Parking lot/asphalt cap, pump islands and propane above ground tanks –from the West.
