ecology and environment, inc.

MEMORANDUM

SUBJECT: Proposed Sampling Approach
Treoil Facility Site
Ferndale, Washington

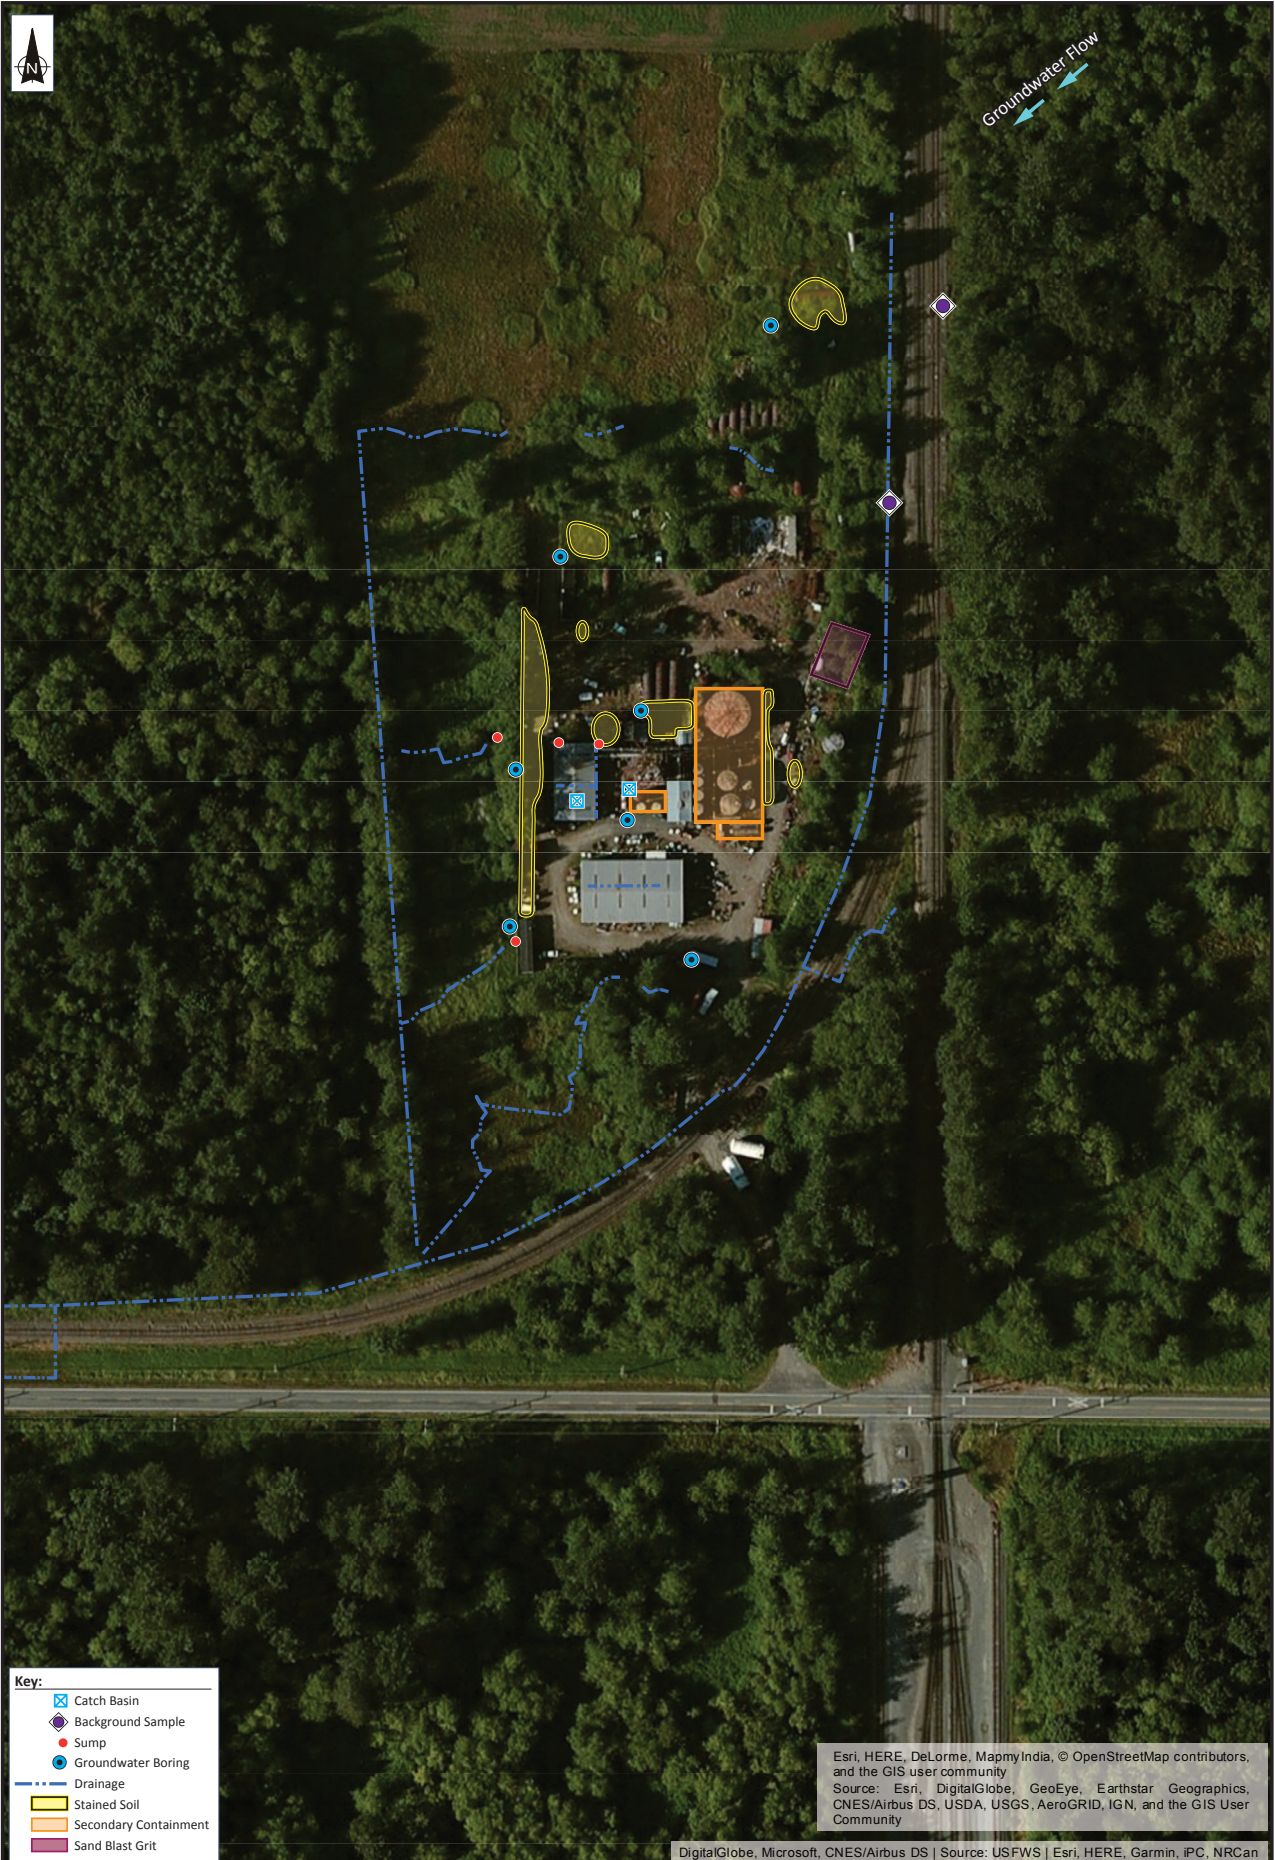
- X Catch Basin
- ◇ Background Sample
- Sump
- Groundwater Boring
- Drainage
- Stained Soil
- Secondary Containment
- Sand Blast Grit

A proposed sampling approach has been designed for the Treoil Facility site, which is located in Ferndale, Washington (Figure 1). Proposed sample locations are presented on Figure 2.

It is recommended that at least 4-8 groundwater samples be taken and assessed for contaminants. Location suggestions for sampling is indicated on Figure 2. Groundwater impacts can be from the numerous stained soils on Site, secondary containment, or any one of the unknown releases of product. Generally, groundwater flows towards the southwest. Establishing a groundwater plume may be necessary to understand contamination leaving the Site. Well installation, if incorporated, should not be completed without consultation with the Lummi Nation.

Background samples will need to be considered carefully since the area resides in a heavy industrial area. Ground water samples should be taken near the northeastern side of the property to account for potential impact from the railways, and surface soil/sediment samples should be taken outside the property or in an area less likely to contain site containments. A water well sample from 4300 Aldergrove can be used for a potential background if access to railways is not possible. Suggested sample locations are marked on Figure 2.
