STATE OF WASHINGTON  
DEPARTMENT OF ECOLOGY

**Re: Opinion on Proposed Cleanup of the following Site:**

<b>Site Name:</b>	Carpenter Road Olympia PD Shooting Range
<b>Site Address:</b>	6530 Martin Way E, Lacey, WA 98516
<b>Cleanup Site ID:</b>	14692
<b>Facility/Site ID:</b>	50400
<b>VCP Project ID:</b>	XS0008

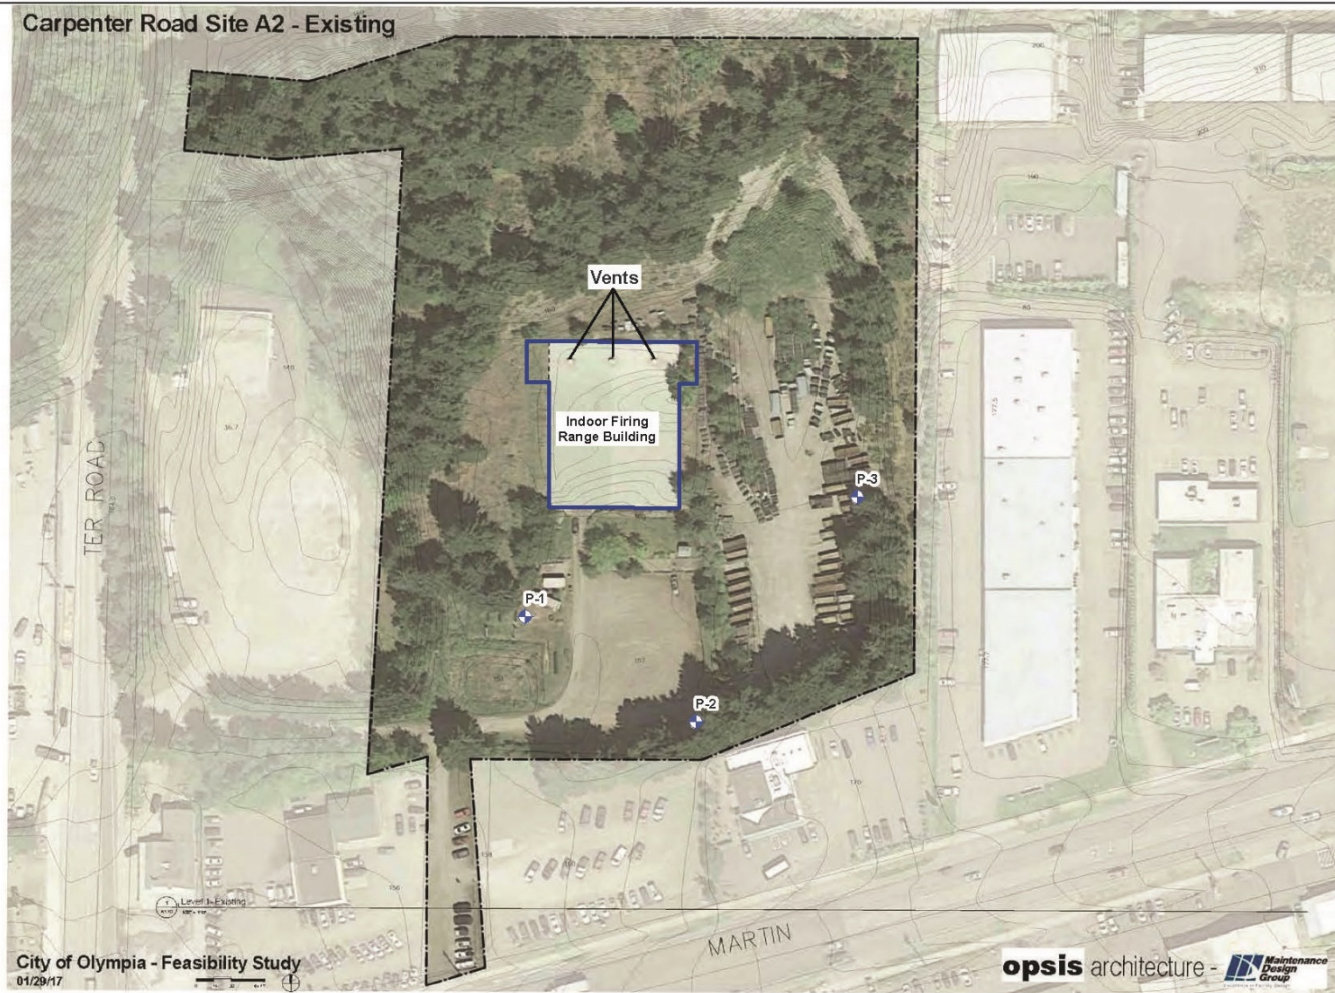
# Carpenter Road Site A2 - Existing

City of Olympia - Feasibility Study  
01/29/17

**Site History:** The Property has been occupied by the City of Olympia Police Department Firing Range since 1987. Prior to 1987, sand and gravel quarrying reportedly took place on the Property between about 1941 and 1980. The sand and gravel quarrying evidently resulted in the irregular topography found on the Property today.
