ALATHEIA RIDING CENTER

REMEDIAL ACTION PLAN FOR LEAD- AND ARSENIC-CONTAMINATED FORMER ORCHARD SOILS

Remedial Action Plan

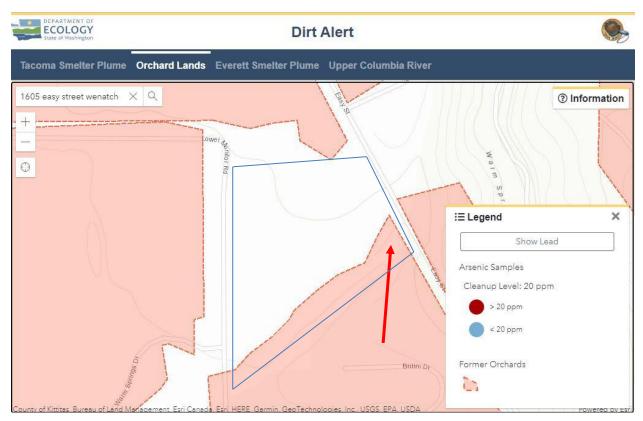
Figure 3. Dirt Alert mapping of the subject parcel.

The relatively level portions of the parcel have been a commercial orchard until the trees were cleared in the spring of 2022. The ravine located along the southern property boundary is undeveloped. Based on the Ecology Dirt Alert online mapping tool, a segment of the parcel may have been in commercial orchard when lead arsenate was still utilized as a pesticide (1890-1955).

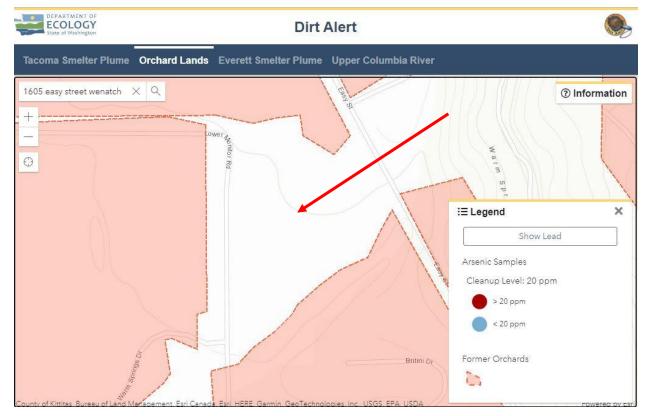
Figure 1. Dirt Alert mapping of the subject parcel and surrounding vicinity.

The subject property is currently undeveloped and was historically utilized as commercial orchard. A majority of the site is mapped on the Department of Ecology (Ecology) Dirt Alter online mapping tool as having been in historic use as commercial orchard prior to 1955 (Figure 1). Ecology utilizes this mapper to identify historic orchards that are likely to contain elevated levels of lead and arsenic in the surface soils due to the allowable use of lead arsenate pesticide prior to 1955. Sampling efforts for the presence and/or absence of lead and arsenic focused on the entirety of the parcel including both mapped and unmapped areas.
