# **Lower Duwamish Waterway Source Control Status Report 2020**

August 2022

Publication No. 22-09-178

Toxics Cleanup Program  
Northwest Regional Office  
Washington State Department of Ecology  
Shoreline, Washington

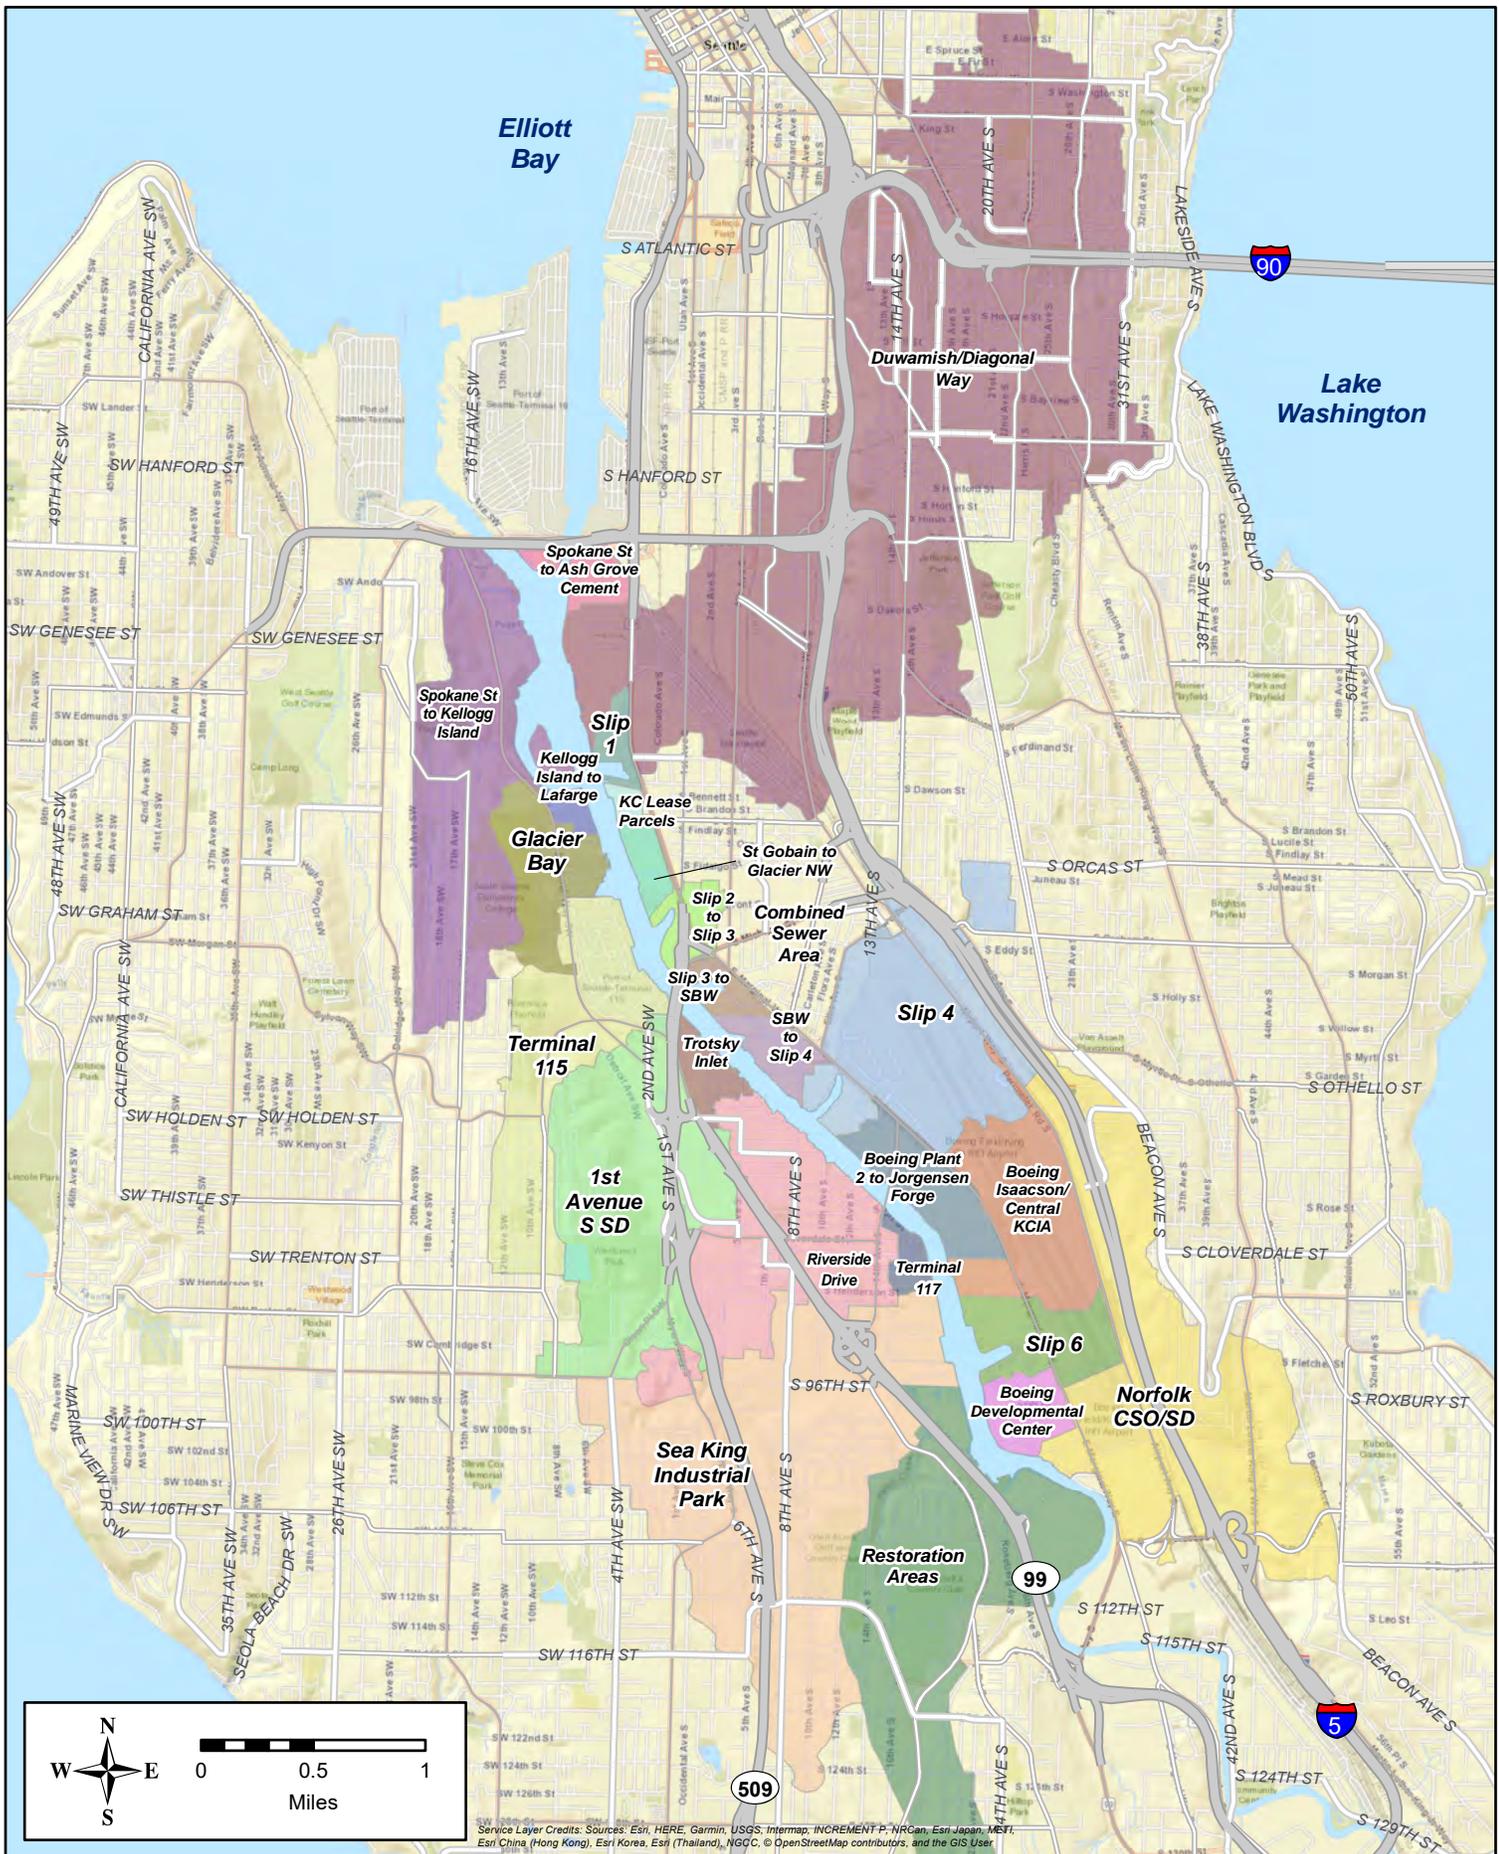
Figure 1-2. Lower Duwamish Waterway Source Control Areas

Ecology conducted source control investigations for each of the 24 source control areas, including review of existing information, identification of data gaps, and preparation of a SCAP. The 24 source control areas are shown in Figure 1-2. The potential for sediment recontamination associated with each source control area is described in detail in the Data Gaps Reports and SCAPs. These documents are available on Ecology's LDW Source Control website.<sup>13</sup>

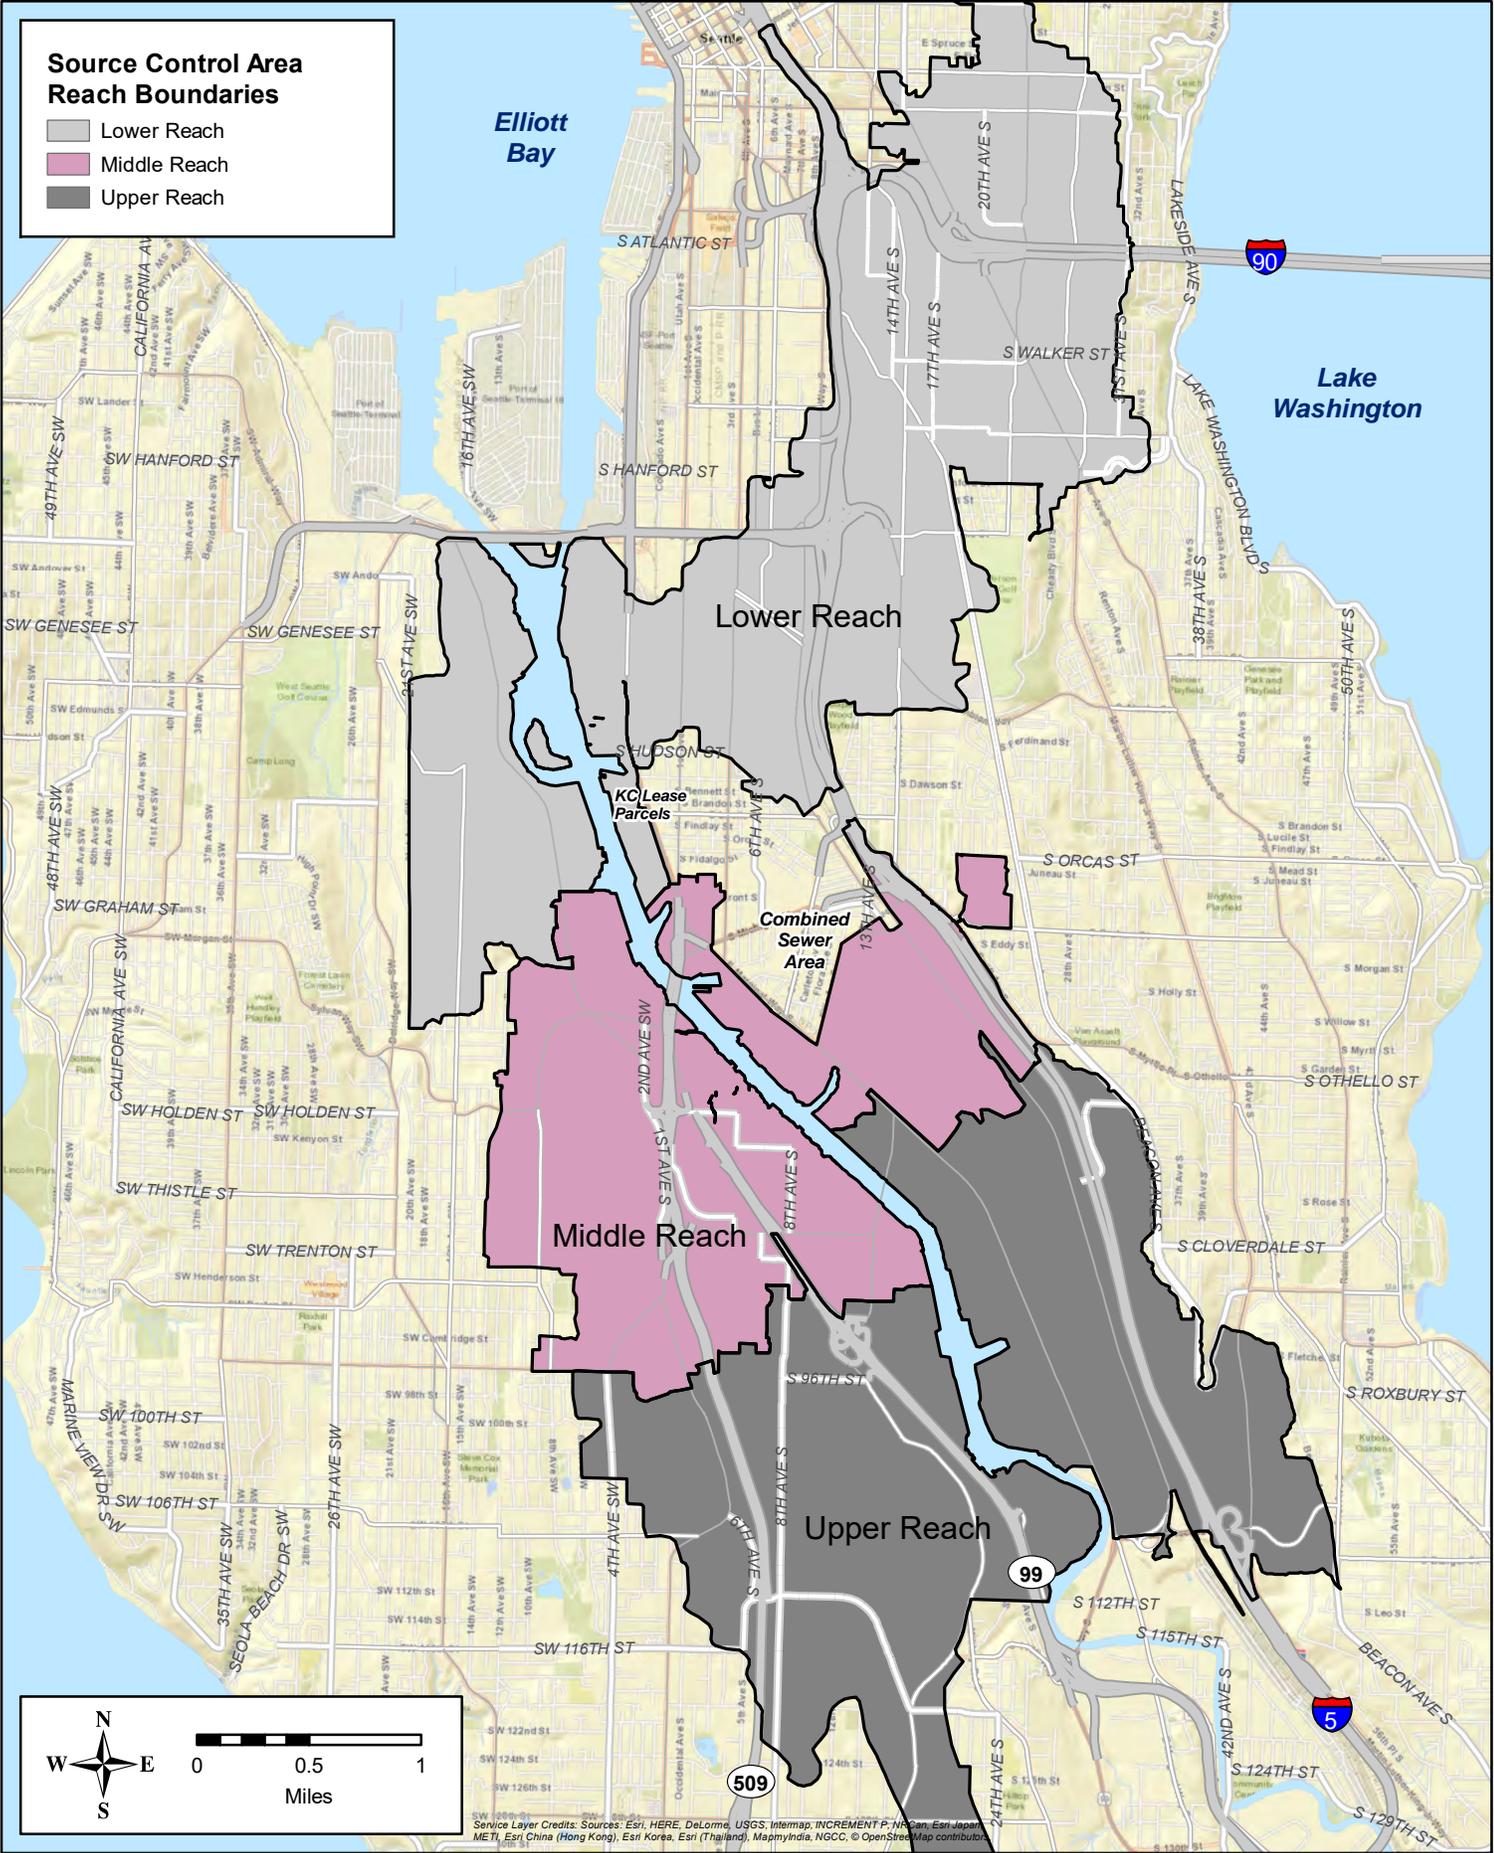
**Figure 1-3. Lower Duwamish Waterway Reach Boundaries**

Ecology grouped the 24 source control areas into three larger sub-areas: Upper Reach, Middle Reach, and Lower Reach (Figure 1-3). Ecology plans to use an upstream-to-downstream approach to source control so that EPA can most quickly begin active cleanup of LDW sediments. Ecology intends to focus on completing high priority action items in the source control areas that comprise each sub-basin. For example, Ecology plans to complete high priority actions first in the Upper Reach, then the Middle Reach, and finally the Lower Reach. More information about Ecology’s plan for completing action items can be found in the Strategy (Ecology 2016b [11051]).

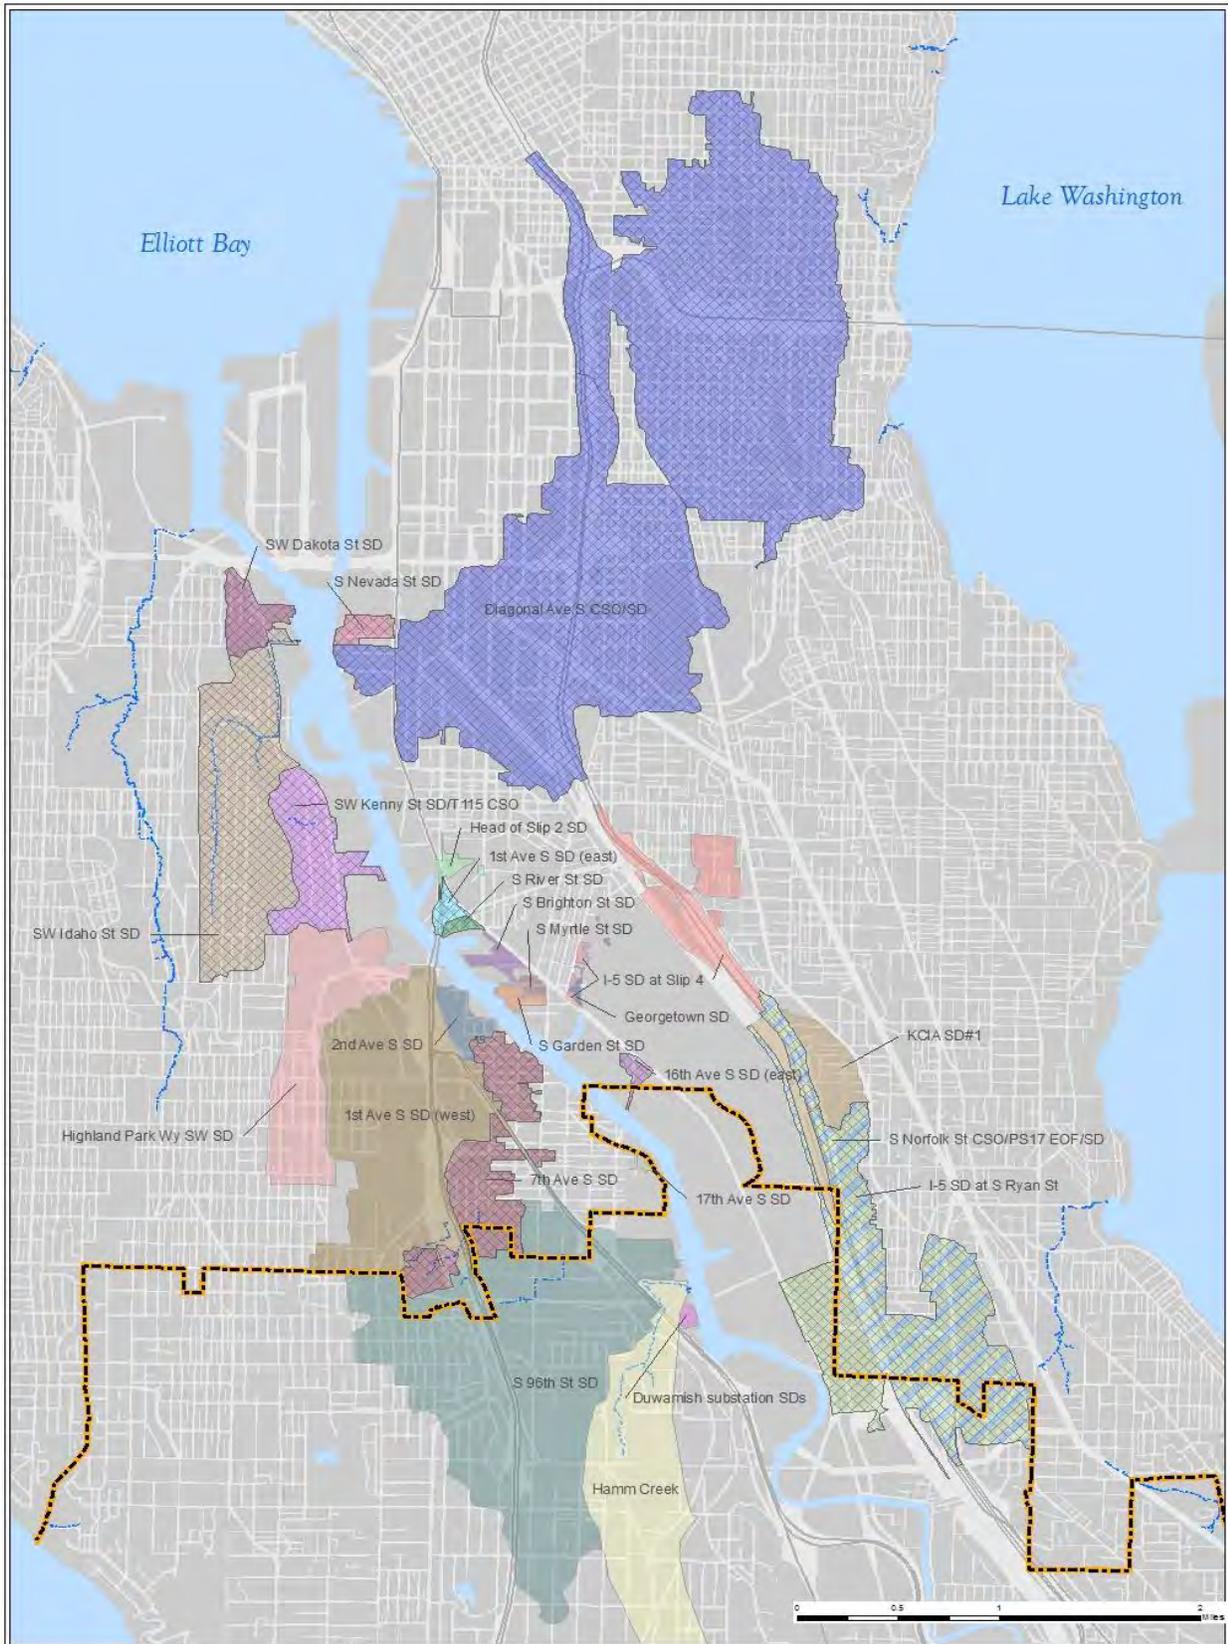
Figure 1 - MS4 Basins

**Figure 2-1. Seattle Storm Drain Basins in the Lower Duwamish Waterway**

- SPU focuses its business inspections in areas that discharge to the LDW through the City MS4 system. Inspections in the combined sanitary/storm sewer system are conducted in response to requests and complaints, and as additional resources allow. SPU's business inspection program conducts stormwater inspections and refers hazardous waste or industrial waste issues to Ecology and King County, respectively. Seattle's storm drain basins are shown in Figure 2-1.

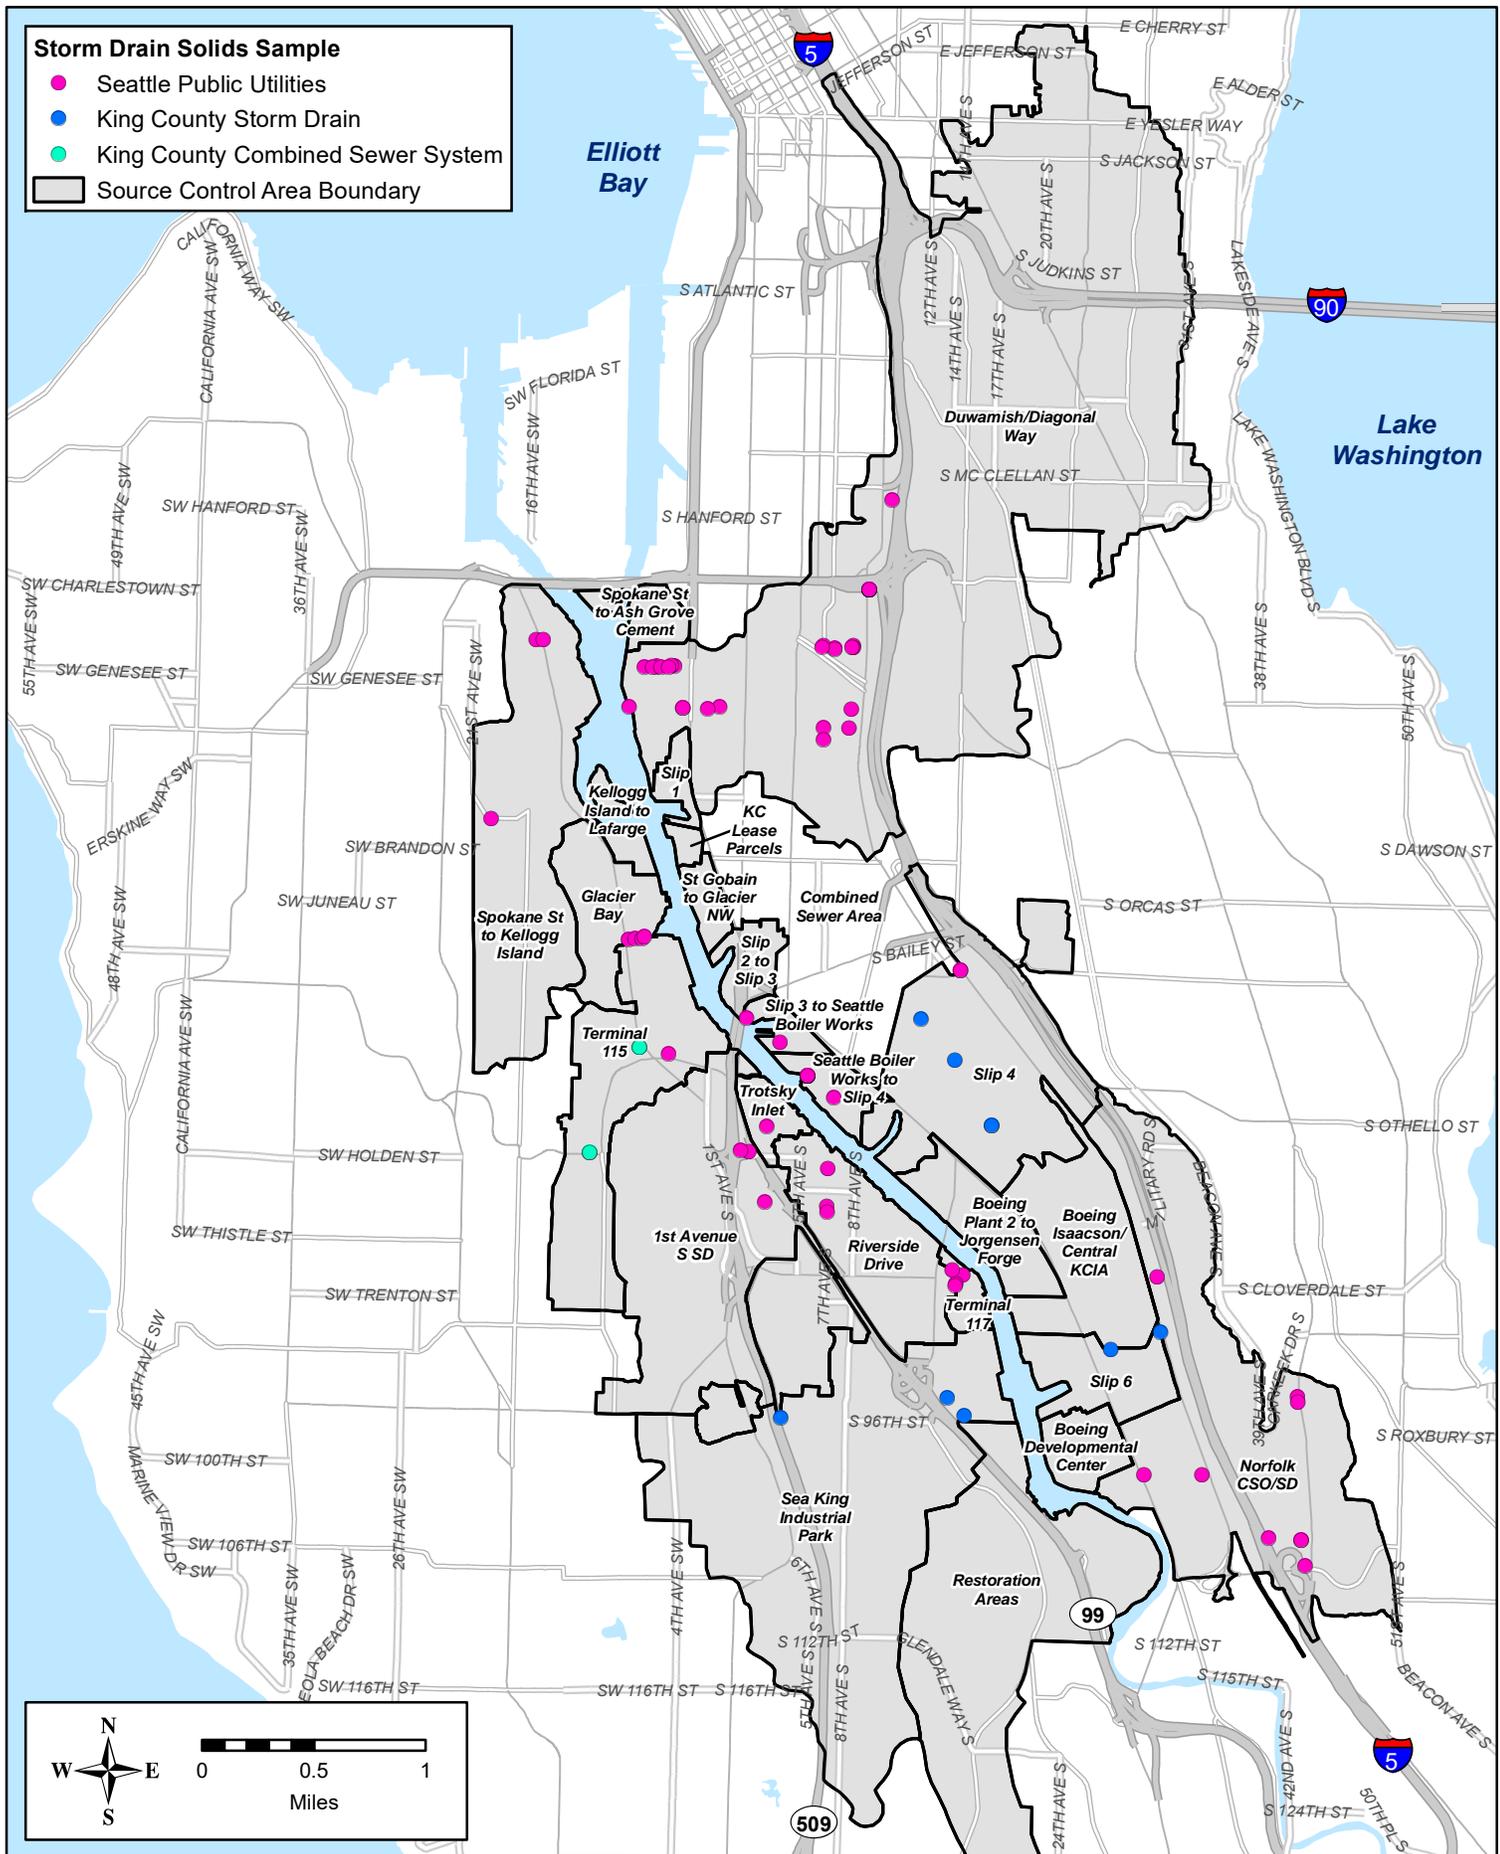
Figure 2-3. Source Tracing Sample Locations in the LDW Storm Drain Basin: 2020

Source tracing locations where samples were collected during the current reporting period (2020) are shown on Figure 2-3. Results are discussed below and as relevant in subsequent sections for the specific source control areas in which they are located.

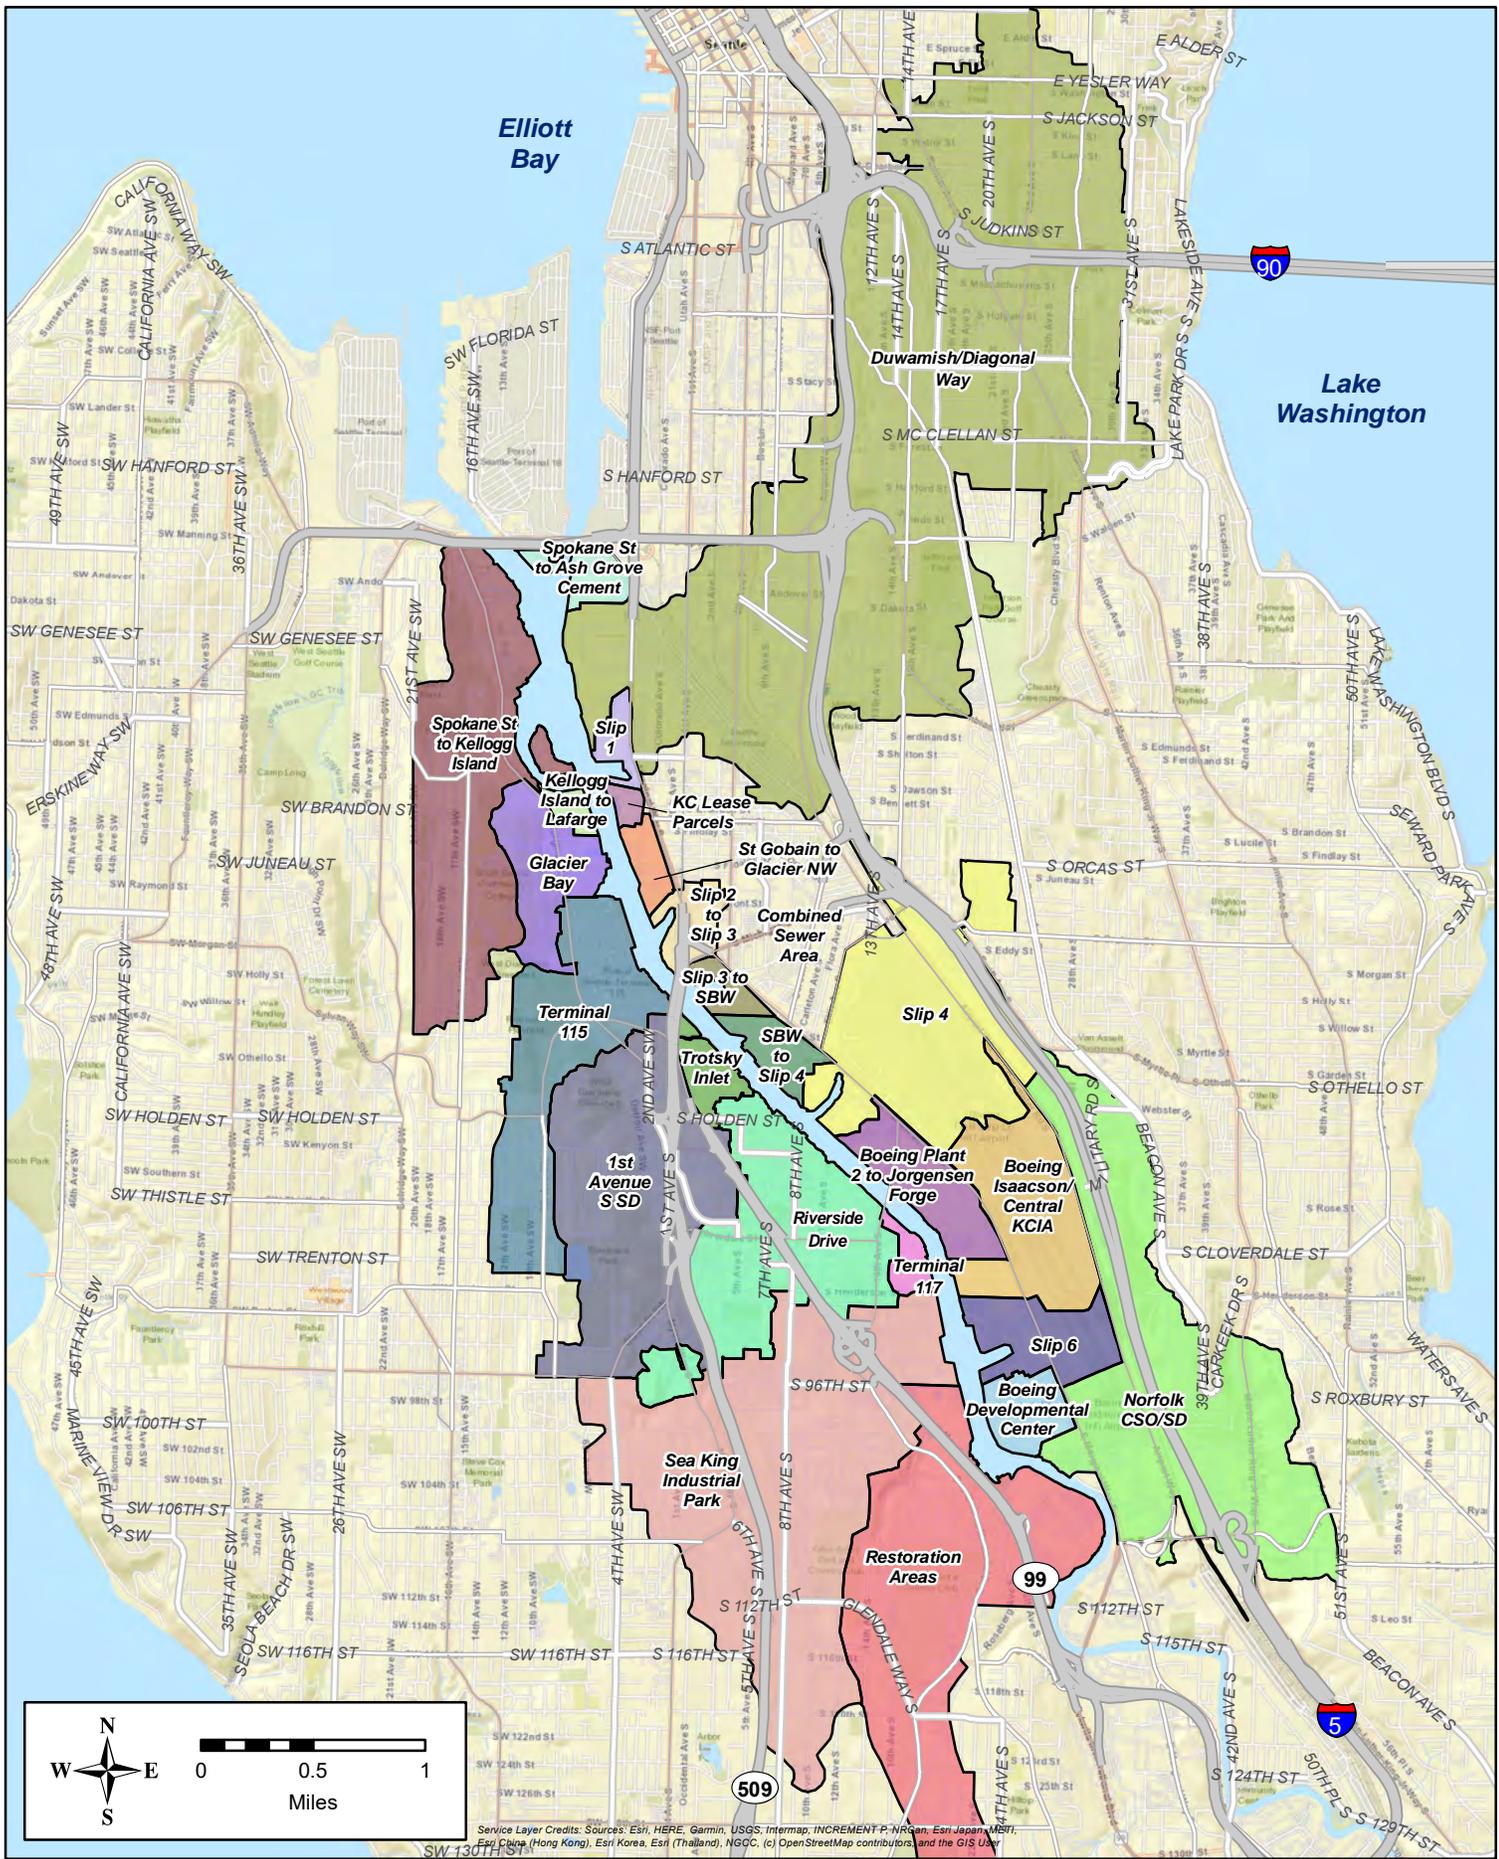
Figure A-1. Lower Duwamish Waterway Source Control Areas

Properties for which no source control activities were conducted during the reporting period are not discussed in this report. Site maps are presented for each of the 24 source control areas in Appendix A. These maps are intended to help identify locations discussed in the text. Additional figures are available in the referenced reports.

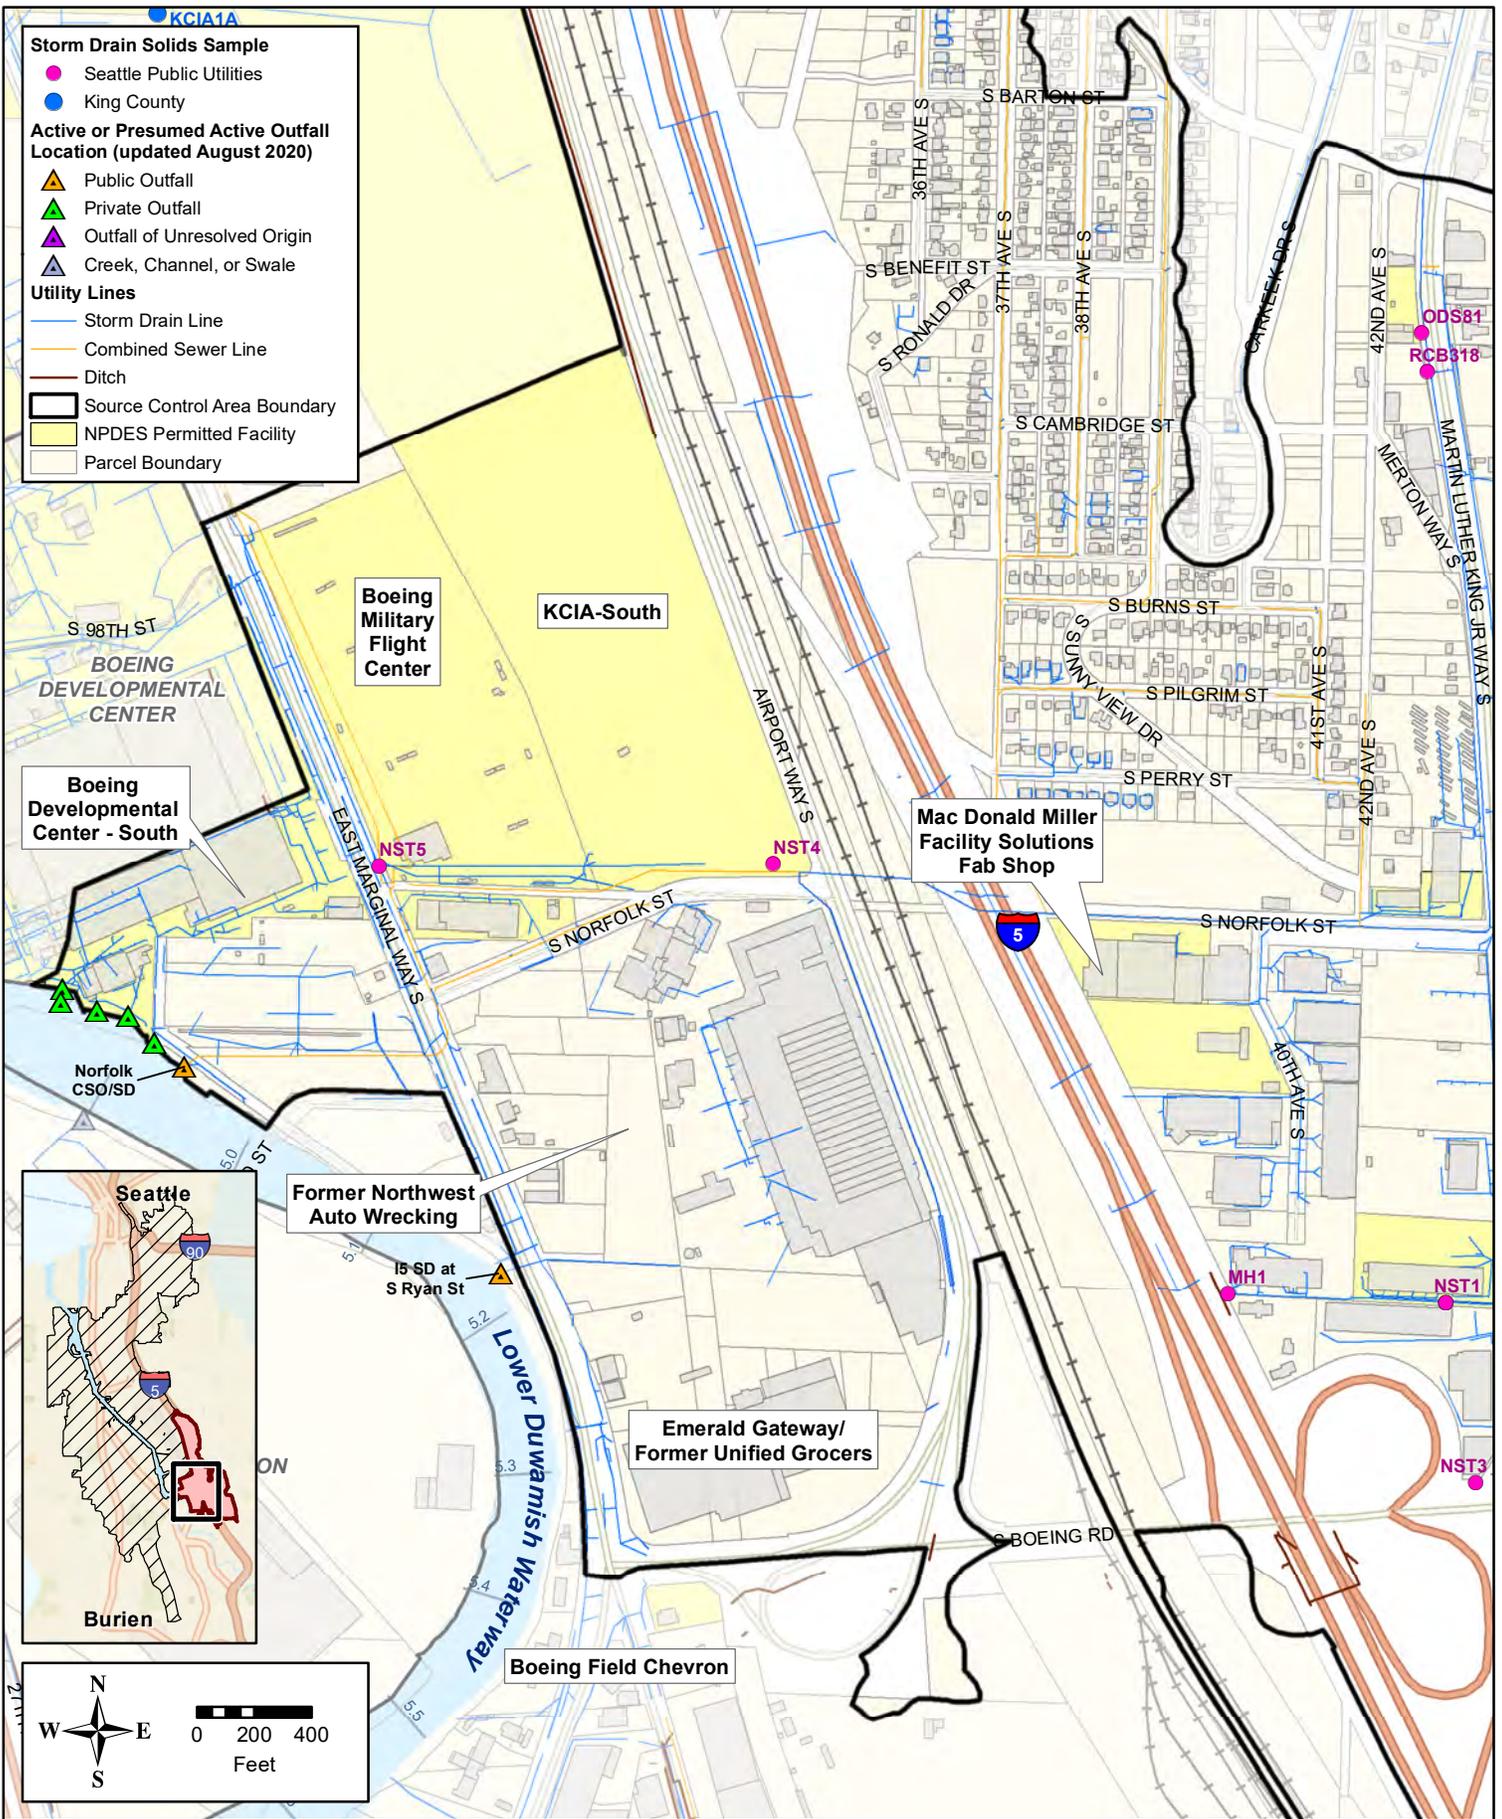
Figure A-2. RM 4.9 East  
(EEA-7: Norfolk CSO/Storm Drain)  
Source Control Area

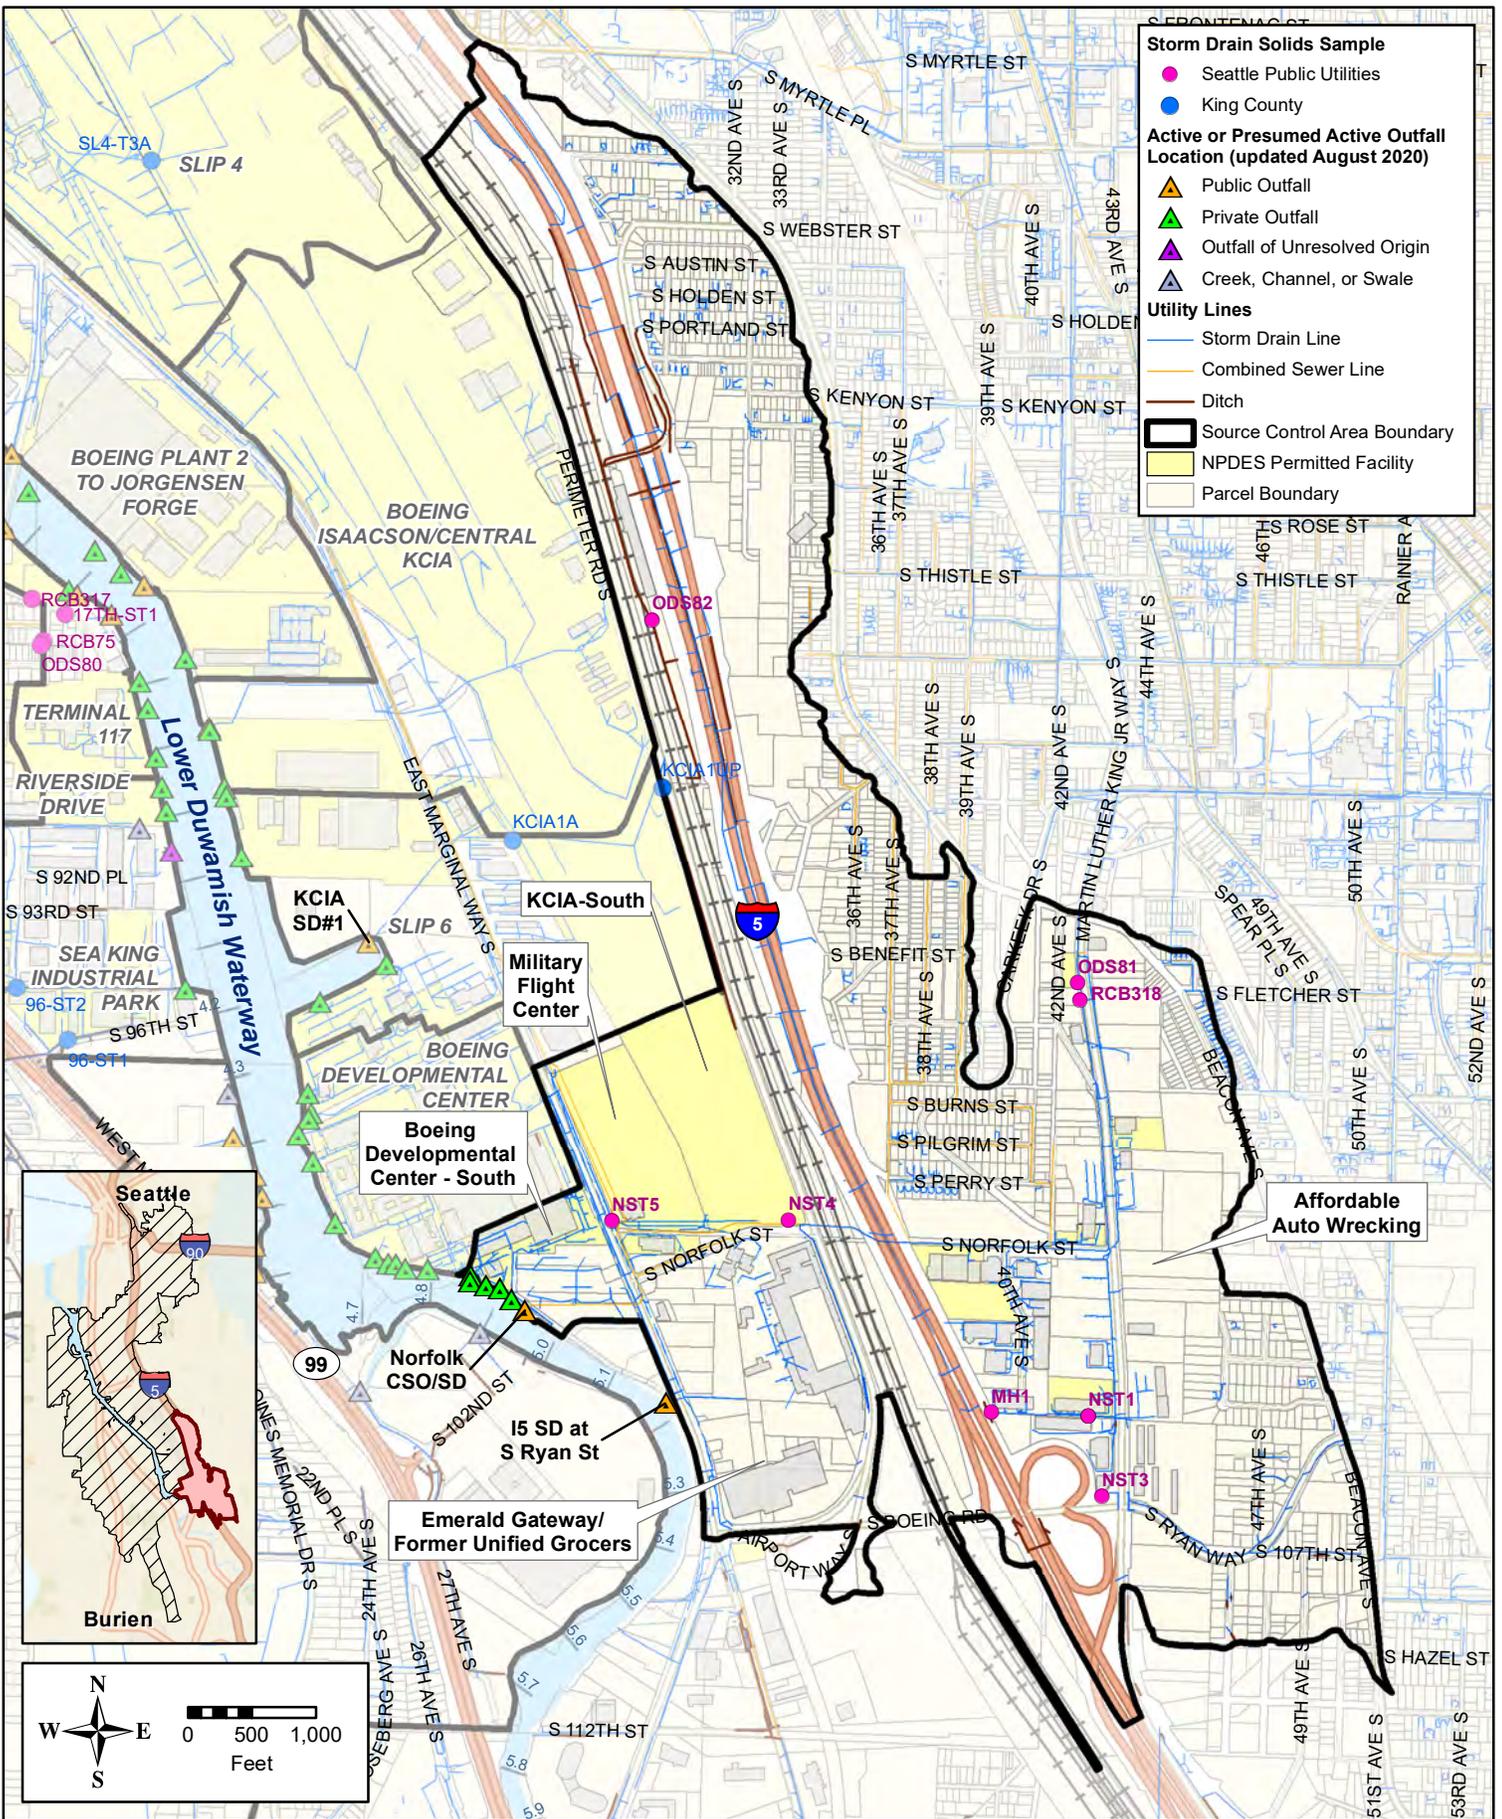
Figure A-3. RM 4.9 East  
 (EEA-7: Norfolk CSO/Storm Drain)  
 Norfolk Basin

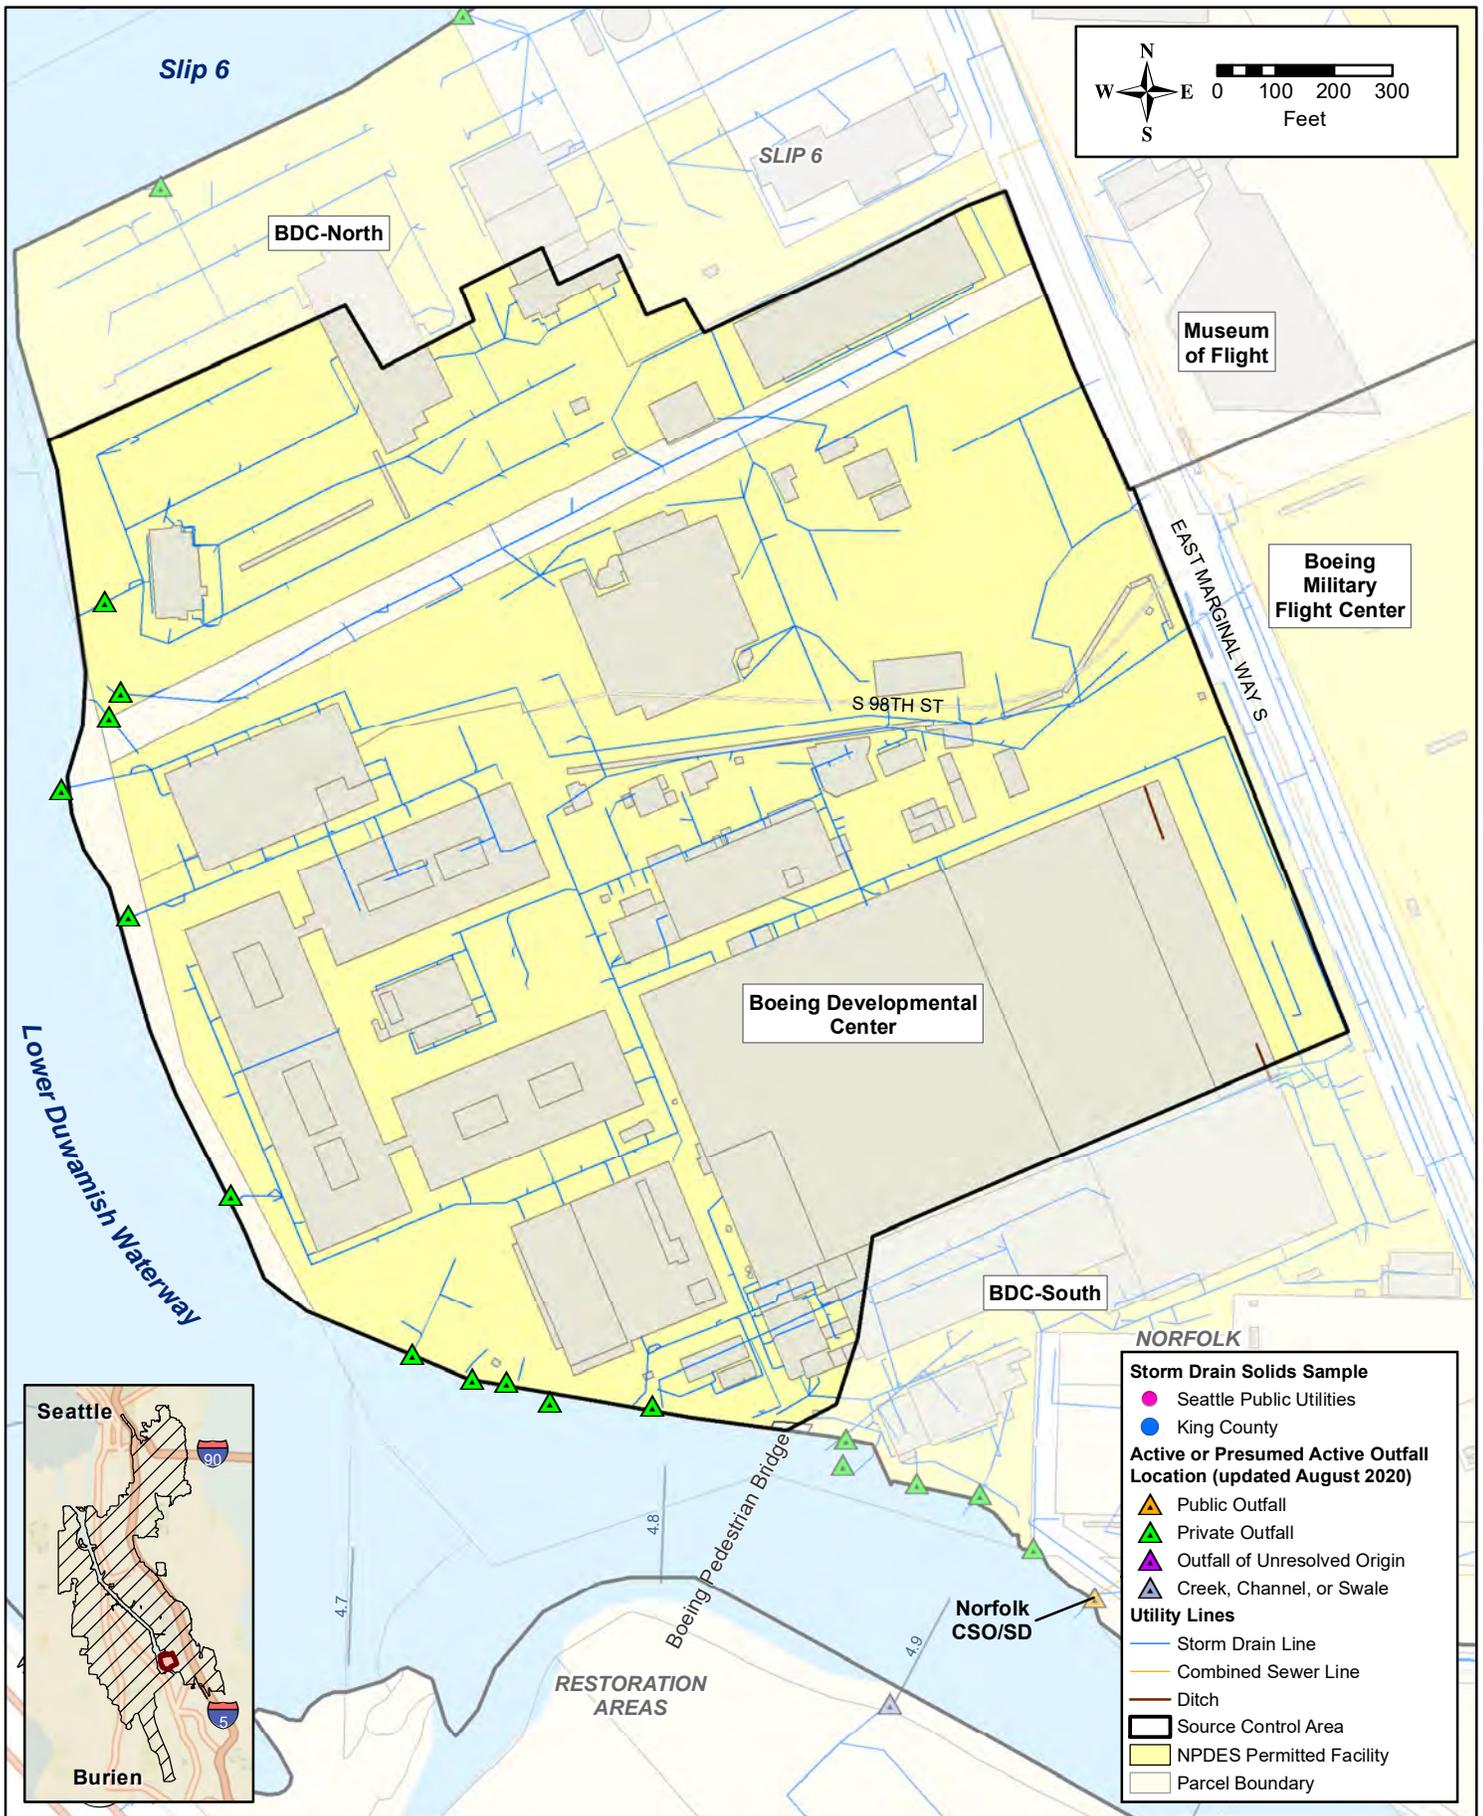
**Figure A-4. RM 4.3-4.9 East  
(Boeing Developmental Center)  
Source Control Area**
