# **Lower Duwamish Waterway Source Control Status Report 2020**

August 2022

Publication No. 22-09-178

Toxics Cleanup Program  
Northwest Regional Office  
Washington State Department of Ecology  
Shoreline, Washington

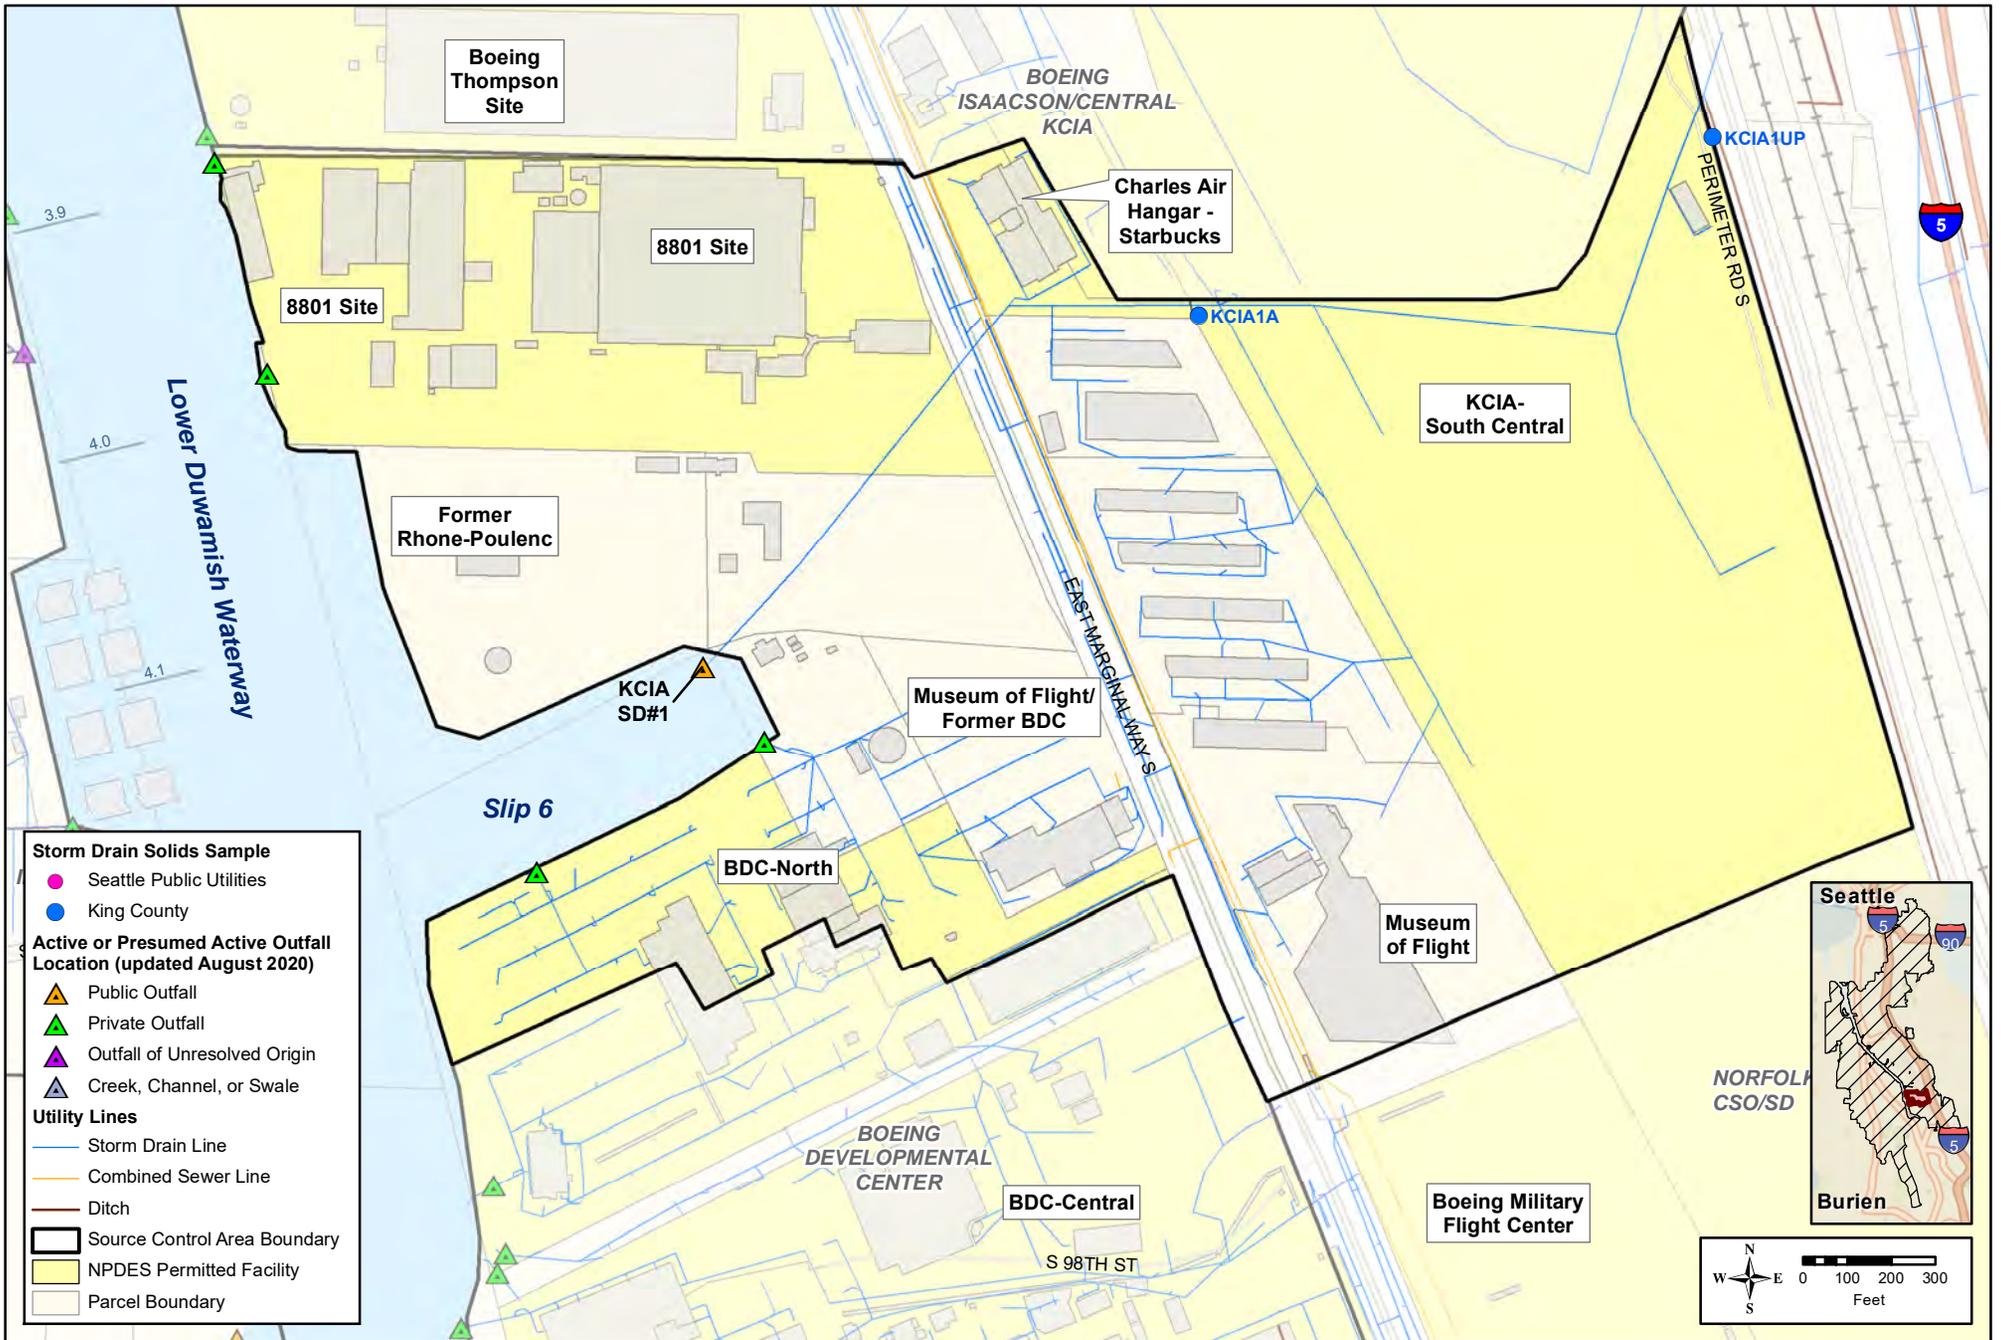
**Figure A-5. RM 3.9-4.3 East (Slip 6) Source Control Area**

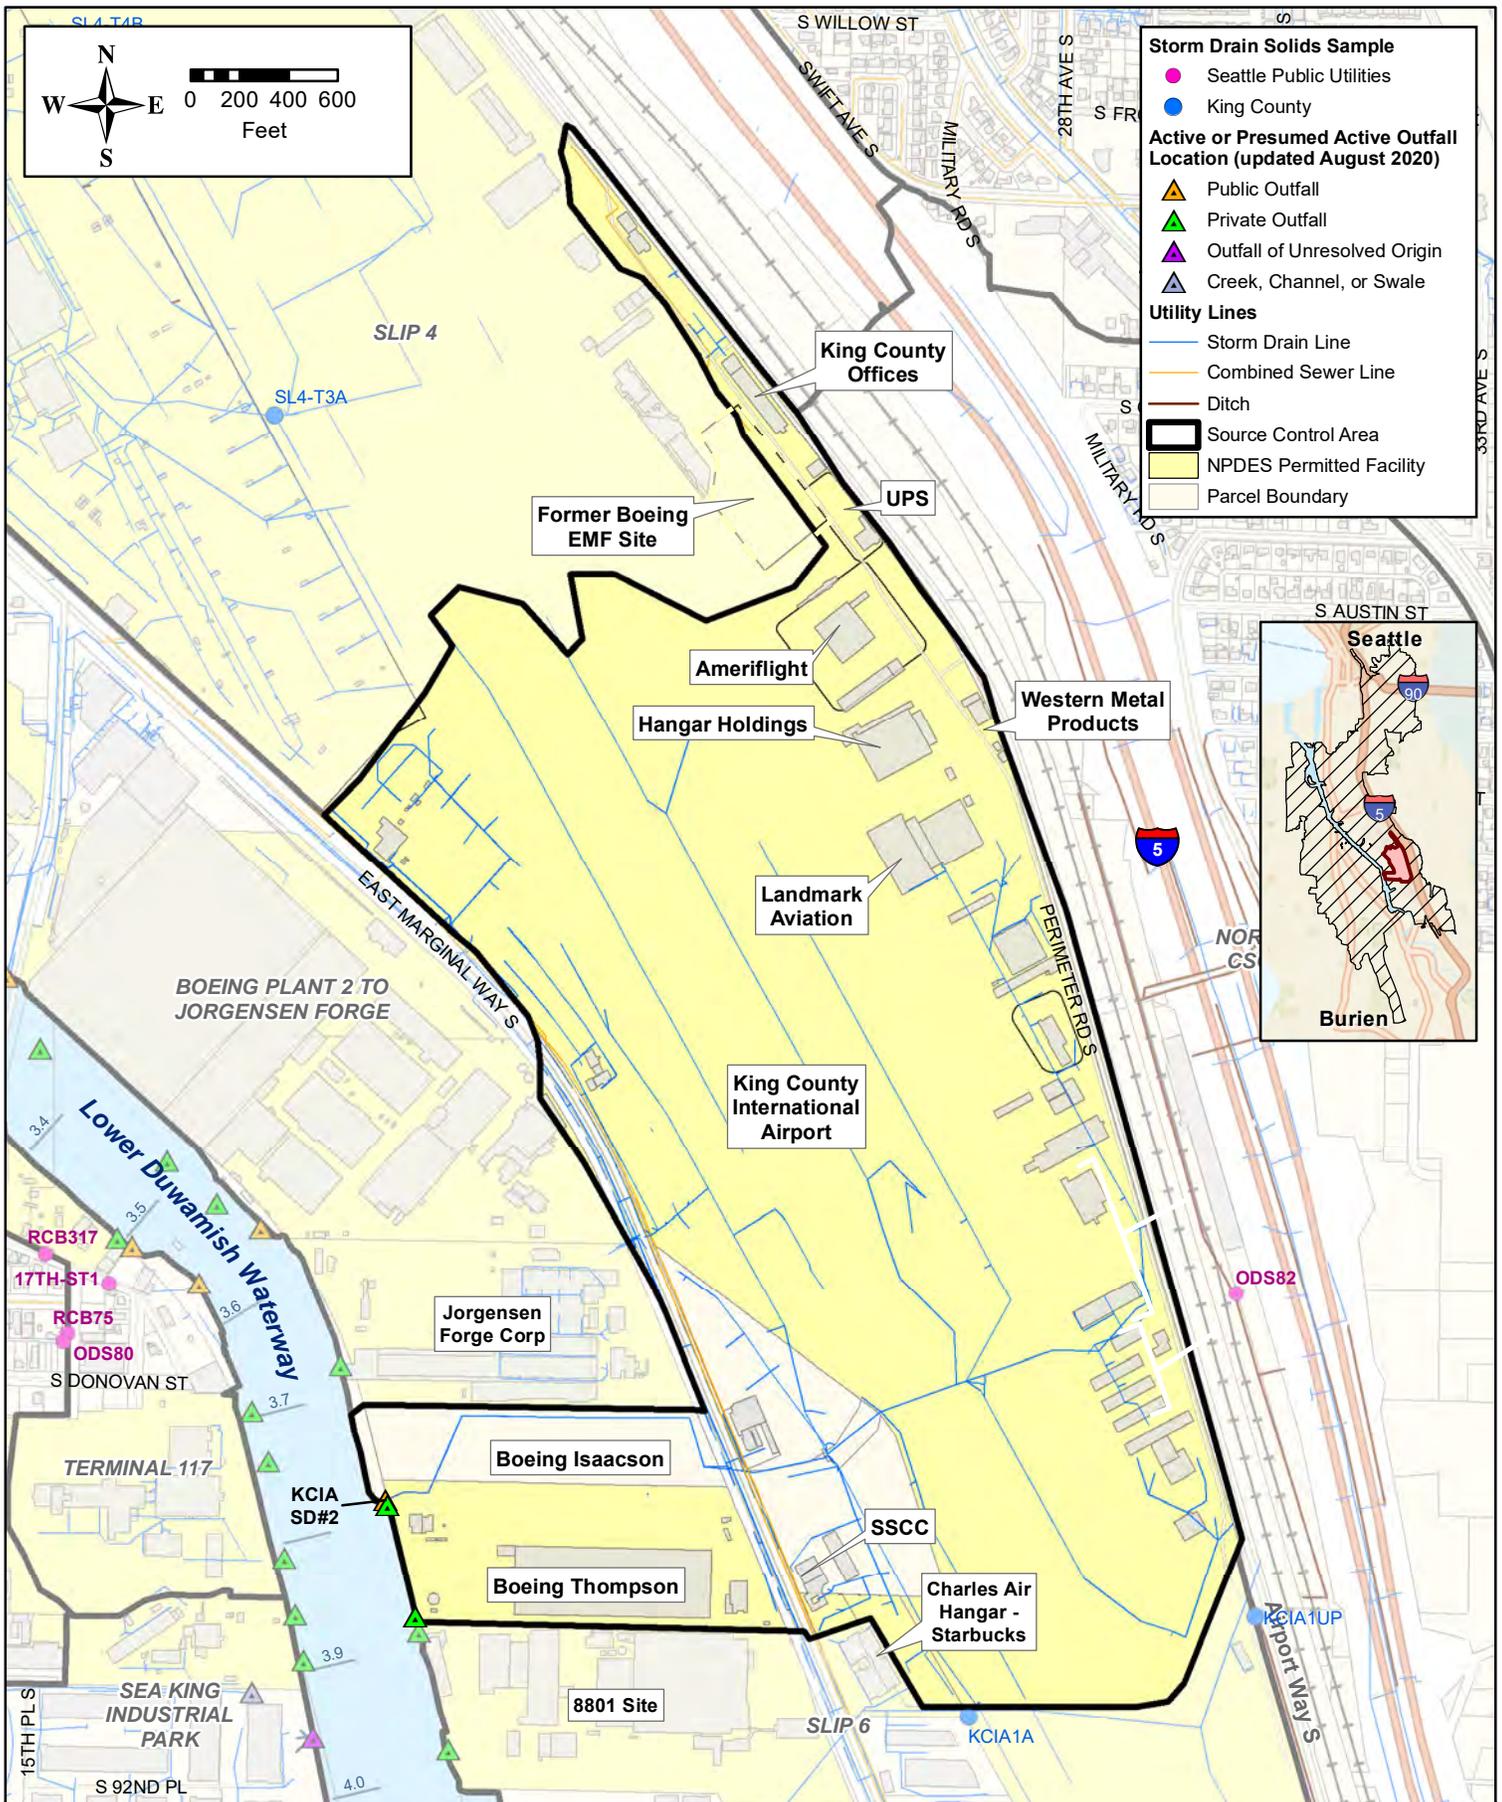
**Figure A-6. RM 3.7-3.9 East  
(EAA-6: Boeing Isaacson/Central KCIA)  
Source Control Area**

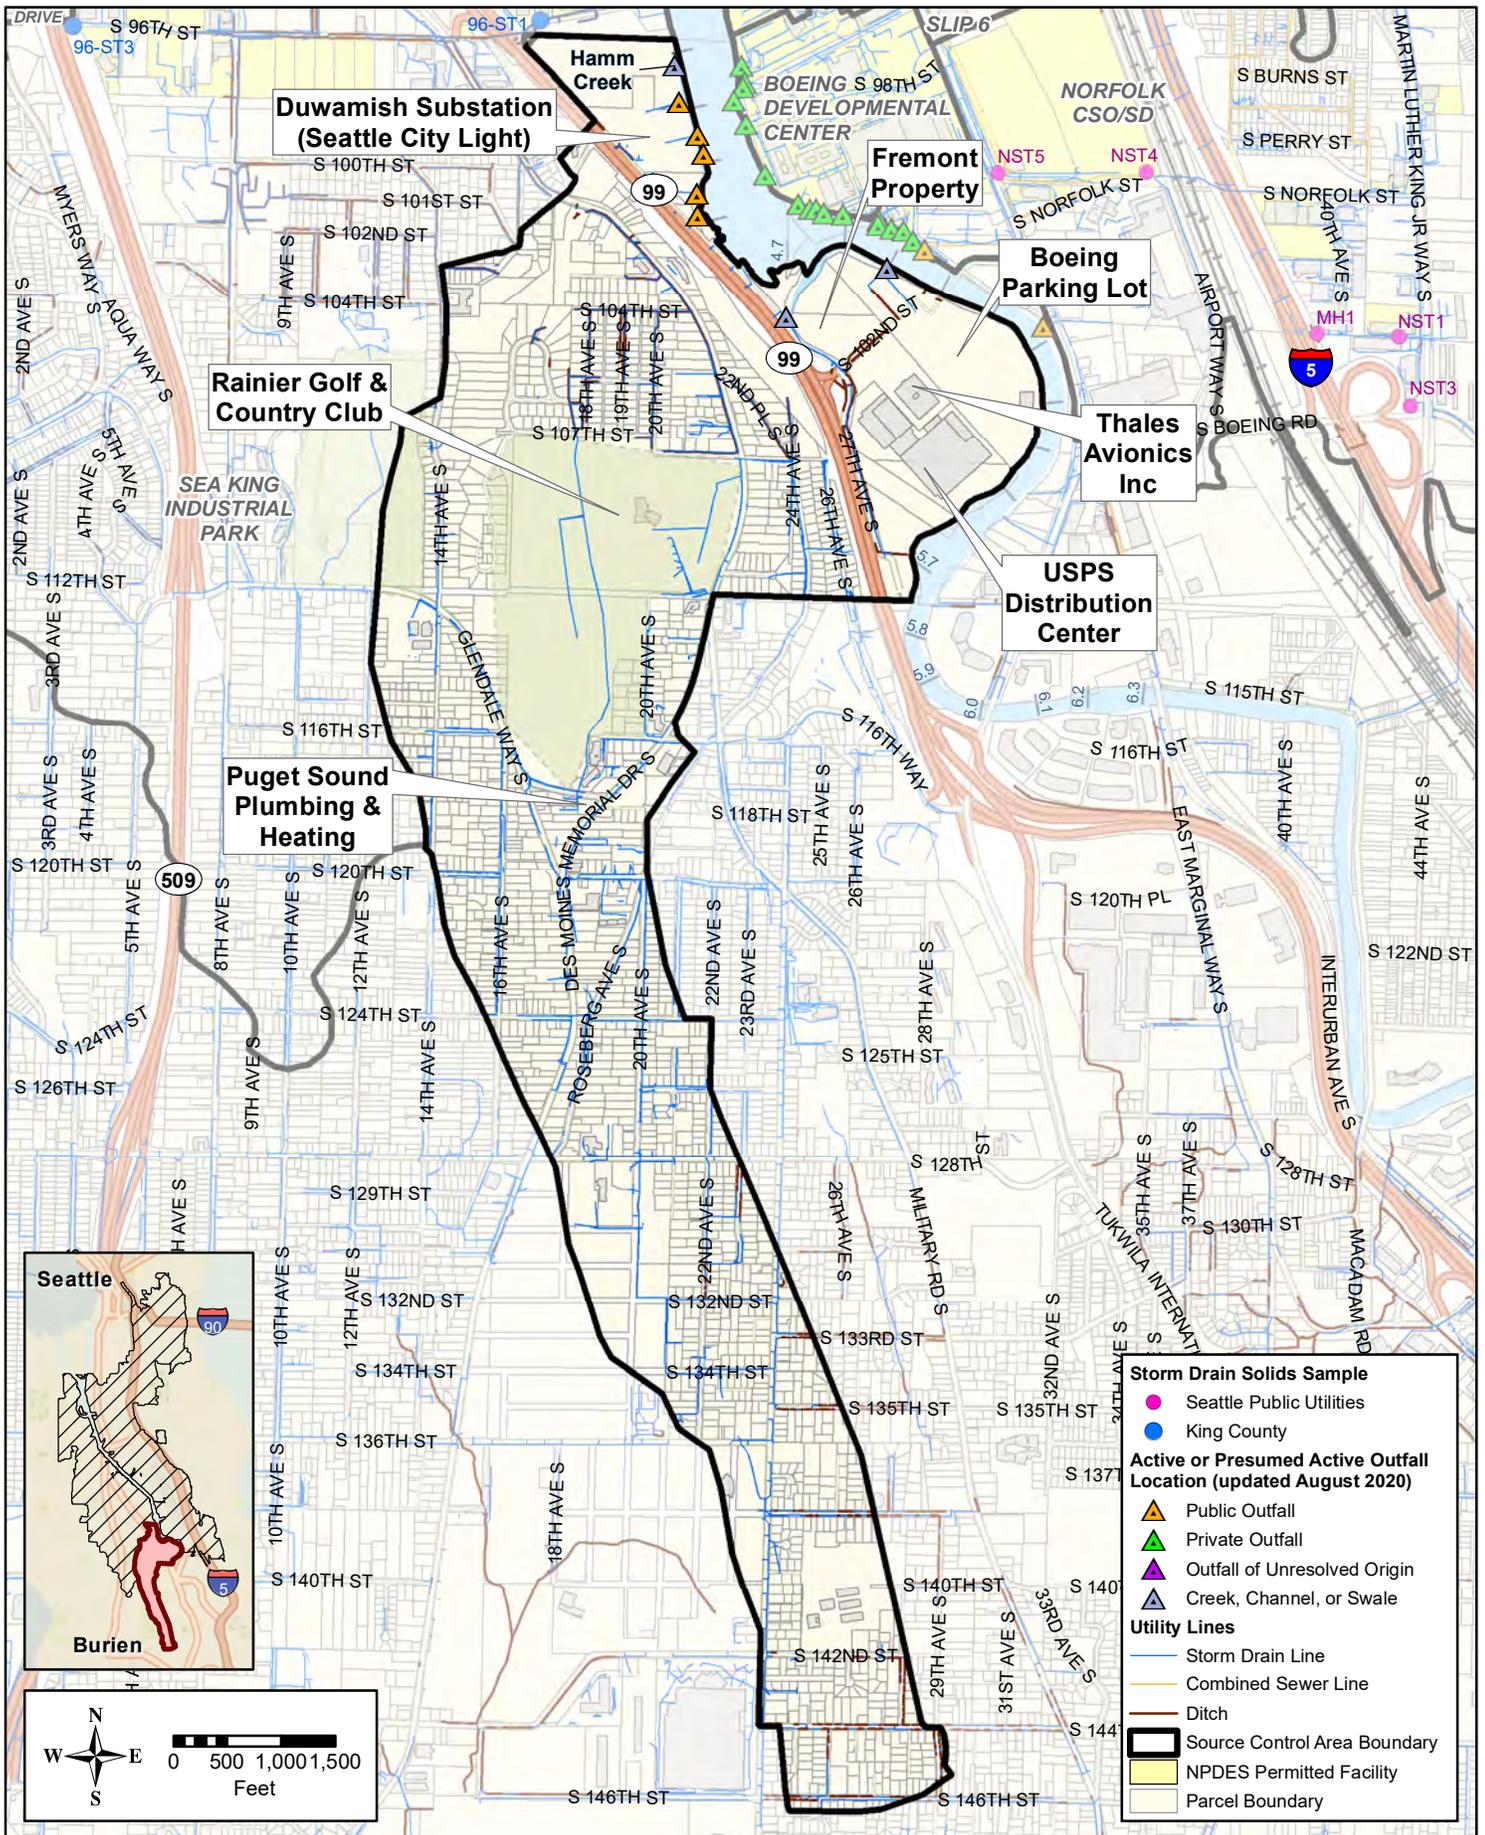
**Figure A-8. RM 4.2-5.8 West  
(Restoration Areas)  
Source Control Area**

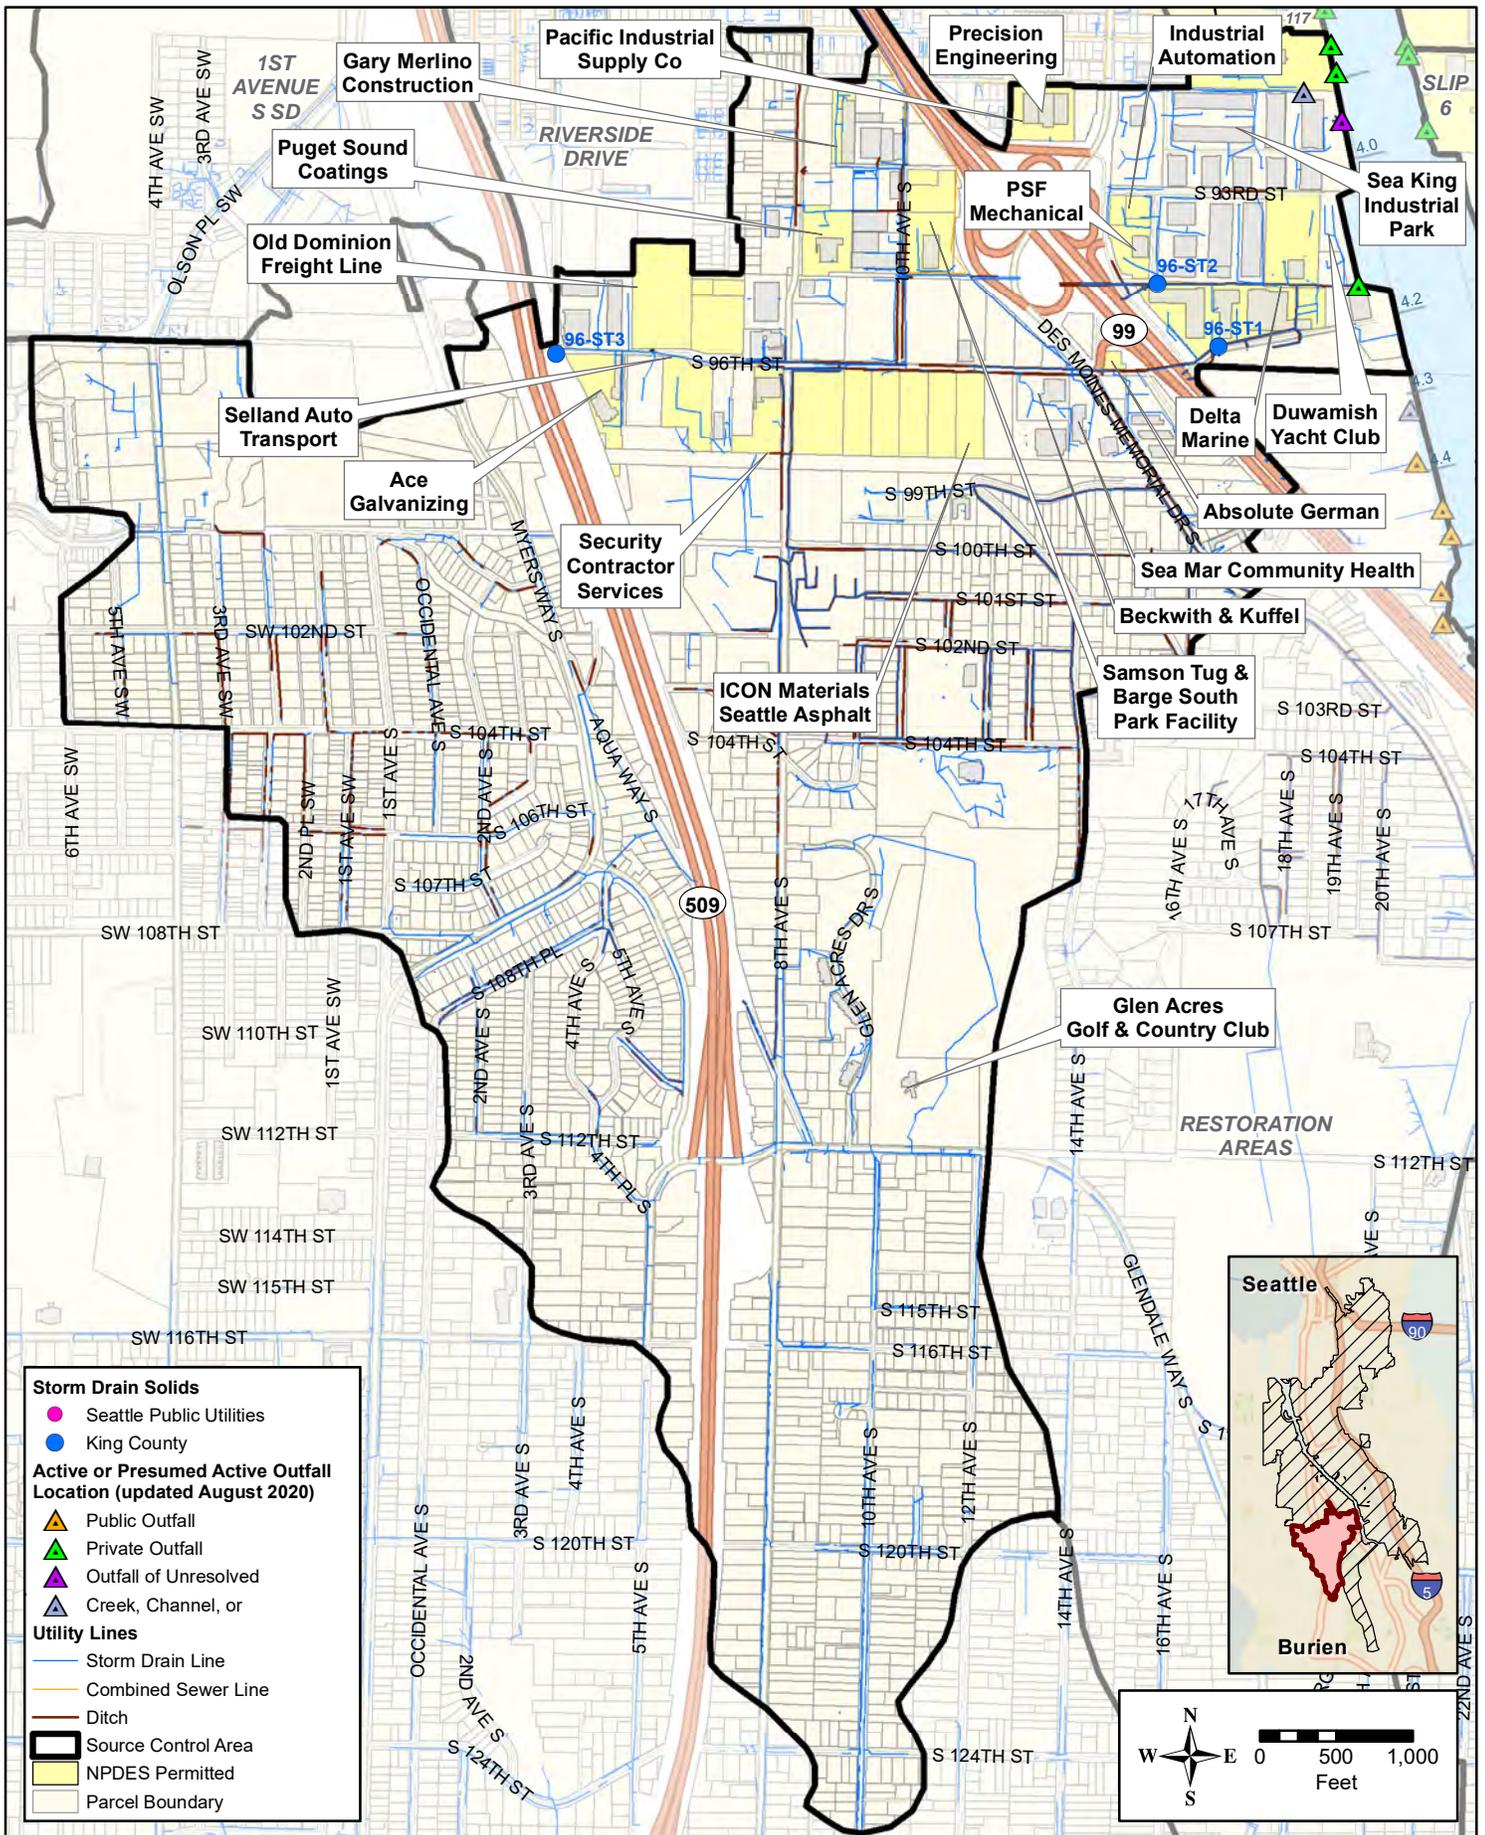
**Figure A-9. RM 3.8-4.2 West  
(Sea King Industrial Park)  
Source Control Area**

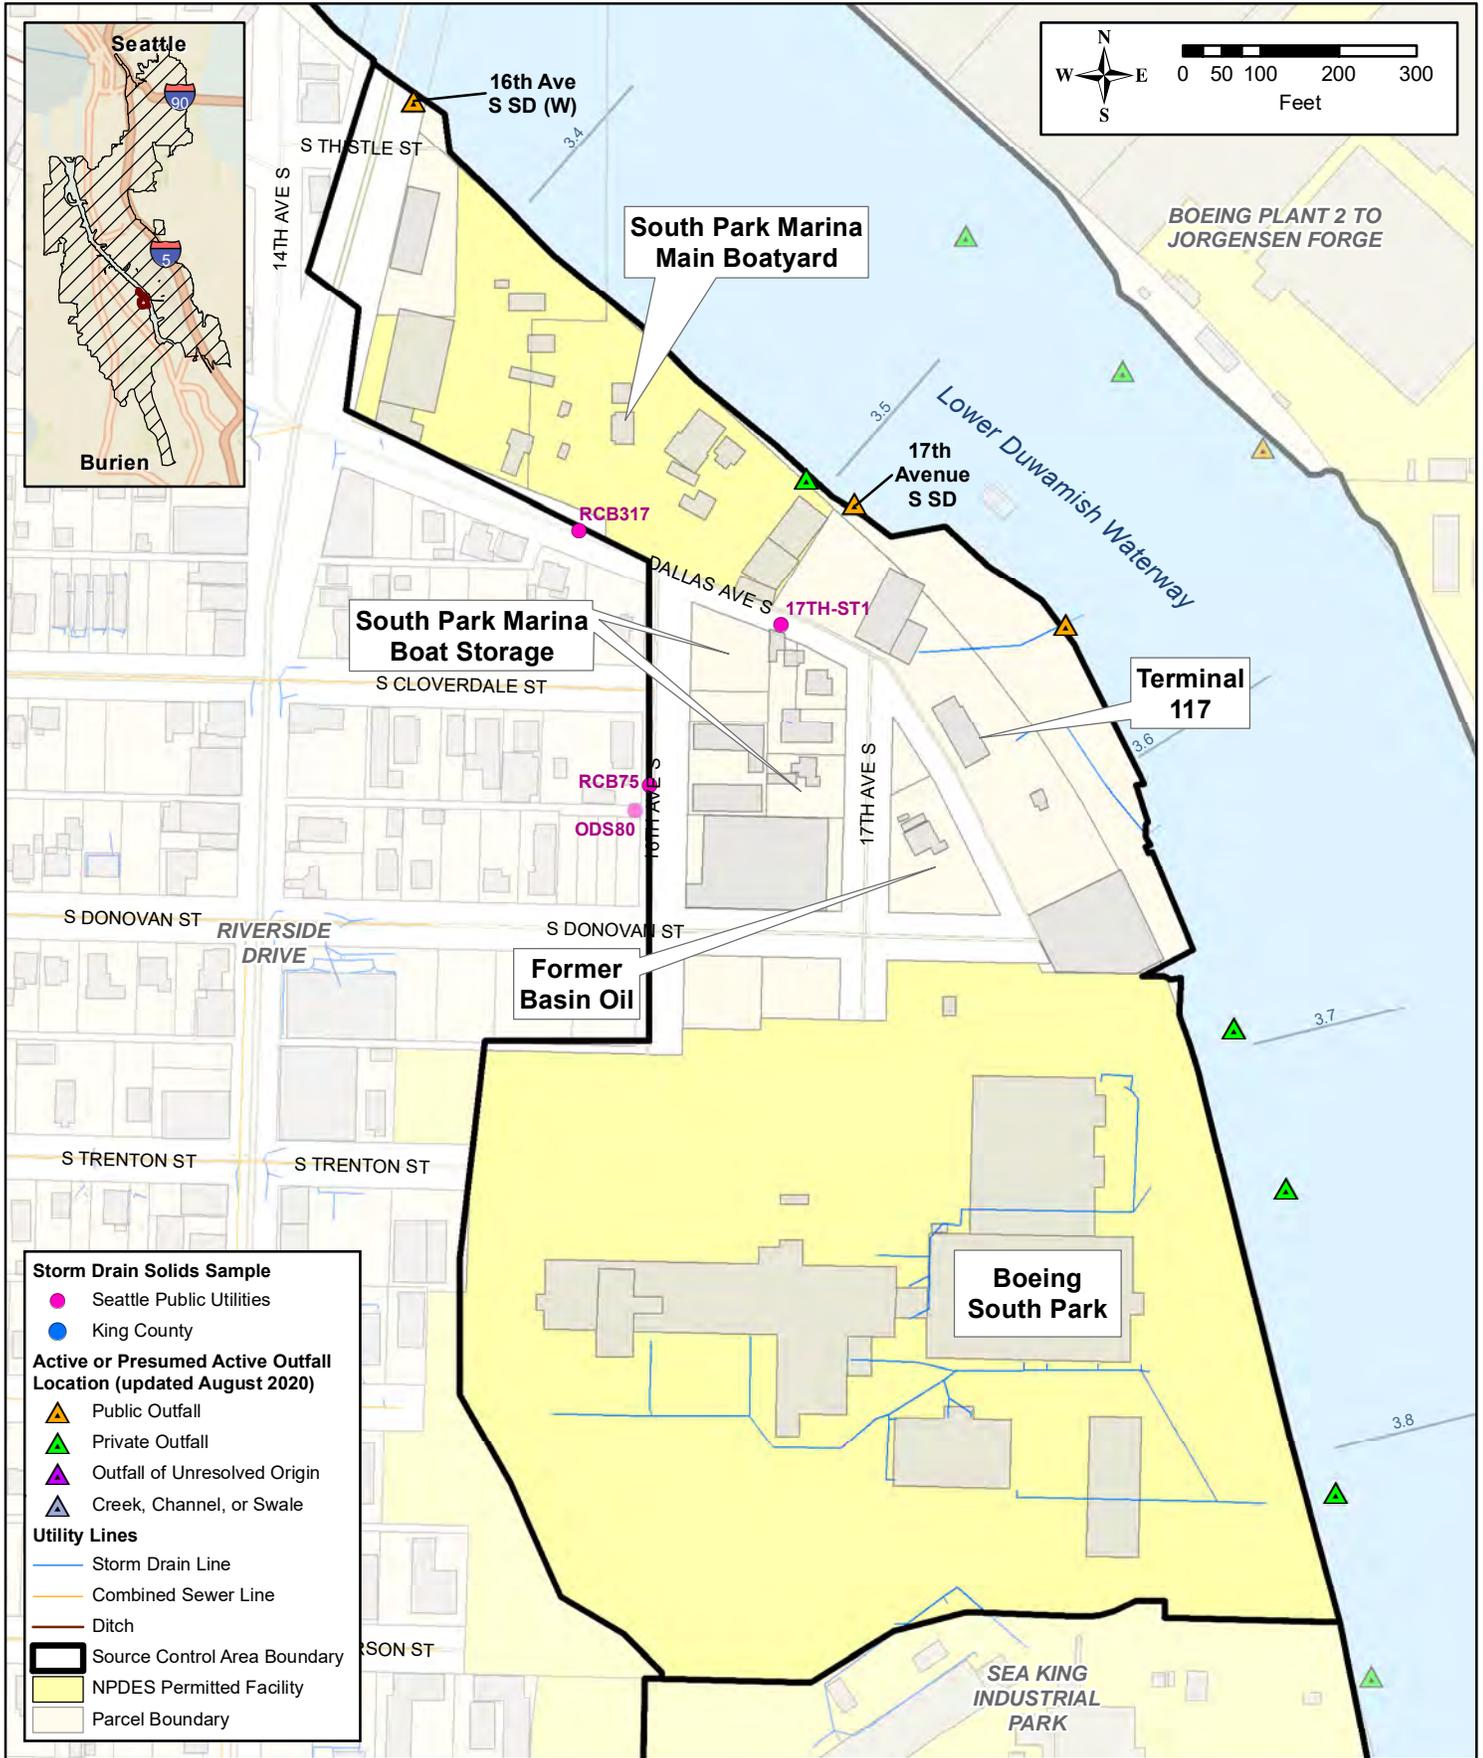
Figure A-10. RM 3.4-3.8 West  
(EAA-5: Terminal 117)  
Source Control Area

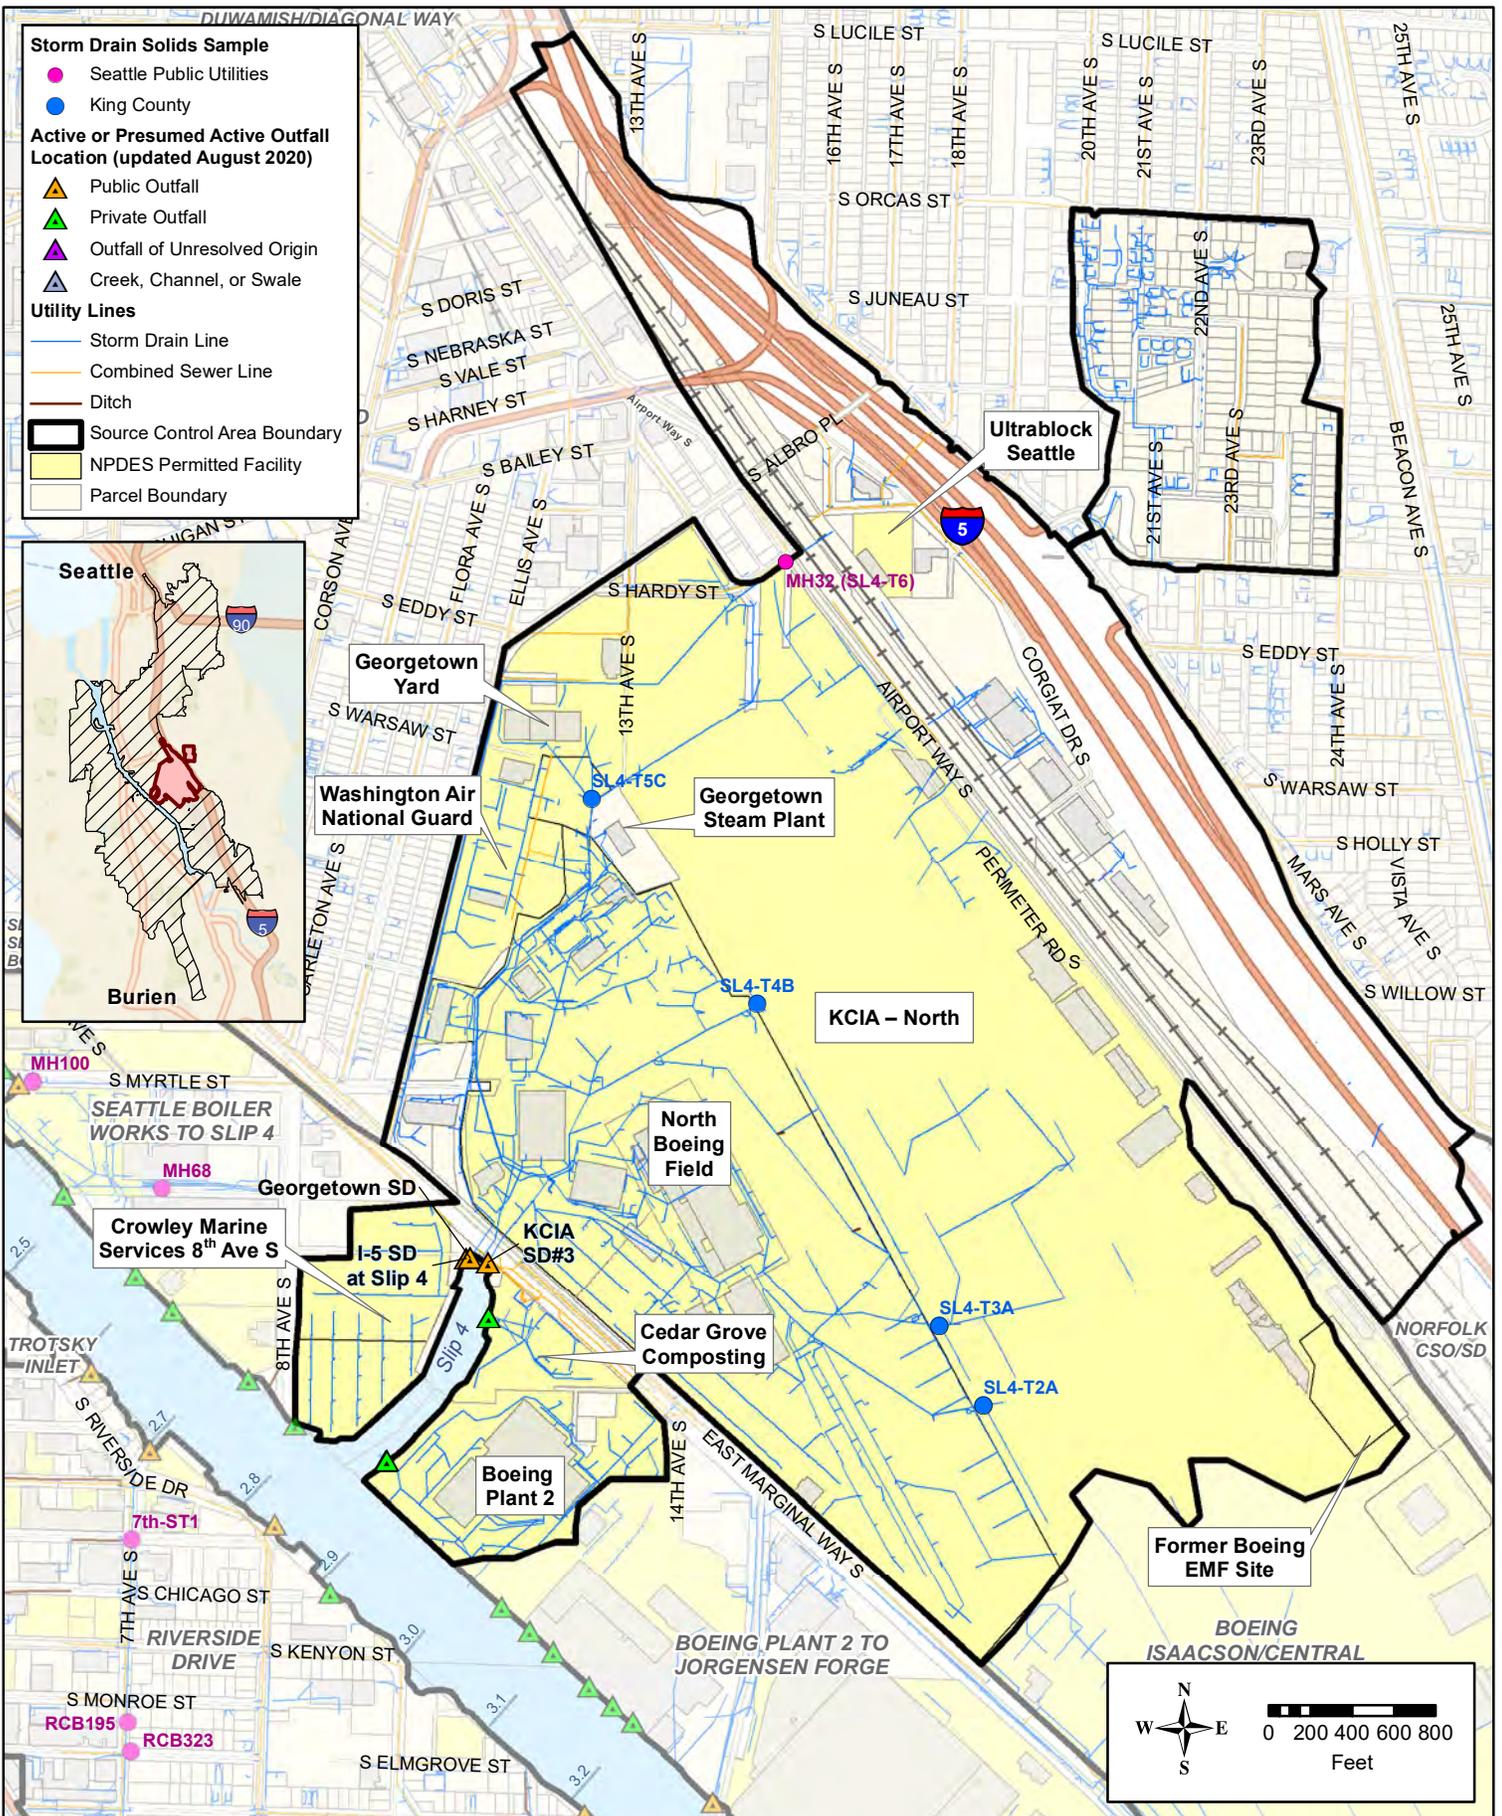
**Figure A-11. RM 2.8 East  
(EAA-3: Slip 4)  
Source Control Area**

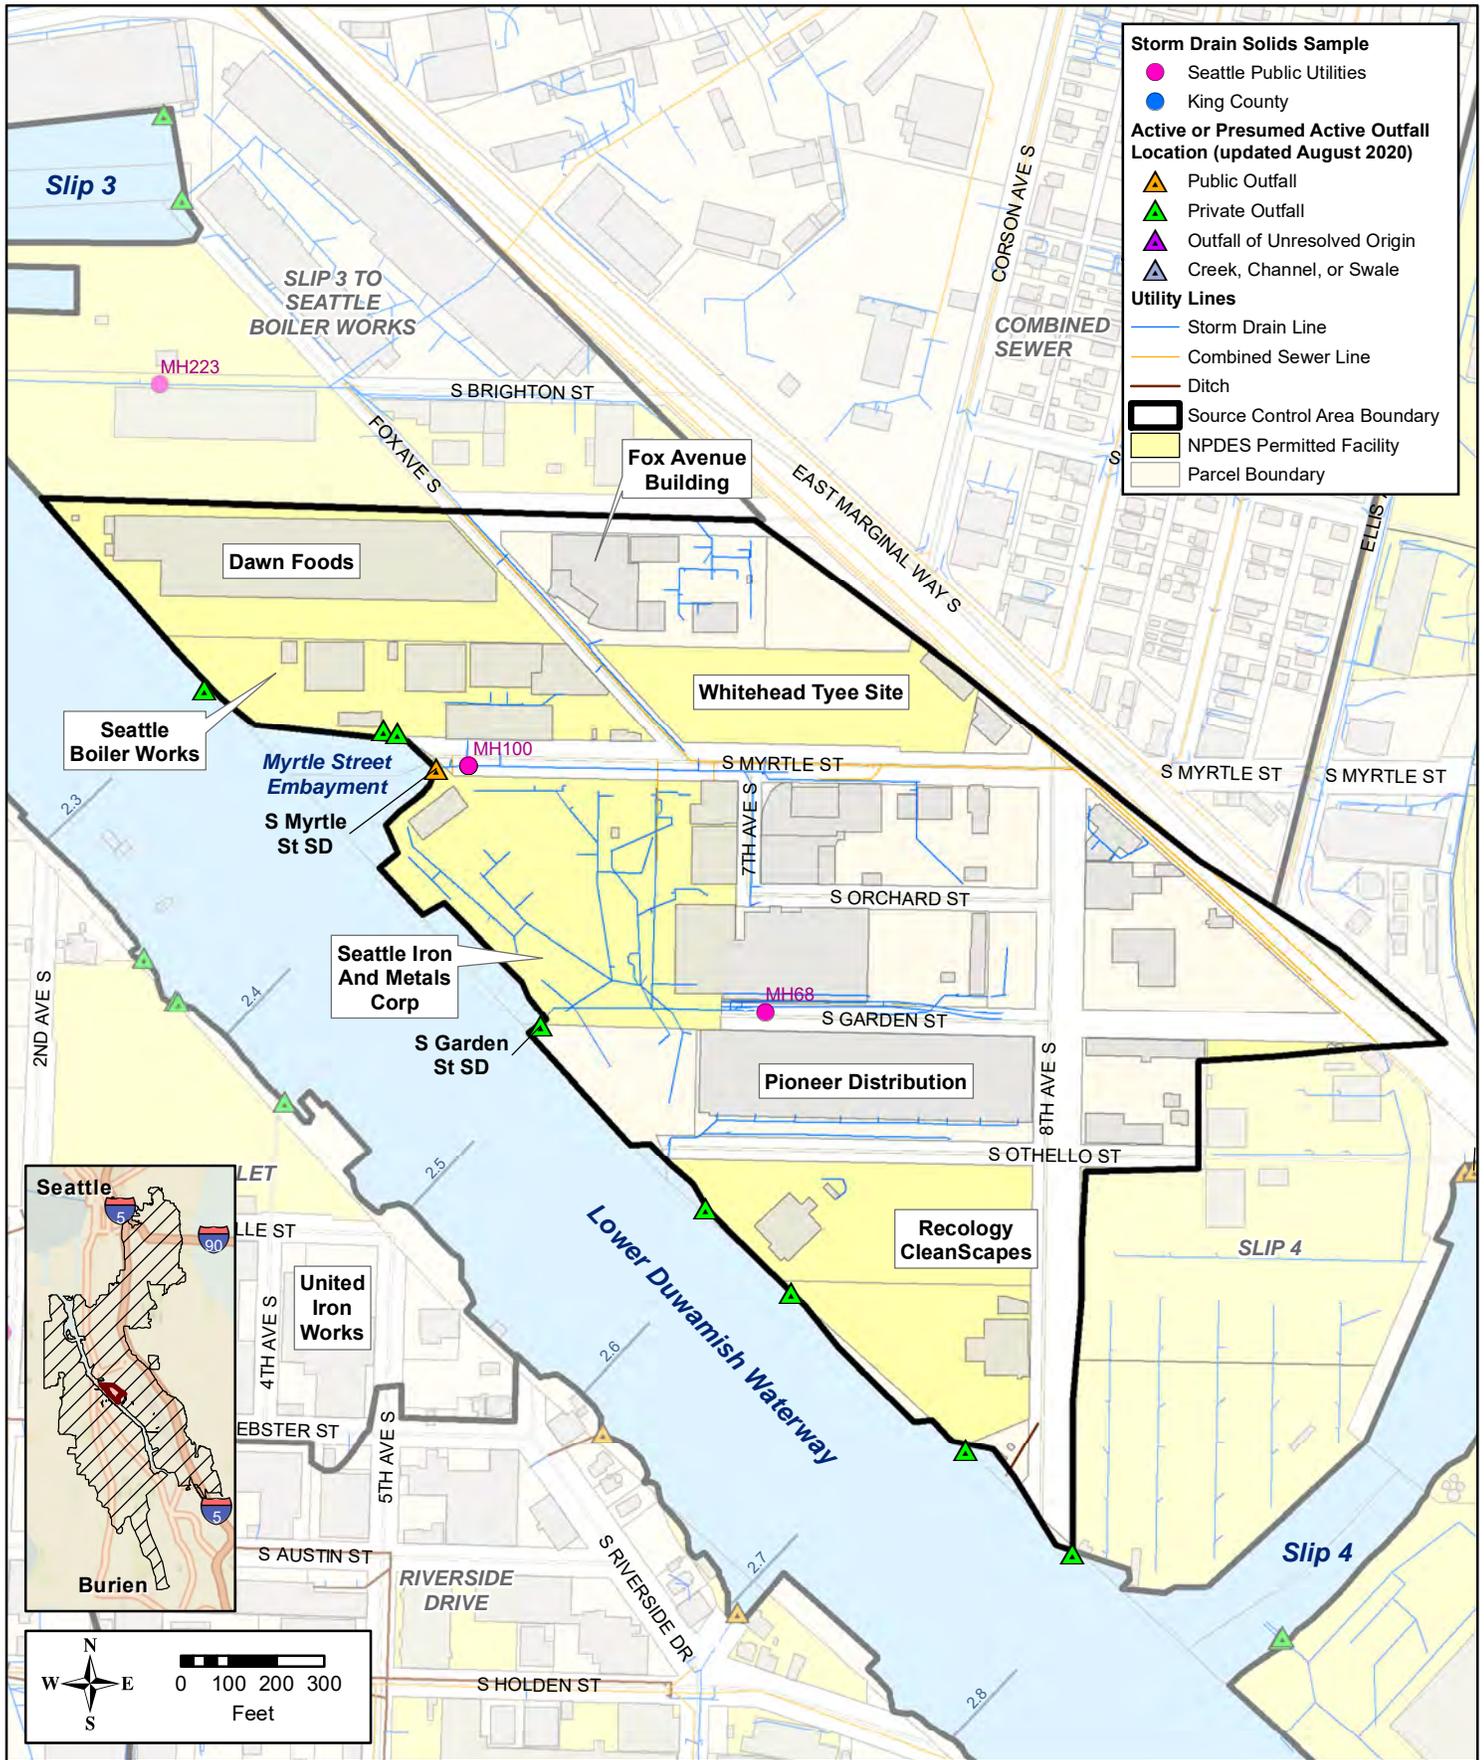
**Figure A-12. RM 2.3-2.8 East  
(Seattle Boiler Works to Slip 4)  
Source Control Area**

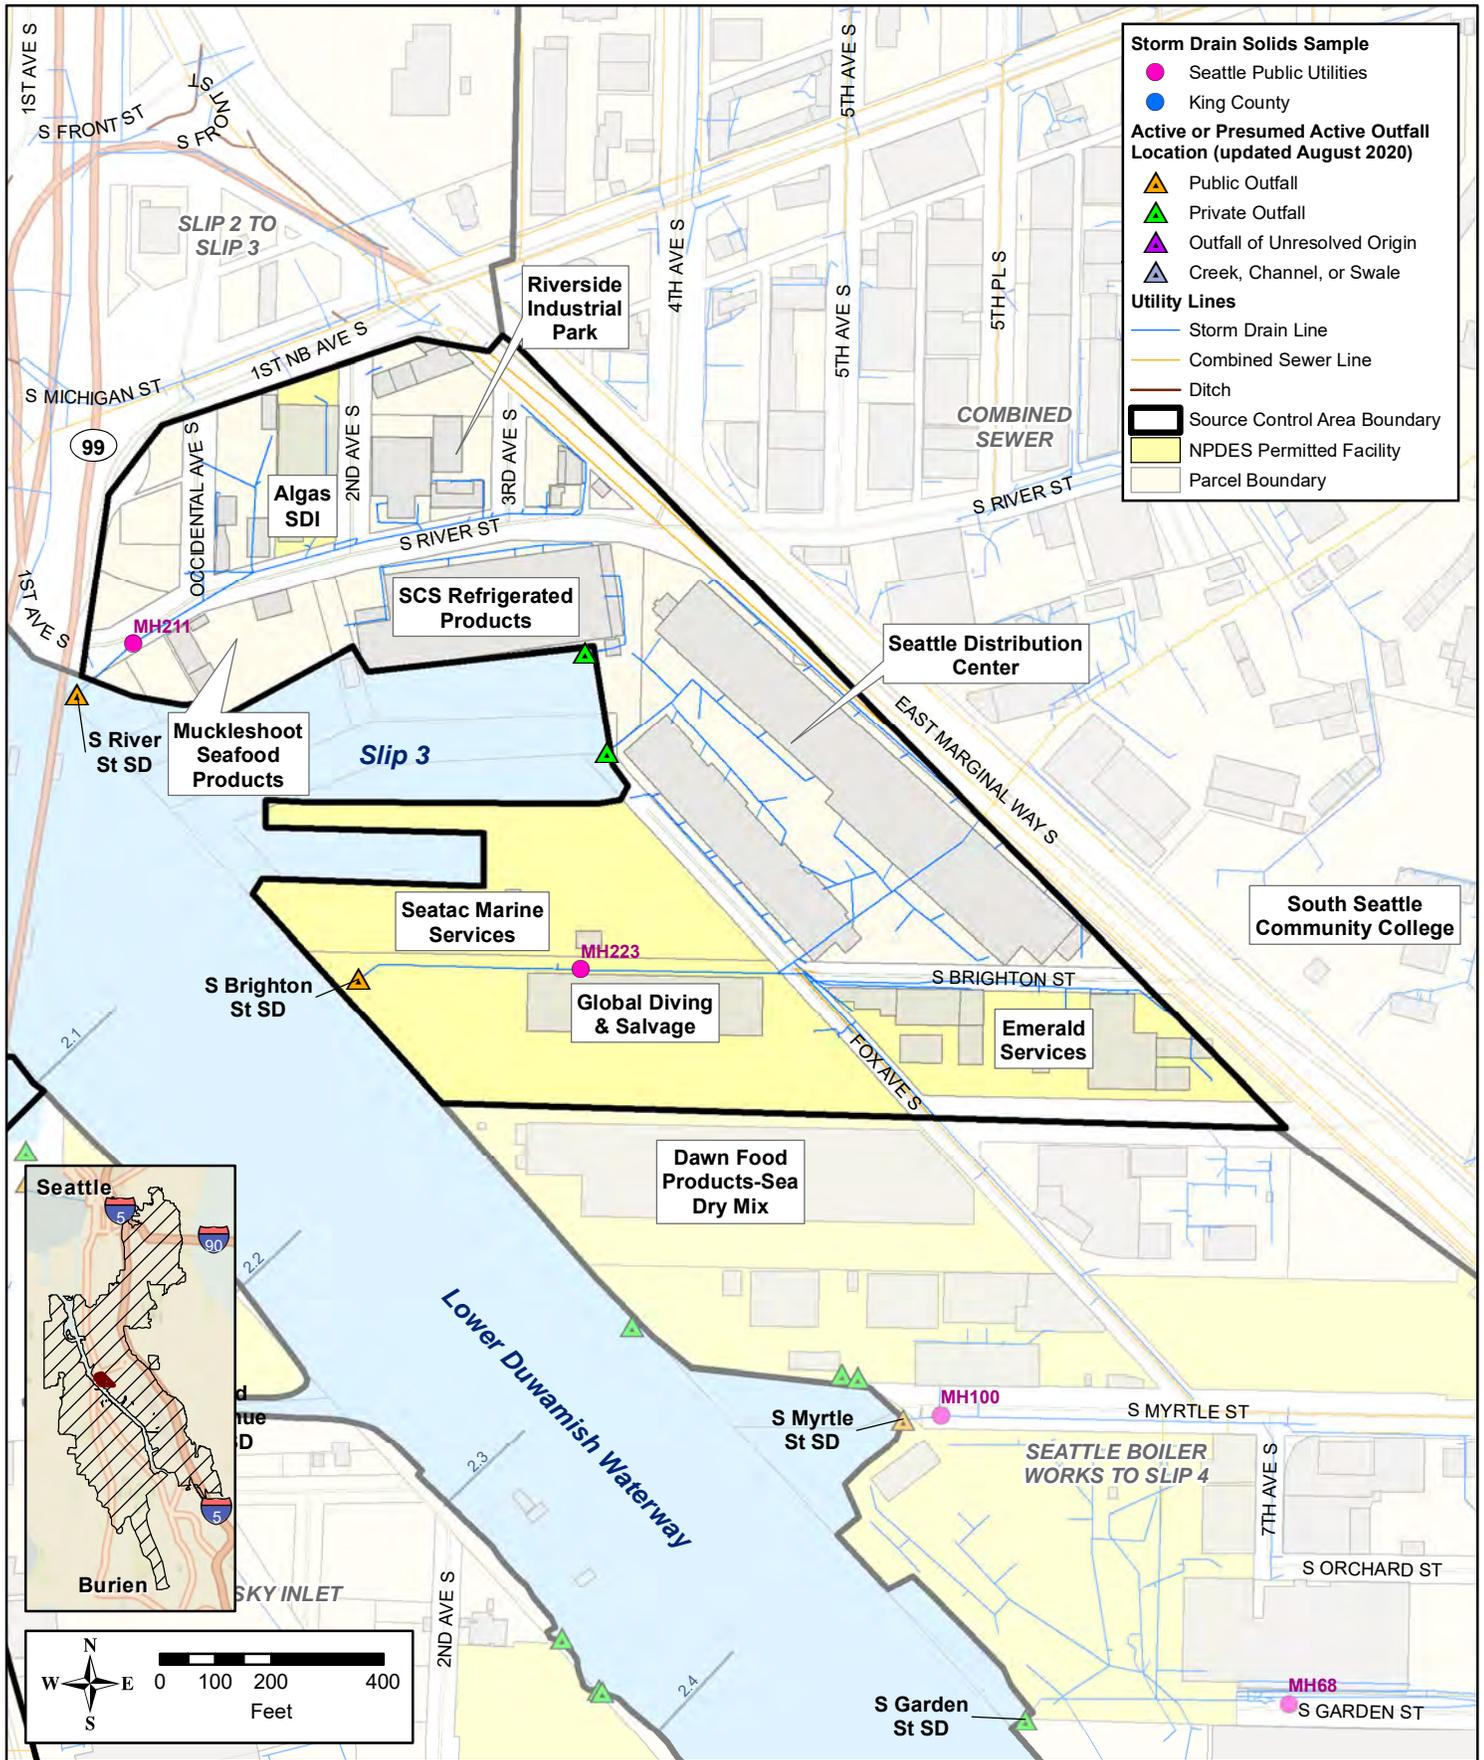
**Figure A-13. RM 2.0-2.3 East  
(Slip 3 to Seattle Boiler Works)  
Source Control Area**
