# **Lower Duwamish Waterway Source Control Status Report 2020**

August 2022

Publication No. 22-09-178

Toxics Cleanup Program  
Northwest Regional Office  
Washington State Department of Ecology  
Shoreline, Washington

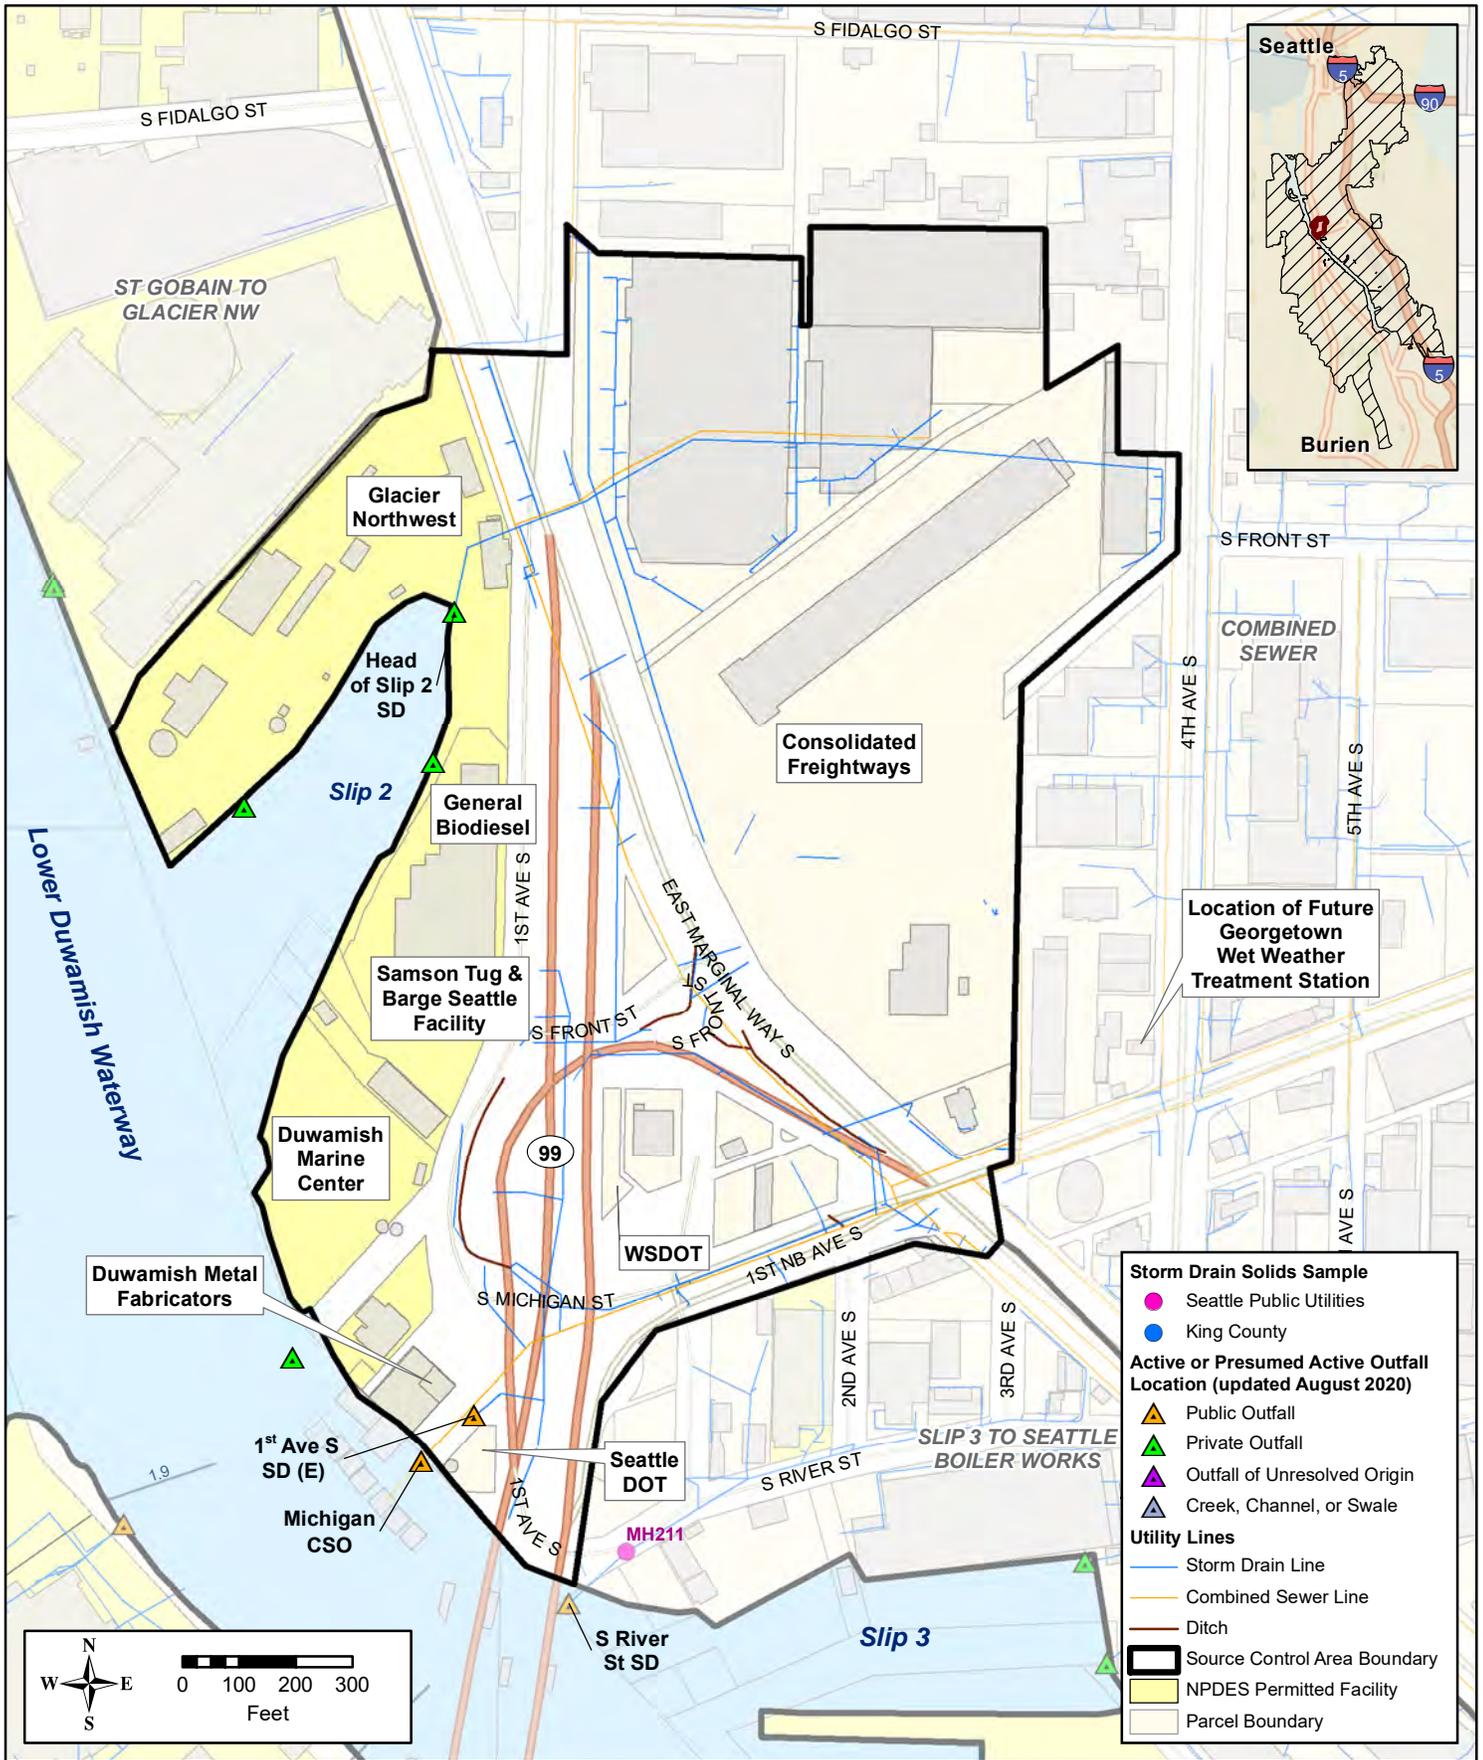
**Figure A-14. RM 1.7-2.0 East  
(Slip 2 to Slip 3)  
Source Control Area**

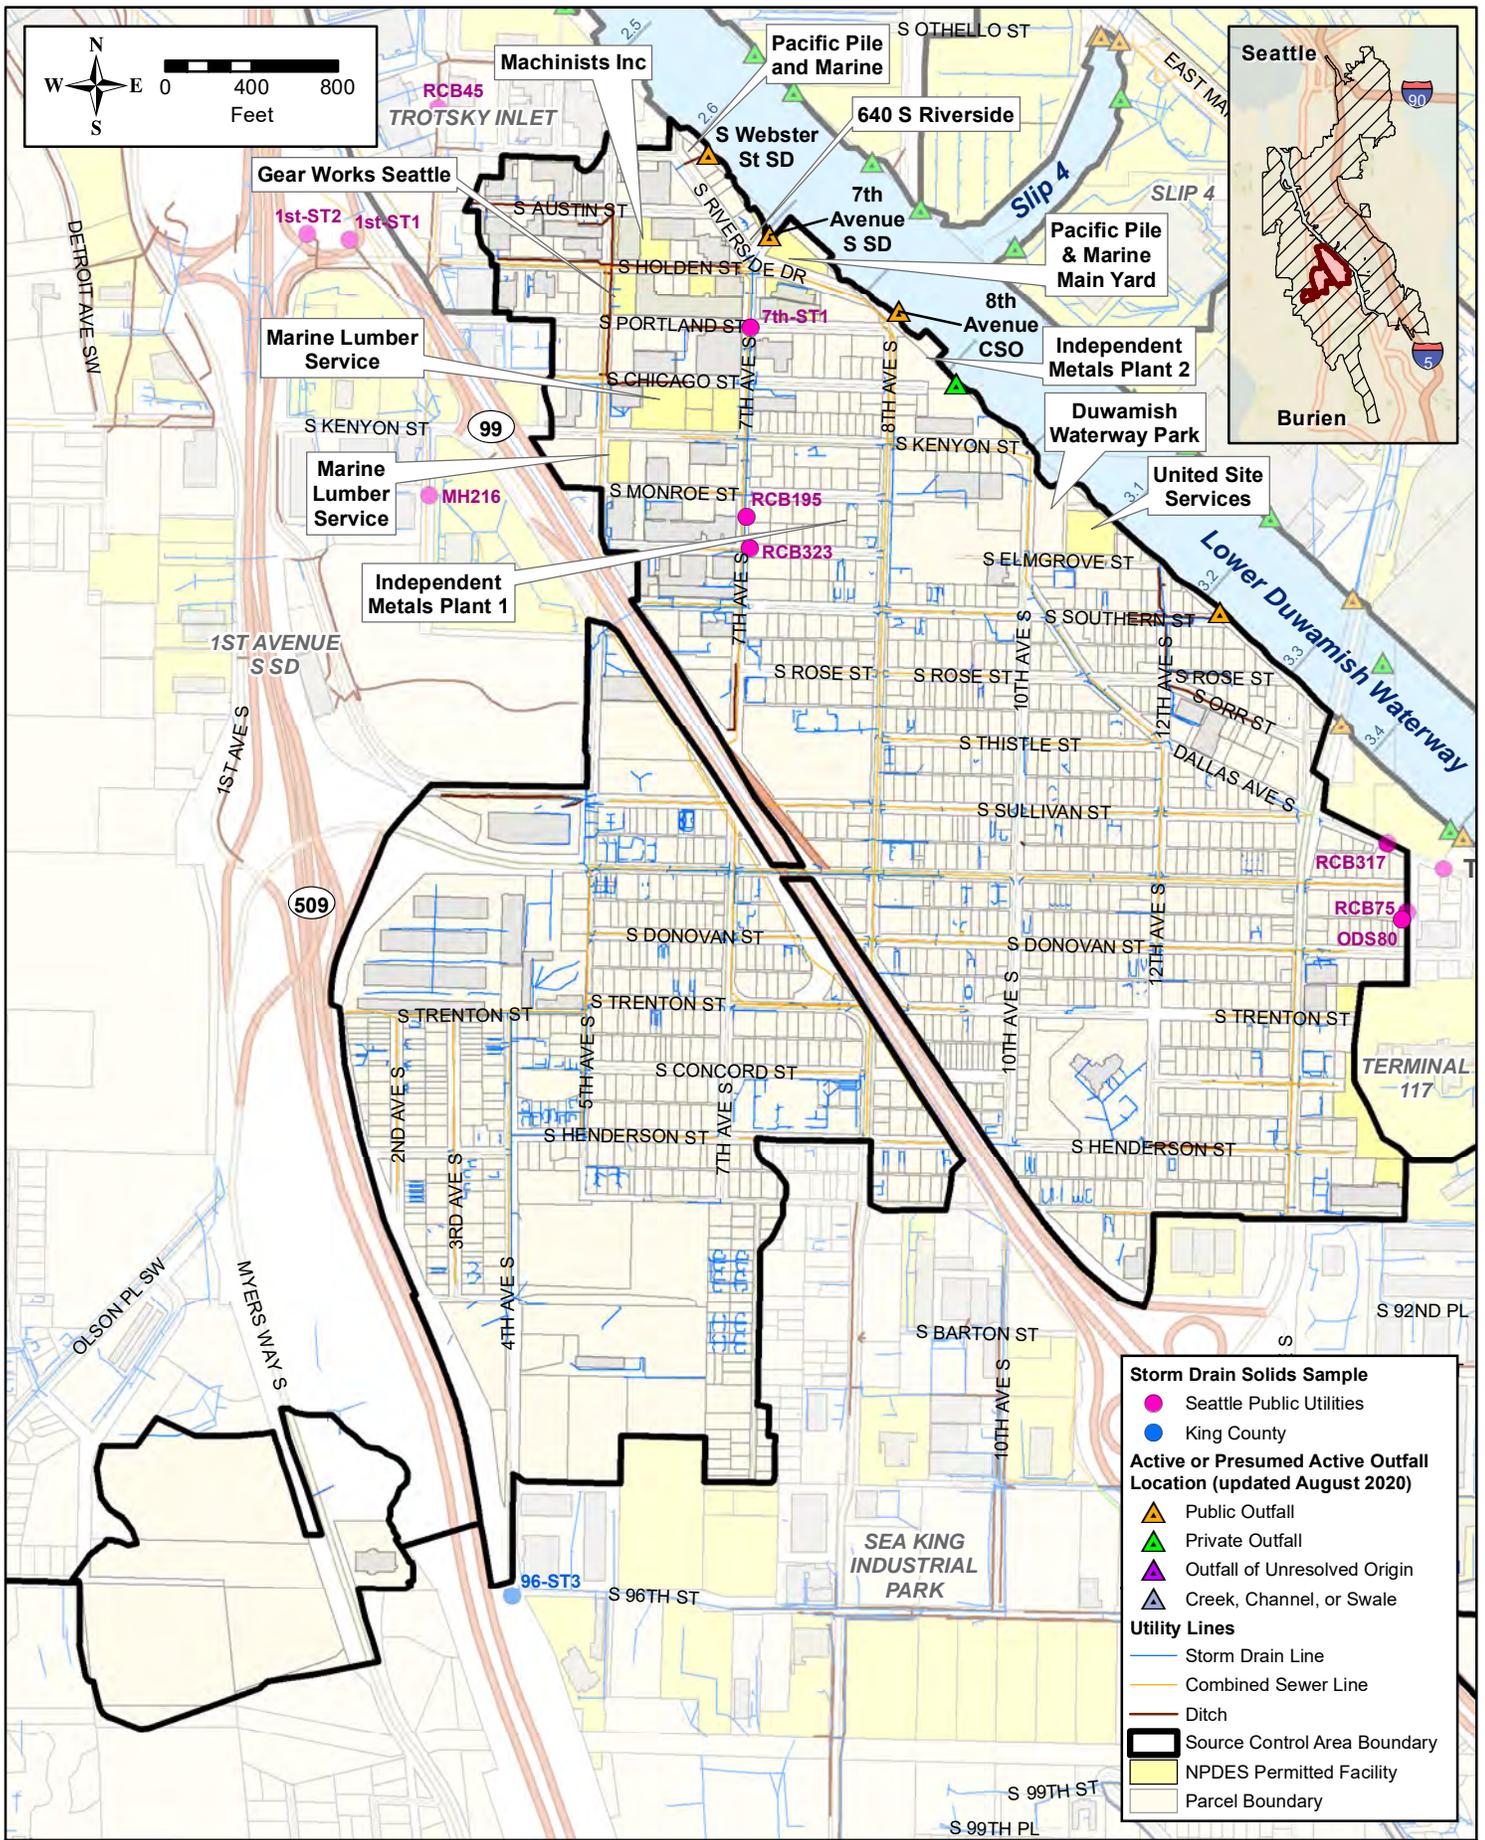
**Figure A-16. RM 2.2-3.4 West  
(Riverside Drive)  
Source Control Area**

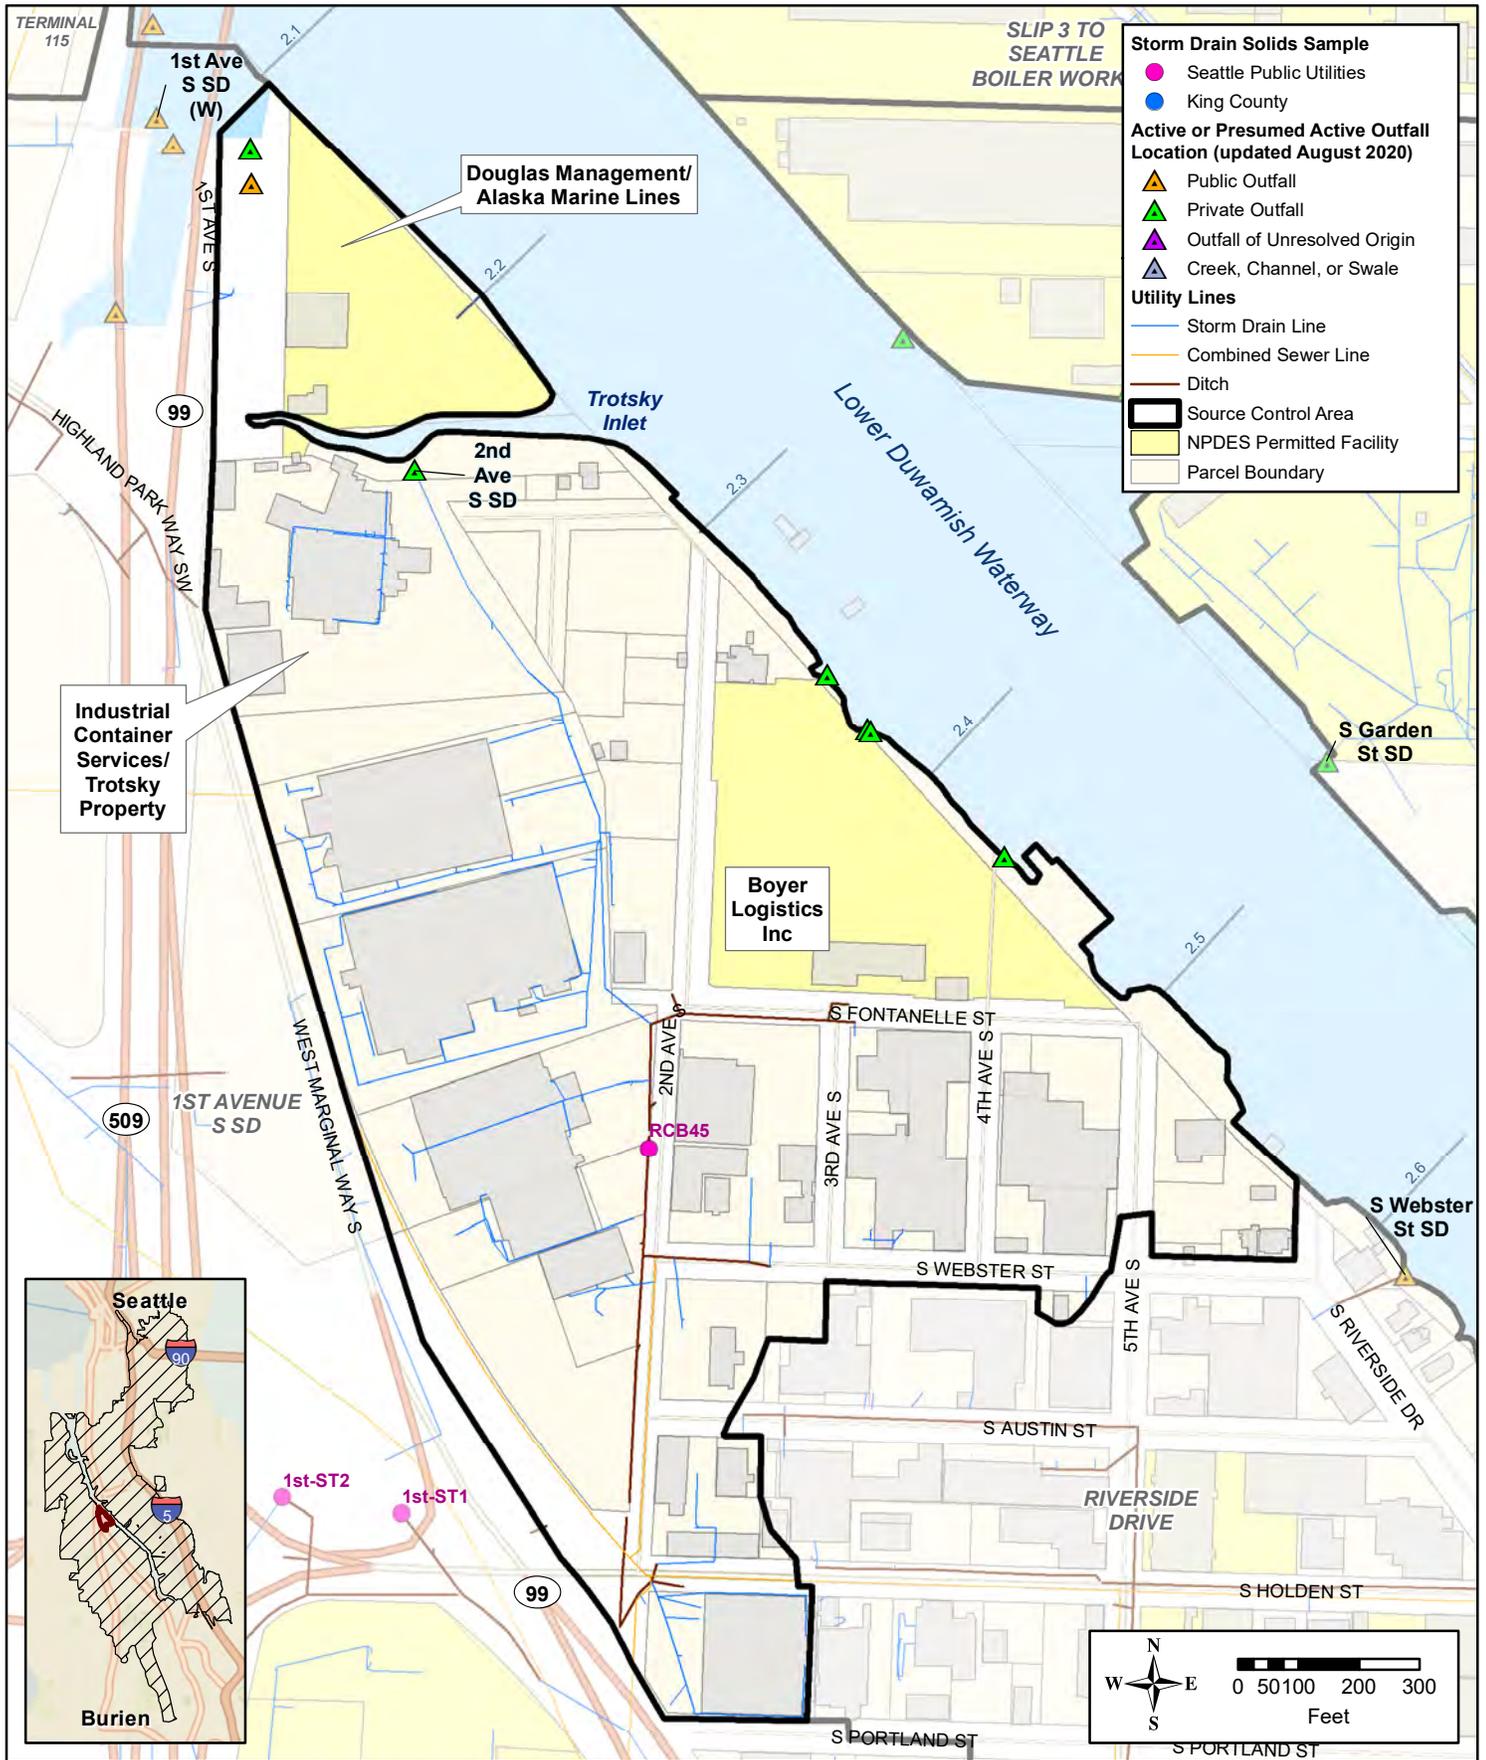
Figure A-17. RM 2.1-2.2 West  
(EAA-2: Trotsky Inlet)  
Source Control Area

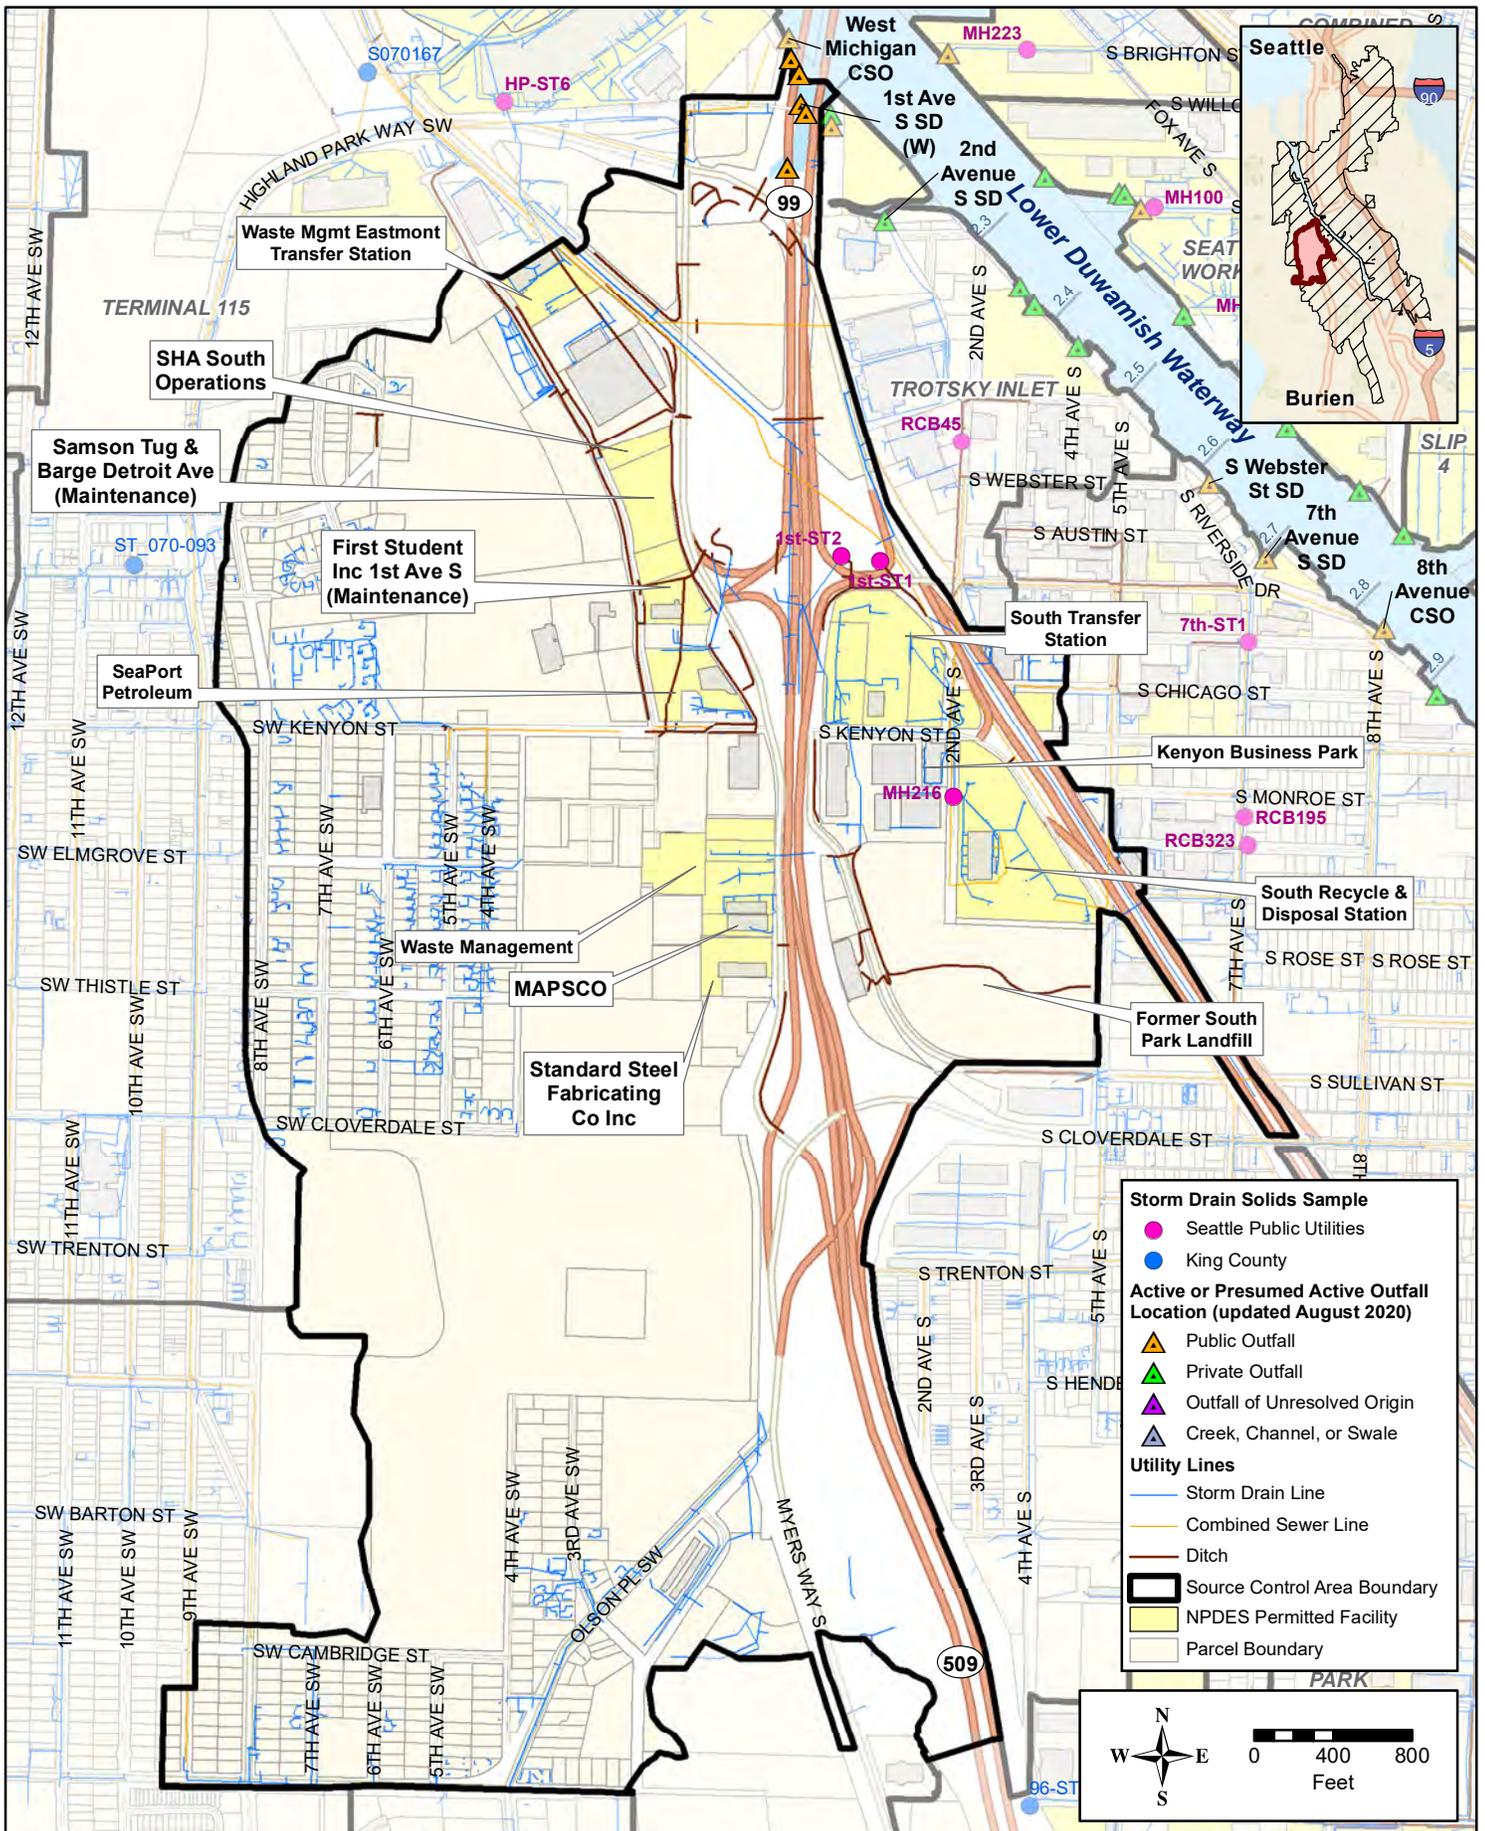
**Figure A-18. RM 2.1 West  
(1<sup>st</sup> Avenue South Storm Drain)  
Source Control Area**

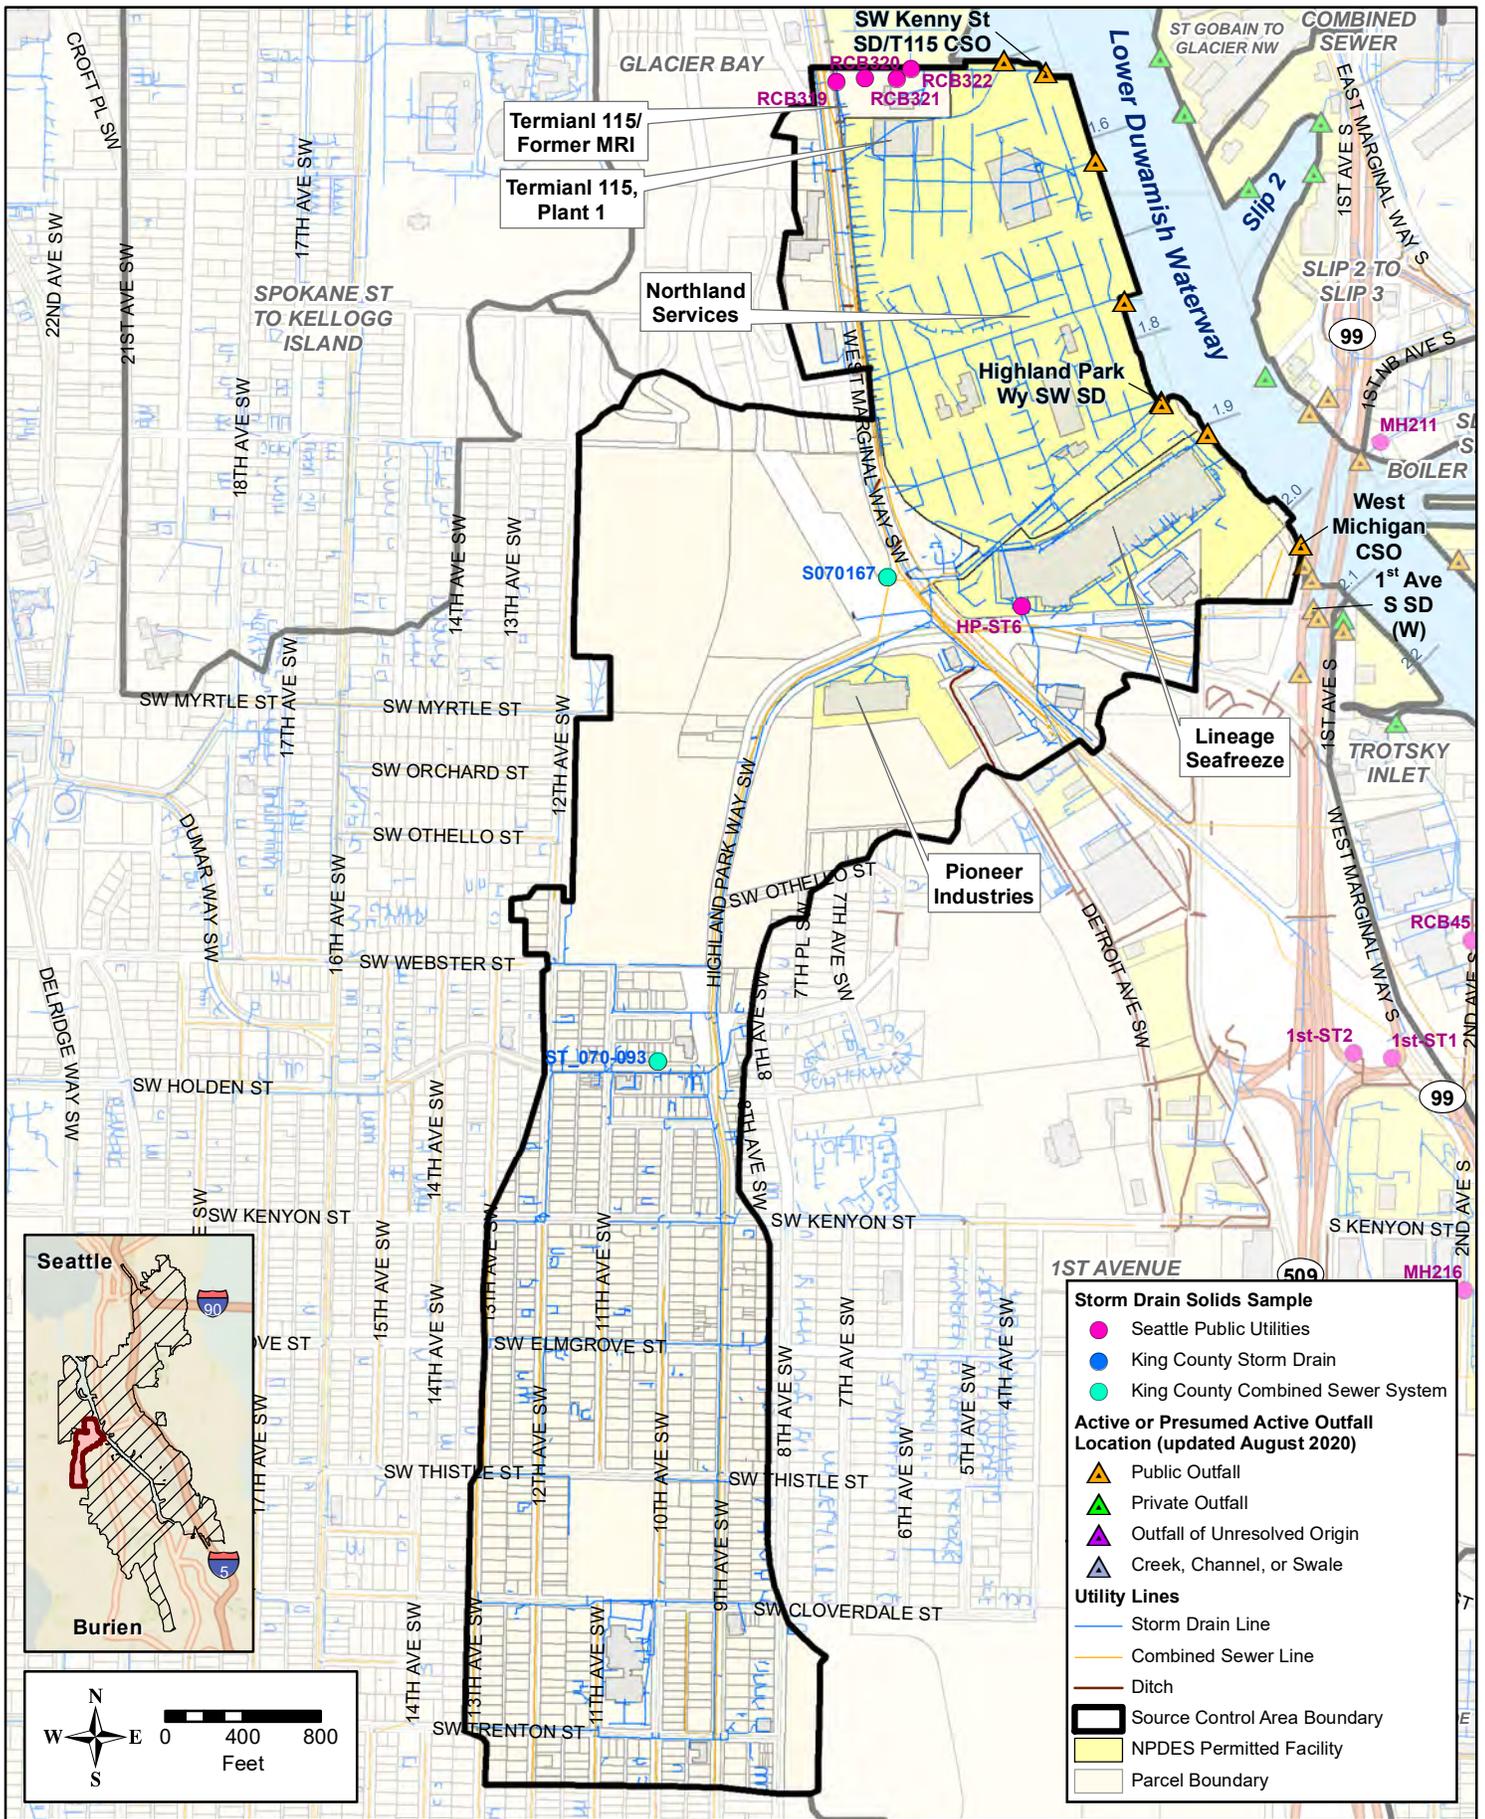
Figure A-19. RM 1.6-2.1 West  
(Terminal 115)  
Source Control Area

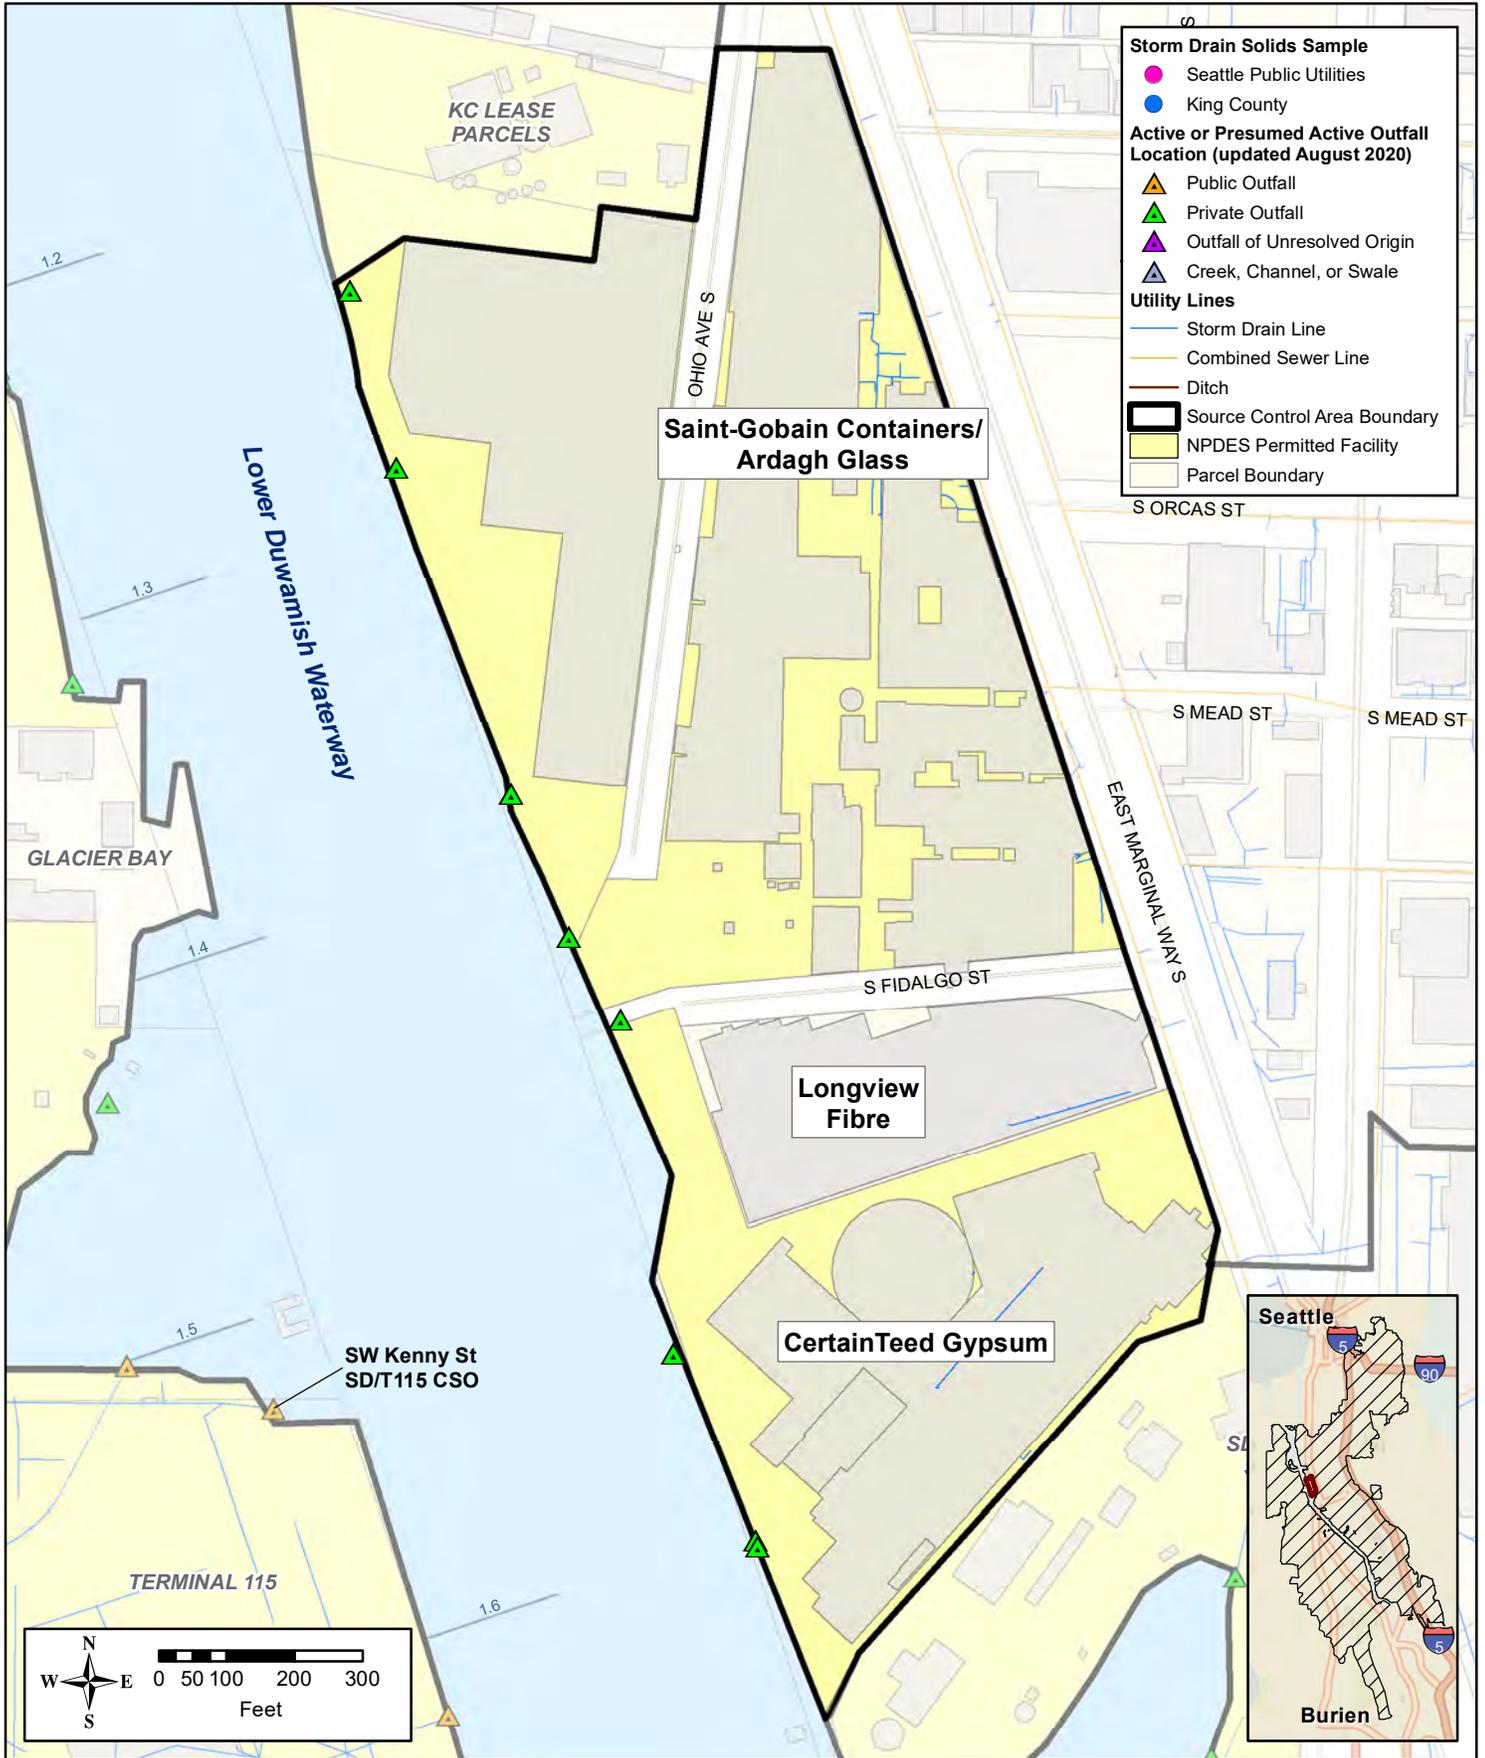
**Figure A-20. RM 1.2-1.7 East  
(Saint Gobain to Glacier Northwest)  
Source Control Area**

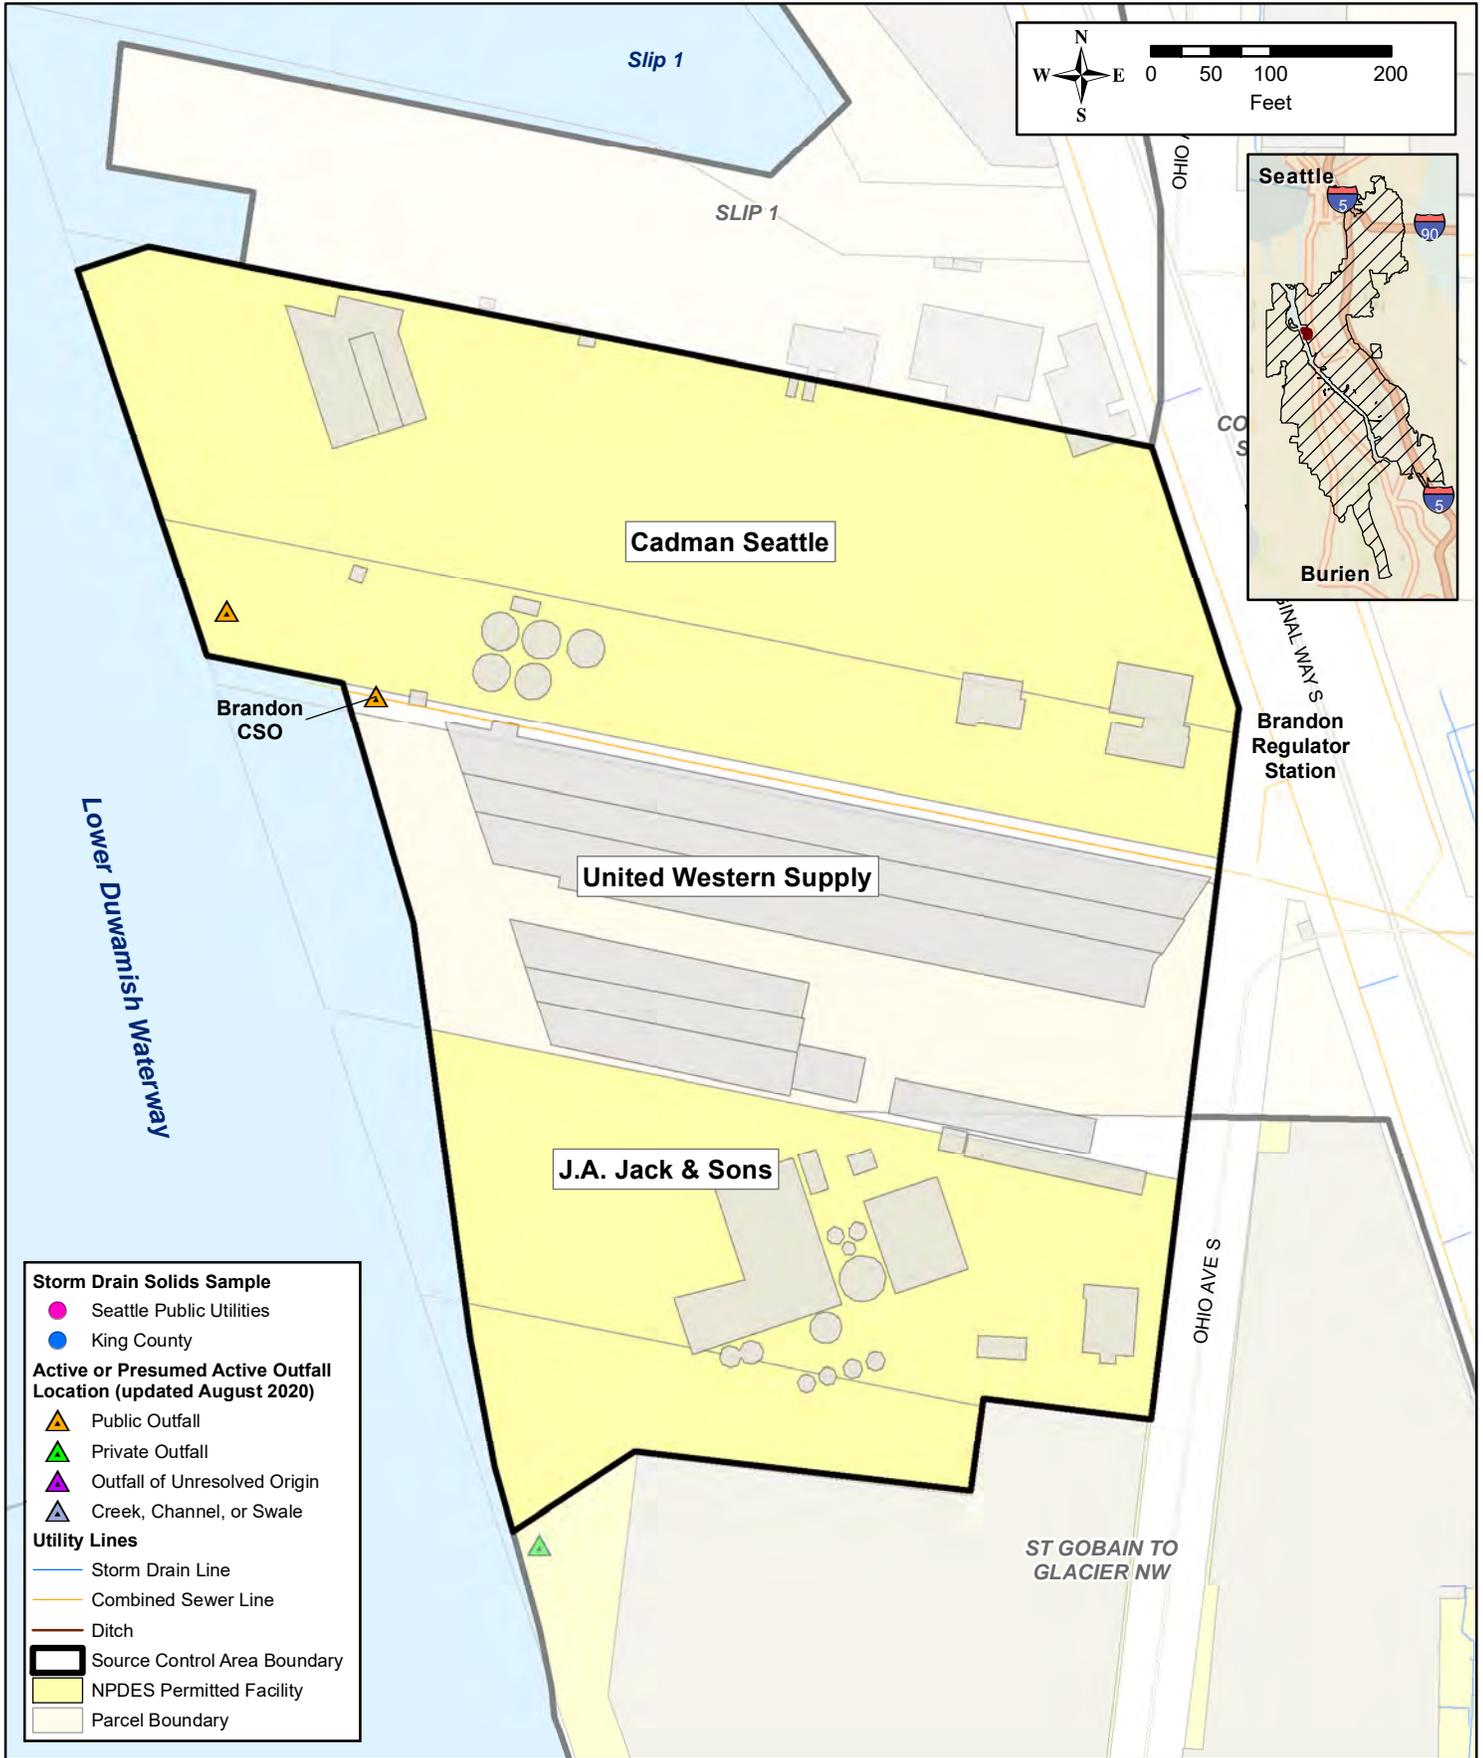
**Figure A-21. RM 1.0-1.2 East  
(King County Lease Parcels)  
Source Control Area**

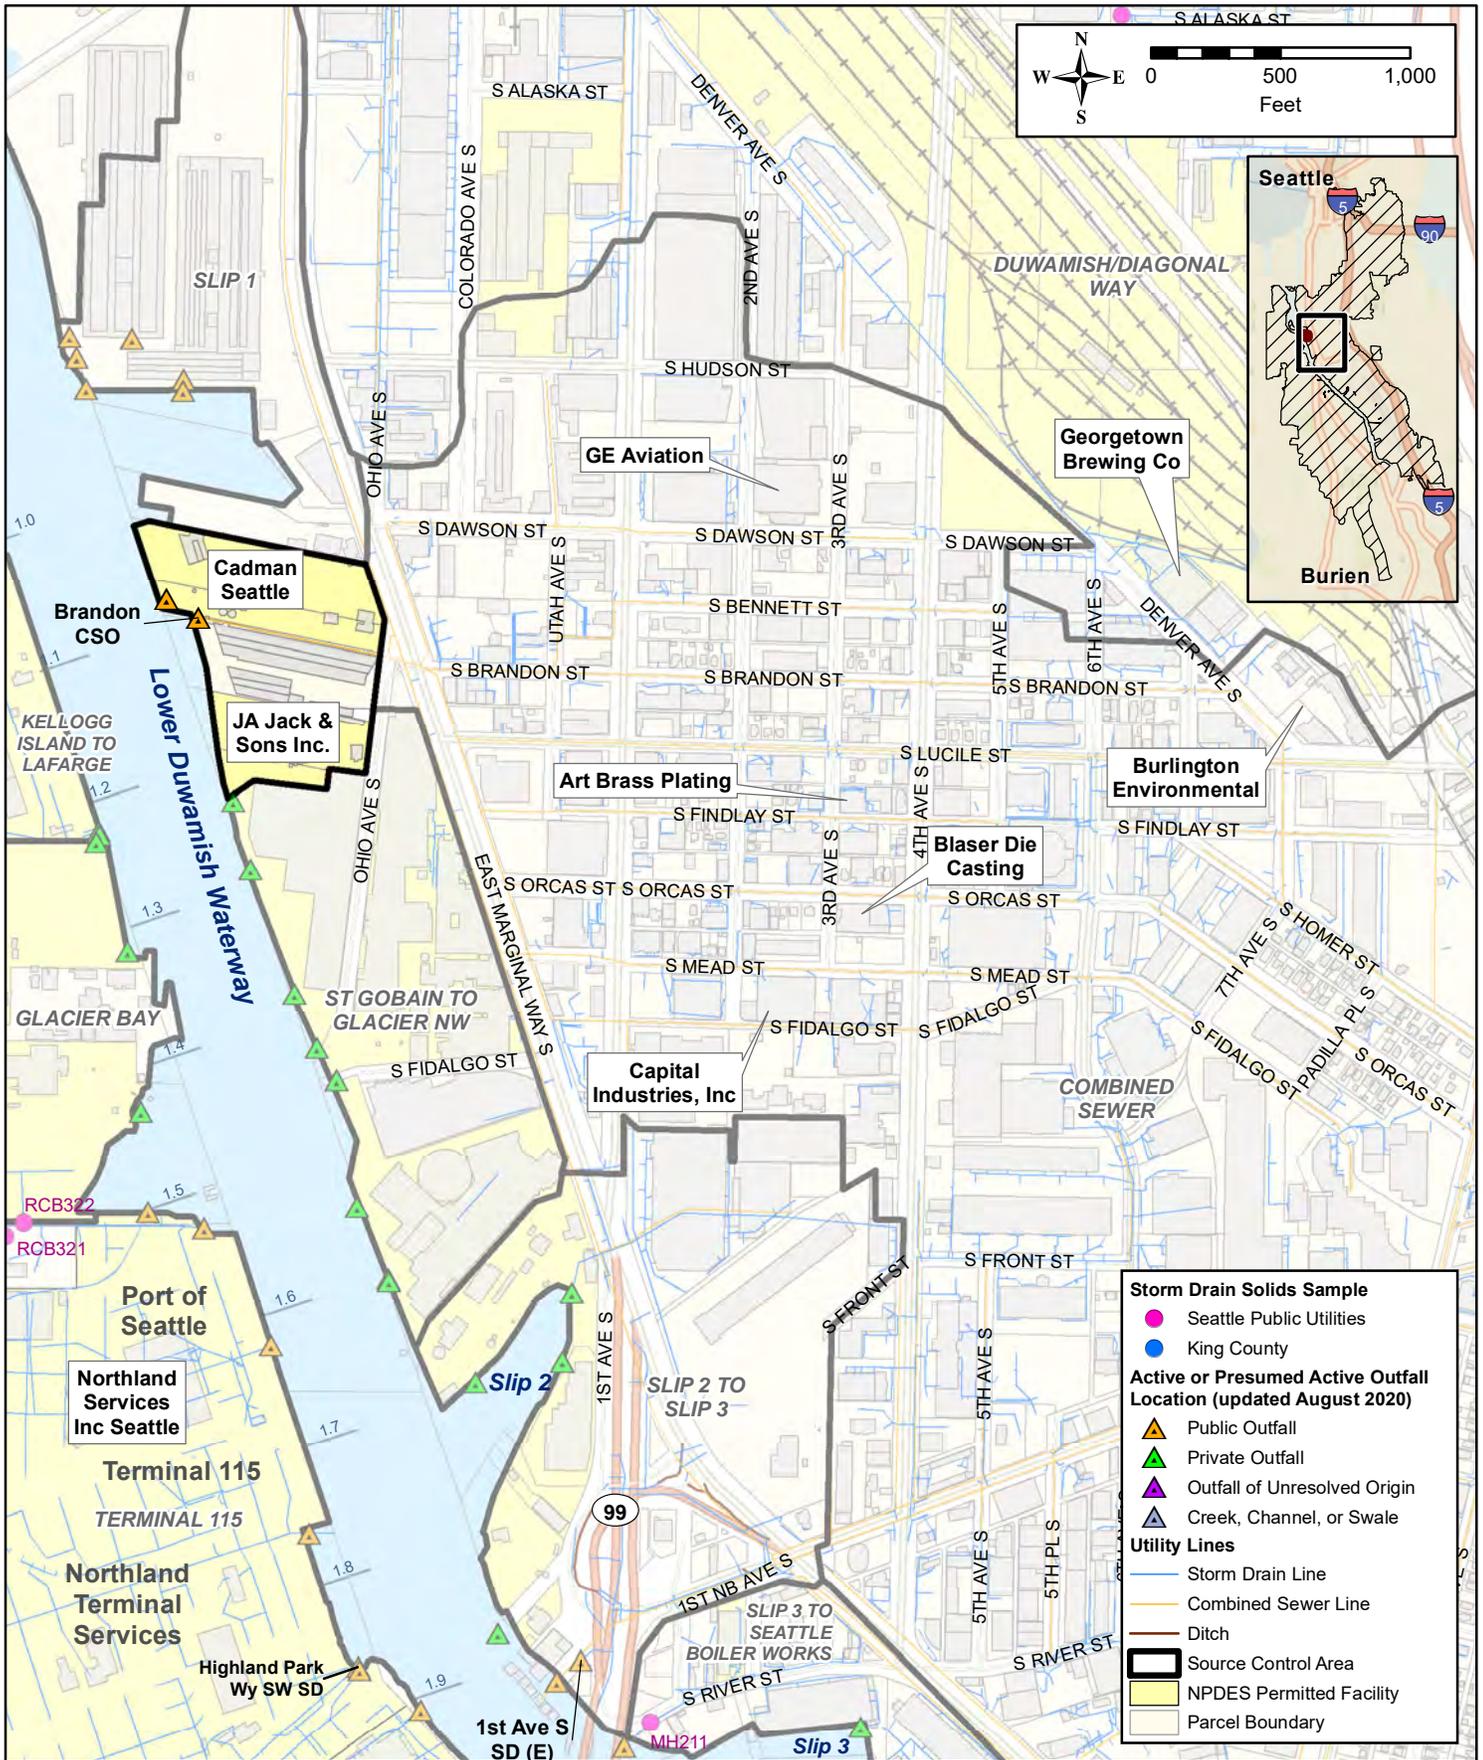
**Figure A-22. RM 1.0-1.2 East  
(King County Lease Parcels)  
Brandon CSO Basin**
