# **Lower Duwamish Waterway Source Control Status Report 2020**

August 2022

Publication No. 22-09-178

Toxics Cleanup Program  
Northwest Regional Office  
Washington State Department of Ecology  
Shoreline, Washington

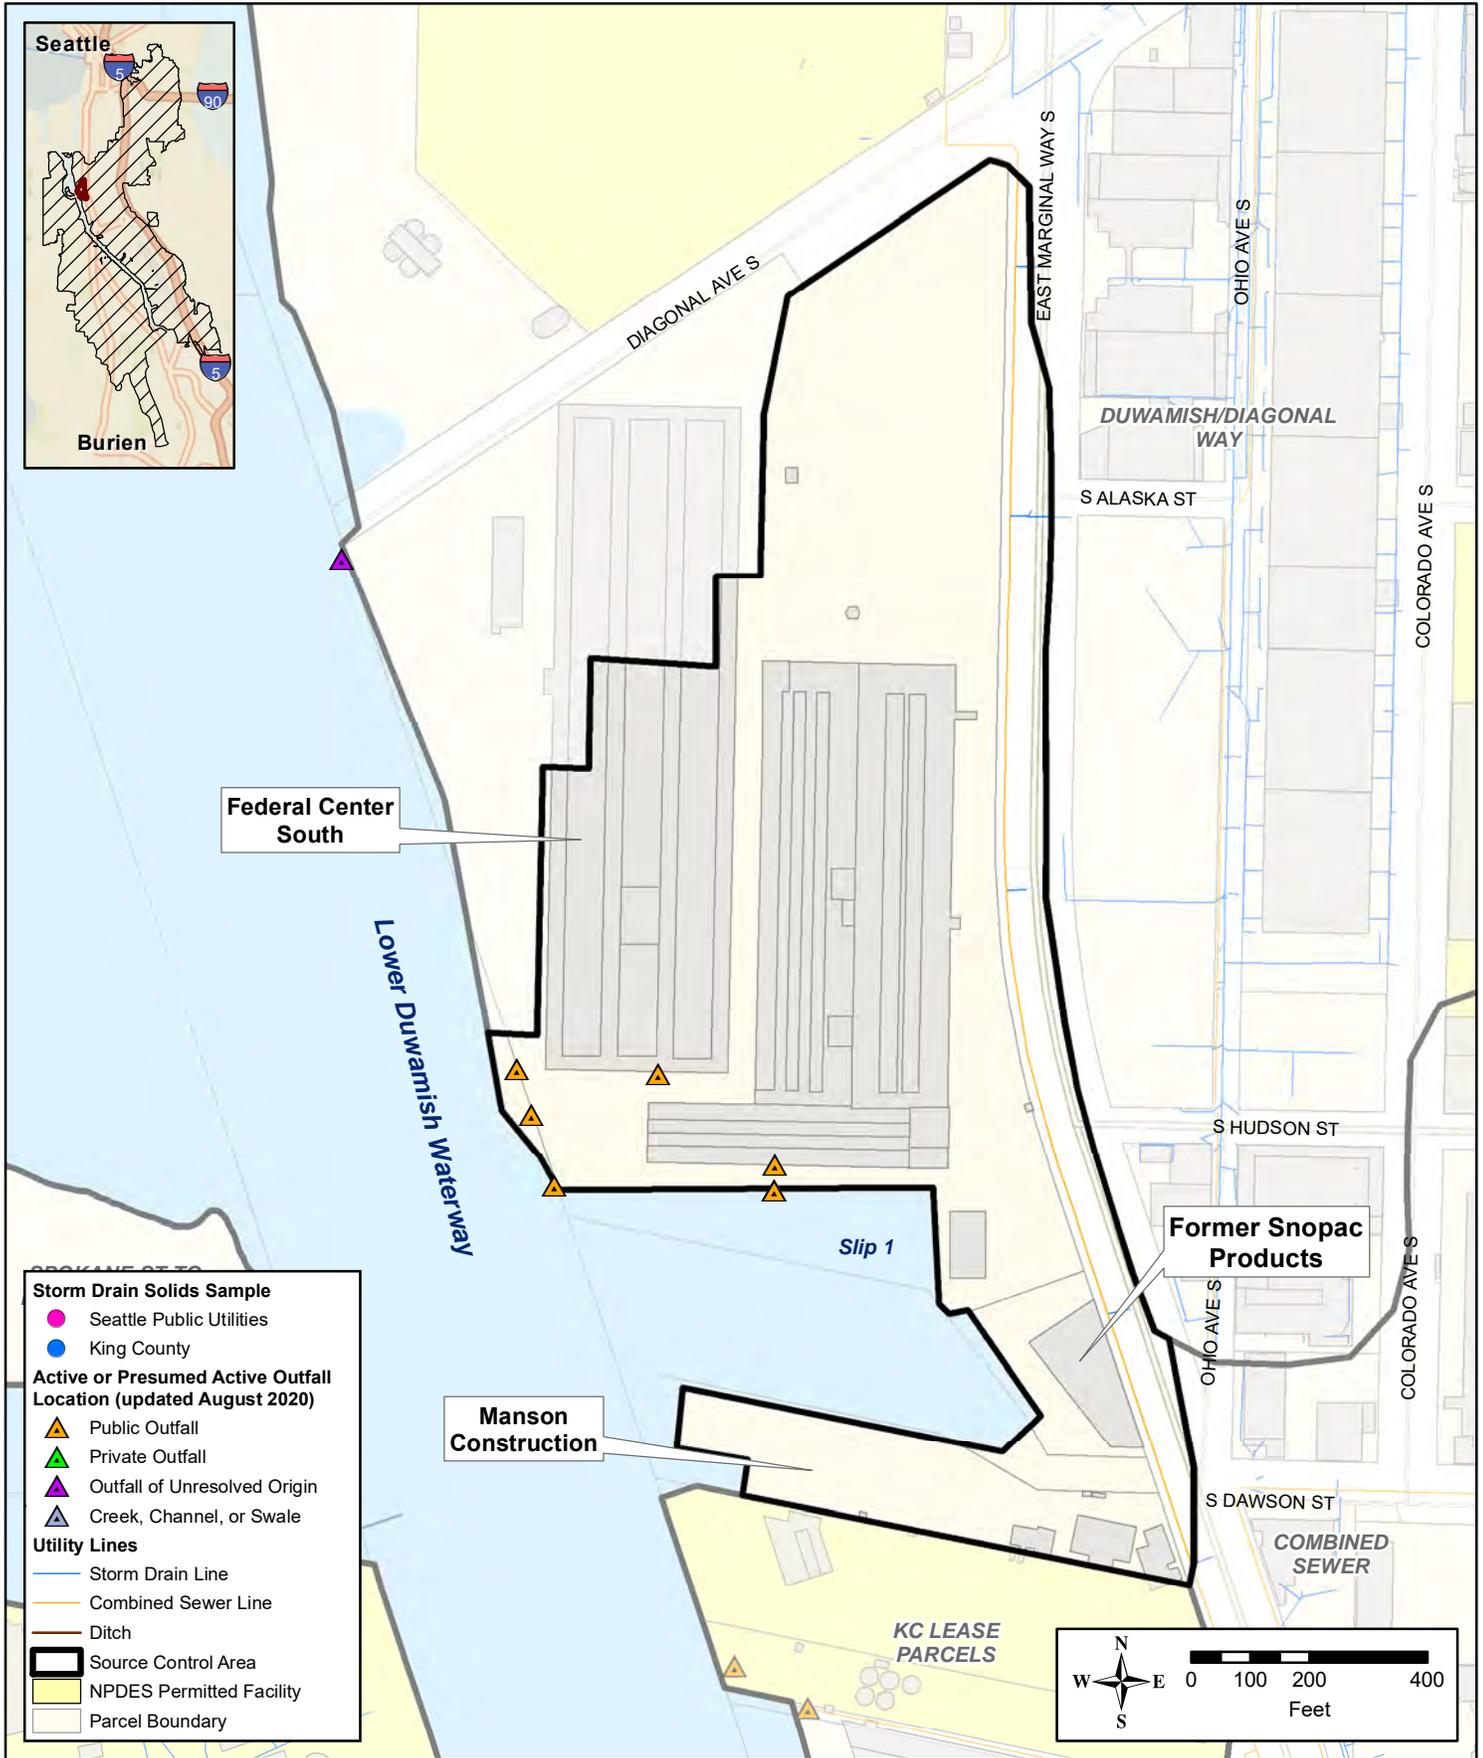
Figure A-23. RM 0.9-1.0 East (Slip 1) Source Control Area

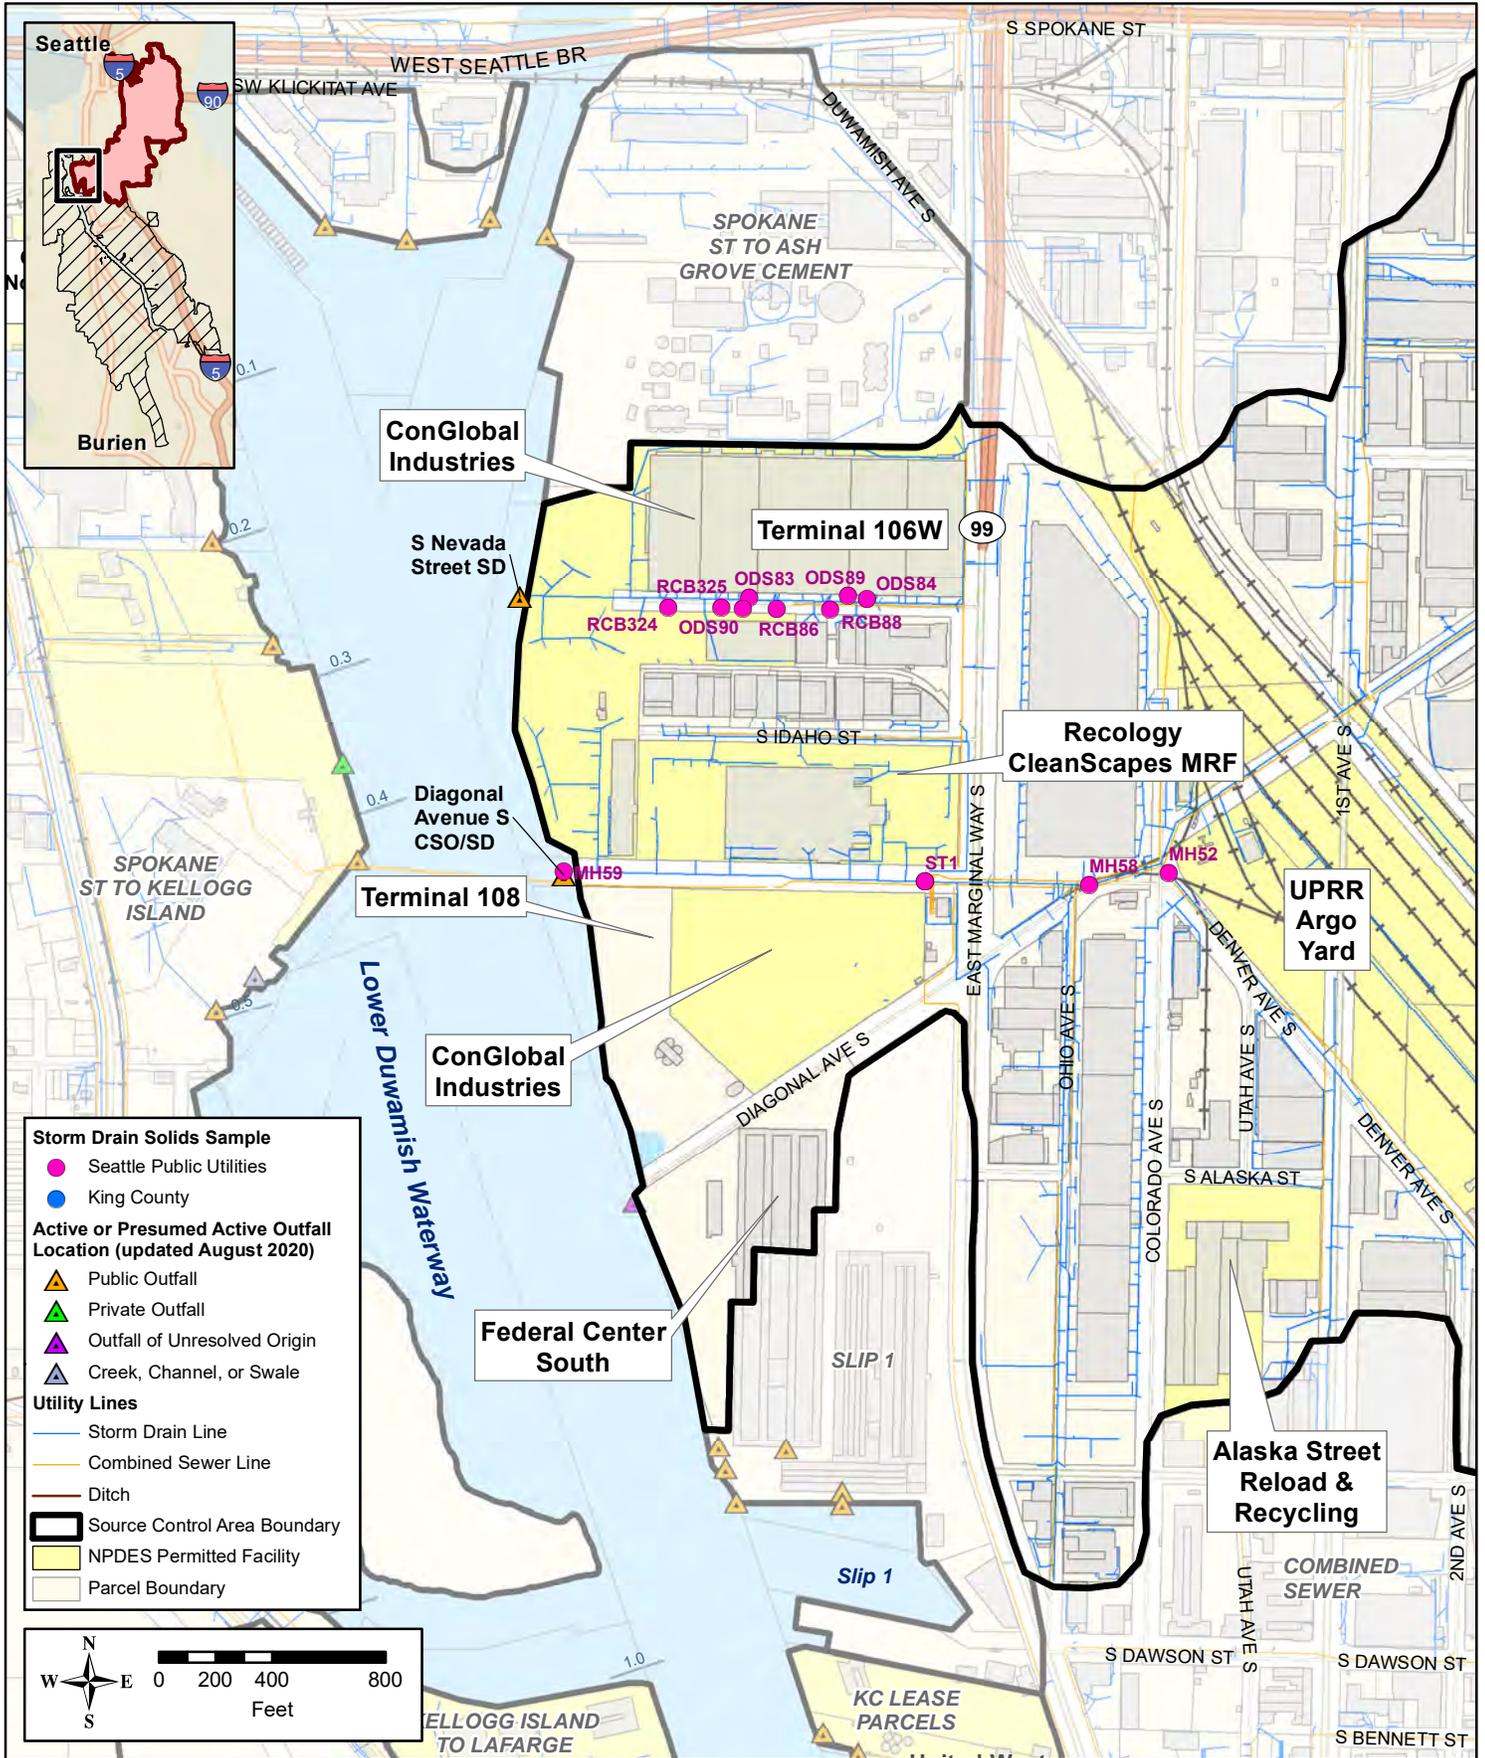
**Figure A-24. RM 0.1-0.9 East  
(EAA-1: Duwamish/Diagonal Way)  
Source Control Area**

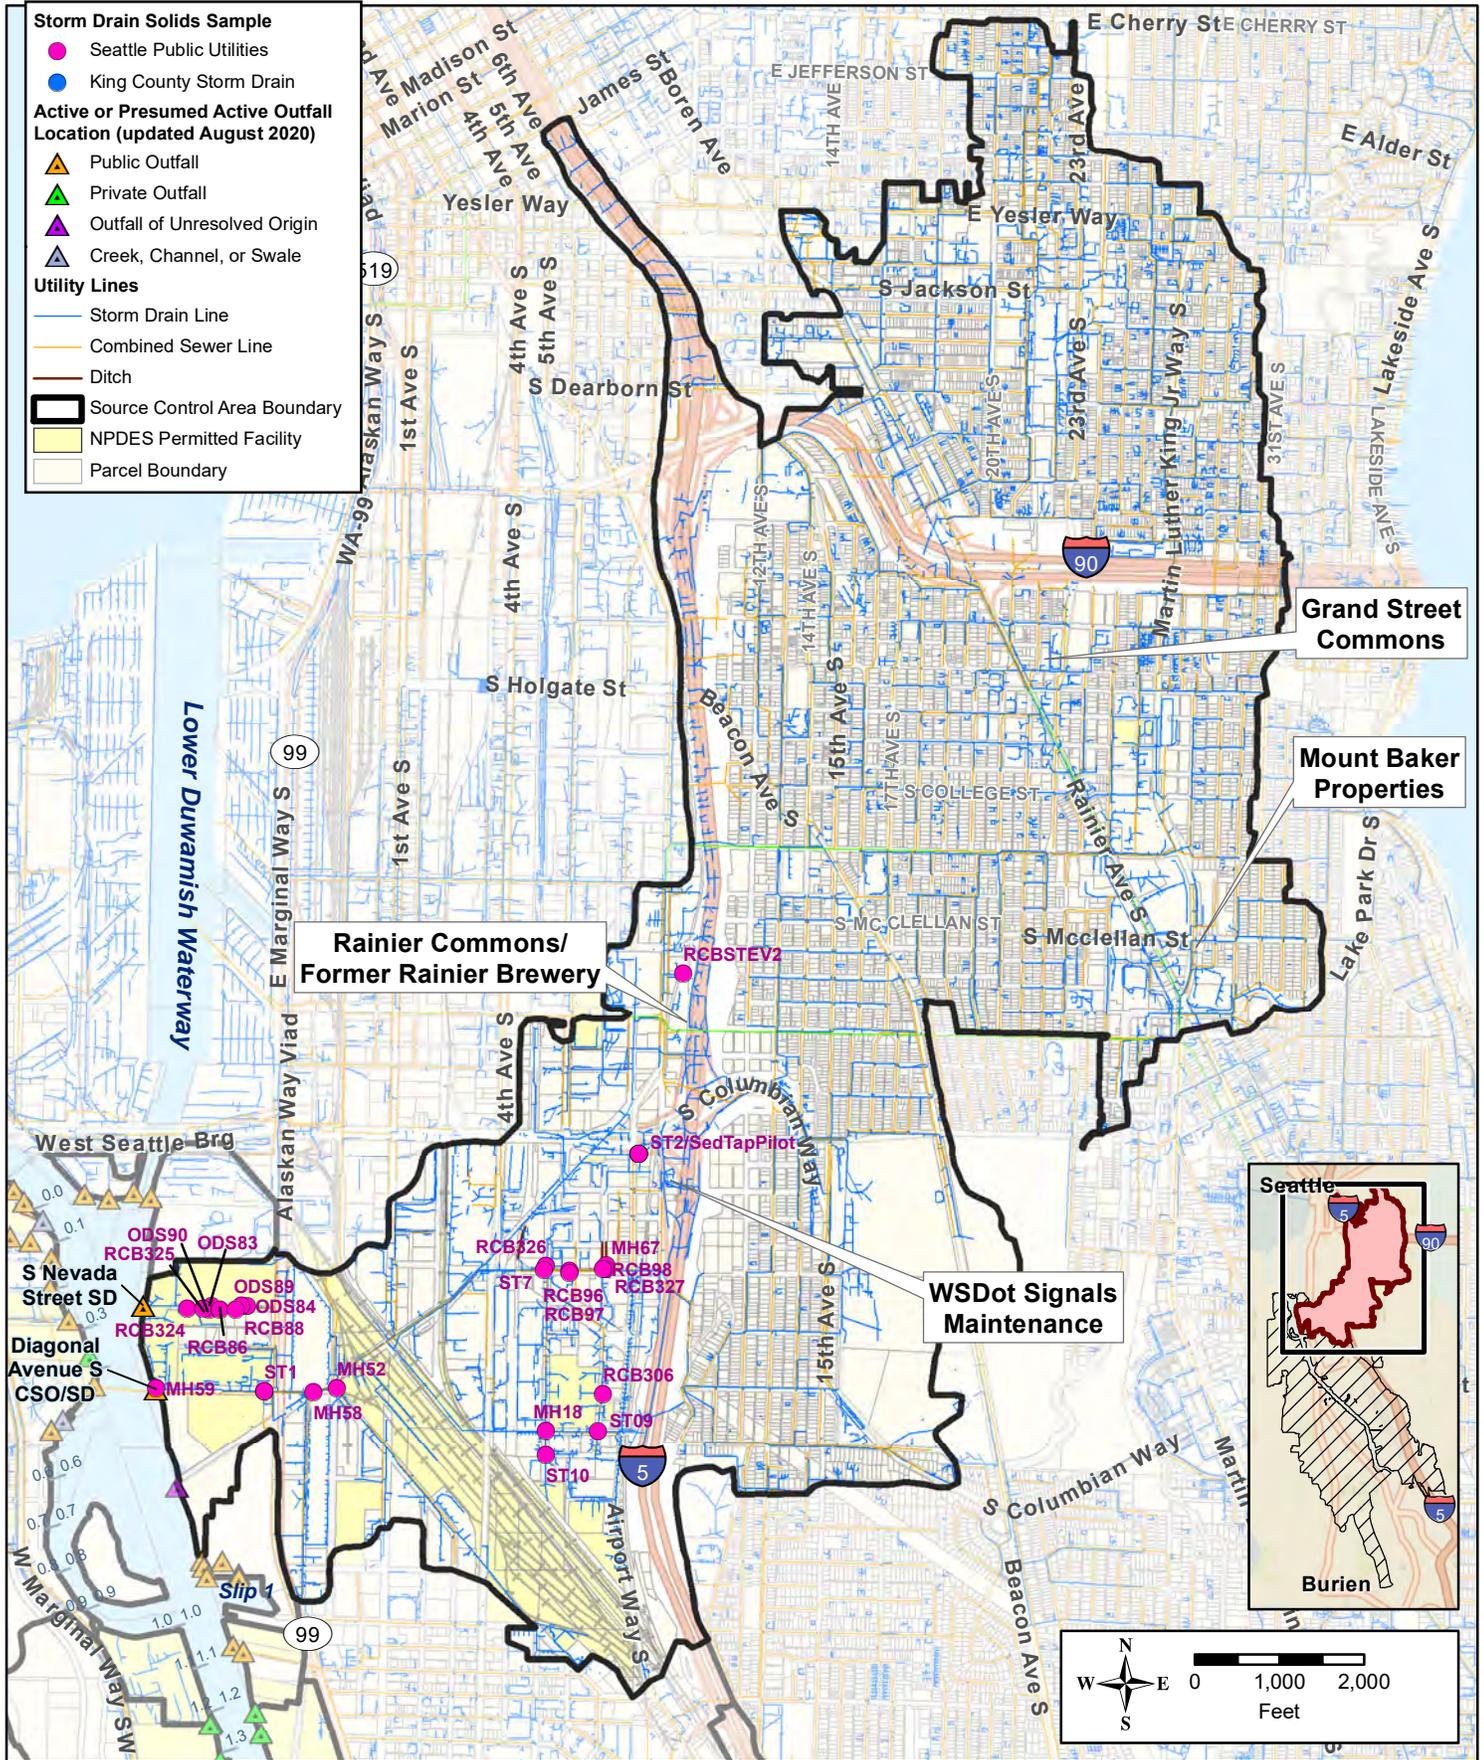
**Figure A-25. RM 0.1-0.9 East  
(EAA-1: Duwamish/Diagonal Way)  
Diagonal Avenue S Storm Drain Basin**

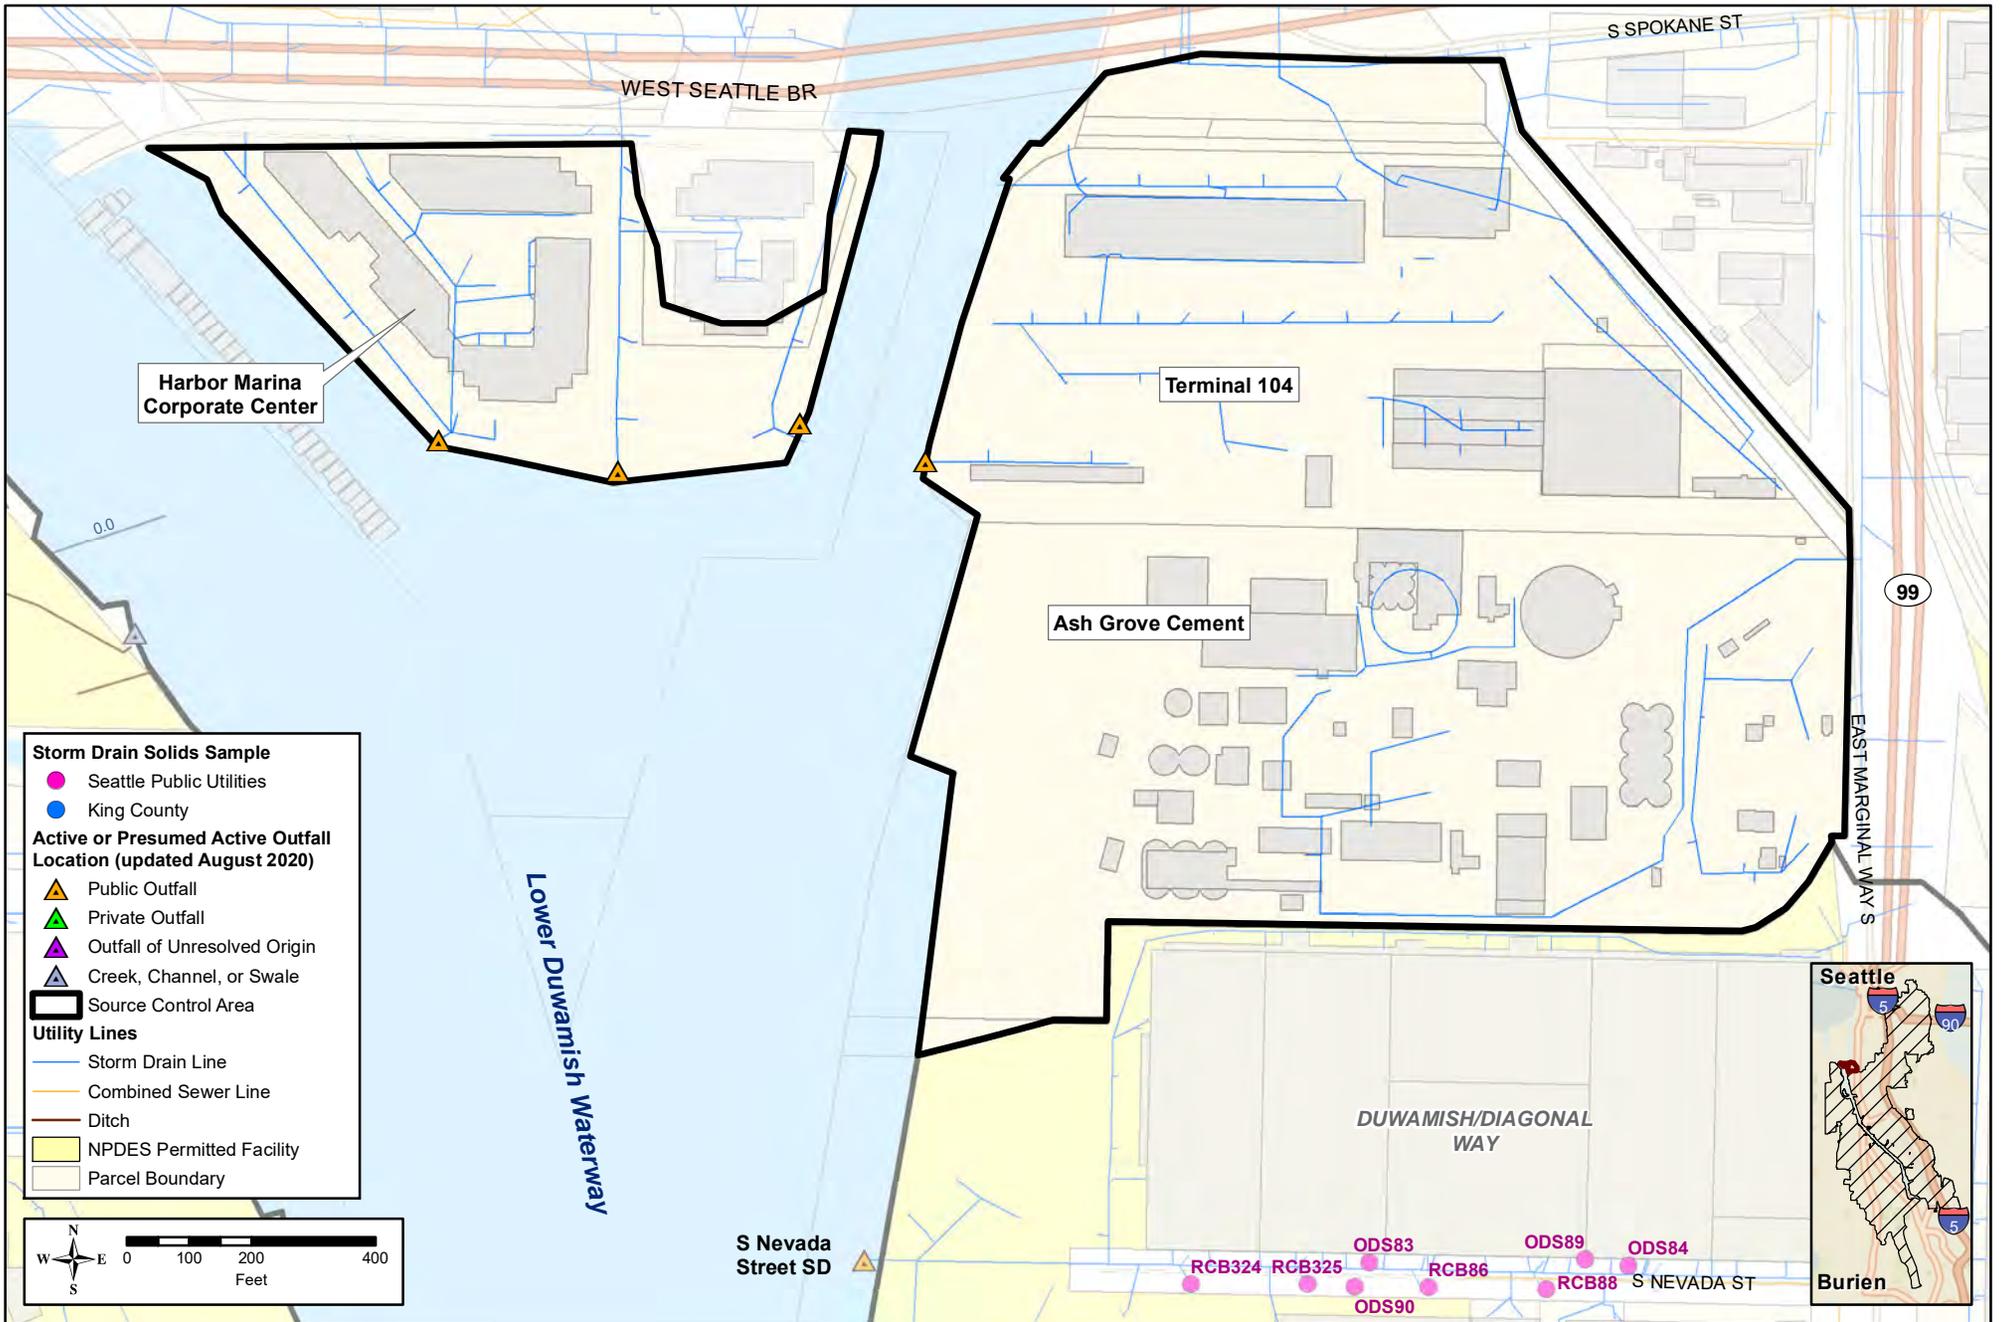
Figure A-26. RM 0.0-0.1 East  
(Spokane Street to Ash Grove Cement)  
Source Control Area

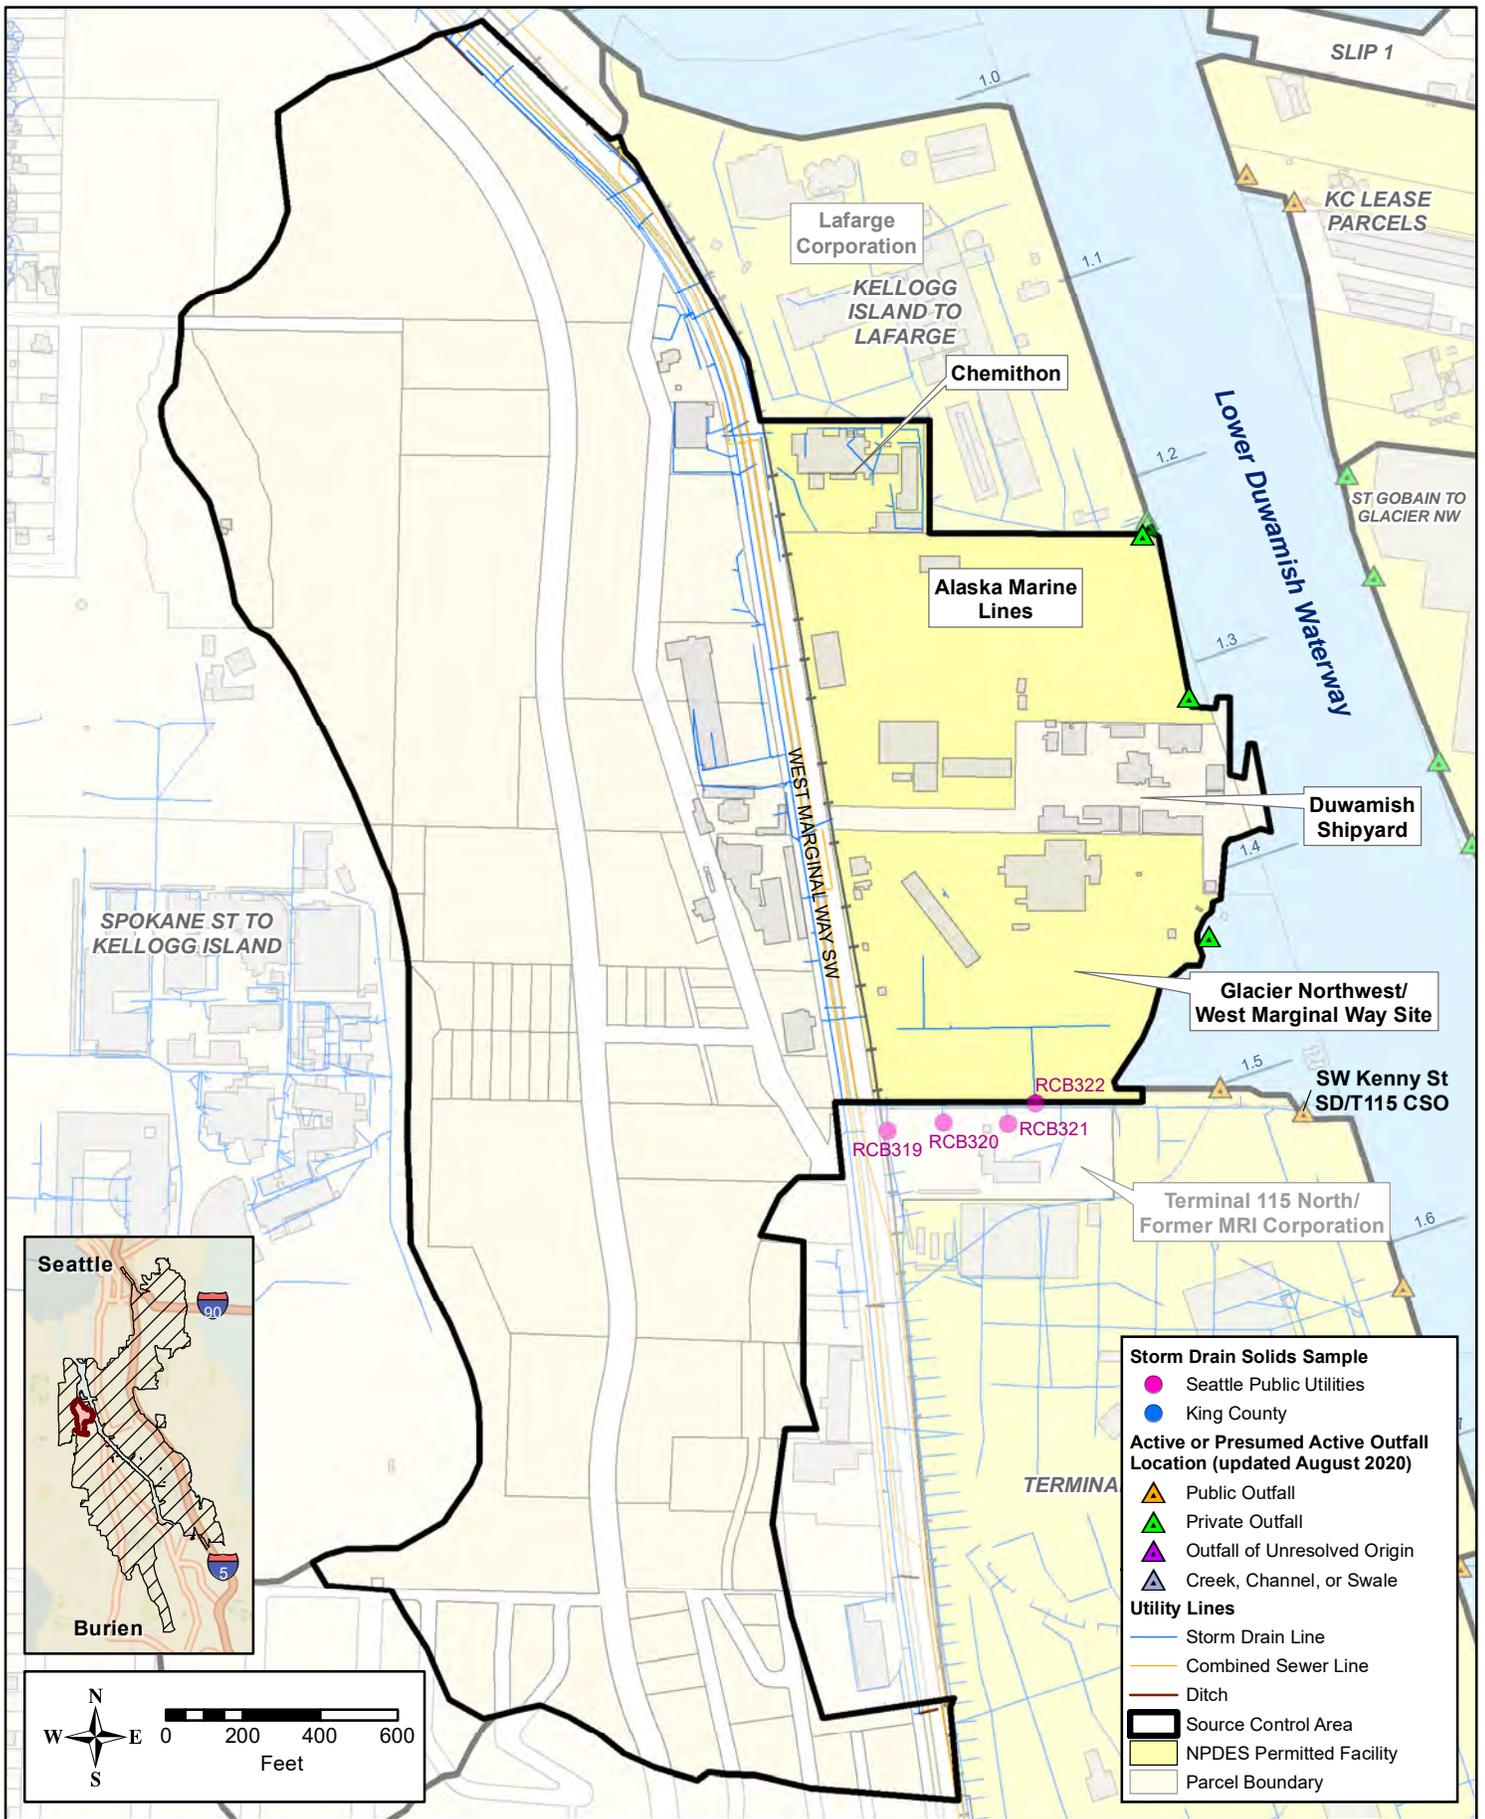
**Figure A-27. RM 1.3-1.6 West (Glacier Bay) Source Control Area**

### ***River Mile (RM) 1.3-1.6 West (Glacier Bay)***

- Ecology approved the Duwamish Shipyard tributyltin (TBT) and Arsenic characterization RI Addendums in May 2020. Ecology stated that both documents adequately address the supplemental investigations for TBT and arsenic as requested by Ecology (Ecology 2020k [12538]).
- Glacier Northwest submitted a Draft RI report. In 2020, Ecology reviewed the Glacier Northwest Draft RI report and worked with the PLPs to complete the RI and move forward with the FS.

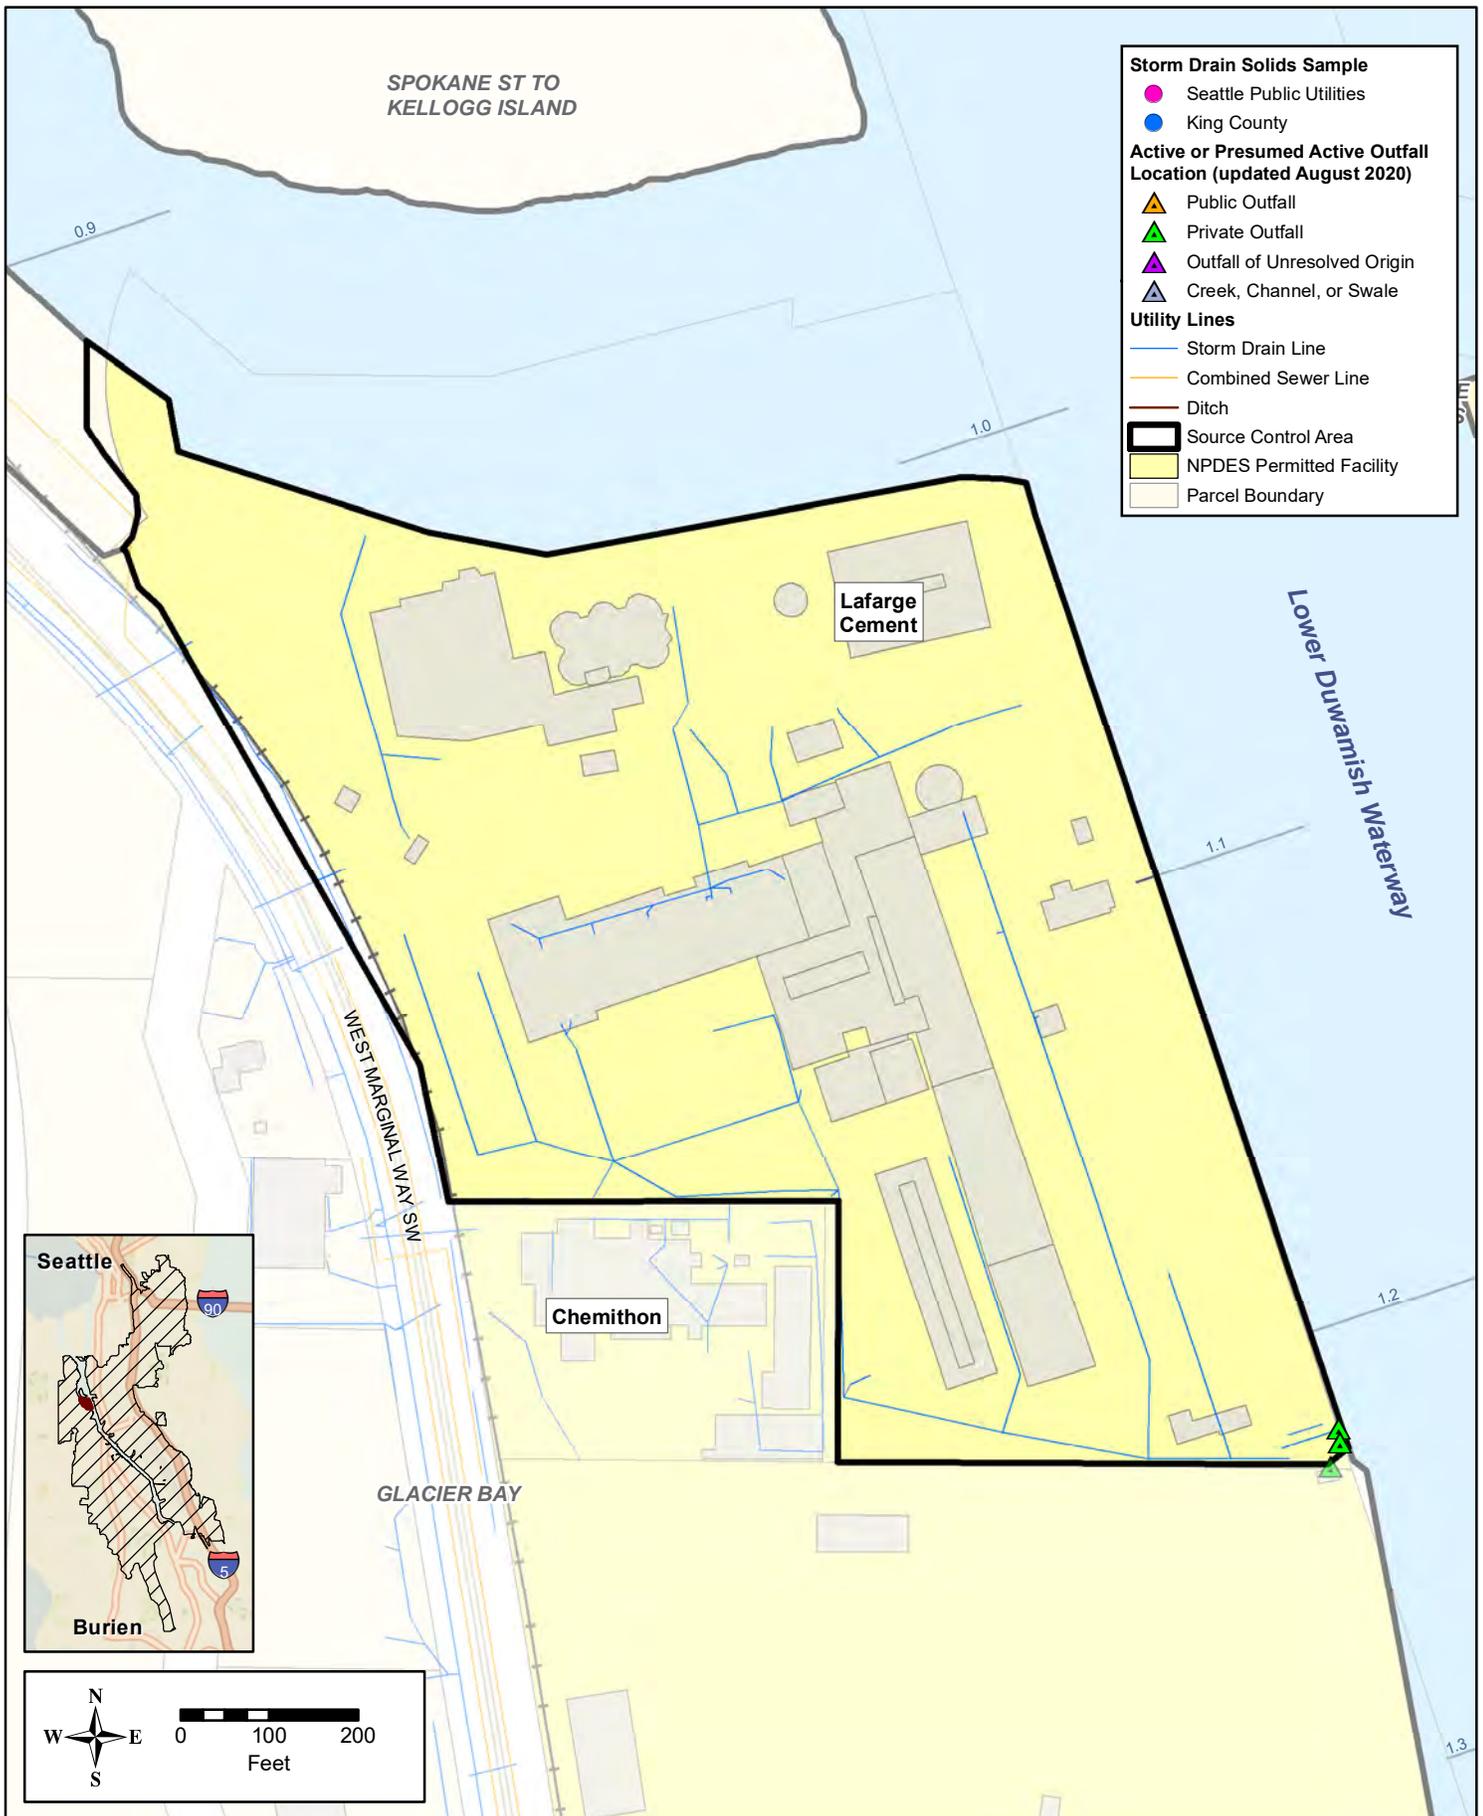
**Figure A-28. RM 1.0-1.3 West  
(Kellogg Island to Lafarge Cement)  
Source Control Area**

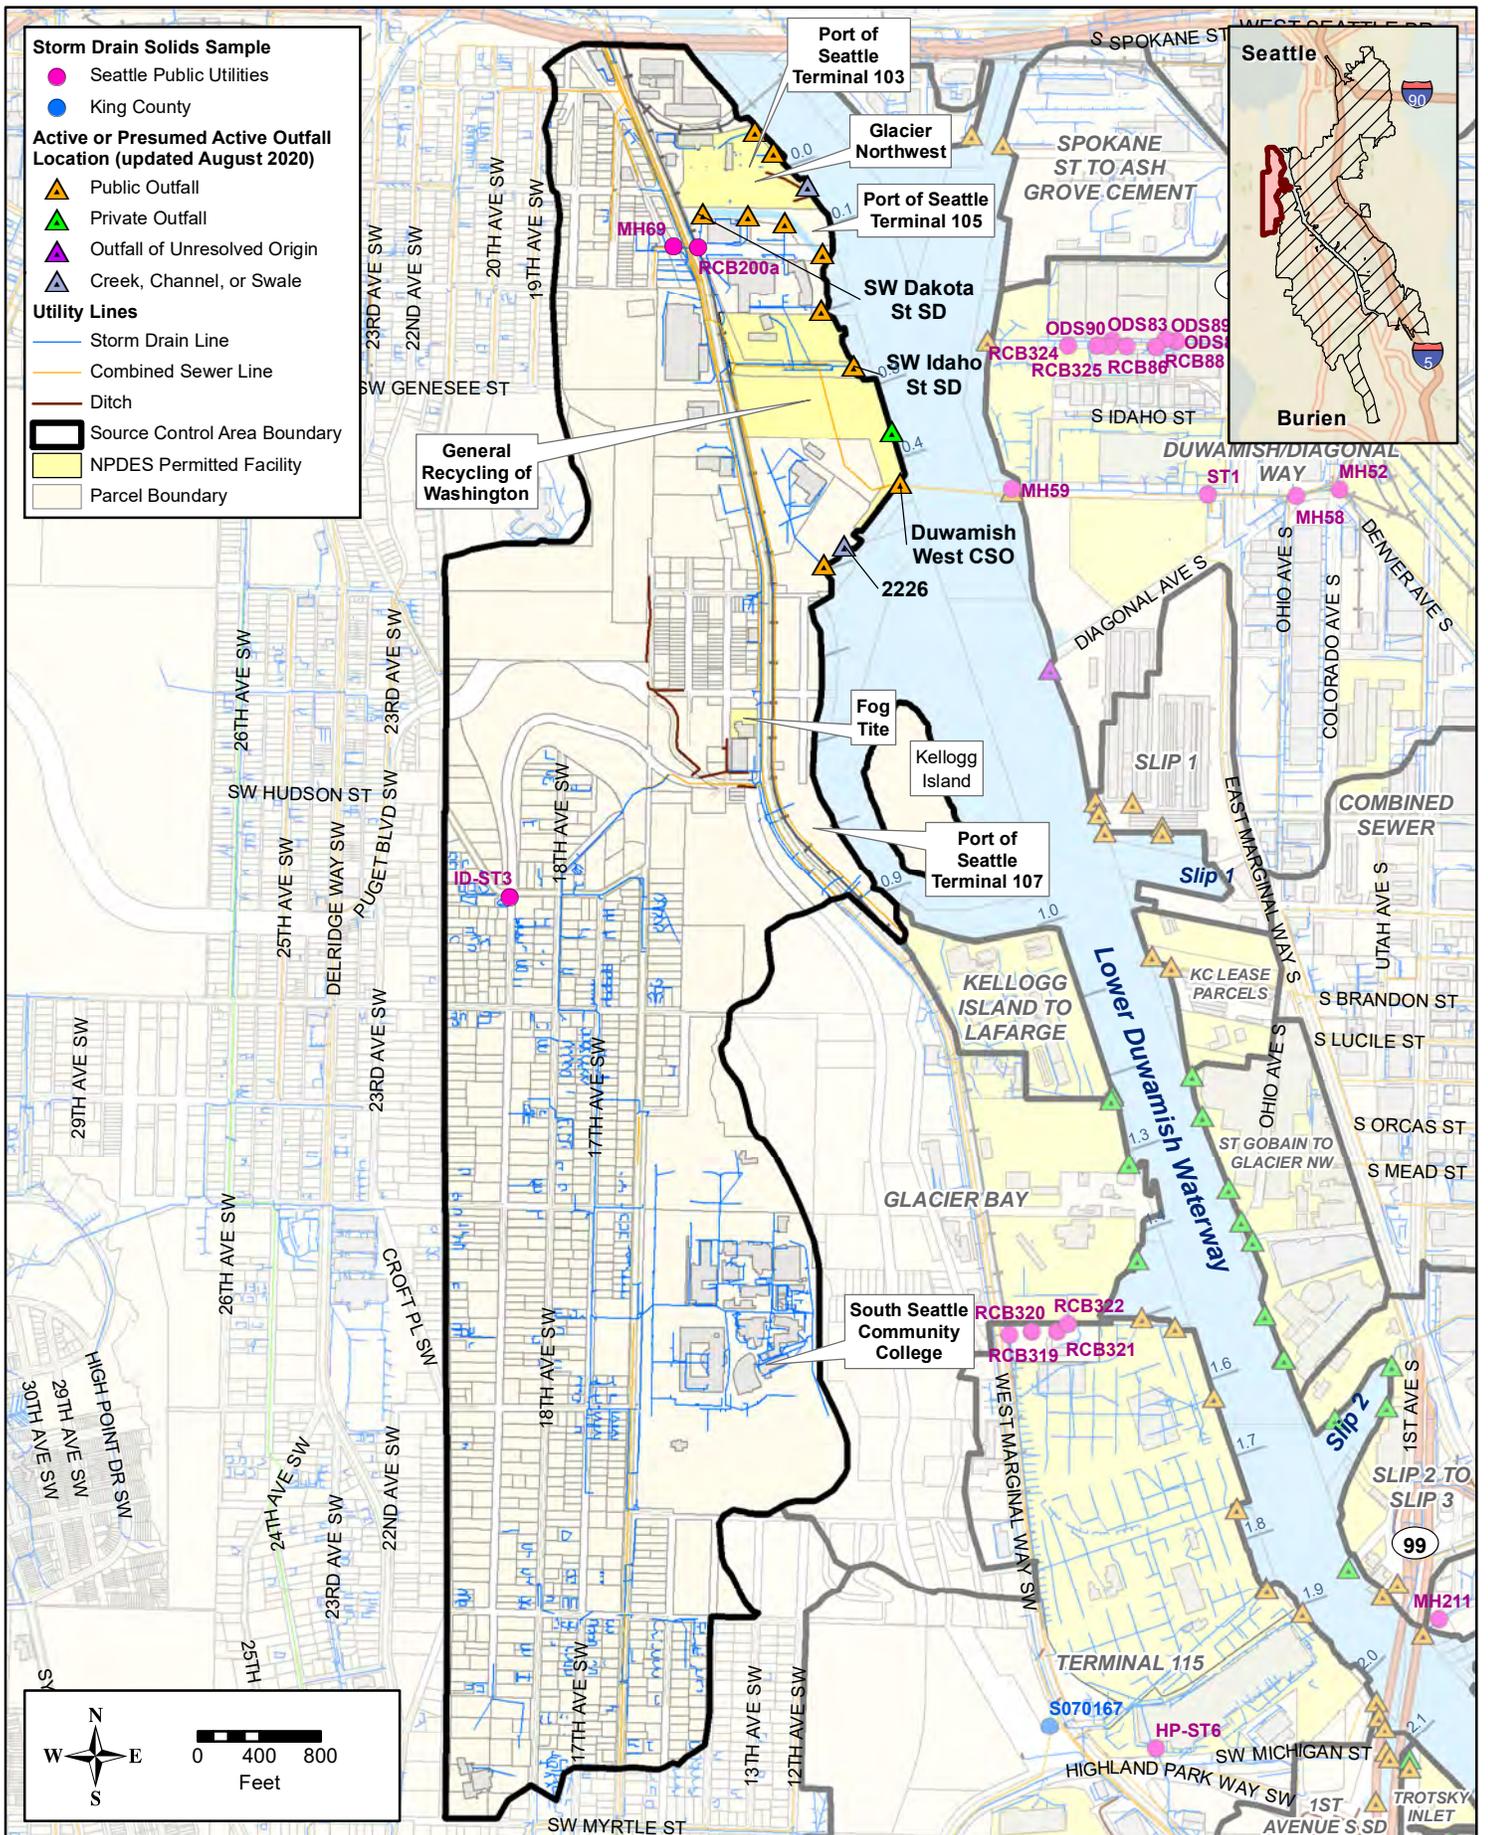
**Figure A-29. RM 0.0-1.0 West  
(Spokane Street to Kellogg Island)  
Source Control Area**
