STORMWATER REPORT FOR

INVENTECH MARINE SOLUTIONS

CITY OF BREMERTON SITE PLAN REVIEW & SITE DEVELOPMENT PERMIT APPLICATIONS

K. Pat Fuhrer, P.E. MAP, Ltd. (Job #6823)

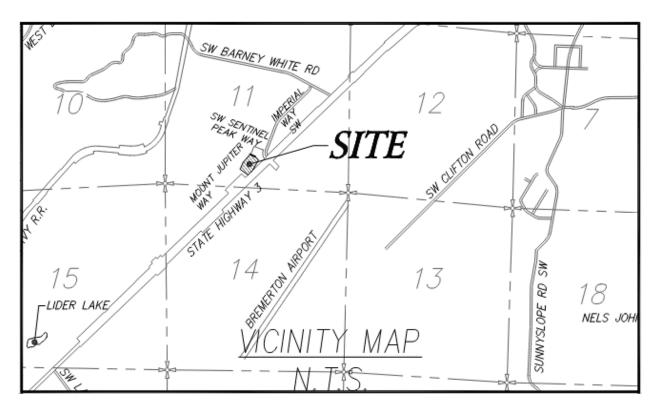
B. VICINITY MAP

The subject property is 4.41 acres in size and is leased land from the Port of Bremerton. It is located southwesterly of SW Sentinel Peak Way and west of State Route 3 on property previously containing the Norseland Mobile Home Park prior to it's abandonment and reclamation of the adjacent landfill cap in 2001.

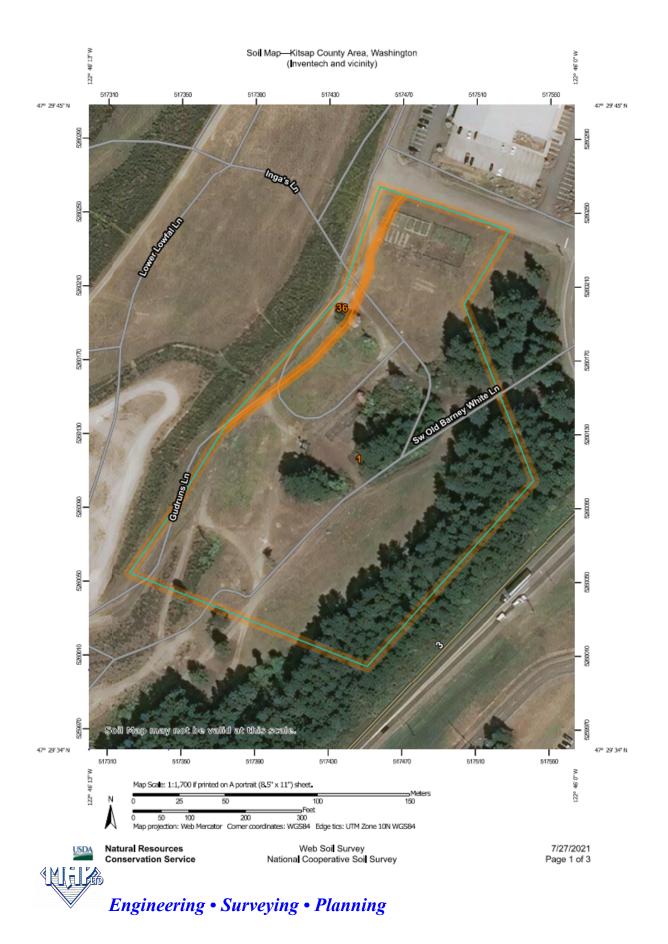
Inventech and vicinity

According to soils reports from surrounding projects and NRCS Soil Maps, the underlying soils, which have been greatly disturbed and compacted from previous land use activities, generally consist of gravelly sandy loam, and more specifically Alderwood-series soils for this portion of the site, which are not conducive to infiltrating site runoff. The site lies at a topographic high point, and compacted glacial till soils are present.

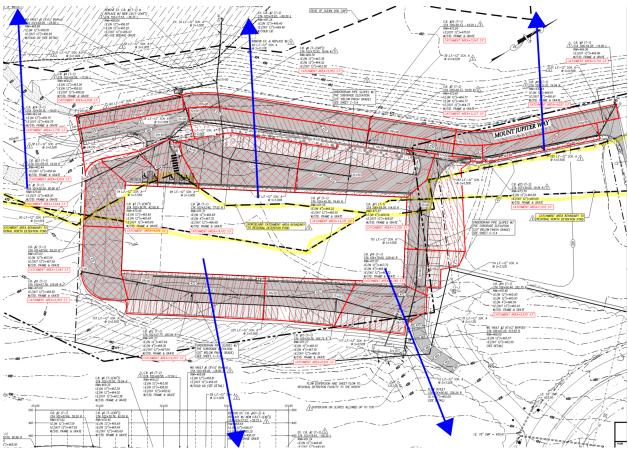
The west basin of the Inventech site drains to the Norseland Regional Detention Pond which was sized based on an assumed Impervious Surface coverage of 66% from the regional pond facility upstream catchment area of 30.6 acres. The catchment boundary is shown on the project plans and highlighted below:

Referenced calculation pages and plans from the Norseland Pond Golder report are included in the appendices. Since this project is the first project constructed in the Norseland Regional Pond catchment area, the proposed impervious surface area draining to it (107,200 s.f.-Page 10) amounts to 8% of the allocated 66%, so 58% impervious is available impervious surface area remaining in the 30.6 acre basin. As noted earlier, this detention facility is proposed to be

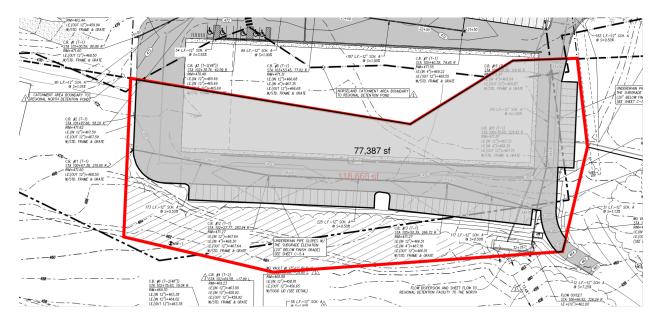
The east basin of the Inventech lies in Basin C which drains to the Regional Detention Pond lying north of Imperial Way which was sized based on an assumed 85% impervious surface coverage from Basin C's 10.3 acre upstream "Industrial Area" catchment designation. This catchment area "C" boundary on the Inventech site is shown on the illustration on the previous page, and was taken from Figure 2.4 in appendix C. As shown below, the amount of impervious area of the proposed project that lies within the industrial portion area of Basin C (118,668 s.f.) is 77,387 s.f, or 65%, well below the 85% coverage assumed for sizing the Northern Regional pond.

Referenced calculation pages and plans from the Phase 1 Regional Stormwater Detention Facilities Cosmopolitan Engineering Group report are included in the Appendix C.

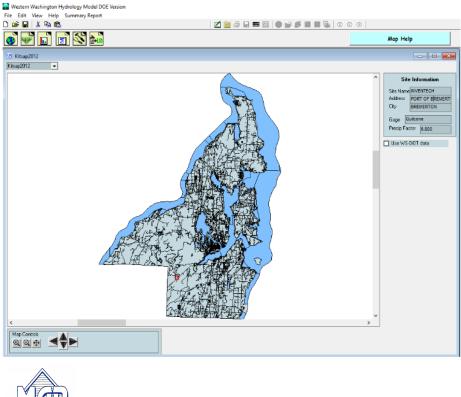
The off-line water quality flow rate estimated from the 2012 WWHM is presented below and then used to specify the BiopodTM vault configuration. This vault contains an internal bypass that bypasses flows greater than the WQ design flow therefore the off-lime water quality flow rate is used from the 2012 WWHM model

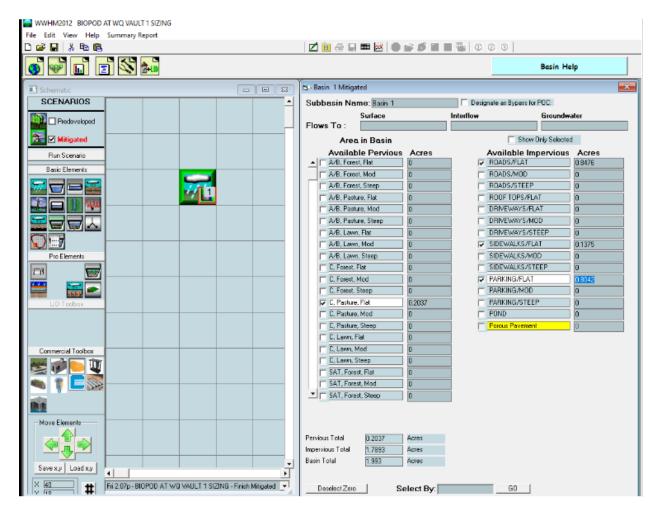
The pervious and impervious surface areas from the west basin shown on pages 9 & 10 are inputted here: 0.2037 Ac. Pasture (Landscaping & Amended Soils), 0.8476 Ac Roadway Flat, 0.1375 Ac. Sidewalk Flat, and 0.8042 Ac. Parking Flat

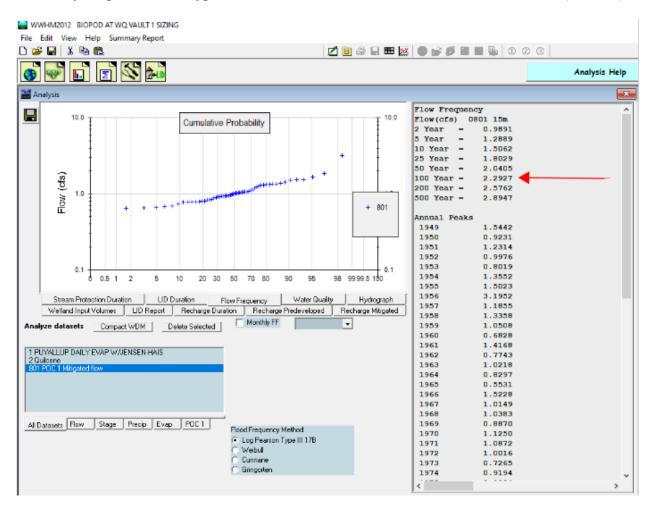
The 100-yr required vault bypass flow rate from the west basin was then determined (2.29 cfs):

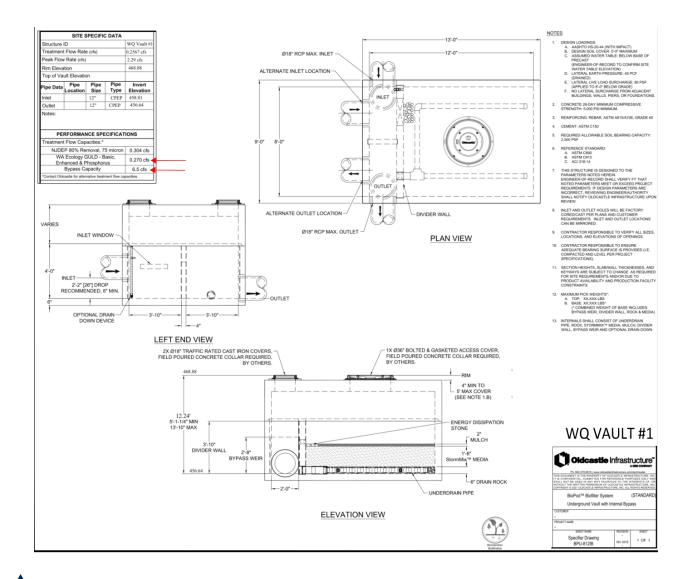
The Biopod Biofilter Underground vault has an internal bypass, so the off-line flow rate of 0.2567 cfs will be used to size the vault and cartridge configuration. A model BPU-812IB 6'x12' vault was found to meet this criteria, with a treatment capacity of 0.27 cfs. Note that the internal bypass capacity of this vault is 6.5 cfs, greater than the 100-yr peak flow from the west basin of 2.29 cfs.

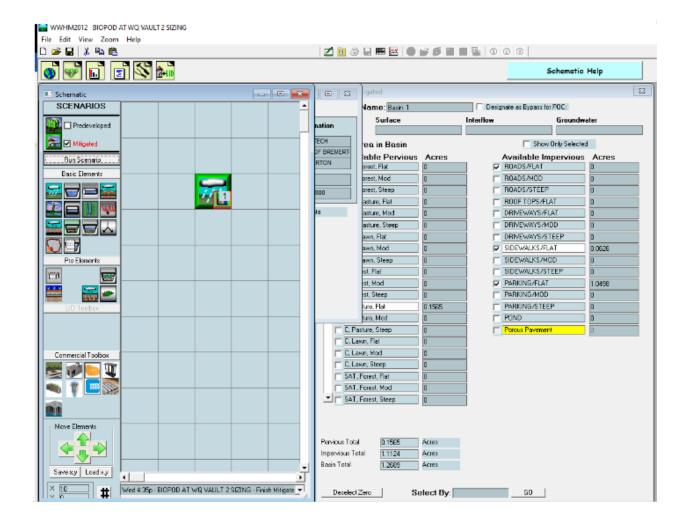
The pervious and impervious surface areas from the west basin were taken from the areas from Pages 9 & 10 and inputted here: 0.1565 Ac. Pasture (Amended Soils), 0.0626 Ac. Sidewalk, and 1.0498 Ac. Parking Flat

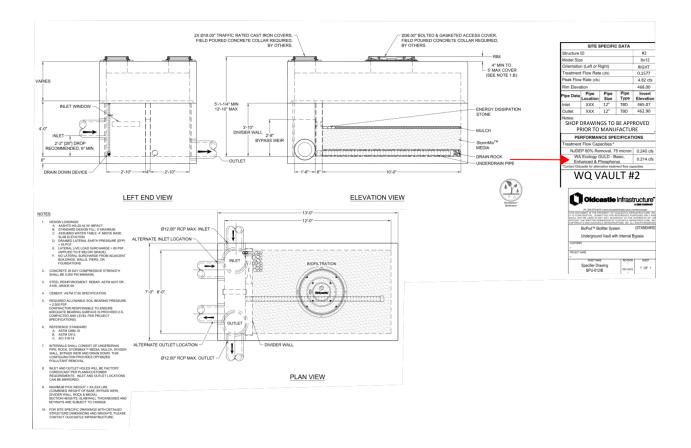
The Biopod Biofilter Underground vault has an internal bypass, so the off-line flow rate of 0.1594 cfs will be used to size the vault and cartridge configuration. Note that the internal bypass capacity of this vault is 4.82 cfs, greater than the 100-yr peak flow from the east basin of 1.44 cfs. Model BPU-612IB 6'x12' vault was found to meet this criteria with a treatment flow rate capacity of 0.214 cfs and is specified on the plans as WQ Vault #2.

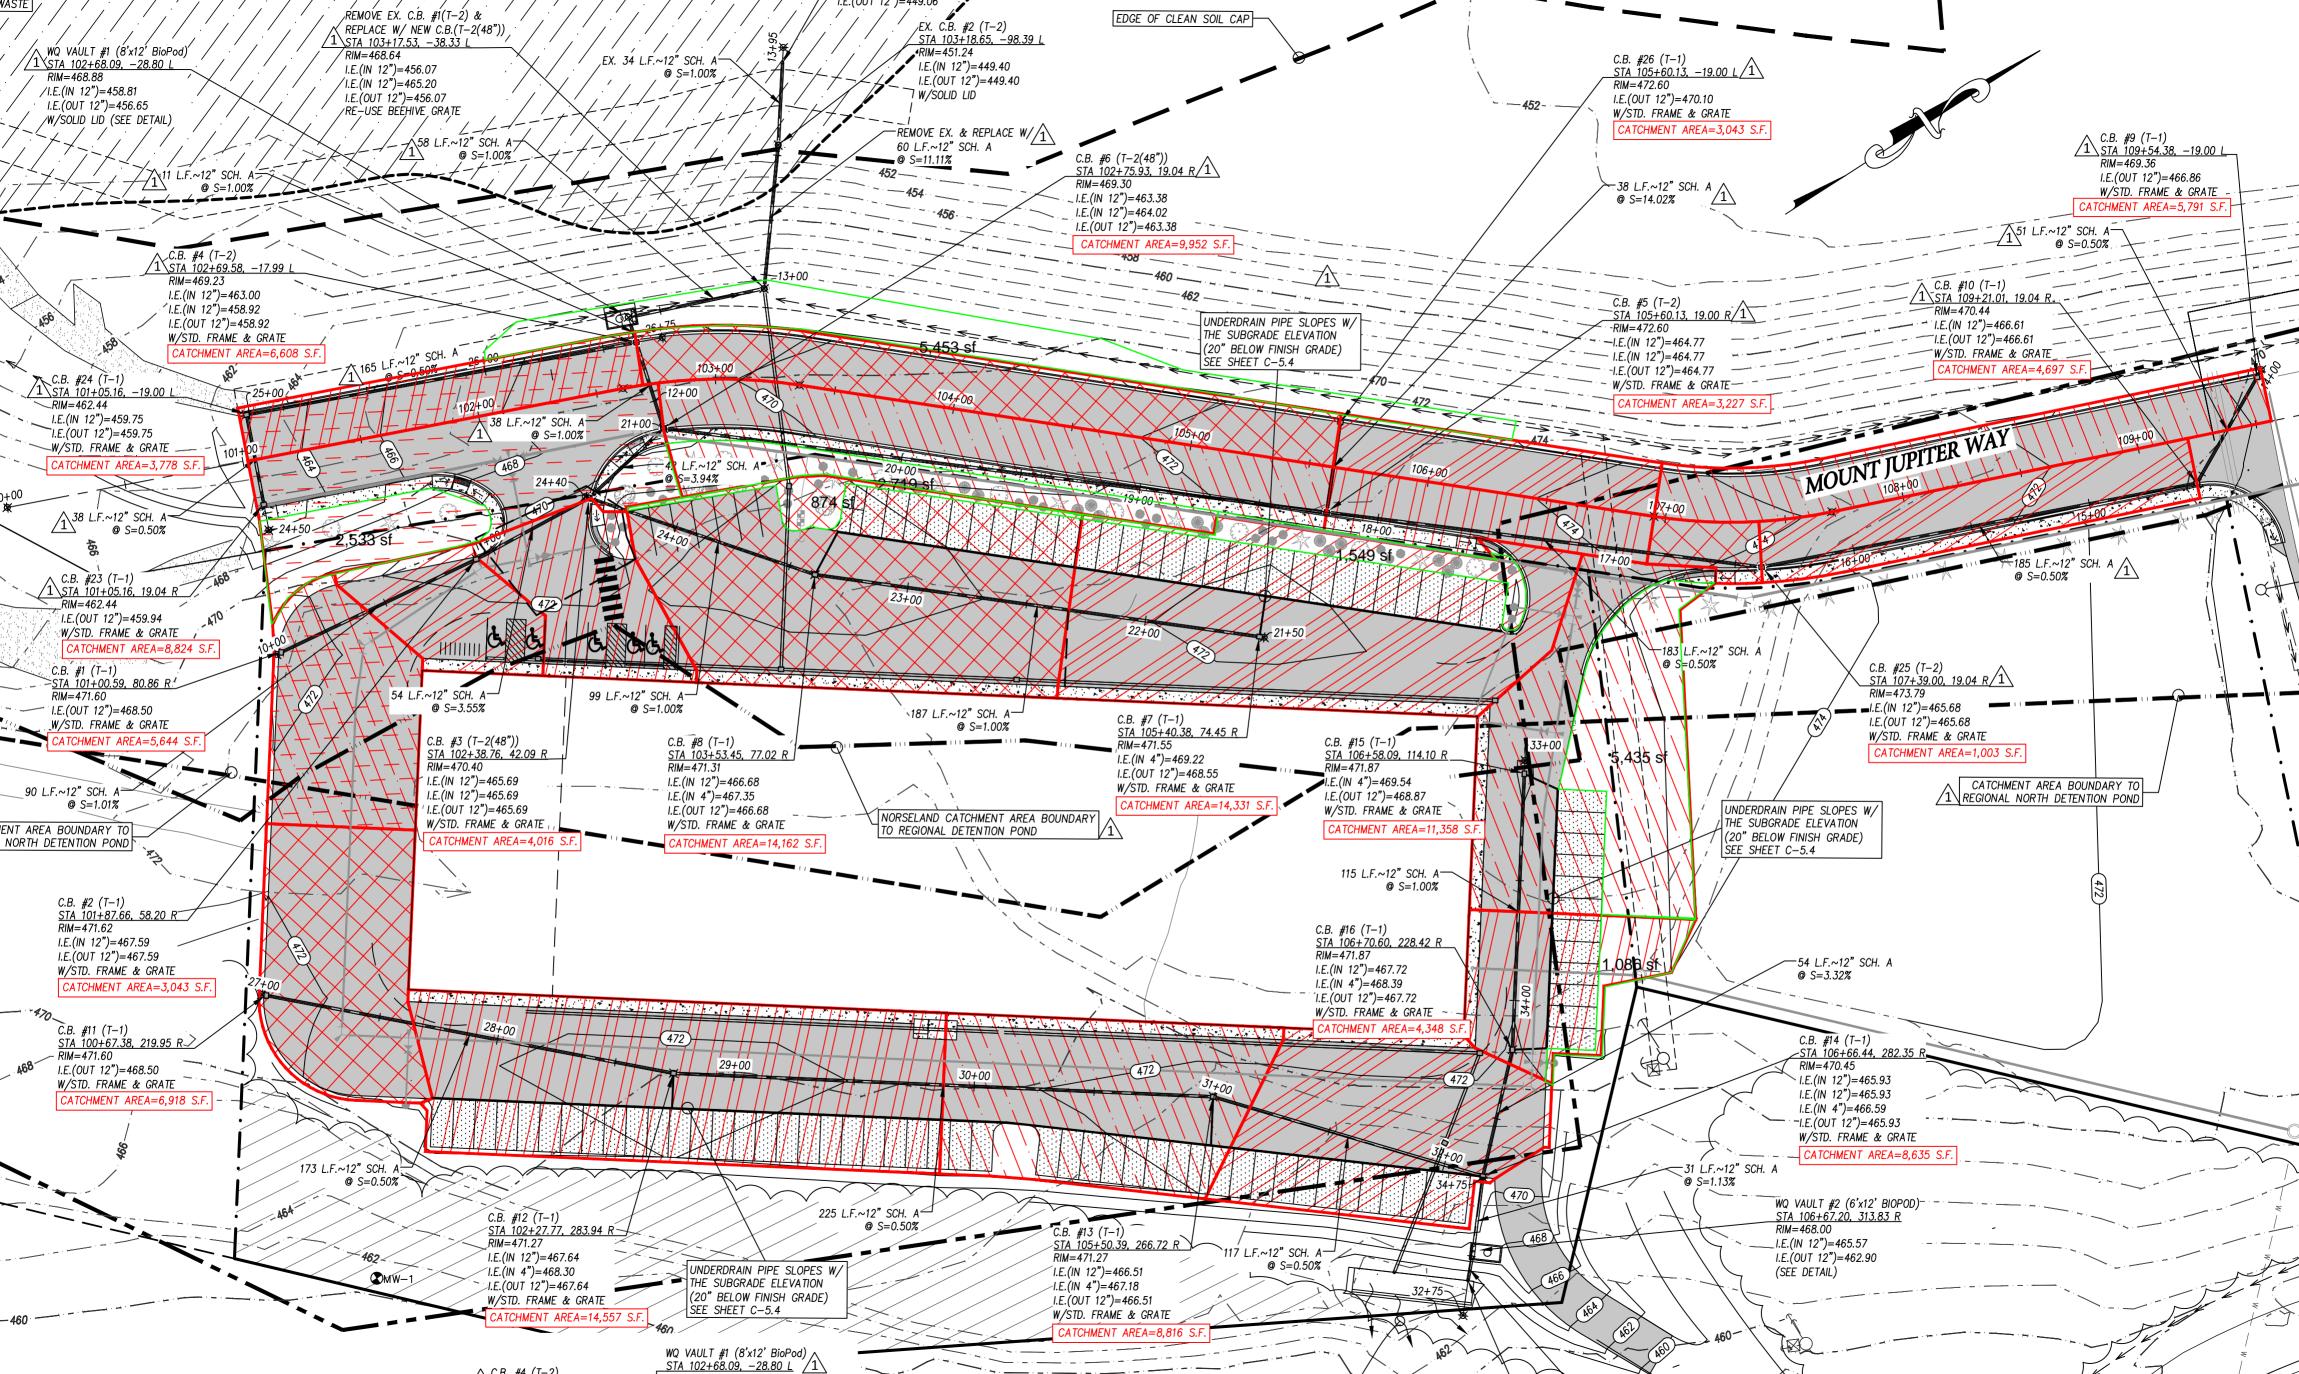
The Santa Barbara Urban Hydrograph method was used in the Autodesk Storm Analysis 2021 computer model to perform a backwater flow analysis and verify gravity-flow pipe capacities for the project for a 100-yr, 24 hour peak rainfall event of 6.5" on pages 28-43.

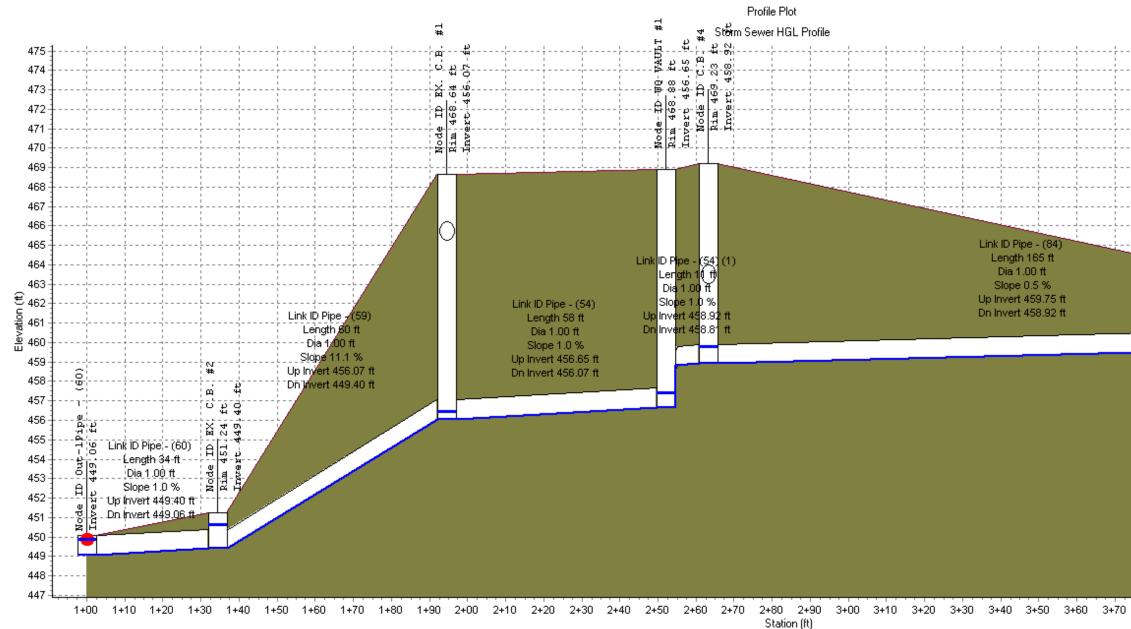
Station (it)		
Node ID:			EX. C	.B. #2	EX. C.	.B. #1	WQ VA	ULT #1	3. #4	C.B. #24	C.B. #23
Rim (ft):			45	1.24	468	3.64	468	3.88 46	9.23	462.44	462.44
Invert (ft):	44	9.06	449	3.40	456	6.07	456	6.65 49	8.92	459.75	459.94
Min Pipe Cover (ft):			0.	84			9.	07 !	.23		
Max HGL (ft):	44	9.86	450	0.62	456	5.44	457	7.37 4!	9.75	460.02	460.18
Link ID:		Pipe -	· (60)	Pipe	- (59)	Pipe	- (54) Pij	pe - (54)	(1) Pipe - (84)	Pipe	: - (85)
Length (ft):		34	ļ	6	0	5	3	11	165		38
Dia (ft):		1.0	10	1.0	00	1.0)0	1.00	1.00	1	00
Slope (%):		1.0)	11	.1	1.	0	1.0	0.5	0	.5
Up Invert (ft):		449.	40	456	6.07	456	.65	458.92	459.75	45	9.94
Dn Invert (ft):		449.	.06	449	9.40	456	.07	458.81	458.92	45	9.75
Max Q (cfs):		3.7	7	3.1	77	2.5	59	2.59	0.43	0	29
Max Vel (ft/s):		5.0	15	6.5	57	5.8	38	4.30	0.98	1	87
Max Depth (ft) Autor		1 0.9	IN Marina A ura A ura	0.1	69	0.5		0.72	0.55	0	25
Autoo	aesk S	storm and San	itary Analys	IS

B. #24 			#23	£14
				Node ID C.B. 3 Rim 462.44 ft Invert 459.75	Link ID I Leng Dia Up Inve	Pipe - (8 th 38 ft 1.00 ft e 0.5 % rt 459.94 rt 459.75	ž.	44 159.
							t	
3+8	0 3+:	90 4+(0 4+20	4+30	4+40	4+50	4+60	4+70

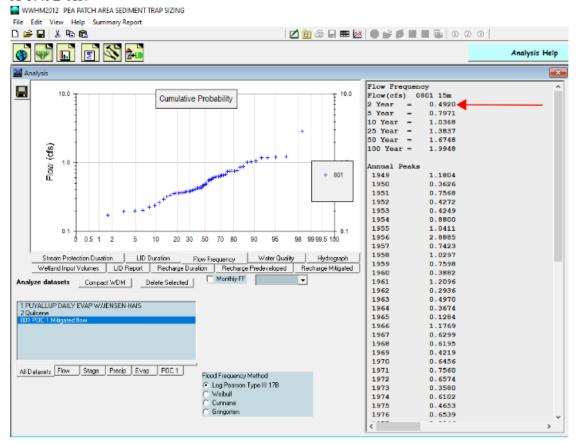
A Sediment Trap is proposed for this 1.82 acre catchment, and using "C, Lawn Flat" as the upstream catchment area developed condition, and the 2012 WWHM estimates a 2-yr peak flow of 0.492 cfs:

Sizing the required Sediment Trap surface area size per BMP C240, the surface area at the overflow weir elevation is 2080 square feet per cfs of inflow, or (2080)(0.492)=**1,023 s.f. minimum**, and is shown on Sheet C-3.0

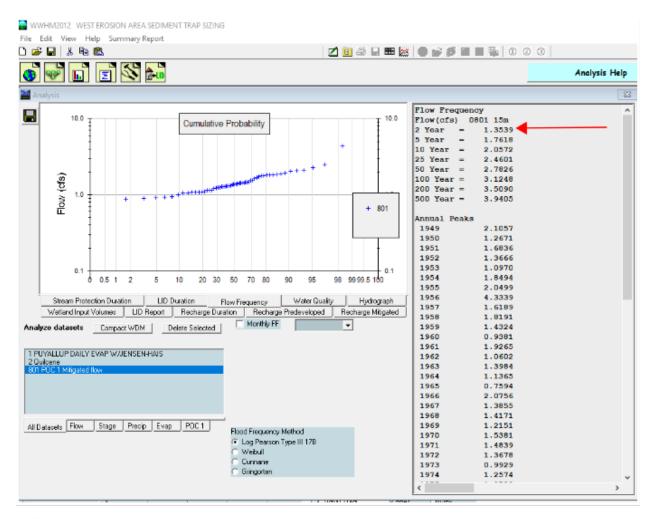
A Sediment Trap is proposed for this 2.66 acre catchment, and using the developed condition coverage used to size WQ Vault #1 and adding one-half of the roof area as the upstream catchment area during construction, and the 2012 WWHM estimates a 2-yr peak flow of 1.36 cfs:

Sizing the required Sediment Trap surface area size per BMP C240, the surface area at the overflow weir elevation is 2080 square feet per cfs of inflow, or (2080)(1.36)=**2,828 s.f. minimum**, and is shown on Sheet C-3.0

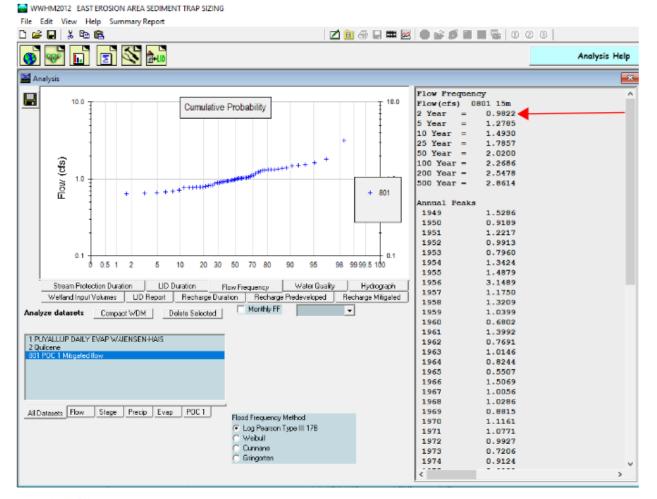
A Sediment Trap is proposed for this 2.47 acre catchment, and using the developed area used to size WQ Vault #2 plus one-half of the roof area as the upstream catchment area during construction, the 2012 WWHM estimates a 2-yr peak flow of 0.982 cfs:

Sizing the required Sediment Trap surface area size per BMP C240, the surface area at the overflow weir elevation is 2080 square feet per cfs of inflow, or (2080)(0.982)=**2,043 s.f. minimum**, and is shown on Sheet C-3.0

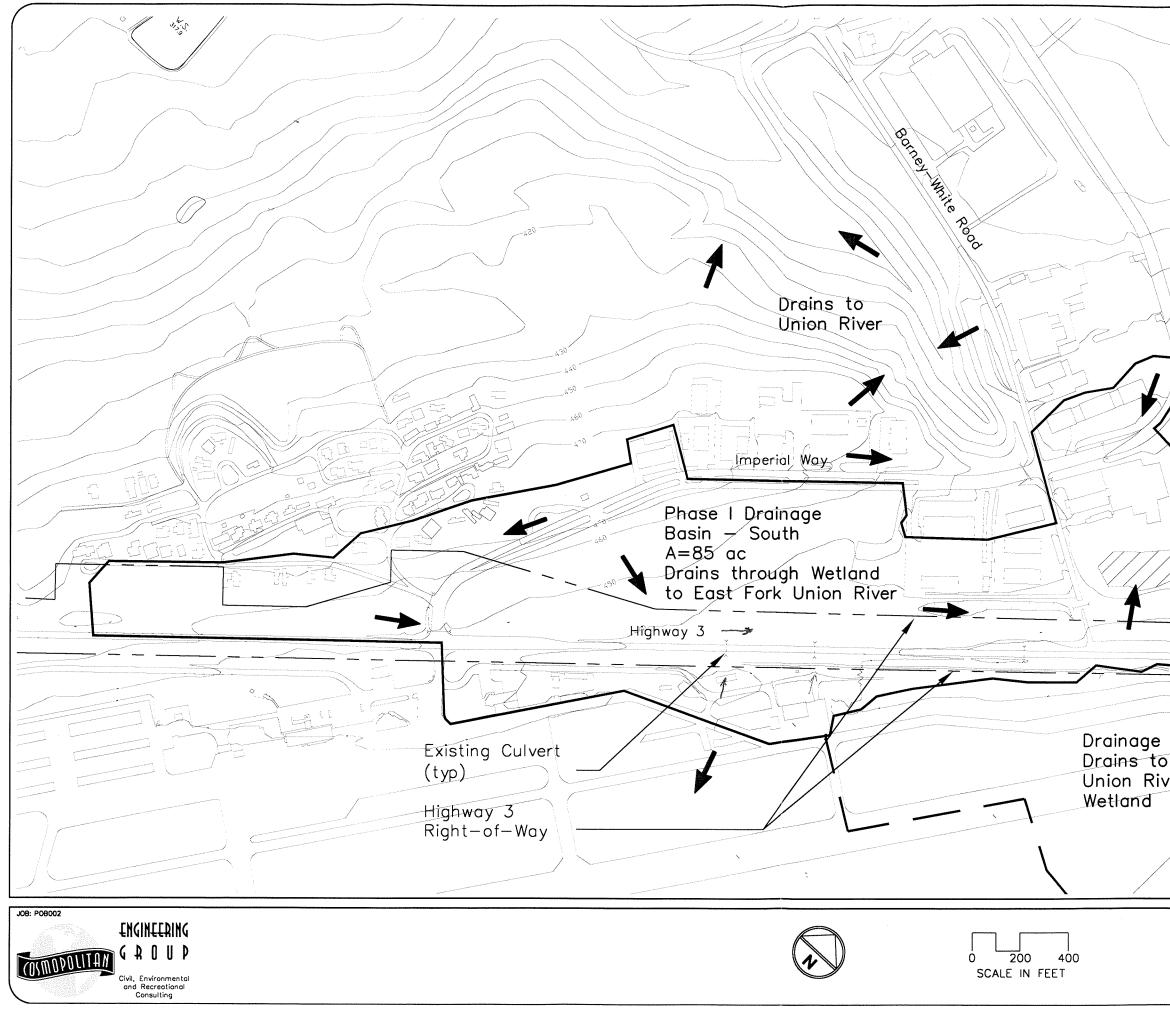
Figure 2.1 Existing Conditions Phase I Drainage Basins

Phase | Drainage Basin – North A=11 ac Drains to East Fork Union River Forle Un Bypasses Wetland Existing Wetland Drainage Basin Drains to East Fork Union River, Bypasses

The east basin also flows as sheet flow through the previously-developed Norseland mobile home park portion of the site before dispersing into the native vegetation understory and forested area parallel to SR 3 in the WSDOT SR 3 right-of-way. Runoff enters one of two 18" culverts located near the intersection of Imperial Way and SR 3, and then flowing to the north along SR 3 in existing channels that discharge to the regional storm water detention facility constructed for this area of the Port property. This regional detention pond facility discharges to the East Fork of the Union River as shown in figure 2.1 of Exhibit C.

The small northerly portion of the Phase I area covers 11 acres and drains directly to the East Fork of the Union River, bypassing the natural wetland. The entire Phase I drainage basin is shown in Figure 2.1.
